**COLORADO DIVISION OF RECLAMATION, MINING AND SAFETY**  
**MINERALS PROGRAM INSPECTION REPORT**  
**PHONE: (303) 866-3567**

<b>MINE NAME:</b> Cooley Reservoir & Fulton Wildlife Area	<b>MINE/PROSPECTING ID#:</b> M-1999-034	<b>MINERAL:</b> Sand and gravel	<b>COUNTY:</b> Adams
<b>INSPECTION TYPE:</b> Monitoring	<b>INSPECTOR(S):</b> Tyler V. O'Donnell	<b>INSP. DATE:</b> August 19, 2015	<b>INSP. TIME:</b> 09:00
<b>OPERATOR:</b> Aggregate Industries - WCR, Inc.	<b>OPERATOR REPRESENTATIVE:</b> Connie Davis and Mike Refer	<b>TYPE OF OPERATION:</b> 112c - Construction Regular Operation

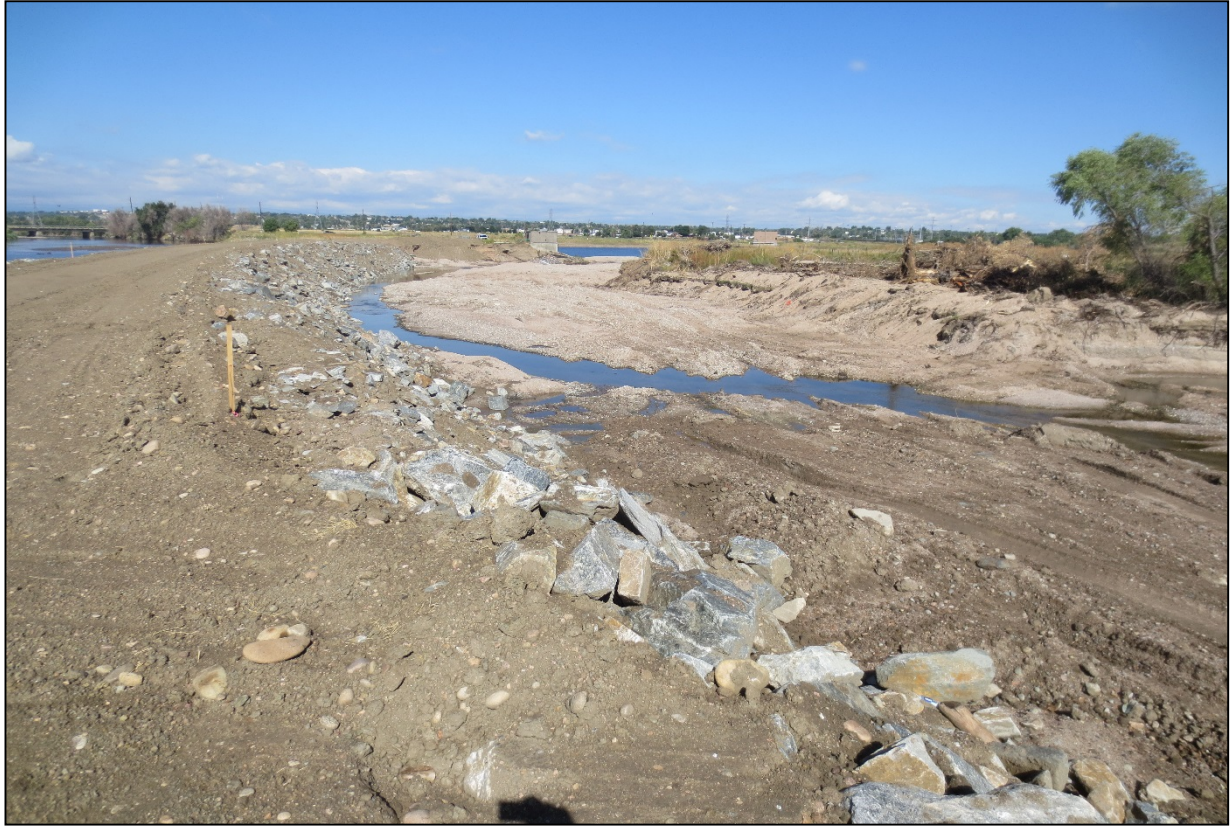
During the inspection, the Division observed the reconstructed earthen embankment between the River and Phase 2 (Photo 1 and 2). The embankment was reconstructed in the same place as where it was prior to the 2013 flood and the 2015 flood. It appears that the embankment had been constructed with on-site overburden and riprap. The core of the embankment appears to have been constructed with a mixture of overburden and riprap. The outsides of the embankment appear to have been armored with riprap. The embankment was approximately 15 to 20 feet wide and approximately 10 feet high. The slopes of the embankment ranged between 1H:1V to 2.5H:1V. The entire embankment along phase 2 and the River had been stabilized and/or repaired. The River appeared to be back in the main channel. Very little water was flowing into phase 2 from the River. The water flowing into phase 2 from the River was only seepage through the earthen embankment (photo 3).

**Photo 1:** Earthen embankment between the South Platte River and Phase 2.

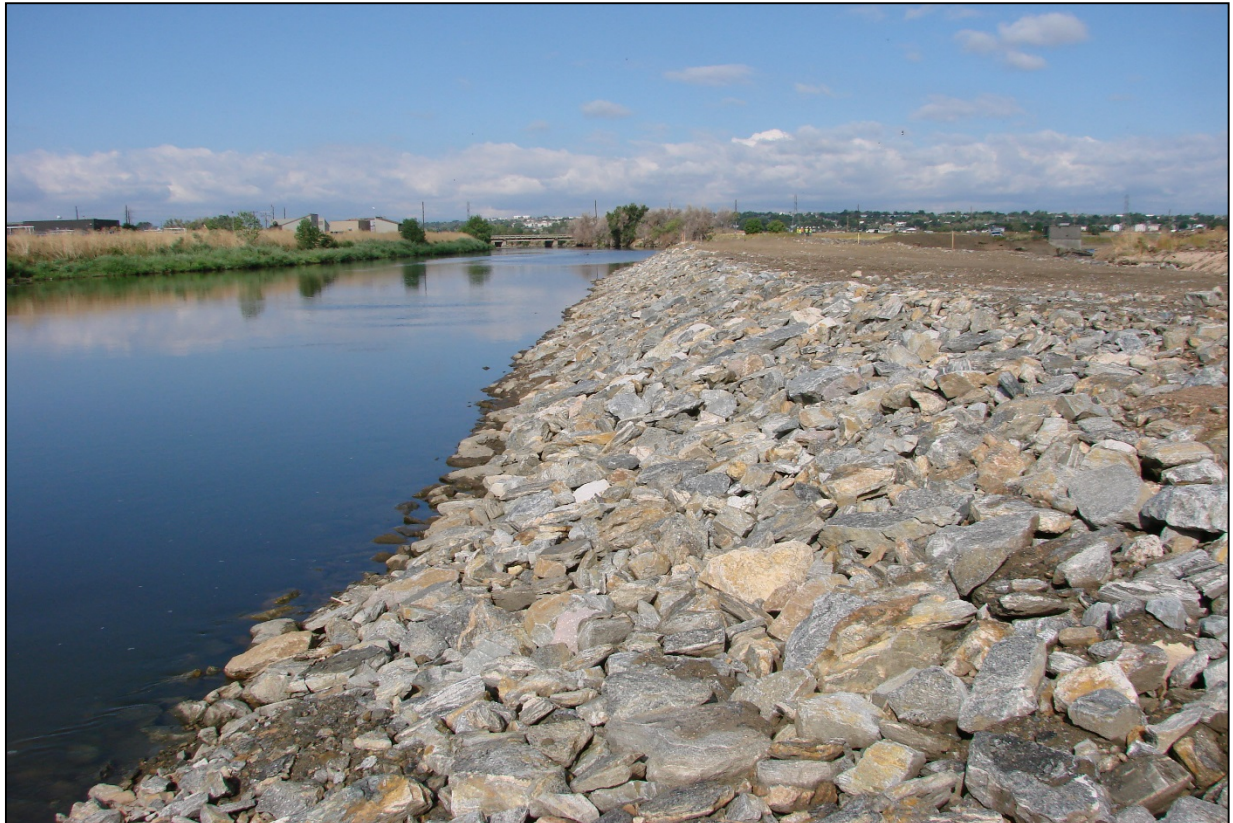
**Photo 2:** Earthen embankment between the South Platte River and Phase 2. Well armored side facing the South Platte River.

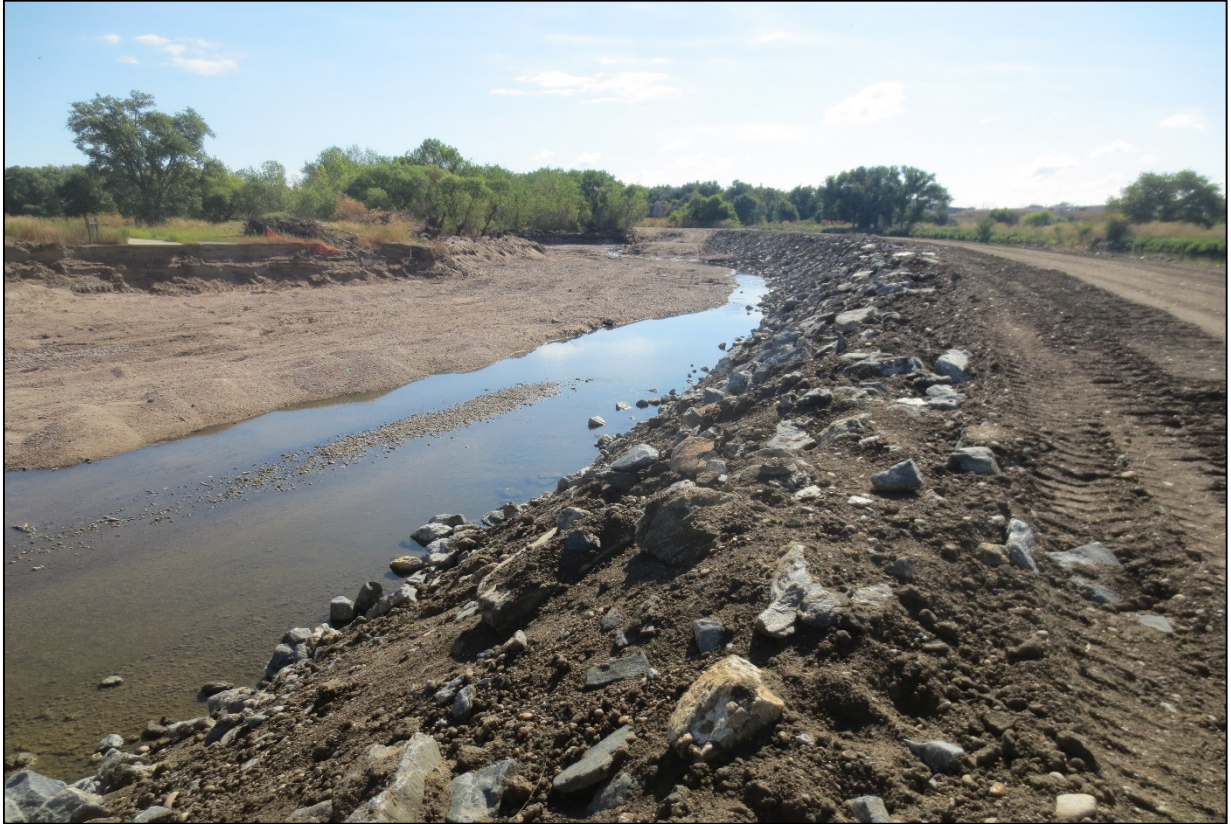
**Photo 3:** Seepage coming through the earthen embankment between the South Platter River and Phase 2.

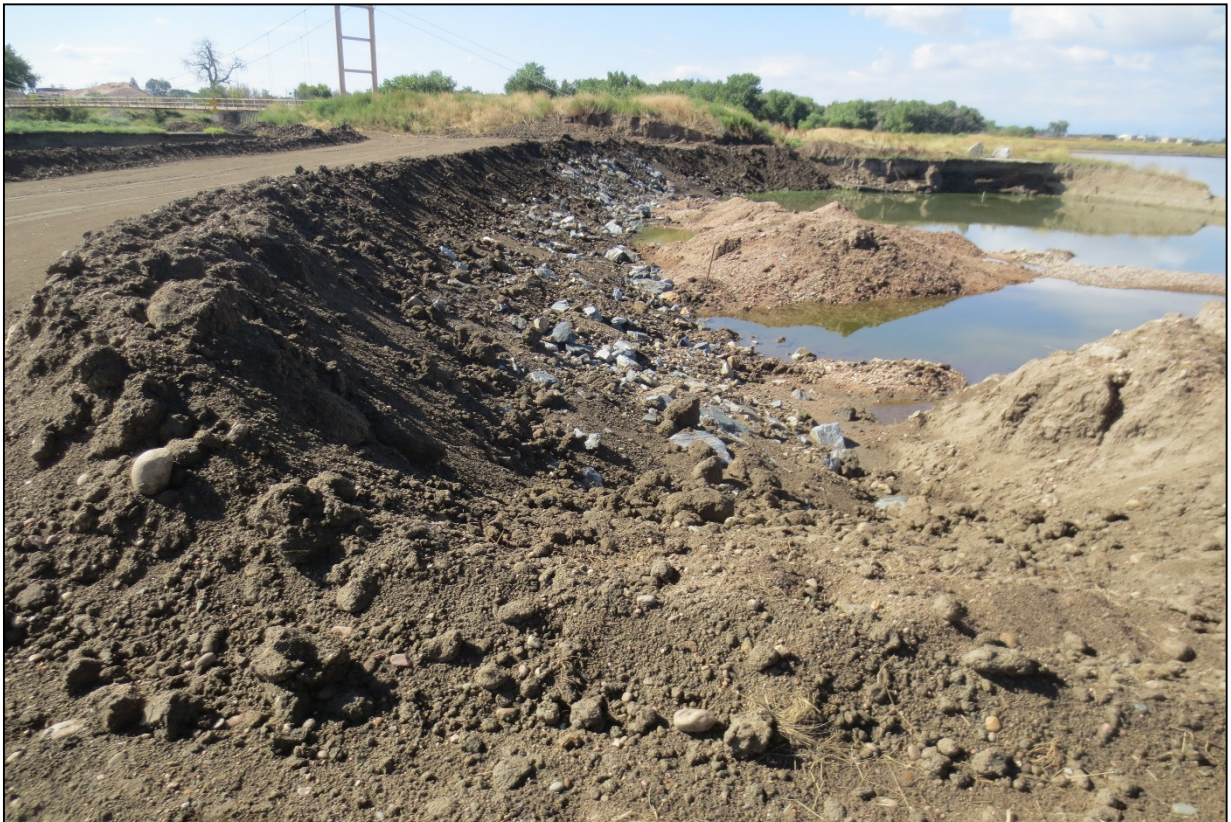
After observing the repairs between phase 2 and the River the Division went to phase 3 to observe and evaluate the repair work between phase 3 and the River. The land between phase 3 and the River was previously eroded after the failure at phase 2, water entering phase 2 exited through phase 3. The area between phase 3 and the River was eroded by water flowing out of the reservoir back to the River. The Division observed an area where an earthen embankment had been placed between phase 3 and the River preventing water from flowing into the River and vice versa (photo 4 and 5). It appears that the embankment had been constructed with on-site overburden and riprap. The core of the embankment appears to have been constructed with a mixture of overburden and riprap. The outsides of the earthen embankment appear to have been armored with riprap. The embankment was approximately 15 to 20 feet wide and approximately 10 feet high. The slopes of the earthen embankment ranged between 1H:1V to 2.5H:1V. No water was observed flowing from phase 3 to the River. No water appeared to be seeping through the earthen embankment.

**Photo 4:** Earthen embankment between the Phase 3 and the South Platte River.

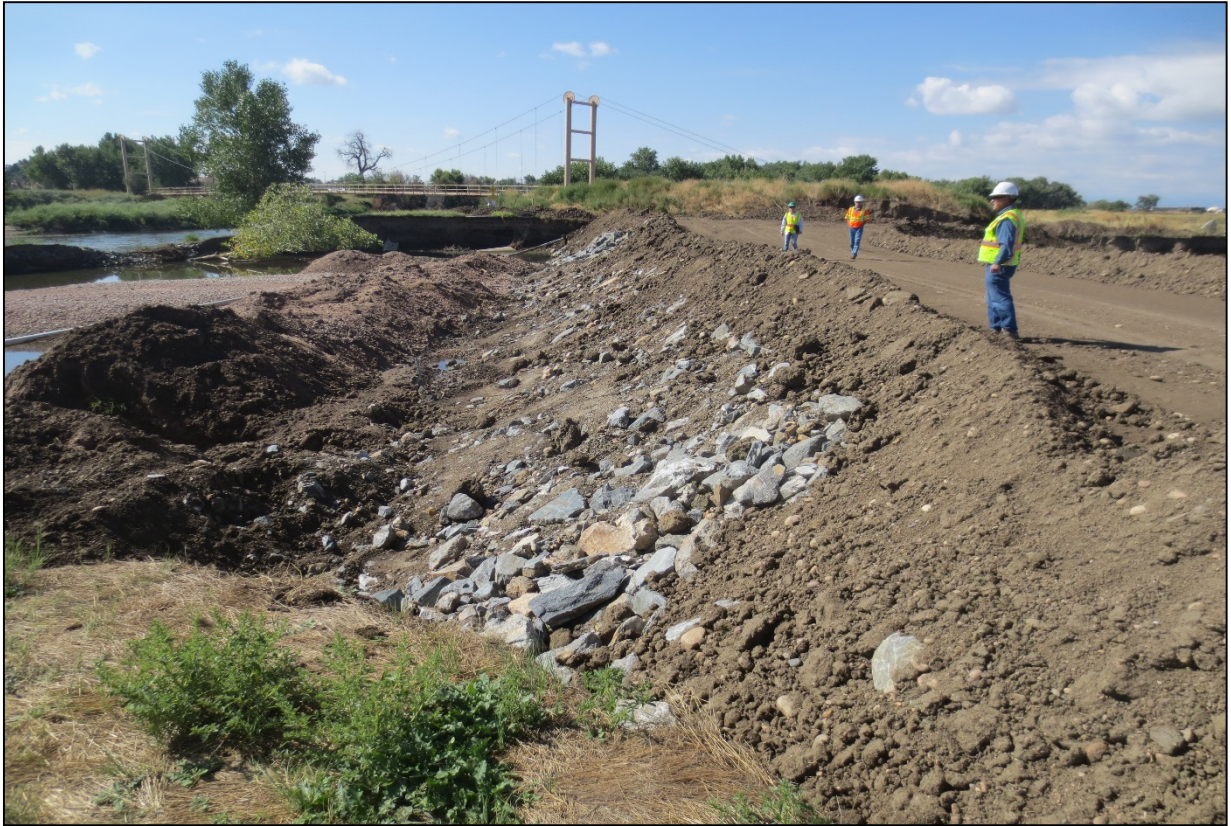
**Photo 5:** Earthen embankment between the Phase 3 and the South Platte River.

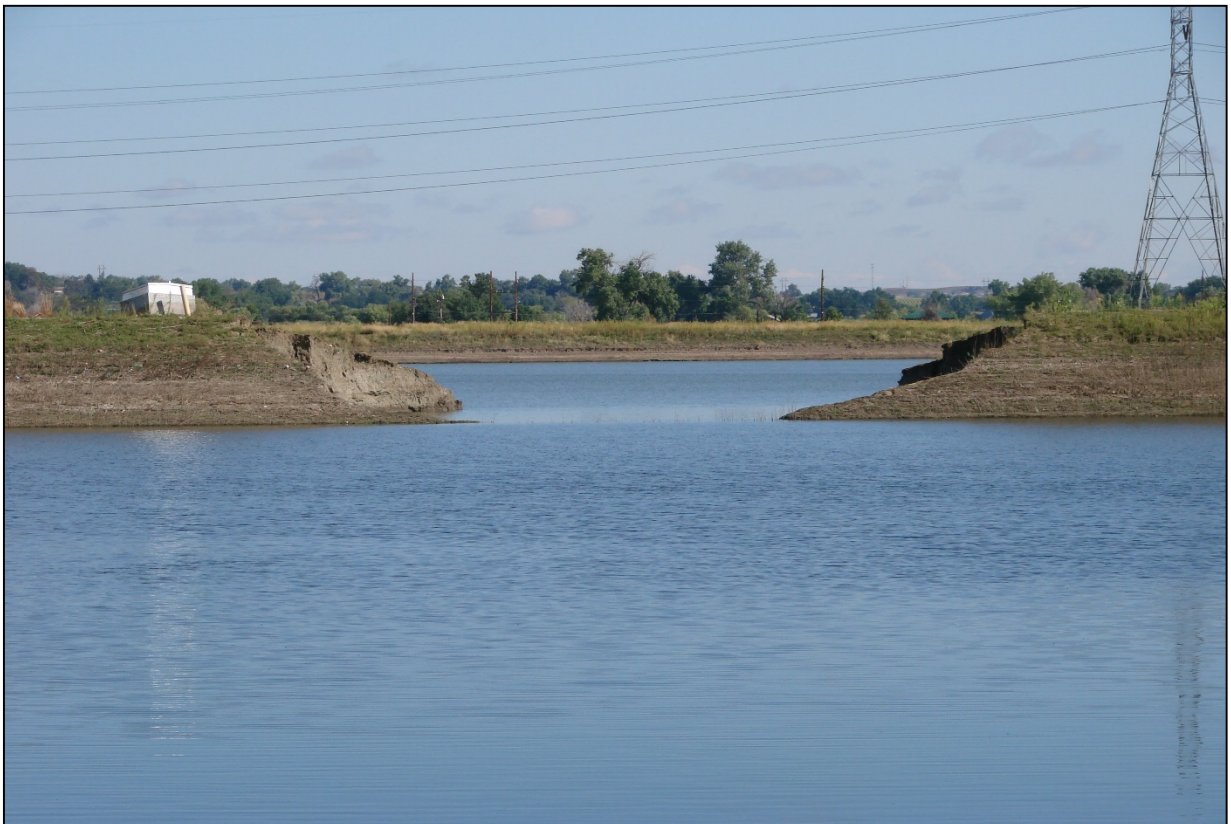
**Photo 6:** Damaged earthen embankment between the Phase 2 and Phase 3.

The repair work appeared to be adequate for temporary stabilization and keeping the South Platte River within the original river channel. Additional work will need to be conducted at the site to repair the damage to the slurry wall, earthen embankment, River embankment and reservoir slopes. Also Additional work will need to be conducted at the site to prevent future damage. In general the slopes will need to be graded to 3H:1V or flatter, damaged sections of the slurry wall will need to be repaired and all disturbed areas will need to be revegetated. The Division will continue to work closely with the Operator and the City of Thornton to make sure adequate repairs are conducted. The Division will work closely with the Operator to evaluate and approve a plan for inlet and outlet flood control structures.
