COLORADO DIVISION OF RECLAMATION, MINING AND SAFETY
MINERALS PROGRAM INSPECTION REPORT
PHONE: (303) 866-3567

MINE NAME: Franson Pit	MINE/PROSPECTING ID#: M-2014-051	MINERAL: Sand and gravel	COUNTY: Yuma
INSPECTION TYPE: Monitoring	INSPECTOR(S): Elliott R. Russell	INSP. DATE: July 10, 2015	INSP. TIME: 08:15
OPERATOR: Franson Family Partnership, a Limited Partne	OPERATOR REPRESENTATIVE: Derek Bueltell	TYPE OF OPERATION: 110c - Construction Limited Impact

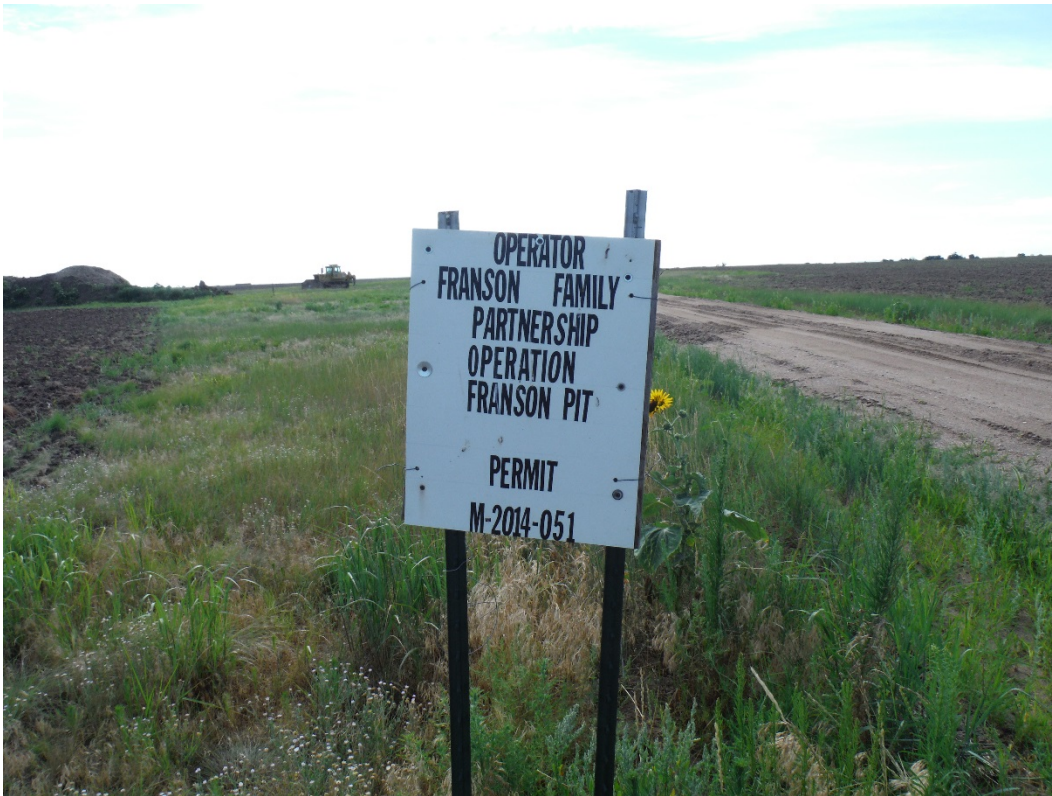
Permit identification sign at the entrance of the access road; looking east.

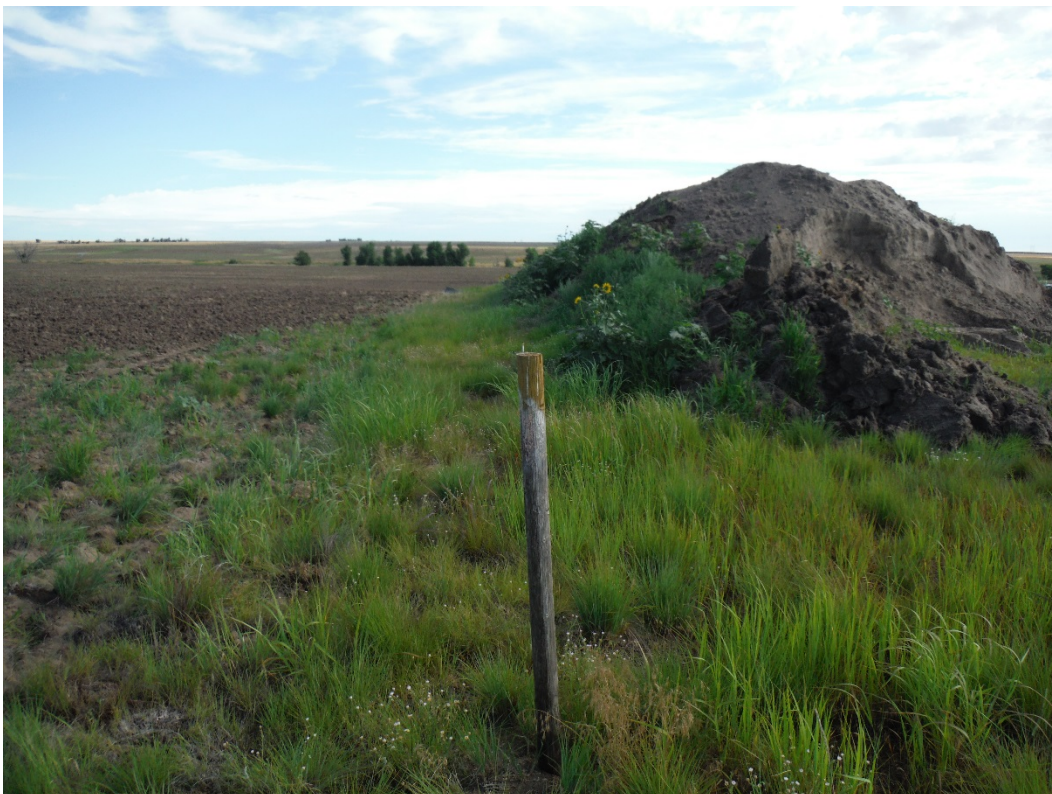
PROBLEM/POSSIBLE VIOLATION: Problem 1: The affected area boundary markers are missing or incorrectly placed. This is a problem for failure to maintain boundary markers around the affected area as required by Rule 3.1.12(2).

Southwest boundary marker and topsoil stockpile from southwest pit; looking north.

CORRECTIVE ACTIONS: The operator shall conduct a survey and replace the boundary markers in the correct location(s). The operator shall provide photographic proof to the Division that this has been done by the corrective action date. The Operator shall also provide coordinates of all the boundary markers.

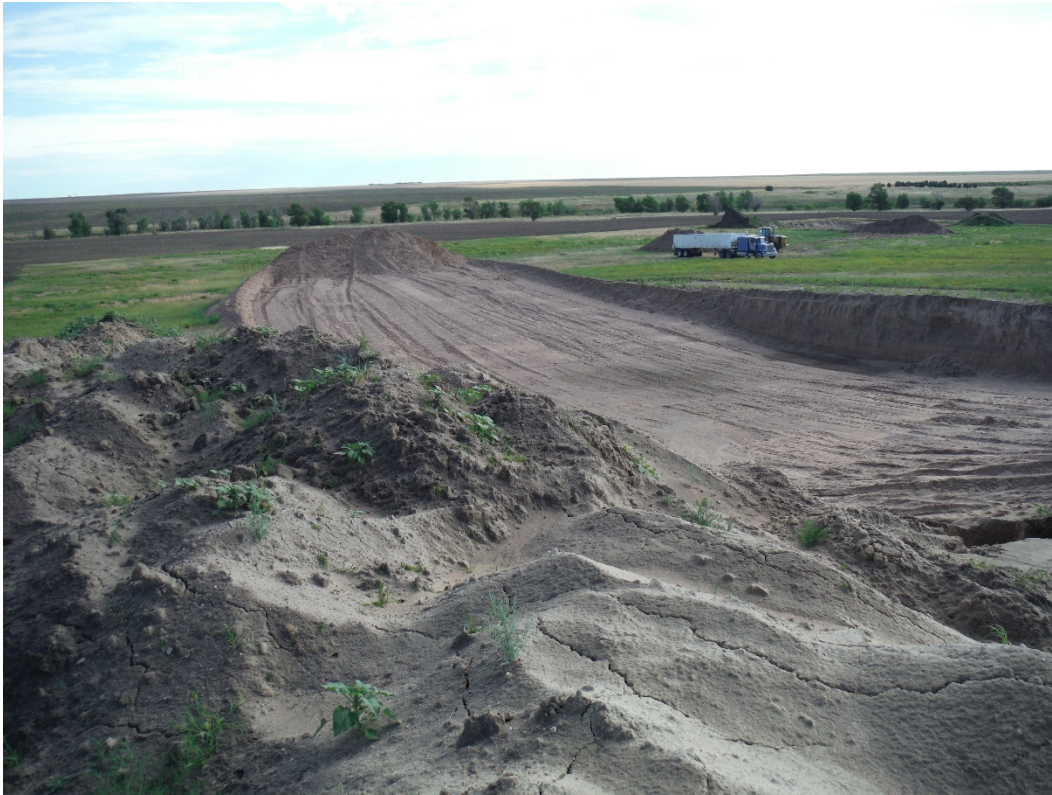
Southwest pit; looking northeast.

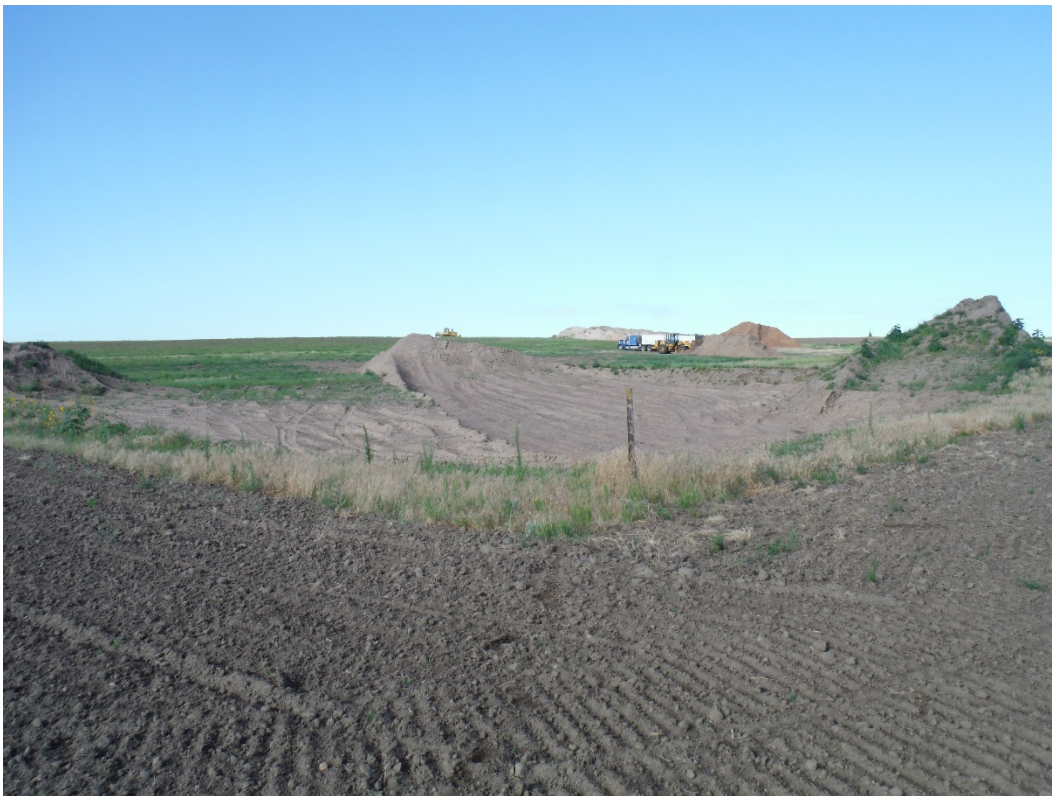
Northeast pit with topsoil stockpiles on either side, northeast wood post boundary marker, and southwest pit in the background; looking southwest.
