112c Annual Report

Geotechnical Addendum

January 2016
Project 1600260

This report summarizes geotechnical observations gathered on January 11 and 12, 2016 at the Morrison Quarry, operated by Aggregate Industries (AI). This report supplements the “2015 Notice of Intent to Continue Mining Operations / Annual Report” for the Morrison Quarry. Rock characteristics such as joint and foliation orientation, shear zones, faults, and instability zones were mapped for areas mined in 2015. Recommendations provided for mine highwall configurations provided are based on GEI Consultants, Inc. (GEI) observations and data analysis. This addendum provides information required by Permit Amendment #5 (carried over from Permit Amendment #3 and #4) to Mining Permit M-1973-021.

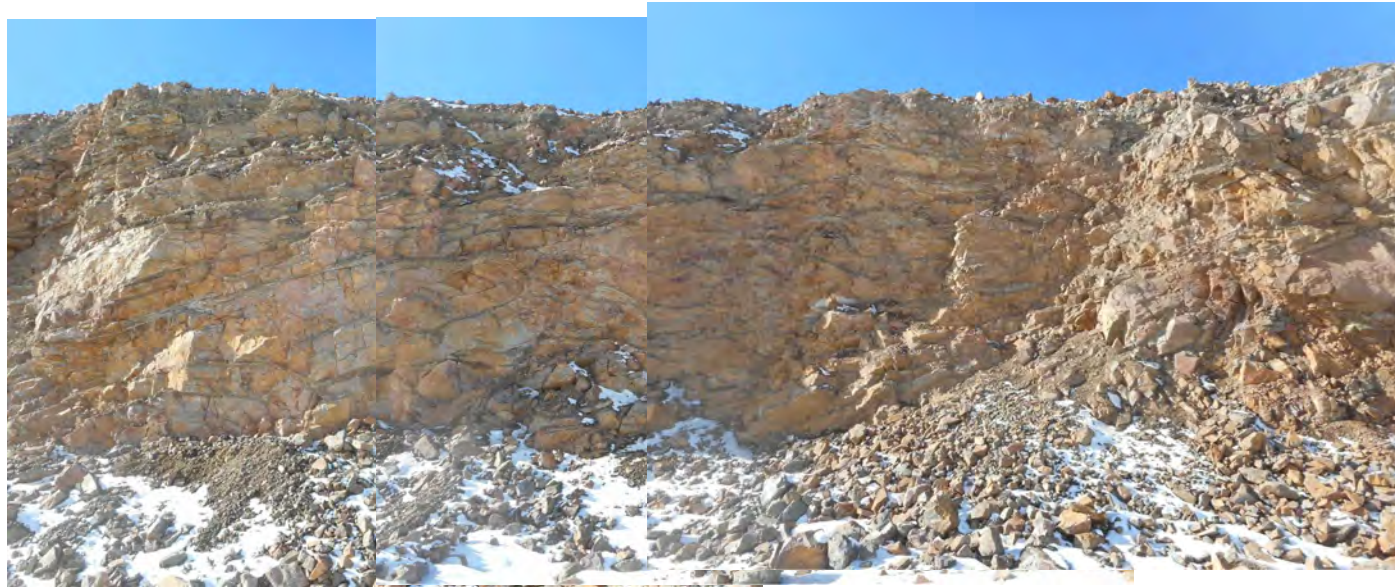
Consultants	BENCH 7000 SECTION A
Aggregate Industries		
Project 1600260	January 2016	Figure 11

- Section A (Sta. 0+00 to Sta. 0+80) of the scanline trended 340 degrees. Foliations exhibited a strike ranging from 340 degrees to 350 degrees with dips ranging from 35 degrees to 60 degrees. Two primary joint sets were evident. The first primary set exhibited an average strike of 345 degrees and average dip of 83 degrees. The second set exhibited an average strike of 80 degrees and an average dip of 82 degrees. Iron oxide staining was prevalent. The RMR classification is Poor to Fair.

NOTE: HIGHWALL SOUTH OF 0+00
WAS NOT MAPPED OR
PHOTOGRAPHED DUE TO
UNSAFE CONDITIONS.

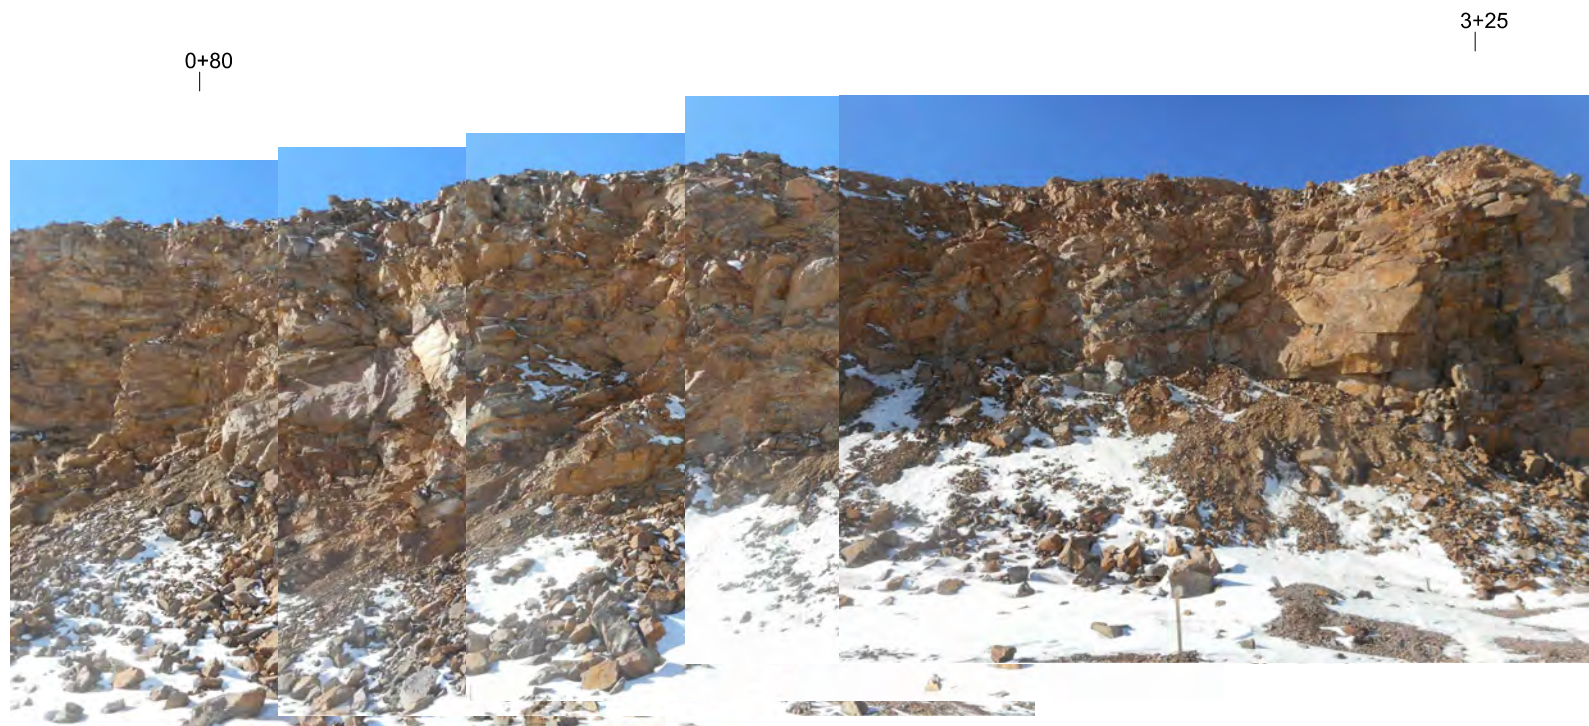
BENCH 7000 SECTION B (1 OF 2)
Aggregate Industries		
Project 1600260	January 2016	Figure 12

- Section B (Sta. 0+80 to Sta. 3+70) of the scanline trended 340 degrees. Foliations exhibited a strike ranging from 340 degrees to 350 degrees with dips ranging from 310 degrees to 350 degrees. Two primary joint sets were evident. The first primary set exhibited an average strike of 147 degrees and average dip of 78 degrees. The second set exhibited an average strike of 45 degrees and average dip of 80 degrees. Iron oxide staining was prevalent. The RMR classification is Poor to Fair.

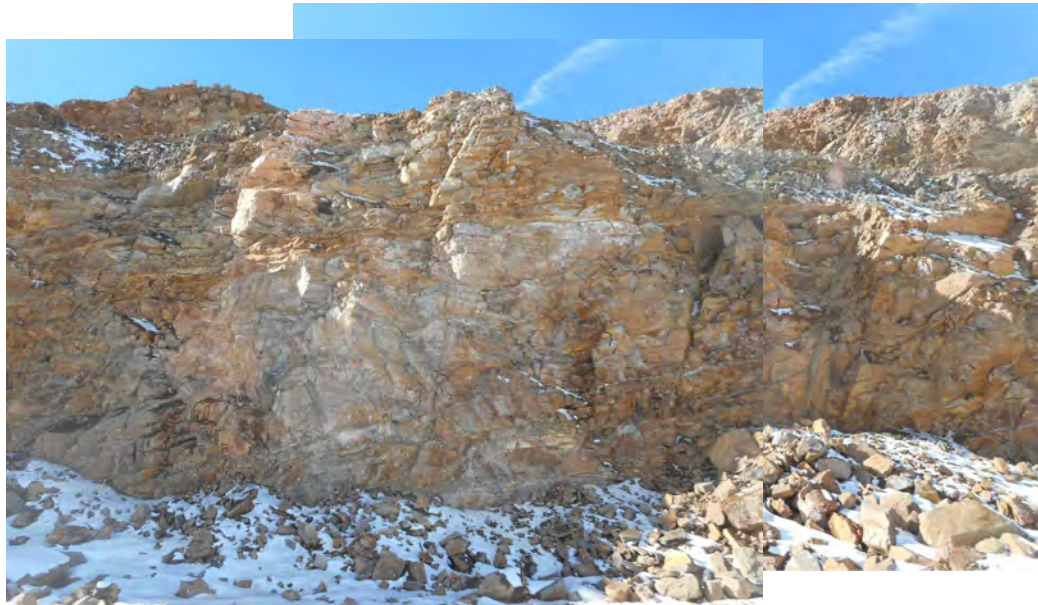
BENCH 6950 SECTION B
Aggregate Industries		January 2016
Project 1600260		Figure 15

- Section B (Sta. 2+40 to Sta. 3+15) of the scanline trended 10 degrees. Foliations exhibited a strike ranging from 330 degrees to 10 degrees with dips ranging from 15 degrees to 40 degrees. Two primary joint sets and one secondary joint set were evident. The first primary set exhibited an average strike of 343 degrees and an average dip of 77 degrees. The second set exhibited an average strike of 52 degrees and an average dip of 87 degrees. The secondary set exhibited an average strike of 303 degrees and an average dip of 80 degrees. Iron oxide staining was slightly less prevalent than in Section A. The RMR classification is Poor to Fair. A vertical pegmatite was visible at Sta. 2+55 and a mafic complex was visible at Sta. 3+15.

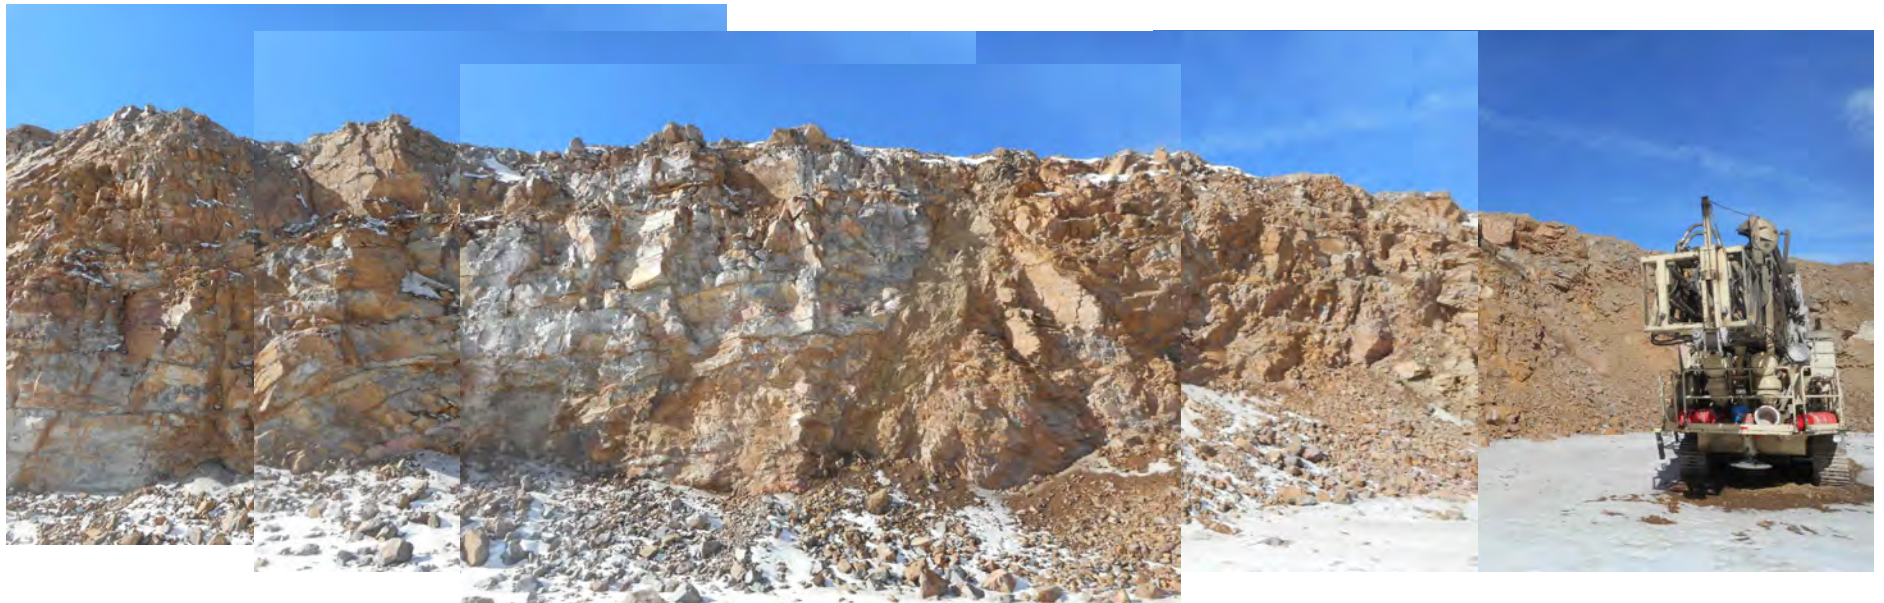
GEI Consultants	BENCH 6950 SECTION F	
Aggregate Industries		Project 1600260	January 2016 Figure 19

- Section F (Sta. 8+20 to Sta. 9+80) of the scanline trended 10 degrees. Foliations exhibited a strike ranging from 310 degrees to 10 degrees with dips ranging from 5 degrees to 80 degrees. Two primary joint sets were evident but were recorded as secondary sets on RMR data sheets because they differed from previous primary joint sets. The first set exhibited an average strike of 333 degrees and an average dip of 65 degrees. The second set exhibited an average strike of 53 degrees and an average dip of 88 degrees. Iron oxide staining was intermittent on the secondary joint surfaces. The RMR classification is Poor to Fair. A mafic complex dipping 60 degrees was visible at Sta. 9+80.

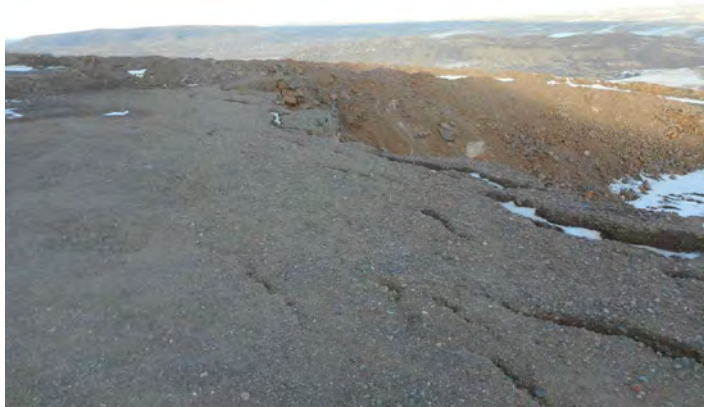
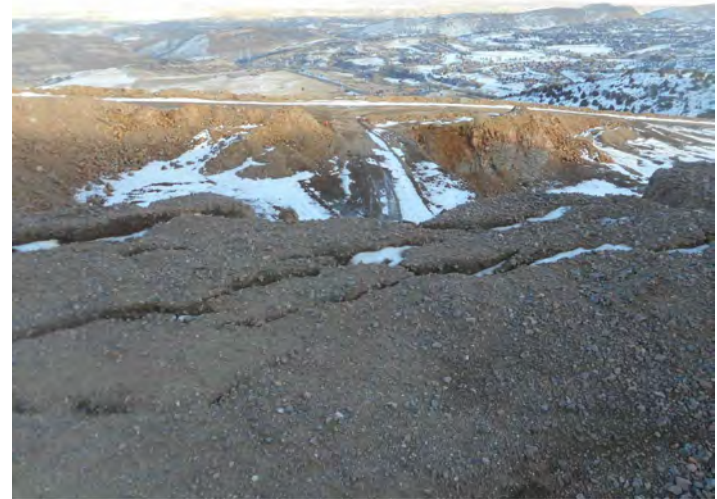
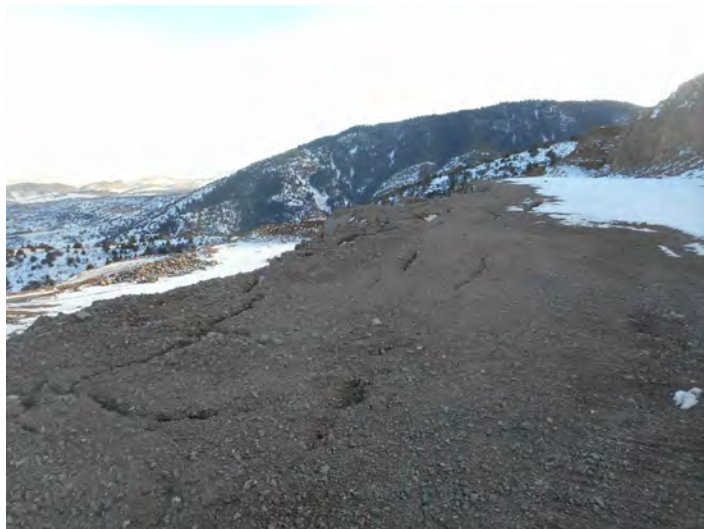
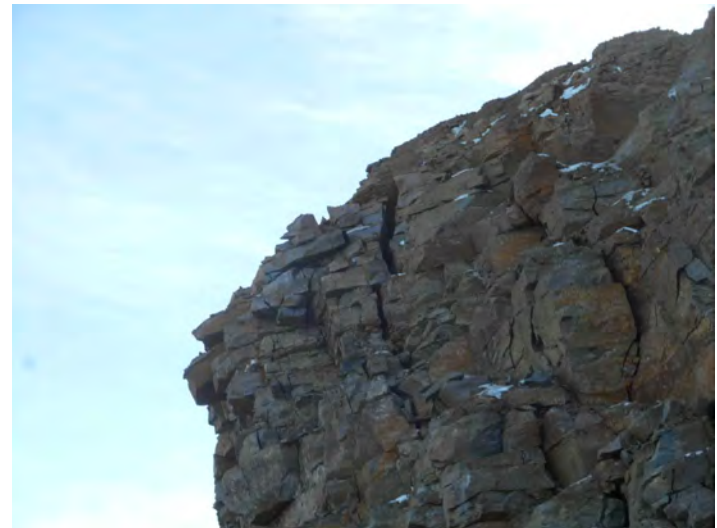
Figures 11 through 13 present photographic documentation of the Bench 7000 scanline. Figure 25 shows typical tension cracks visible on the bench and the highwall scanline.

BENCH 7000
TYPICAL TENSION
CRACKS

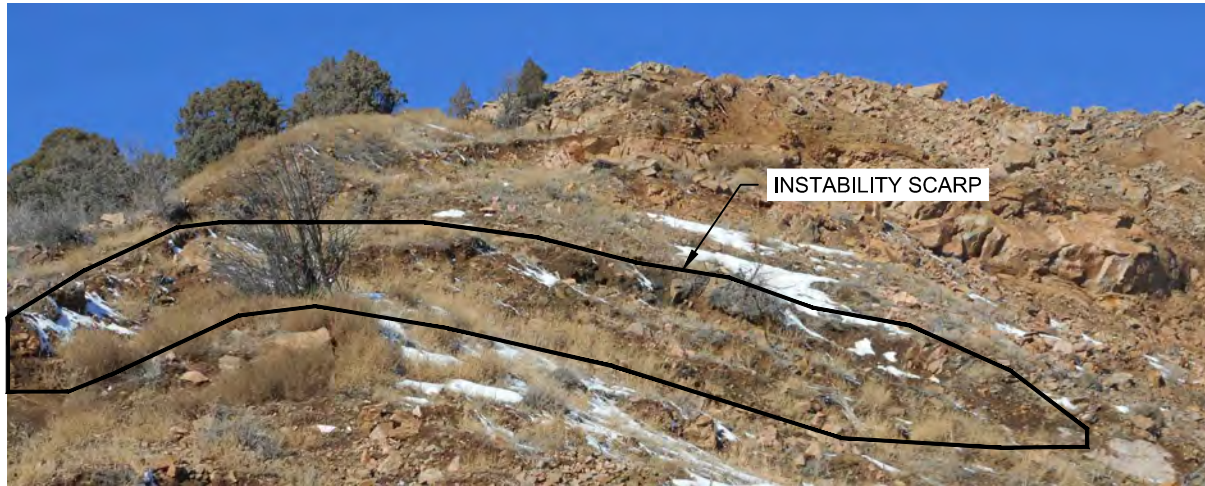
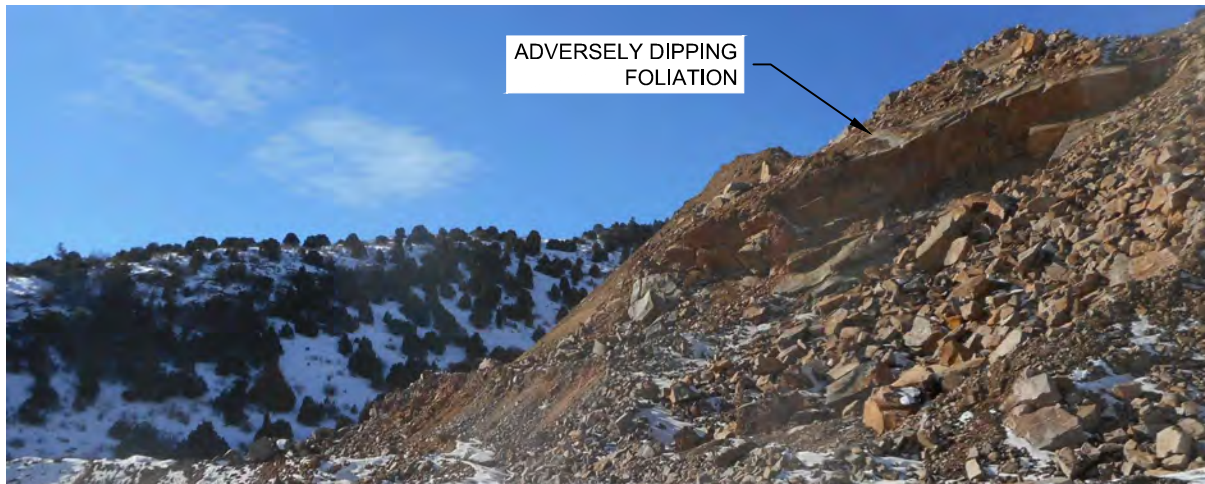
GEI Consultants	INSTABILITY ABOVE RUN AWAY TRUCK RAMP 6875 2015 - 2016 COMPARISON	
Aggregate Industries		Project 1600260	January 2016 Figure 26

An instability scarp was noted above Runaway Truck Ramp Highwall 6875 in the 2013 addendum. Additional movement was not observed during the 2014 review and the area was

removed in 2015 leaving a current slope that contains rock debris and exposed bedrock with adversely dipping foliation (Fig. 26). Changes in the Bench 6820 instability area were not observed during the 2015 review. GEI noted that mining activities above Bench 6820 have caused material to accumulate on the bench (Fig. 29). This is occurring along the entire bench, including the area of instability. The additional loading from the mining material on the instability area increases the possibility of additional movement/failure of the bench. As such, GEI advises AI to monitor and mitigate any additional loading of Bench 6820 caused by waste rock from mining at uphill highwalls.

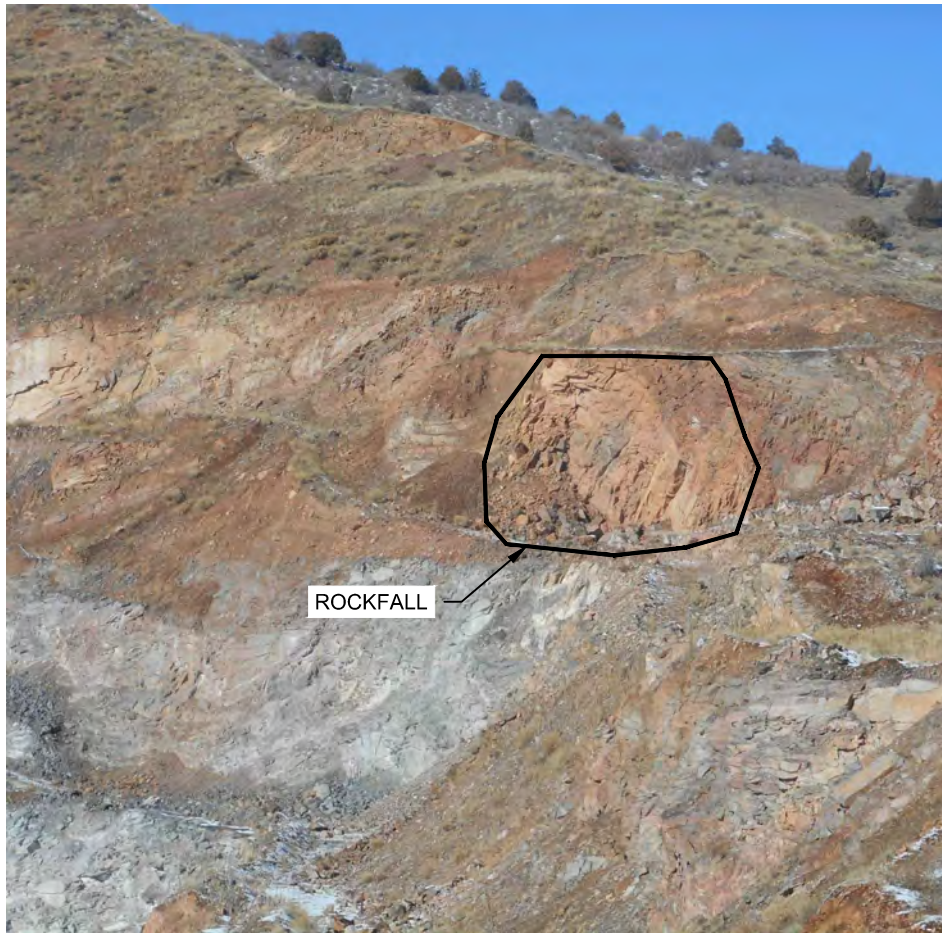
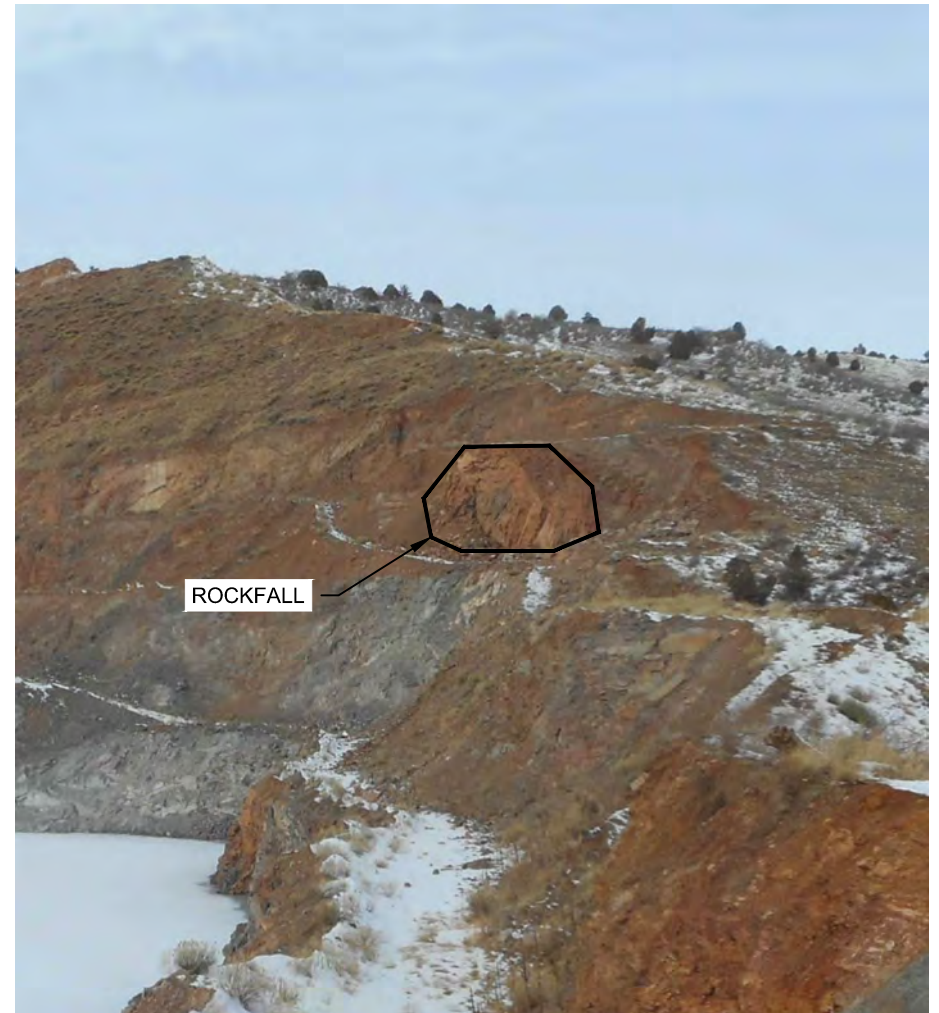
GEI Consultants	NORTH QUARRY MINOR ROCK FALL COMPARISON 2015-2016	
Aggregate Industries		Project 1600260	January 2016
			Figure 28

Mining in the North Quarry was completed in 2007 therefore no mining activity occurred in the North Quarry in 2015. The North Quarry is currently being used as a raw water storage reservoir for the Town of Morrison and production water storage for AI. The pond has a water elevation of approximately 6400 feet above MSL. Figure 2 shows the current configuration of the North Quarry, including the reservoir and the North Repository. A minor rockfall disturbance, possibly caused by freeze-thaw action, was noted in the northeast corner in 2014 (Fig. 28). GEI did not observe a change in the rockfall disturbance in 2015.

NOTE: NO CHANGE OBSERVED
BETWEEN 2015 AND 2016.

- No major failures occurred last year;
- Minor, localized sloughing and raveling occurred;
- No change was observed in the 2014 minor rockfall in the northeast corner of the quarry near El. 6450. It is not anticipated to grow or impact safety to personnel or equipment;
- Nearly all rockfall was contained on the benches. Several puncture marks were present on the ice of the reservoir in the quarry, indicating some rockfall into the pond;
- Continued observation of the minor rockfall area and the reclaimed bench near mine office for signs of slope instability is recommended for 2016.
