## MEMO

**RE:** Aggregate Industries – WCR, Inc., DRMS Permit No. M-2004-031, Hazeltine Mine  
Enforcement Hearing

Consideration of a possible violation, corrective actions, and civil penalties, for failure to minimize disturbance to the prevailing hydrologic balance in the surrounding area and failure to protect areas outside the affected land from damage.

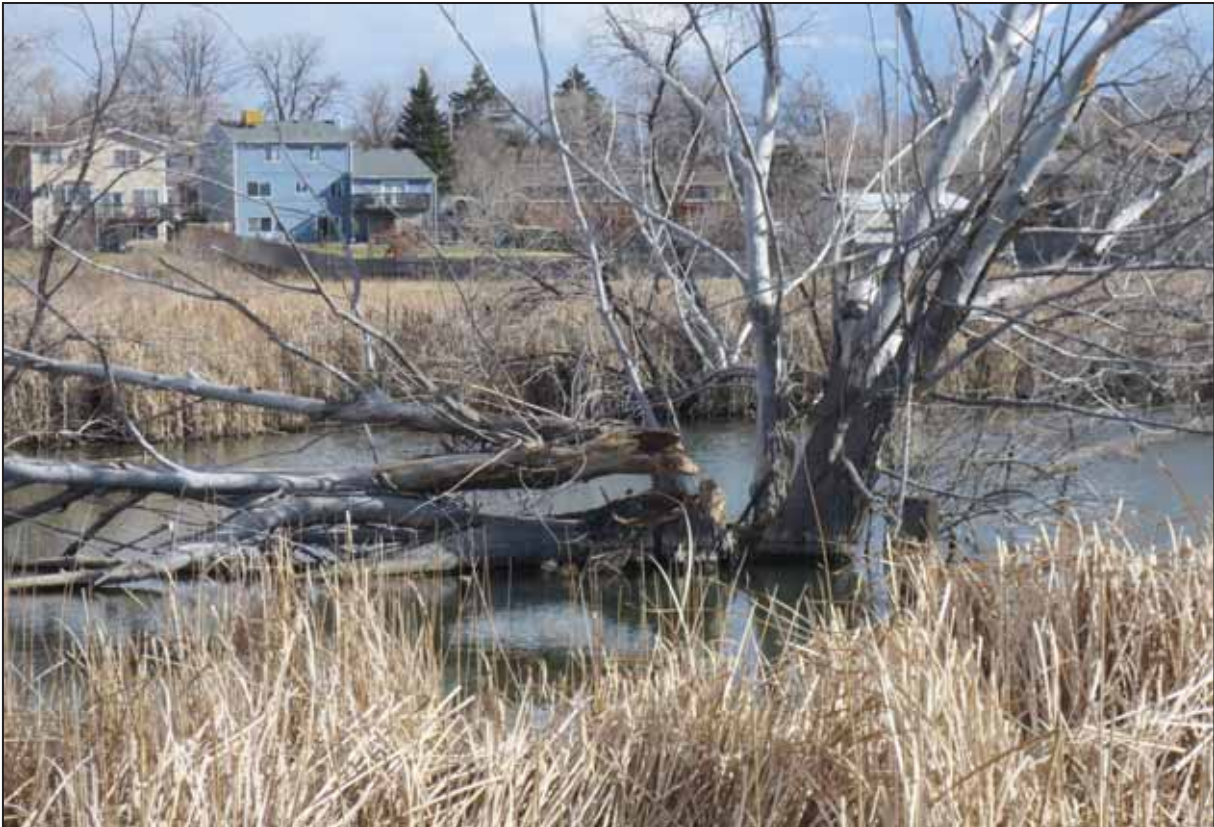
The inspection began at the Orr property. The inspection consisted of a visual examination of the Orr property and a discussion of the ongoing issues detailed in the written complaint. The visual inspection of the Orr property found that the land surface was wet. Portions of the Orr property were supporting hydrophytic vegetation. The Division believes the lowest point of the Orr property is located in the northwest corner with an approximate elevation of 5038.5 feet. The northwest corner of the Orr property was submerged (see photo 1). Based on visual estimates portions of the Orr property was covered by 1 to 2 feet of water

**Photo 1:** View looking east/southeast from the west side of the bull seep. The tree in the center of the photo is near the northwest corner of the Orr property.

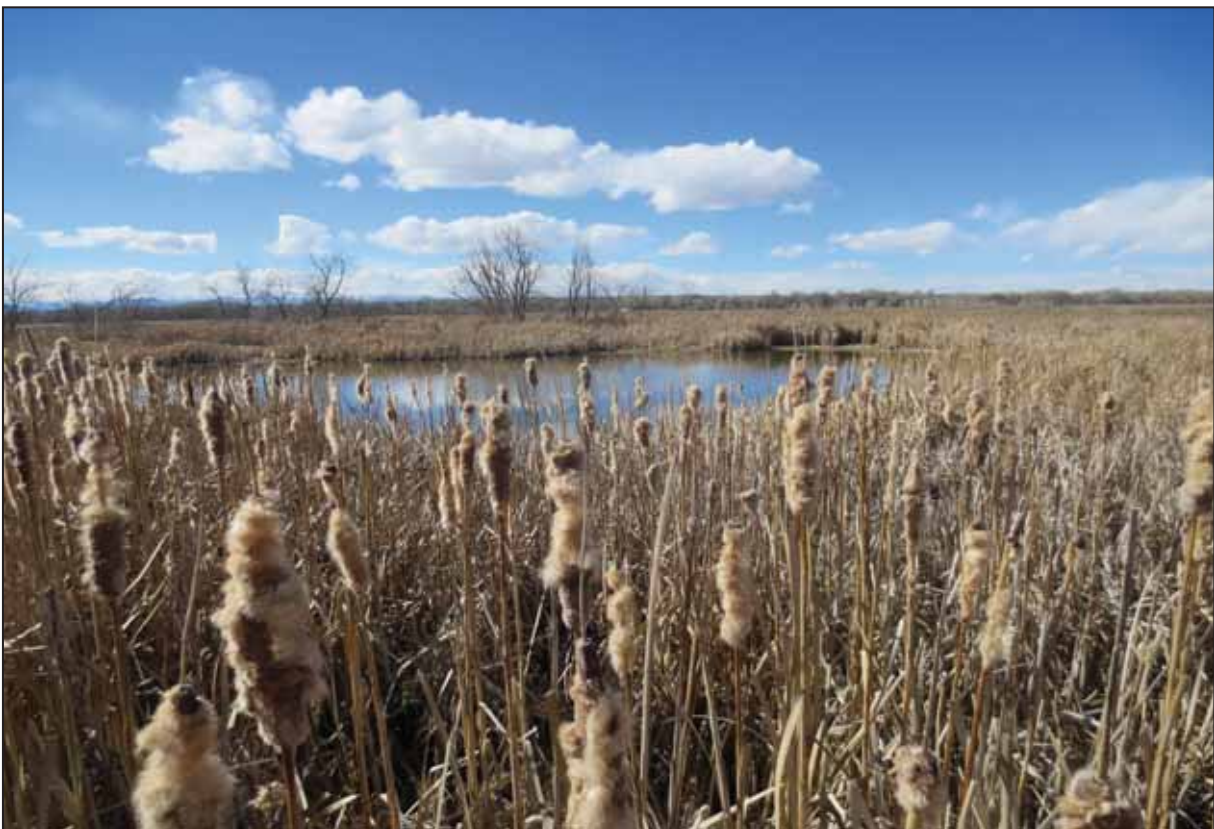
**Photo 2:** View looking west from north central part of the Orr property.

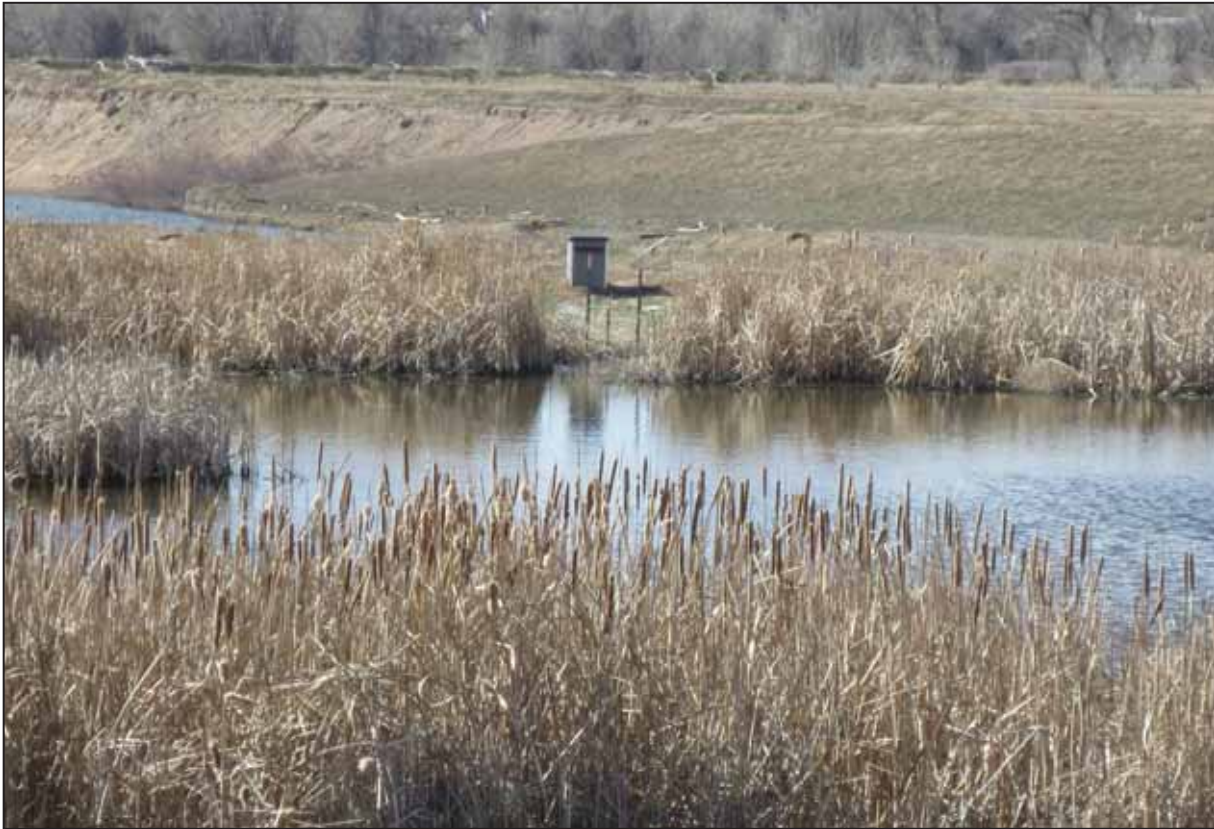
At the present time it appears that the Agridrain has not lowered the water level to the elevation predicted in TR-02. The Division believes the Operator has failed to resolve the problem cited in the October 5, 2011 inspection report. That problem was failure to minimize the disturbances to the prevailing hydrologic balance of the affected land and of the surrounding area pursuant to 34-32.5-116(4)(h), and failure to protect areas outside of the affected land from slides or damage occurring during the mining operation pursuant to 34-32.5-116(4)(i). The Operator shall submit an application for a Technical Revision, which sets forth a weekly monitoring and maintenance plan for the Agridrain, with annual reporting of the monitoring results to the Division. The revision shall also include a revised inlet screen design to prevent the Agridrain from becoming blocked by debris. The Operator shall submit the technical revision by May 9, 2014. The Division will conduct a follow up inspection in mid May, 2014 to observe water levels at the Orr property and observe the water level at the Agridrain Inlet.

**Photo 3:** View looking northwest from the ditch access road. The Agridrain is near the center of the photo.

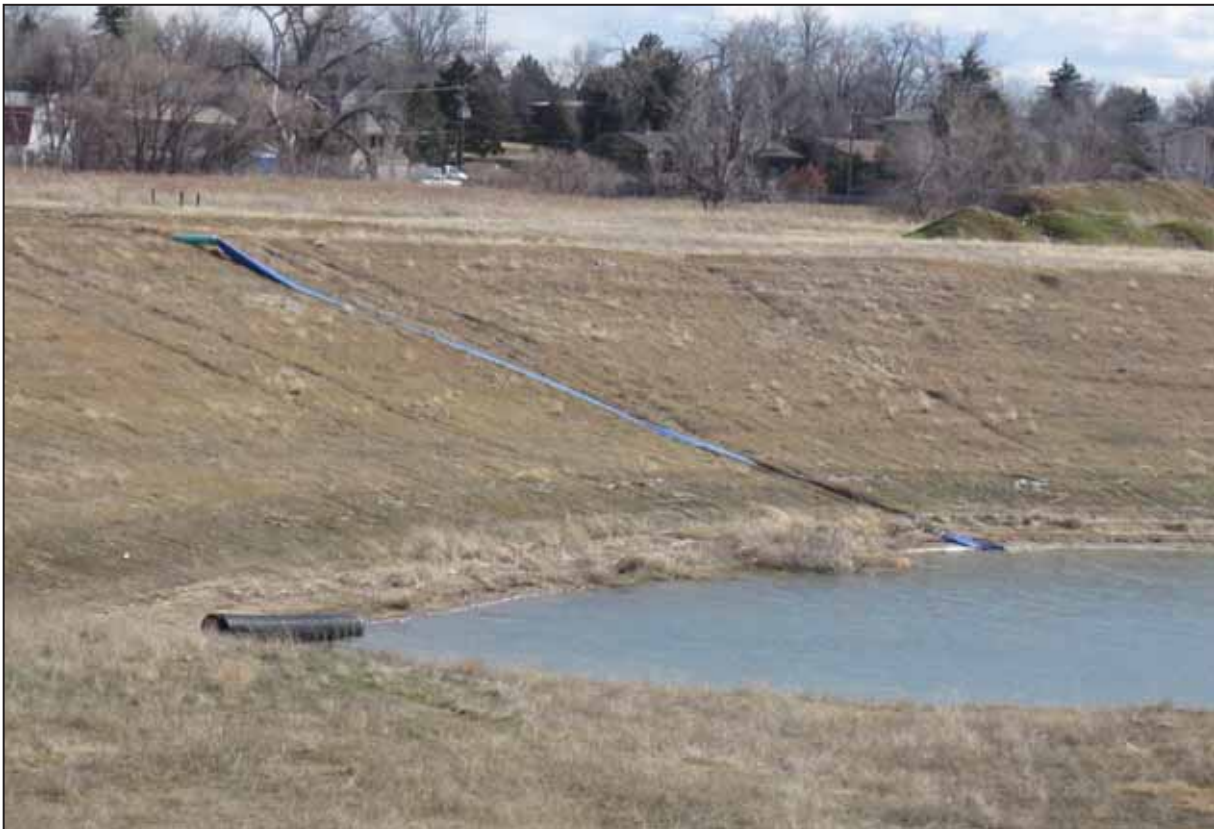
**Photo 4:** The Agridrain outlet on the inside of the Slurry wall.

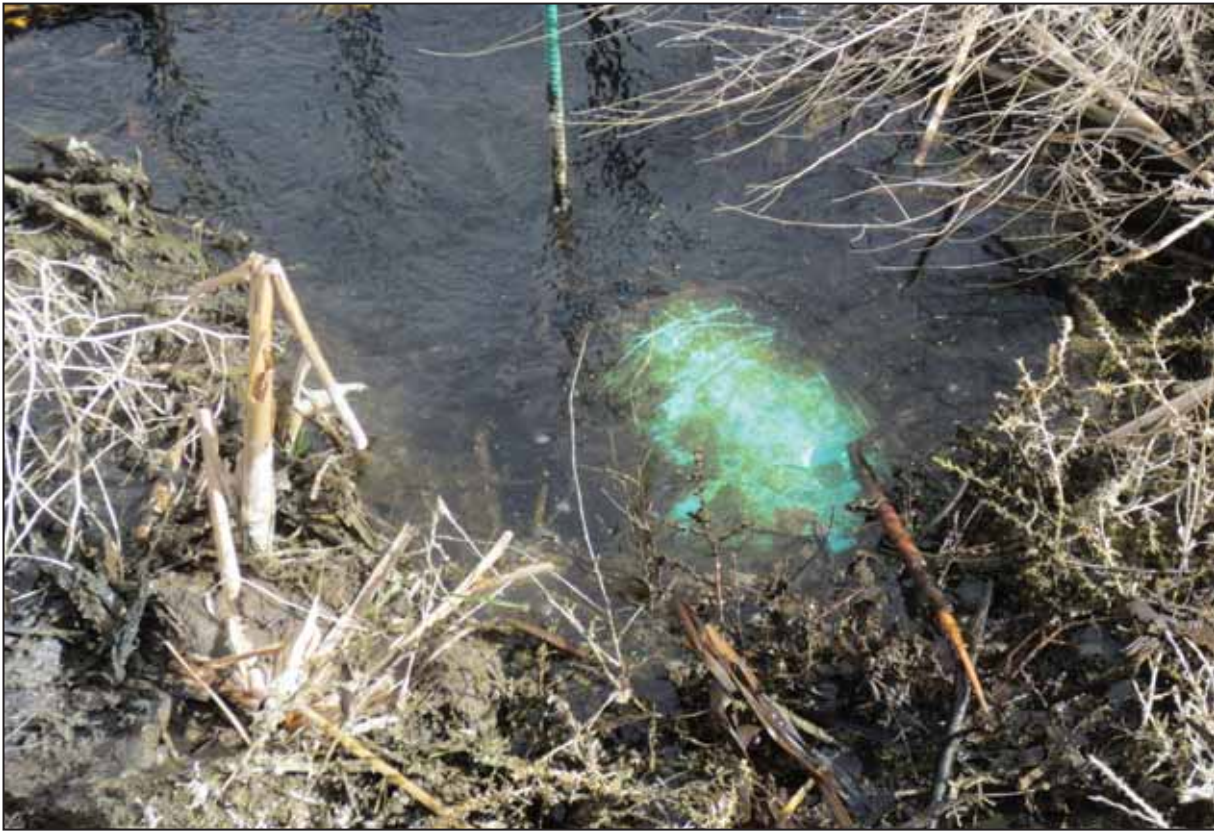
**Photo 5:** Agridrain inlet on the outside of the slurry wall. This photo was taken after the inlet was cleared of debris. Water depth is estimated to be 2 to 4 inches above the inlet pipe.

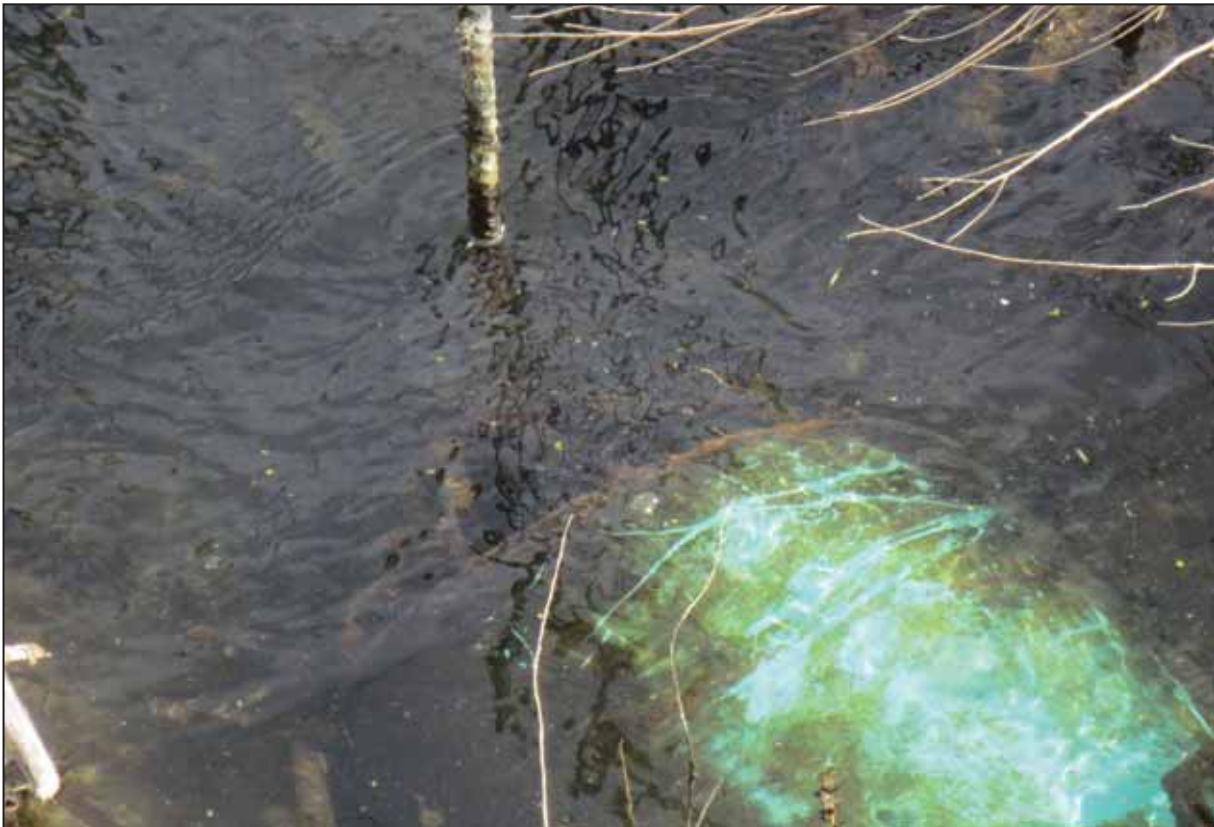
**Photo 6:** Agridrain inlet close up. This photo was taken after the inlet was cleared of debris.

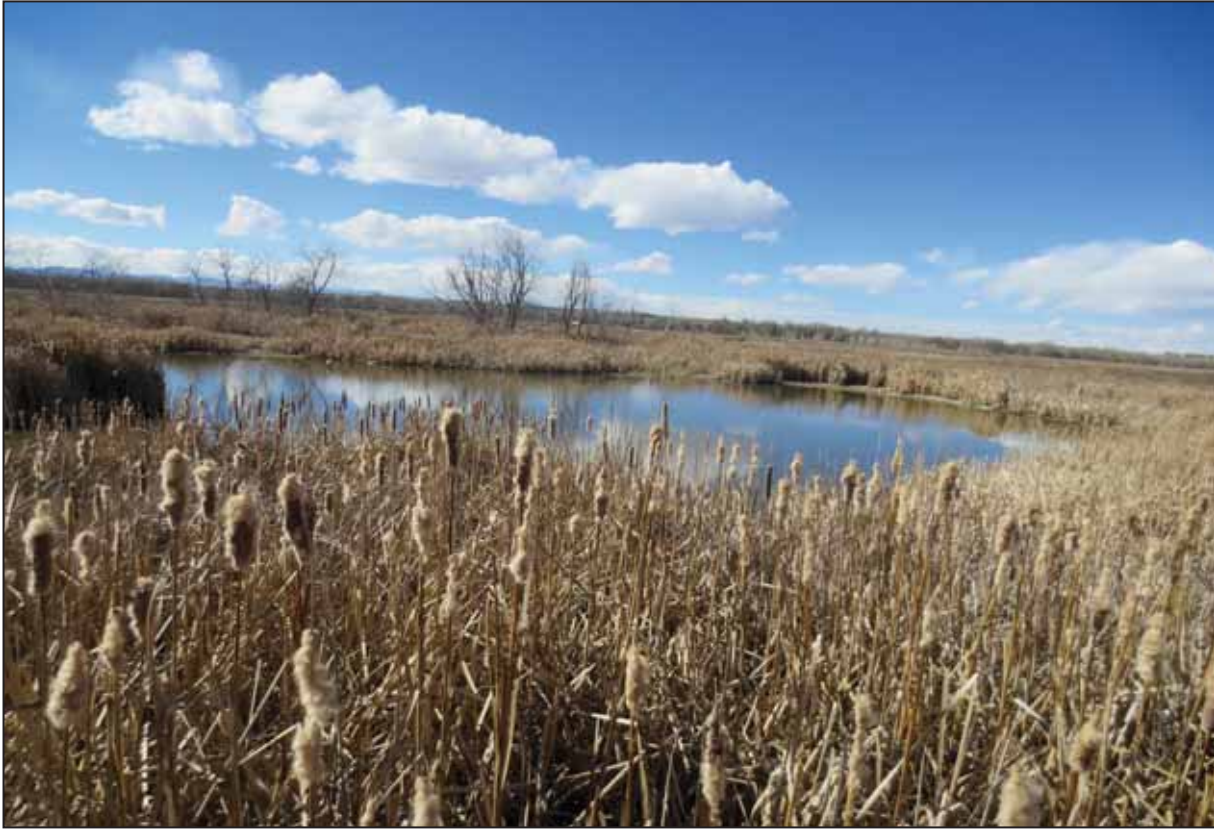
The inspection began at the Orr property. The inspection consisted of a visual examination of the Orr property and a discussion of the ongoing issues detailed in the written complaint. The visual inspection of the Orr property found that the land surface was still wet. The Division believes that the water level in the depression in the central part of the Orr property has dropped approximately 4 to 6 inches since the Division's March 27, 2014 inspection. The Division came to this conclusion by comparing photos taken during the March 27, 2014 (see photo 1) inspection and this inspection (see photo 2 and 3).

**Photo 1:** Photo of the depression in the central part of the Orr property taken on March 27, 2014.

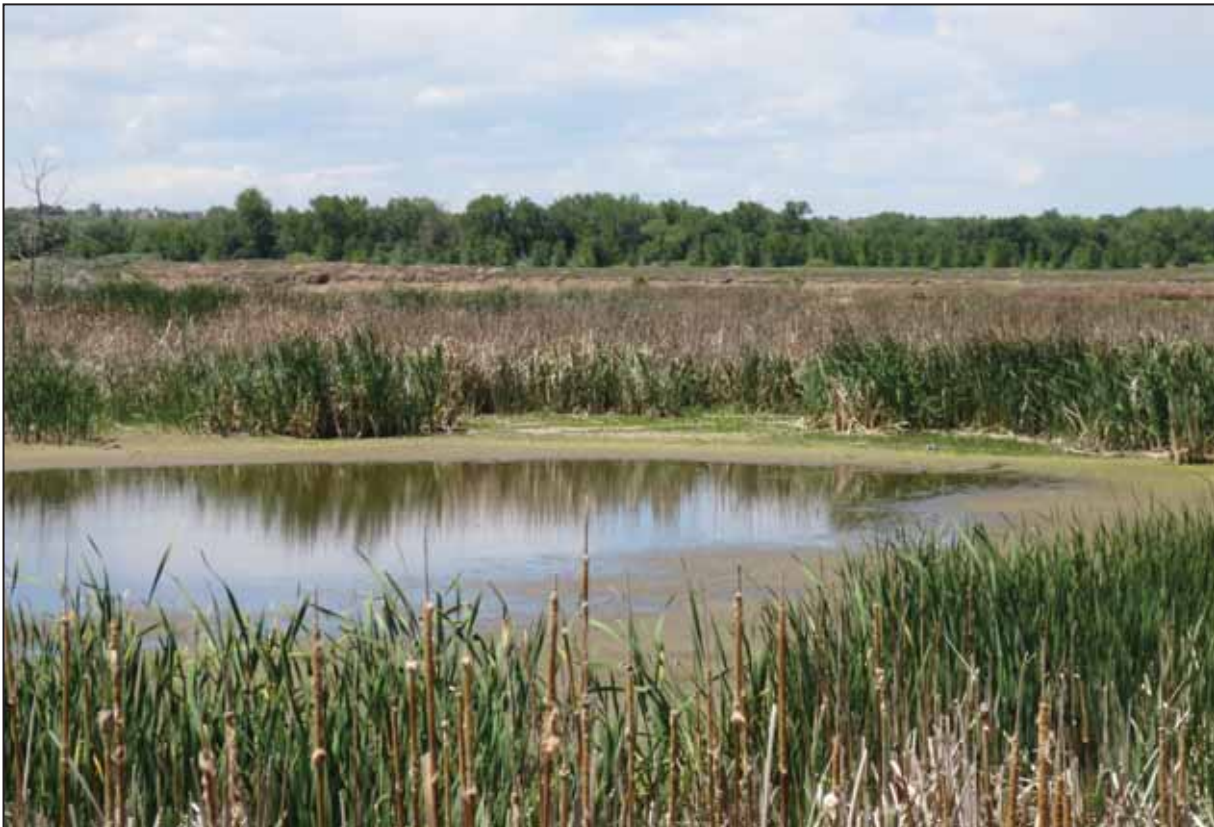
**Photo 2:** Photo of the depression in the central part of the Orr property taken on May 27, 2014.

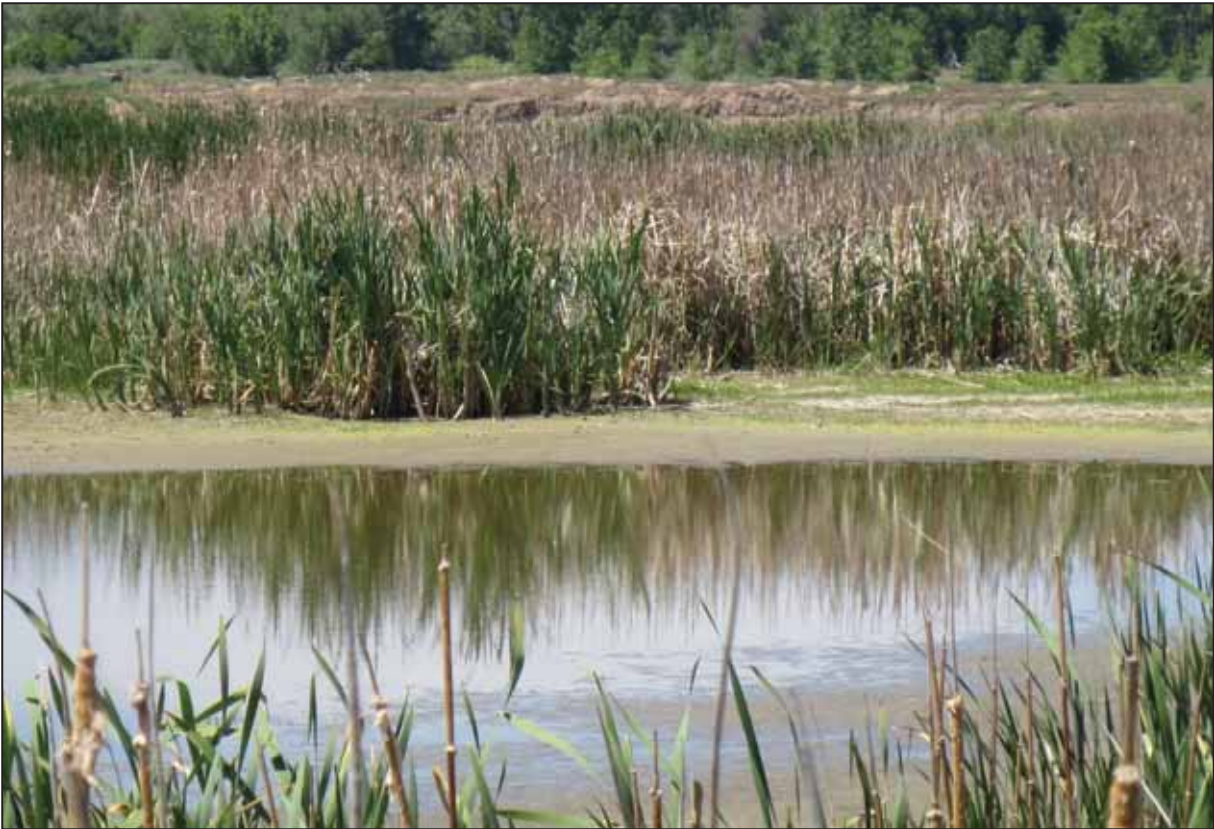
**Photo 3:** Photo of the depression in the central part of the Orr property taken on May 27, 2014.

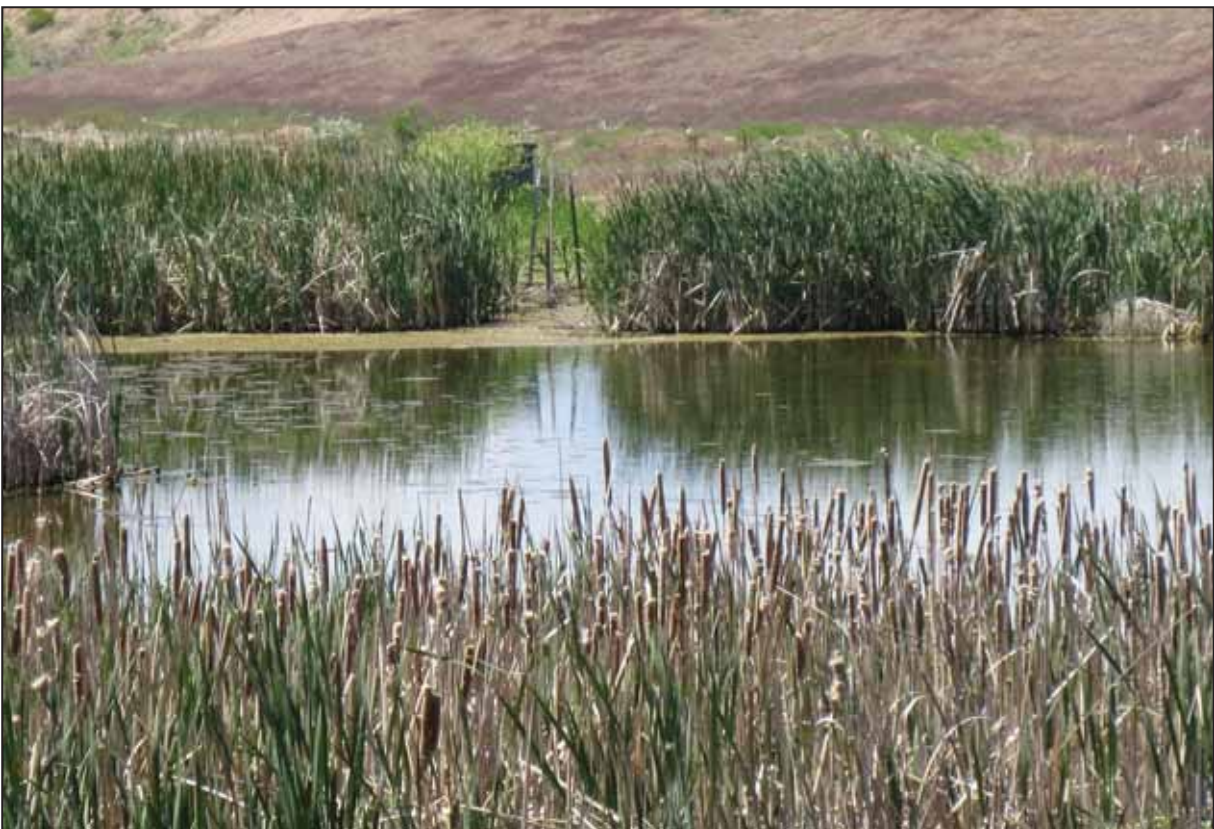
**Photo 4:** View looking northwest from the ditch access road. The Agridrain is near the center of the photo.

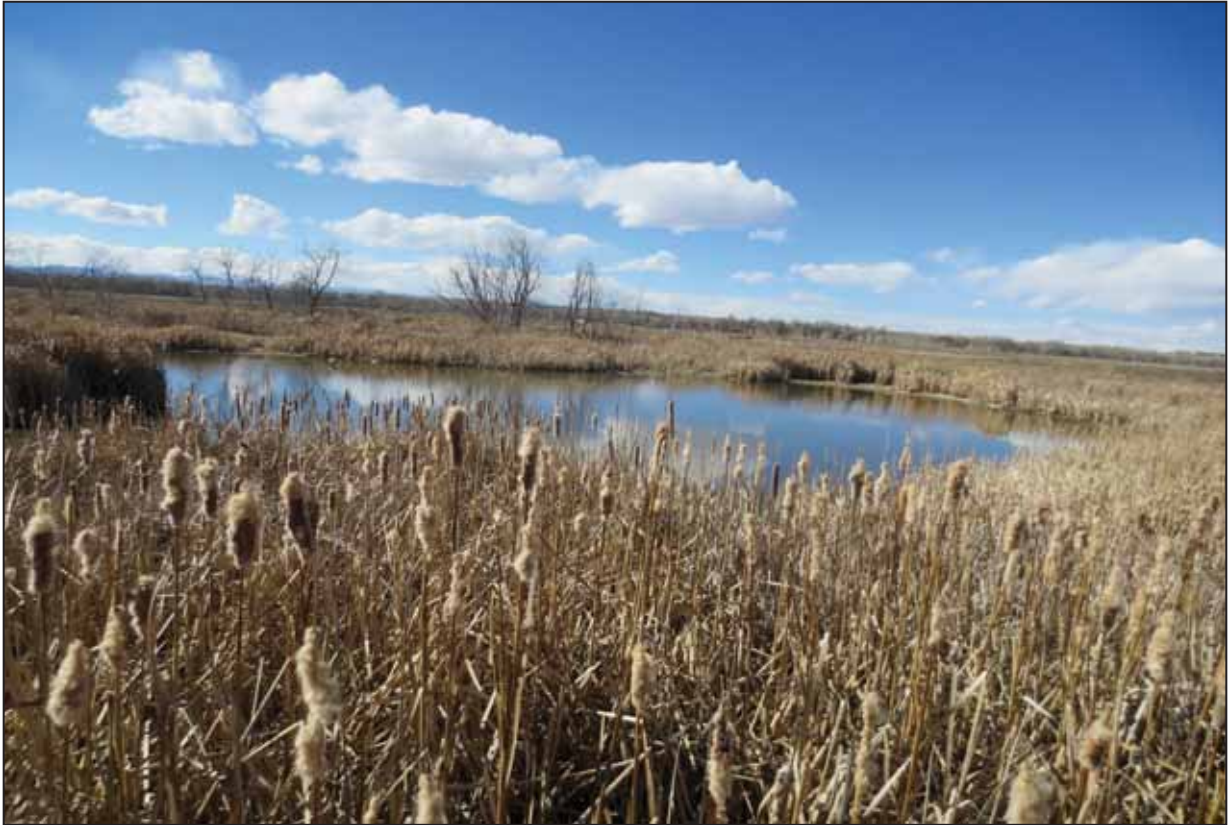
**Photo 1:** Submerged depression on the west side of the Orr property, photo taken on March 27, 2014.

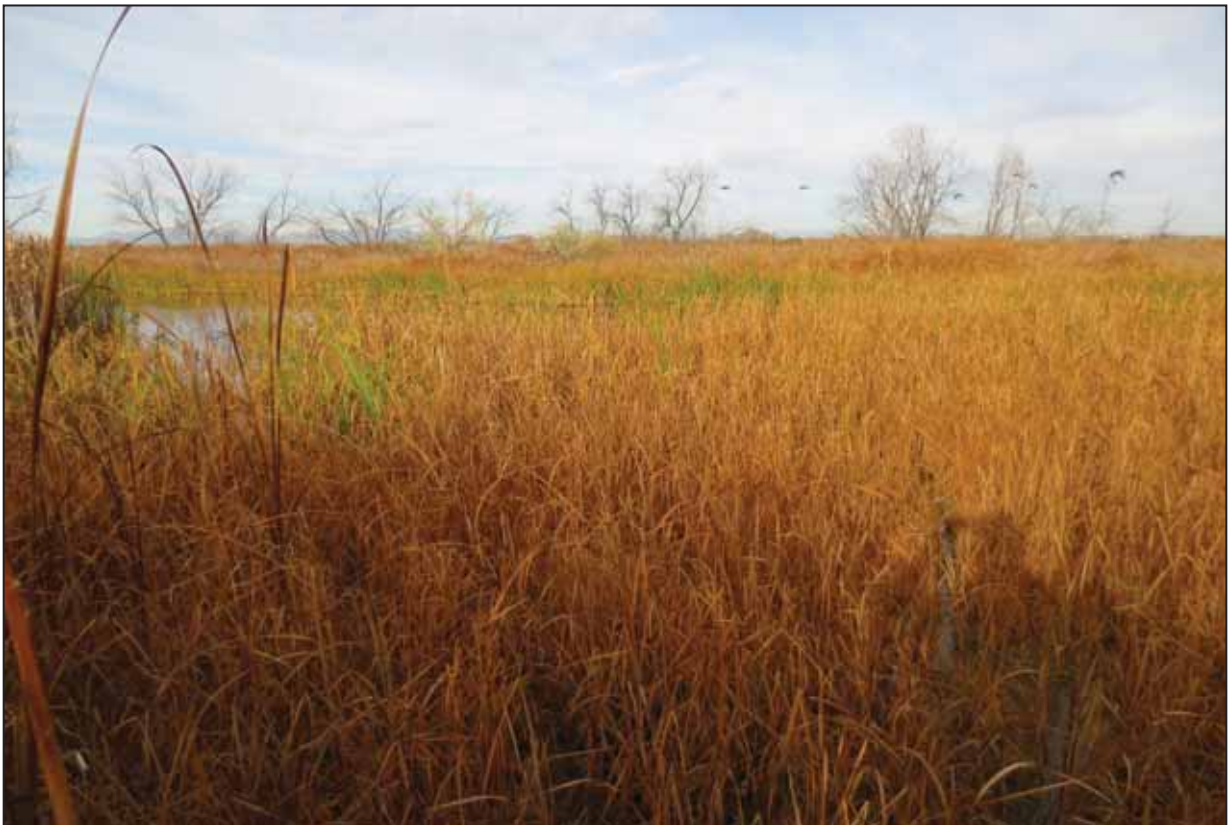
The inspection began at the Orr property. The inspection consisted of a visual examination of the Orr property and a discussion of the ongoing issues detailed in the complaint. The visual inspection of the Orr property found that portions of the land surface remain submerged. DRMS visually estimates that the water level on the Orr property has dropped approximately one foot since the March 27, 2014 inspection (see photo 1 from the March 27, 2014 inspection, compared to photo 2, which was taken during the October 31, 2014 inspection). DRMS believes the lowest point of the Orr property is located in the northwest corner with an approximate elevation of 5,038.5 feet. The northwest corner of the Orr property remains submerged (see photo 3 from the March 27, 2014 inspection, compared to photo 4, which was taken during the October 31, 2014 inspection). It appears that the groundwater elevation in the northwest corner of the Orr property has not changed much since the March 27, 2014 Inspection. Based on visual estimates made during the current inspection, portions of the Orr property were still covered by 1 to 2 feet of water.

**Photo 2:** Submerged depression on the west side of the Orr property, photo taken on October 31, 2014.

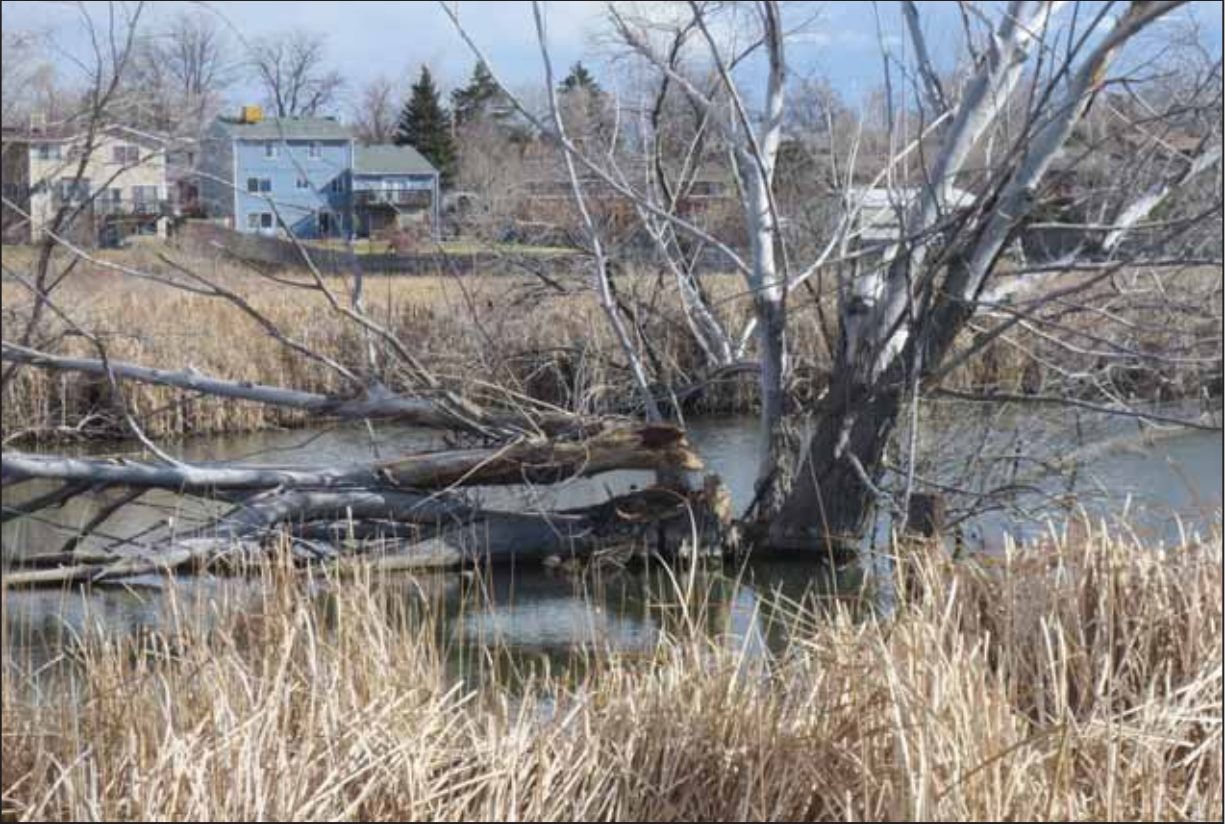
**Photo 3:** Northwest corner of the Orr property, photo taken on March 27, 2014.

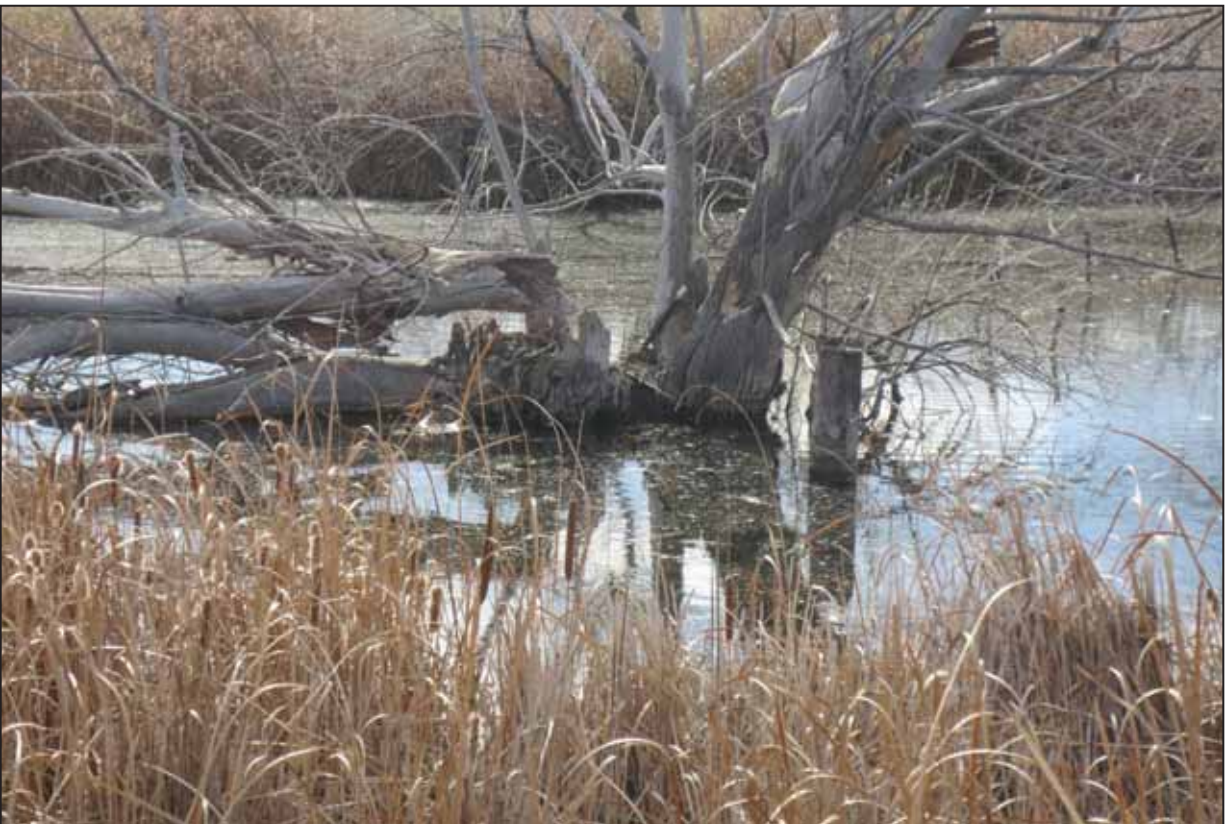
**Photo 4:** Northwest corner of the Orr property, photo taken on October 31, 2014.

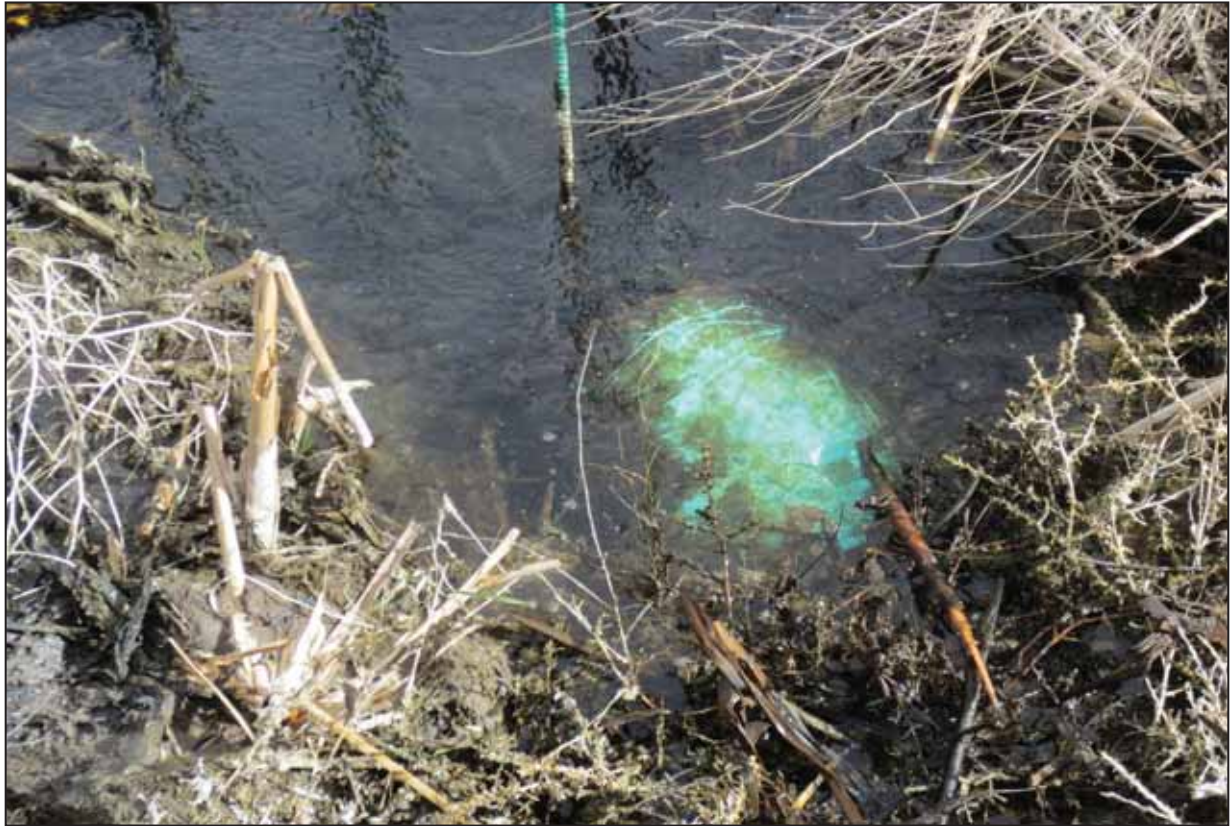
**Photo 5:** Agridrain, photo taken on March 27, 2014.

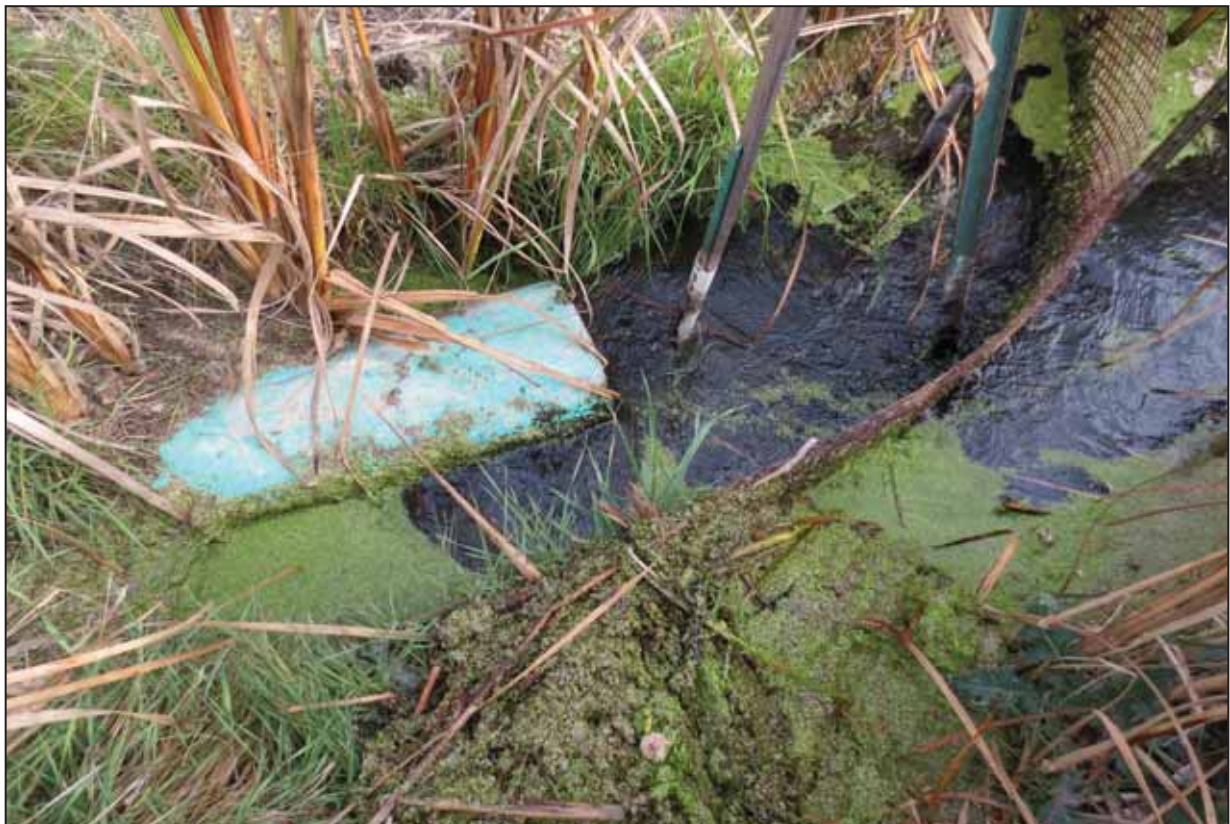
Although it appeared during the current inspection that the Agridrain has lowered the water level to the elevation predicted in Technical Revision No.2 (TR-02), the Orr property remains locally submerged, resulting in the Operator's failure to minimize disturbance to the prevailing hydrologic balance.

**Photo 6:** Agridrain, photo taken on October 31, 2014.

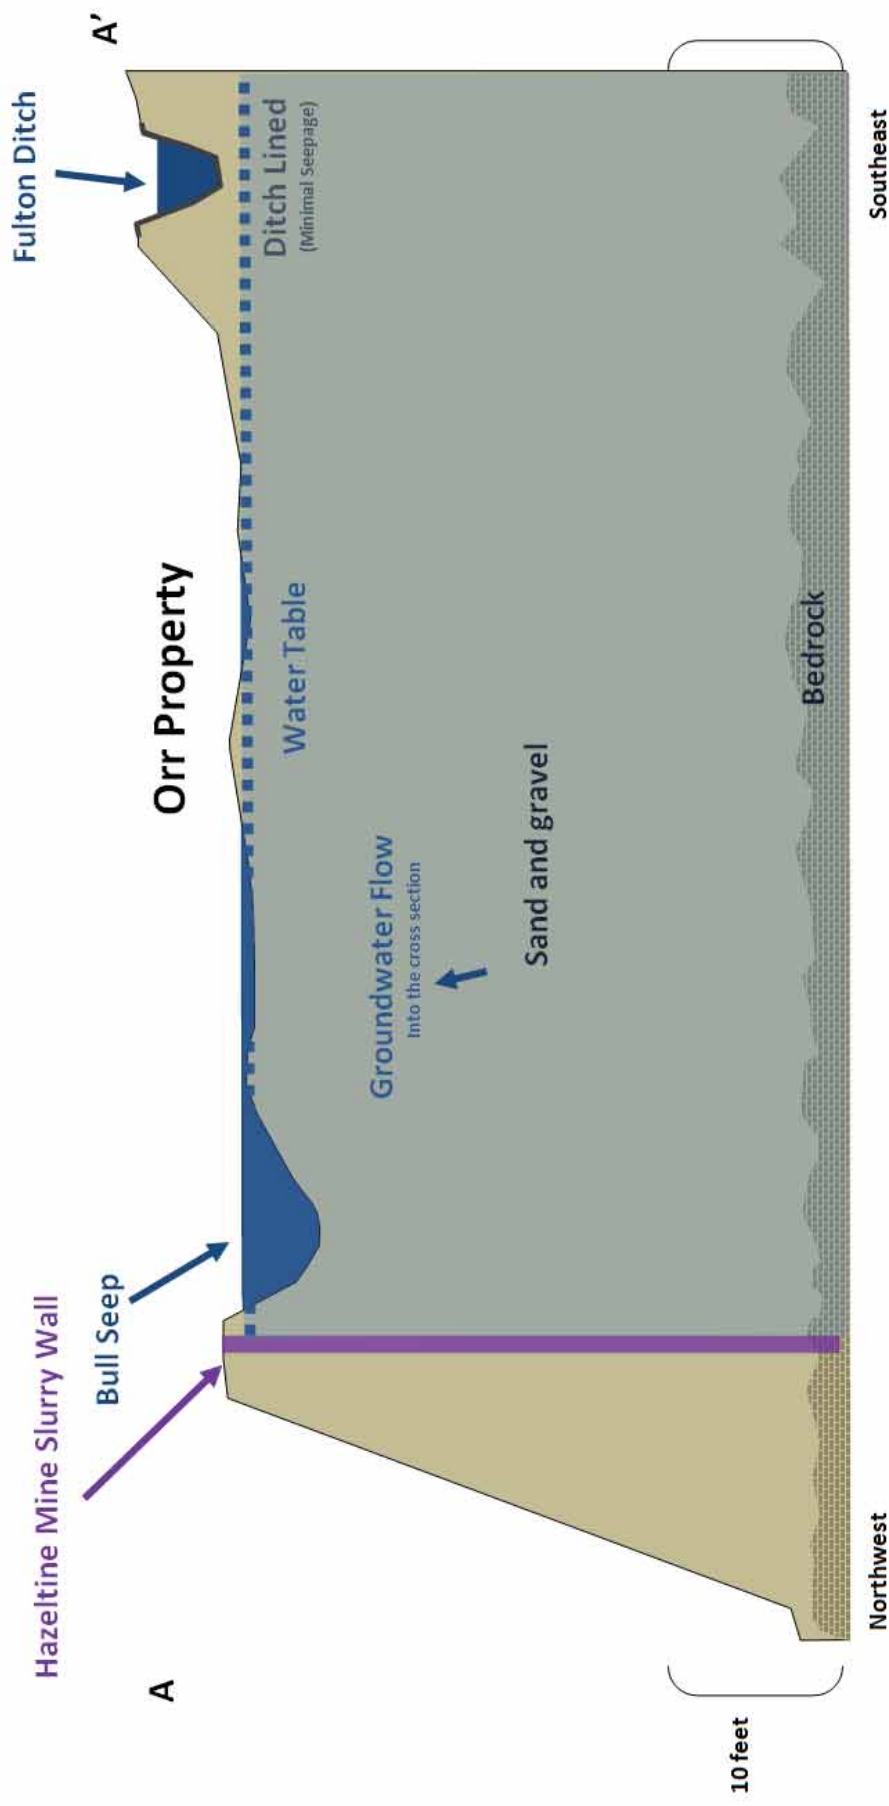
# Groundwater mounding at the Hazeltime Mine

Result: Groundwater table above the land surface throughout most of the Orr property.
