COLORADO DIVISION OF RECLAMATION, MINING AND SAFETY
MINERALS PROGRAM INSPECTION REPORT
PHONE: (303) 866-3567

MINE NAME: Hazeltine Mine	MINE/PROSPECTING ID#: M-2004-031	MINERAL: Sand and gravel	COUNTY: Adams
INSPECTION TYPE: Monitoring	INSPECTOR(S): Tyler V. O'Donnell	INSP. DATE: August 19, 2015	INSP. TIME: 10:15
OPERATOR: Aggregate Industries - WCR, Inc.	OPERATOR REPRESENTATIVE: Connie Davis and Mike Refer	TYPE OF OPERATION: 112c - Construction Regular Operation

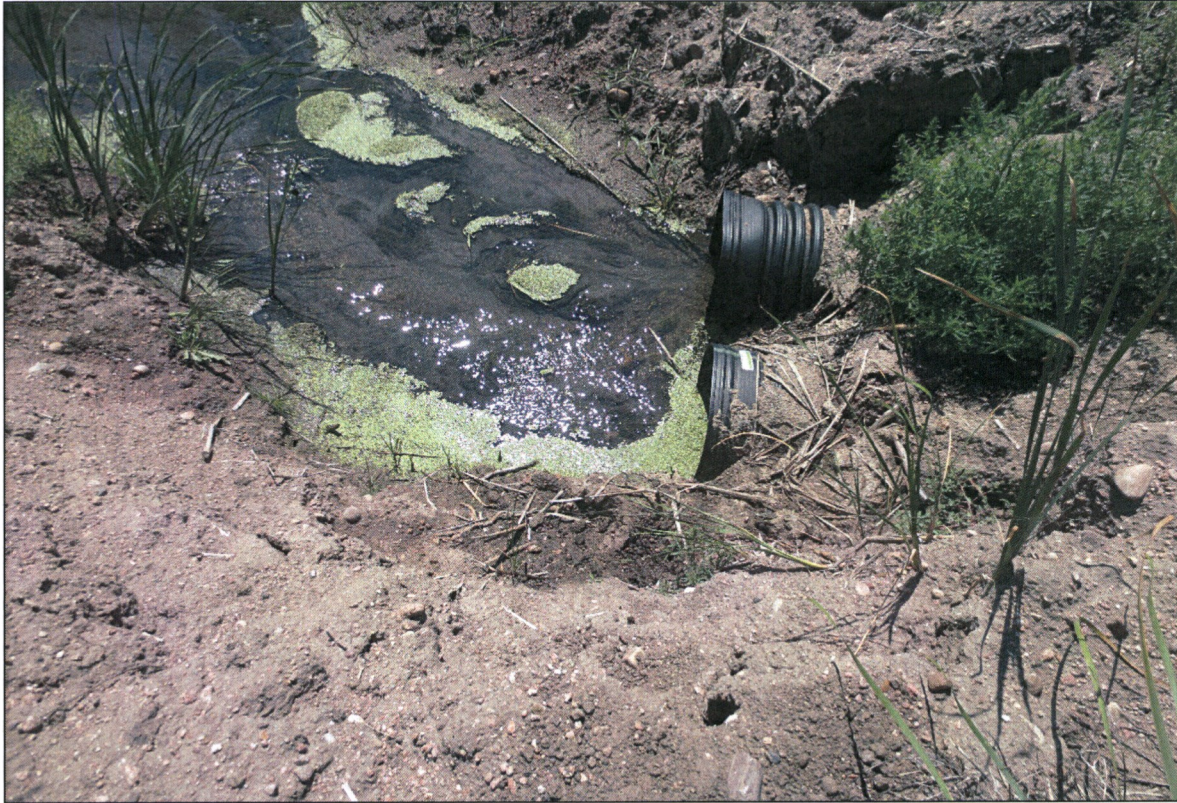
Photo 3: Two 18-inch CMP pipes, installed through the slurry wall. As approved under the temporary plan.

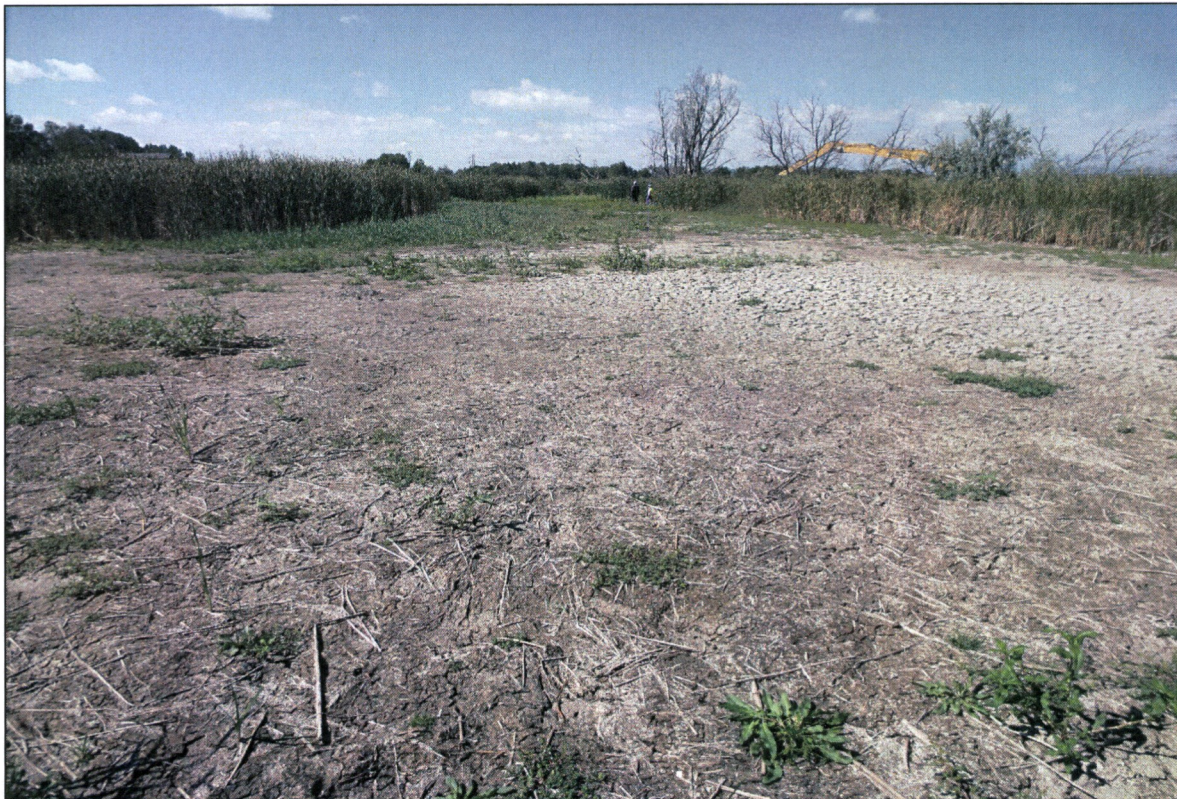
visual estimate, it appears that the water elevation along the western side of the Orr property had dropped roughly 2 feet. This assumption was made based on the debris hanging from the second strain of barbwire on the fence around the Orr Property. The Orr property was much dryer then when the Orr property had been observed during previous inspections. During the inspection water was observed seeping through the soil along the western side of the Orr property (photo 6), the western portion of the Orr property slopes into the bull seep. The furthest western portion of the Orr property remained saturated, but not inundated by mounded groundwater. The Division believes it will take additional time for the furthest western portion of the Orr Property to dry out.

Based on observations made during the inspection, it appears that the temporary plan has begun to mitigate the impacts of the groundwater mounding. The Division believes that it will take several months to completely evaluate the effects of the temporary plan. The Division will continue to work closely with the Operator and the adjacent landowner.

Photo 4: Western portion of the Orr property that was historically submerged/inundated by mounded groundwater. It appears the temporary plan has significantly dried out this portion of the property.
