112c Annual Report

| | Operation Name: | Mesita Hill Pit |

Subject: Mesita Hill Pit Annual Report for 2015

2015 REVEGETATION MONITORING REPORT

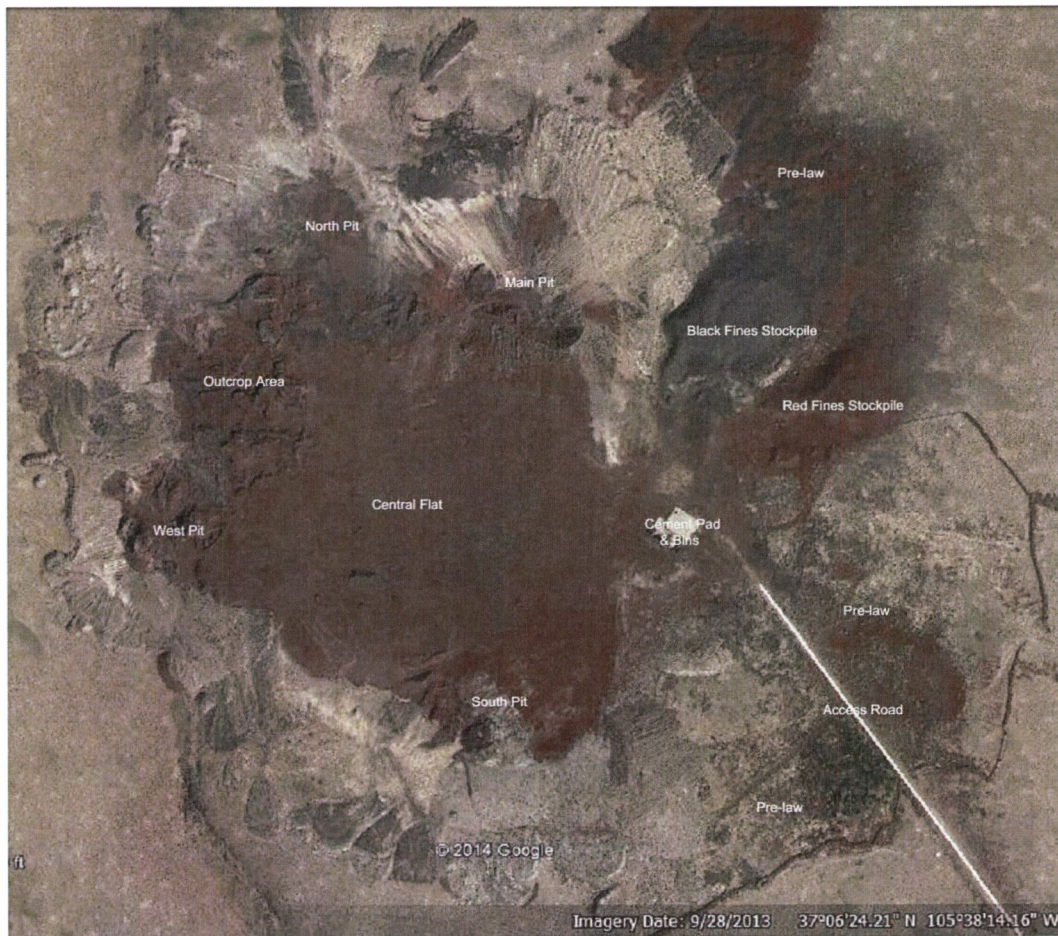
Figure 3. Mesita Hill Mine site aerial view from googleearth, September 28, 2013.

The access road and a cement pad with bins will remain as permanent features as approved by Colorado State Division of Reclamation, Mining and Safety. Two fine-material scoria stockpiles remain on the eastern portion of the site (Appendix A, Figure 3).

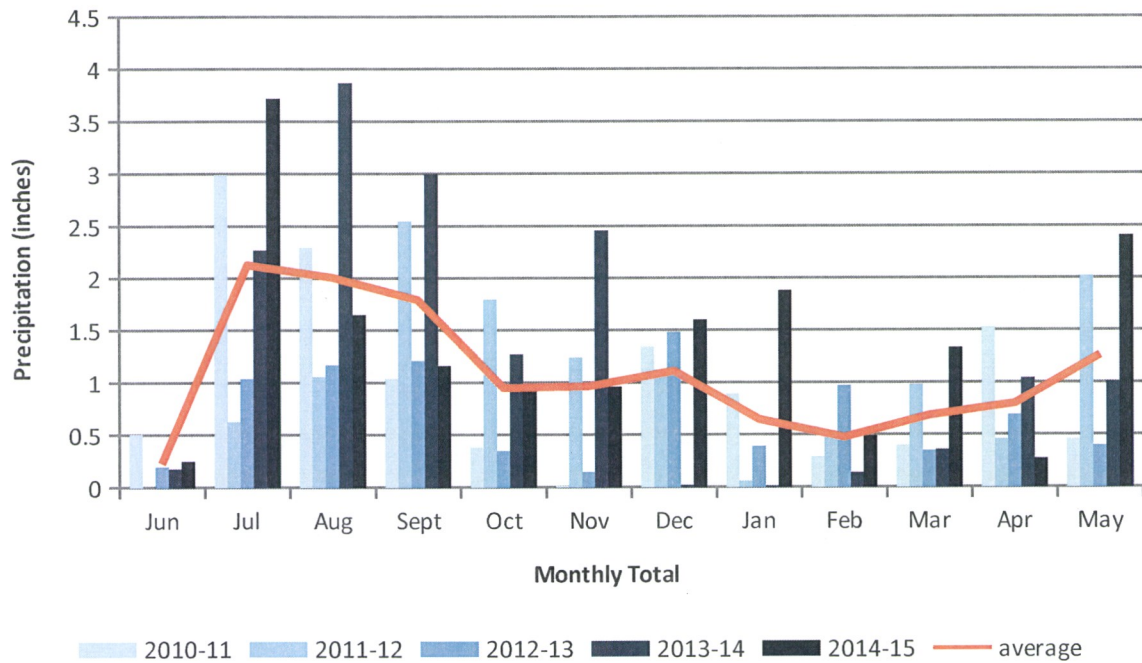
Figure 4. Precipitation totals by month from June 2010 to May 2015 (blue bars) at San Luis, Colorado; average monthly precipitation for this time frame is identified with the tan line.

In Figure 3, precipitation is analyzed for the 12-month period immediately prior to the annual June monitoring survey, i.e., June of the prior year to May of the monitored year. The 12-month total precipitation for 5 cycles (June-May) preceding were:

Precipitation has been greater than typical (11.8" per year) during four of the five 12-month cycles prior to the monitoring in June 2015.

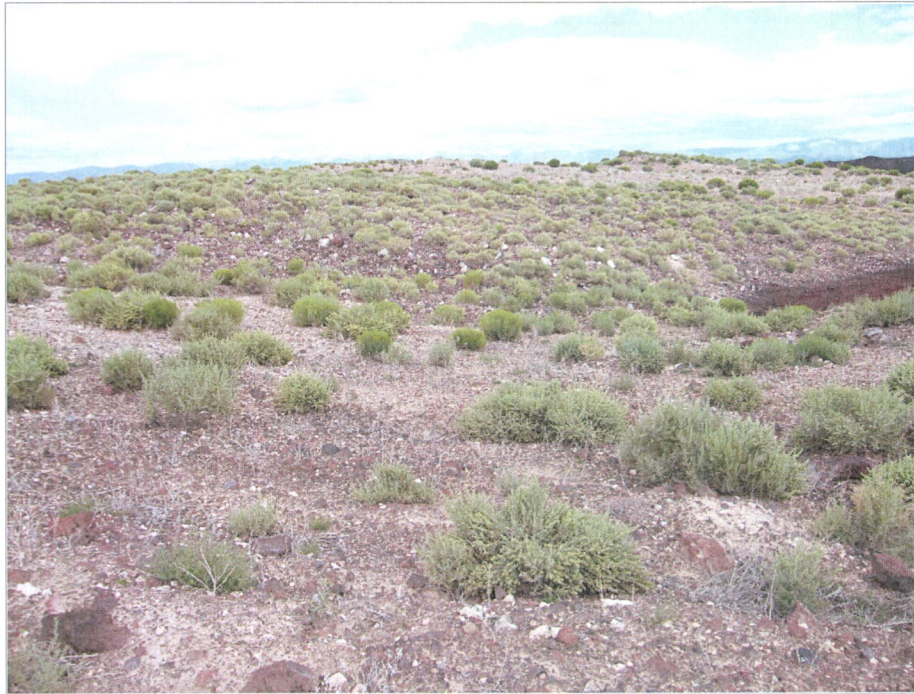
Most of the Mesita Mine site had good vegetative ground cover (Table 1). The perimeters of the site have the greatest plant cover, partially in the northeast and northwest (Photo 1). These are the areas with the most extensive topsoil cover, greatest topographic relief, and the longest time since reclamation. Vegetative cover type and percentage were locally variable depending on substrate, location, and reclamation event (with some variation in seed mixes used).

Photo 1. Many areas have excellent shrub and perennial herb cover, northeastern portion adjacent to Main Pit, Mesita Hill Mine, July 2015.

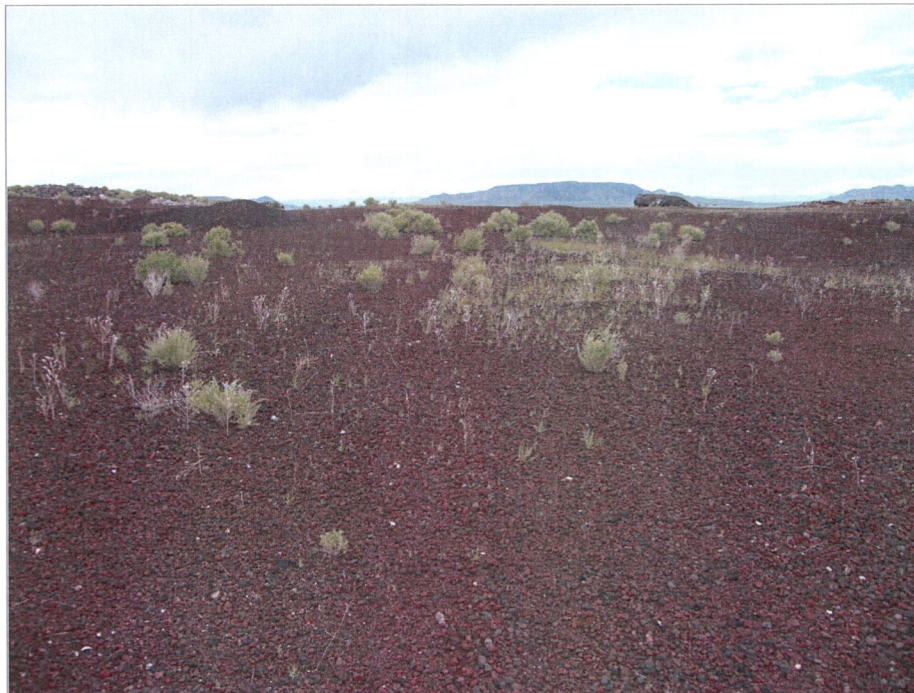
In the last two years with above average winter and spring precipitation, shrub cover has increased significantly. New seedlings were observed in all reclaimed portions giving evidence of self-regeneration by the native vegetation (Photo 2). Exceptions to the good cover were observed in a couple of limited areas in and around minor remaining pits and outcrops on the western portion where vegetative cover was low (Photo 3). Even in these areas some plant presence was observed during this annual monitoring, attesting to the beginning of soil system development on these raw run-of-mine surfaces.

Photo 2. The site has good regeneration as evidenced by seed set and seedlings, Mesita Hill Mine, July 2015.

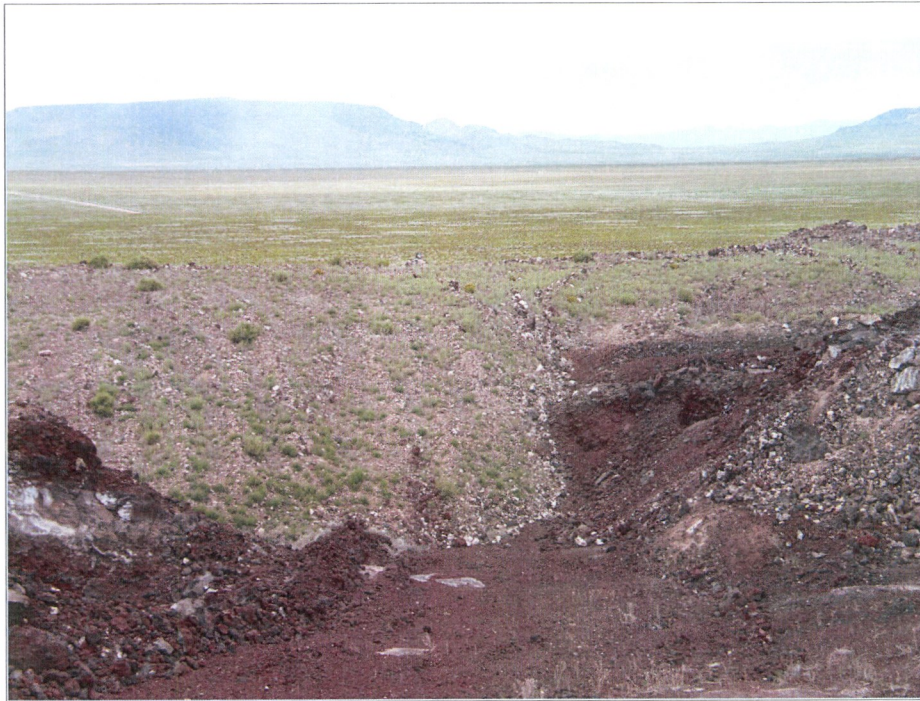
Photo 3. Remnant pit and outcrop area with have lower vegetative cover but provide good bird and small animal habitat, Mesita Hill Mine, July 2015.

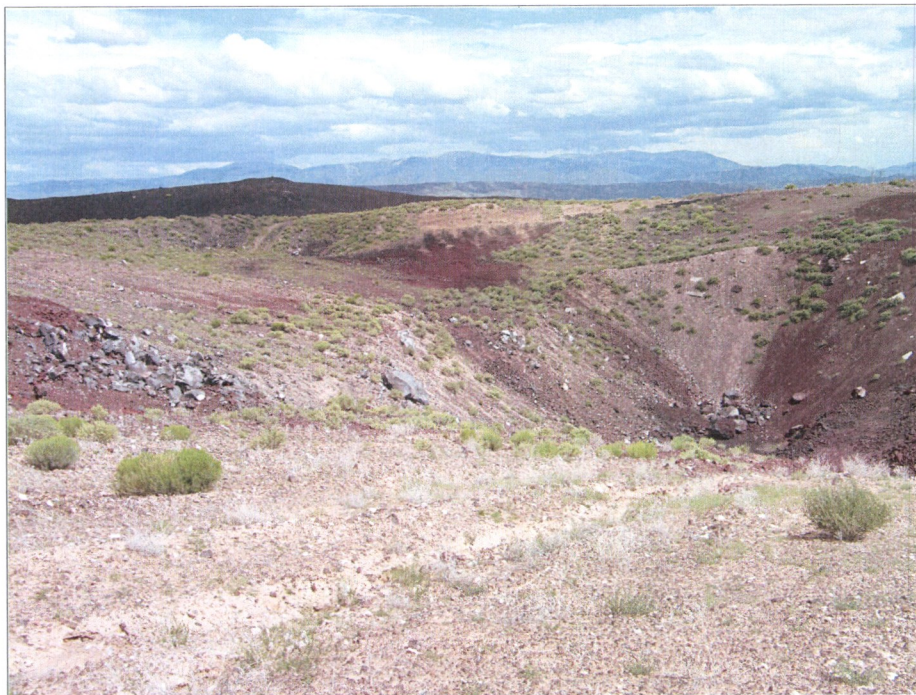
Slopes of the Main Pit (central north in Figure 3, Appendix A; Photo 4) had variable cover depending on location. The upper portion, where the slopes were reduced and topsoil placed, have good to excellent cover. The lower slopes have low vegetation cover with some bare areas.

Photo 4. The Main Pit slopes have vegetated well providing added stability, Mesita Hill Mine, July 2015.

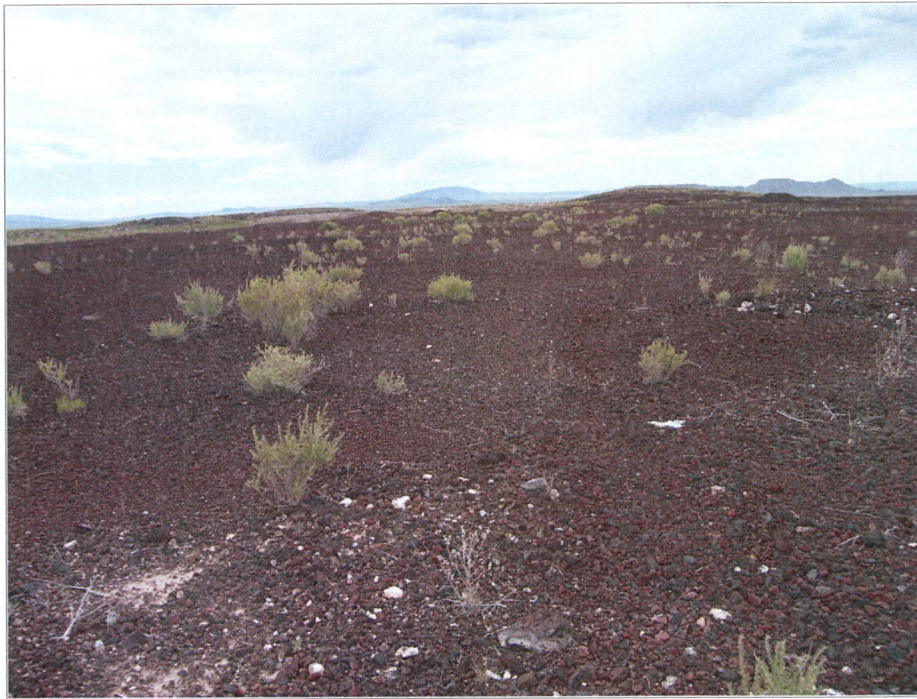
The central flat area with the run-of-mine scoria surface averaged 20% vegetative ground cover, double or more the cover last year (Photo 5). This area has been slower to grow and regenerate than the remainder of the site. This may be due to the lower moisture retention of the substrate and a greater surface temperature during the summer days from the dark surface and lack of topographic relief. The southwest portion of the central flats continues to have very low cover with large areas bare, but also had increase cover from previous years.

Photo 5. The Central Flat portion has no topsoil or topographic relief however the shrub density is continuing to increase, Mesita Hill Mine, July 2015.

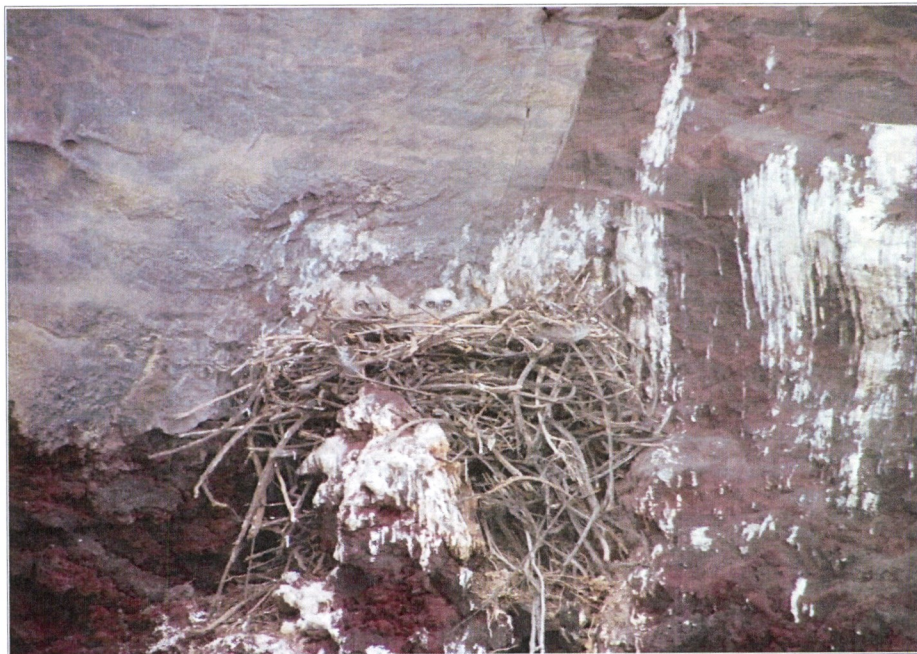
common raven (*Corvus corax*). A mourning dove (*Zenaida macroura*) with nest was present. The large raptor nest on a rock face in the western portion of the site was occupied by a great horned owl (*Bubo virginianus*) with two owlets (observed through binoculars) during the June 2015 site survey. Direct observation included pronghorn antelope (*Antilocapra americana*), numerous eastern cottontail rabbit (*Sylvilagus floridanus*), short horned lizard (*Phrynosoma hernandesi*), other lizards, and insects (including spider and butterfly). Animal sign included rodent (burrows) and domestic cow (dung and tracks).

Photo 6. Wildlife has adapted to the site and includes nesting Great Horned Owl (picture taken with telephoto lens), Mesita Hill Mine, June 2015.
