COLORADO DIVISION OF RECLAMATION, MINING AND SAFETY
MINERALS PROGRAM INSPECTION REPORT
PHONE: (303) 866-3567

MINE NAME: Bachus Pit	MINE/PROSPECTING ID#: M-1995-034	MINERAL: Borrow material for and sand	COUNTY: Alamosa
INSPECTION TYPE: Monitoring	INSPECTOR(S): Stephanie J. Mitchell	INSP. DATE: November 18, 2015	INSP. TIME: 08:00
OPERATOR: Daniel M Russell	OPERATOR REPRESENTATIVE: Dan Russell	TYPE OF OPERATION: 112c - Construction Regular Operation

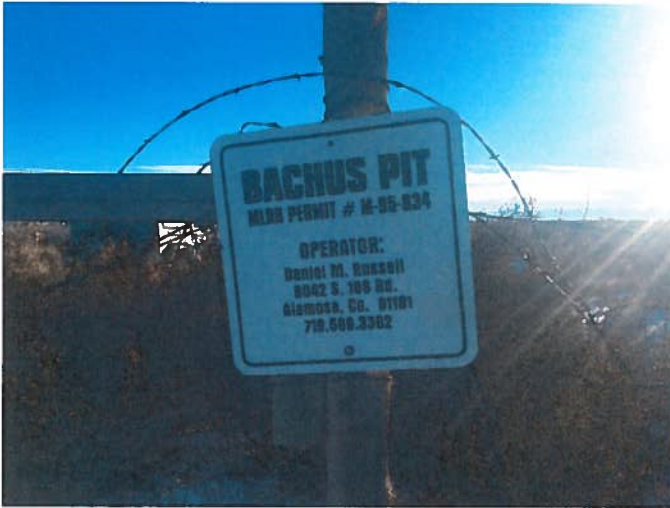
The Mine Identification sign was located at the entrance to the mine site. All activity is within the permit boundaries.

Mine ID sign

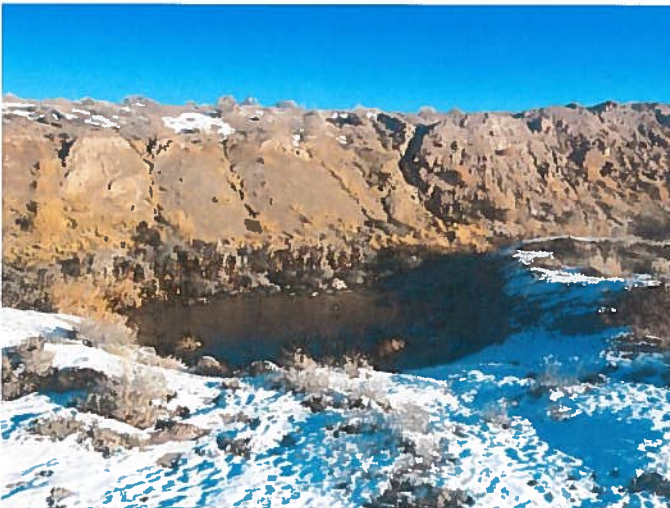
PROBLEM/POSSIBLE VIOLATION: Problem: The site is improperly impounding surface drainage/runoff.

There was some water present on the north side of the permit area. The retained water has a foot print of 10'x10'. This retained water (pond) needs to be backfilled and is noted as a problem at the beginning of this inspection report. Please submit photo documentation to the Division of the pond backfilled.

Pond 10'x10'

CORRECTIVE ACTIONS: Submit documentation from the State Engineer's Office demonstrating that the impoundment of water in this pit is authorized by that office. Operator could also remove impediments to proper surface drainage. Backfilling of impoundment is acceptable.

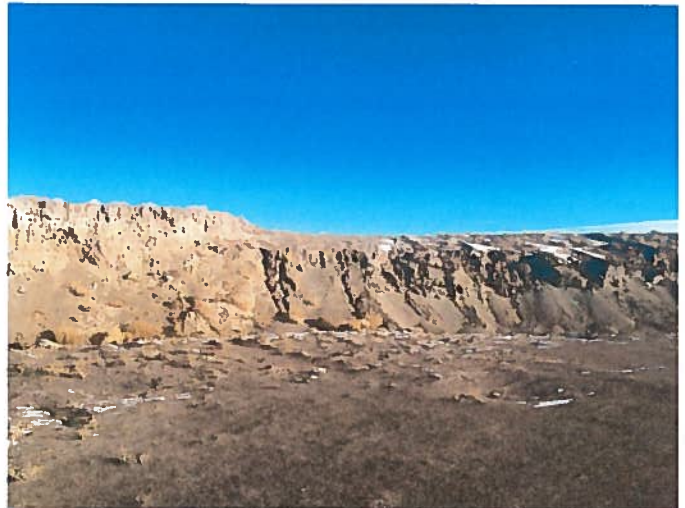
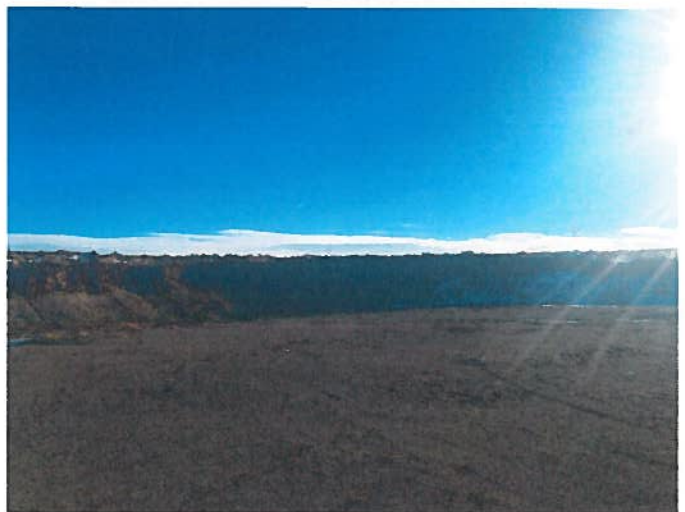
The current disturbance is located in the eastern portion of the permit area and is approximately 20 acres in size, and moving to the west. The excavation is about 20 feet deep with a vertical highwall. The highwall appears to be in the eastern part of the permit area. The western part of the site is frequented by Adams State College geology students for Lake Alamosa sediment deposit observations. Topsoil is not required to be stripped and salvaged. No erosion or sedimentation issues were observed.

Highwall
