COLORADO DIVISION OF RECLAMATION, MINING AND SAFETY
MINERALS PROGRAM INSPECTION REPORT
PHONE: (303) 866-3567

MINE NAME: Lee No 2 Placer	MINE/PROSPECTING ID#: M-1987-072	MINERAL: Gold	COUNTY: Gilpin
INSPECTION TYPE: Surety-Related Inspection	INSPECTOR(S): Michael A. Cunningham	INSP. DATE: January 21, 2016	INSP. TIME: 10:00
OPERATOR: Thomas Musch and Valerie Musch	OPERATOR REPRESENTATIVE: None	TYPE OF OPERATION: 110(2) - Hard Rock Limited Impact

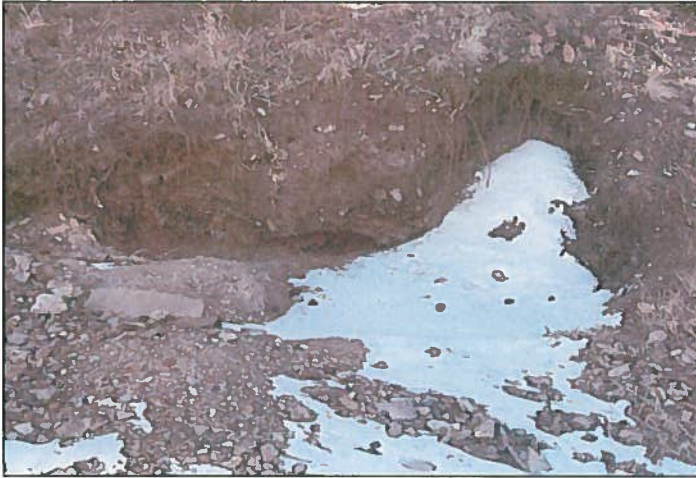
1. Excavation on northern bank of Russell Gulch.

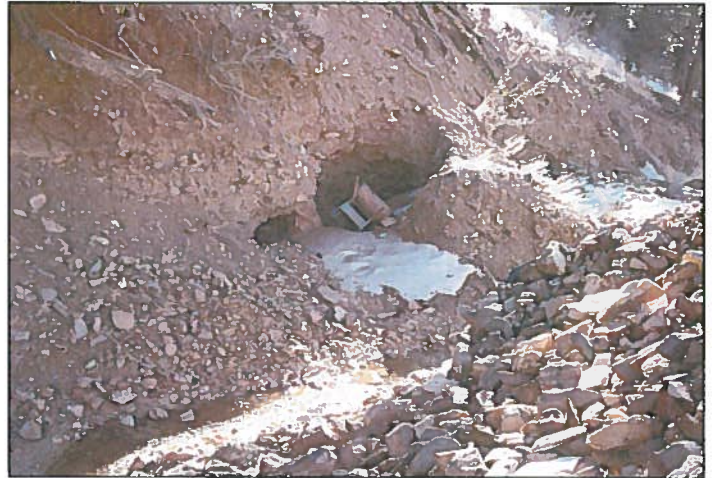
2. Excavation on northern bank of Russell Gulch.

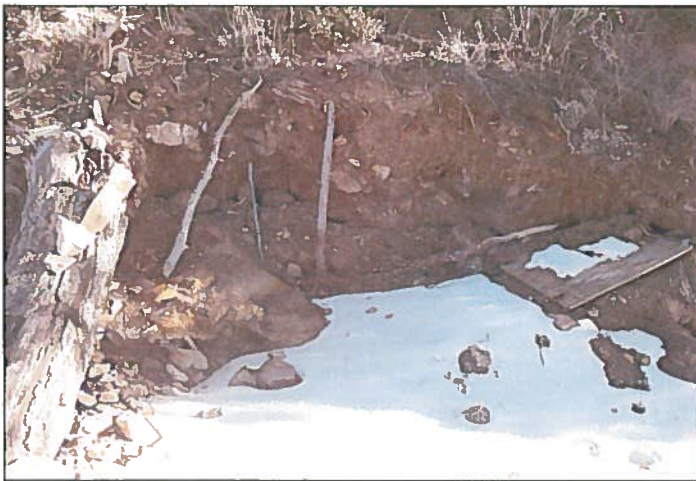
3. Excavation on northern bank of Russell Gulch.

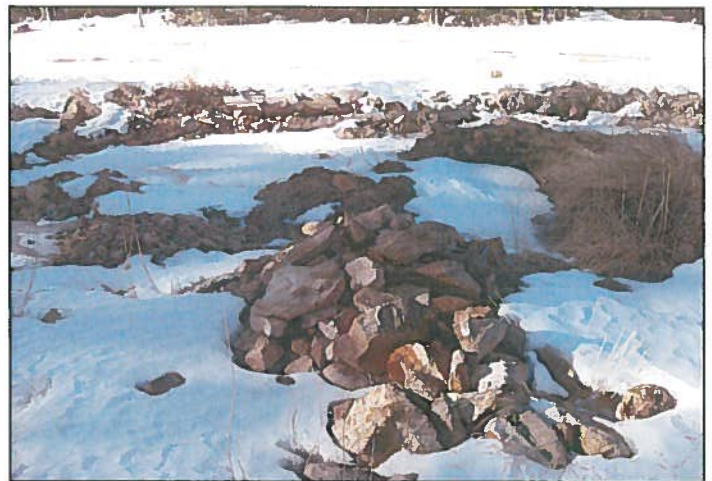
4. Rock check dam within Russell Gulch.
