COLORADO DIVISION OF RECLAMATION, MINING AND SAFETY
MINERALS PROGRAM INSPECTION REPORT
PHONE: (303) 866-3567

MINE NAME: Thornburg Pit	MINE/PROSPECTING ID#: M-1983-060	MINERAL: Sand and gravel	COUNTY: Adams
INSPECTION TYPE: Monitoring	INSPECTOR(S): Tyler V. O'Donnell	INSP. DATE: December 7, 2015	INSP. TIME: 09:00
OPERATOR: Thornburg Family Limited Partnership	OPERATOR REPRESENTATIVE: Stanley Thornburg	TYPE OF OPERATION: 112c - Construction Regular Operation

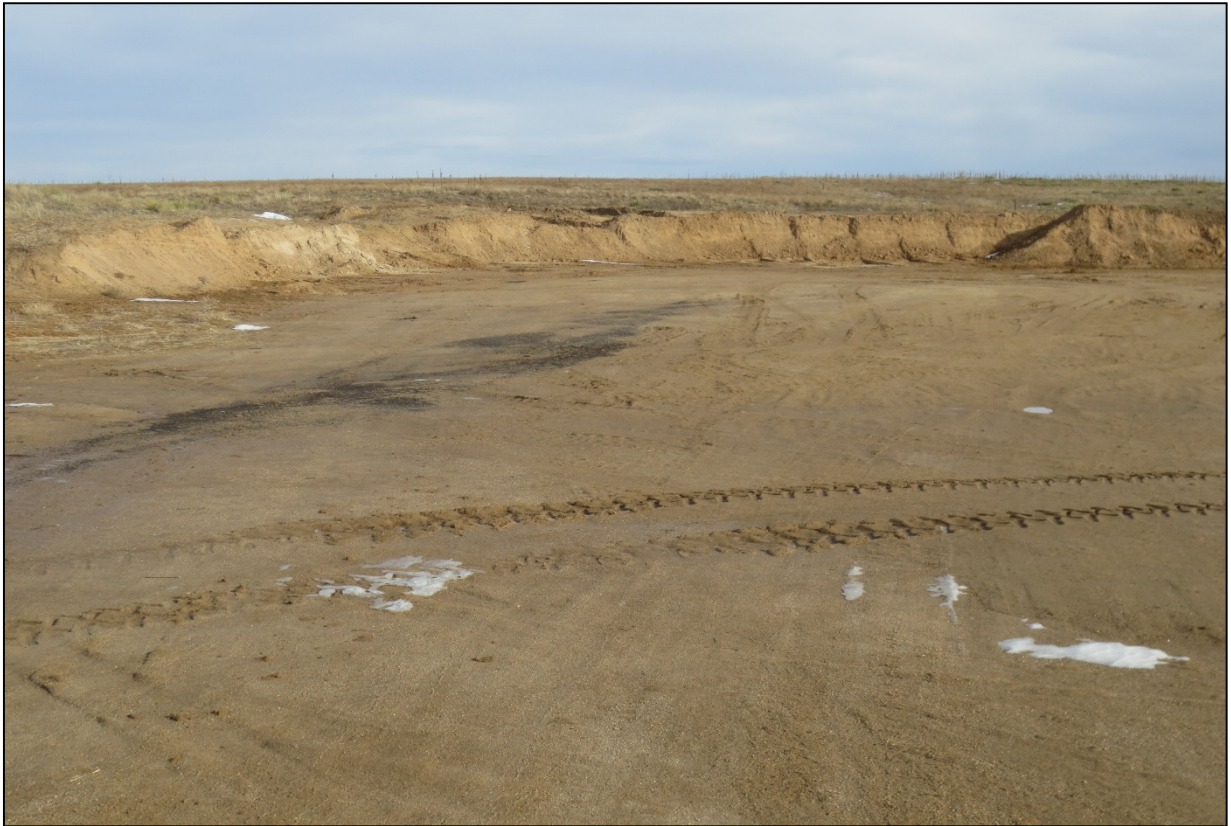
Photo 1: Active highwall. Mining is progressing to the north and east.

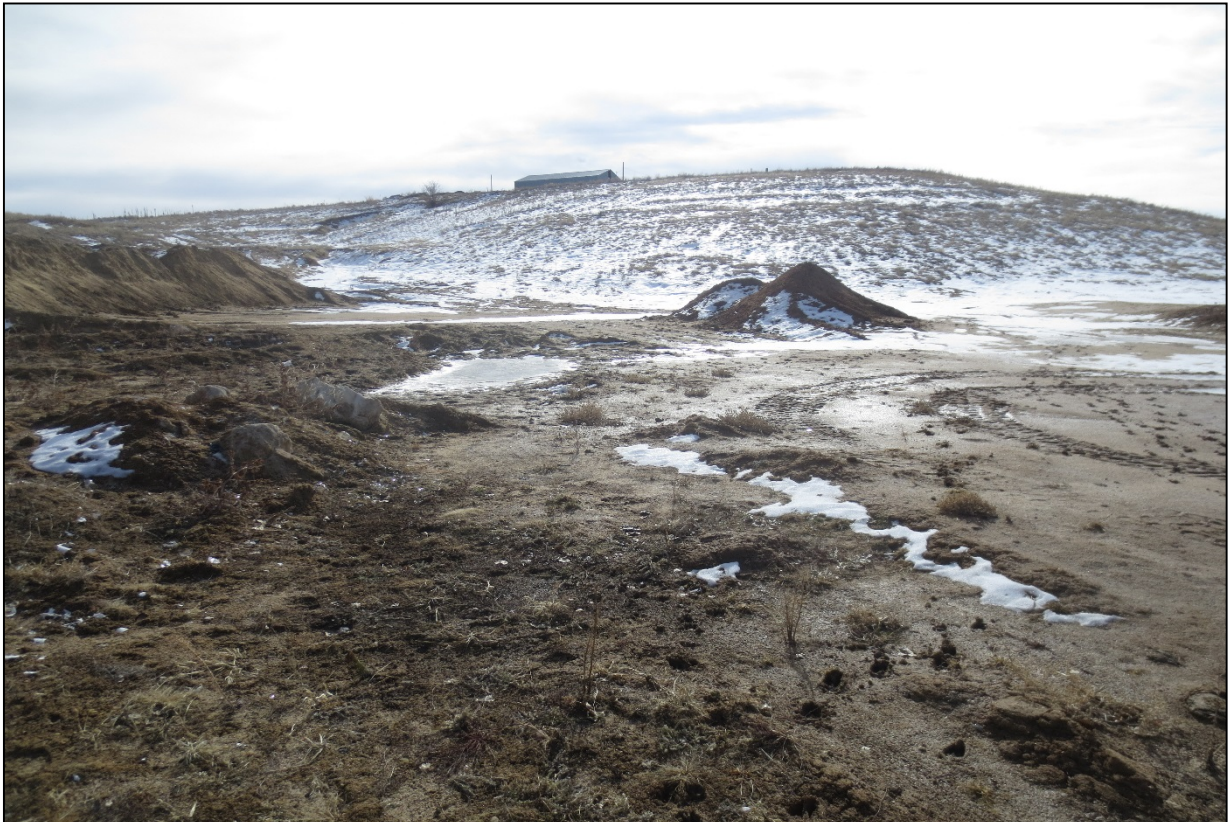
Photo 2: Active highwall left hand side of the photo. Partially reclaimed slope in the background.

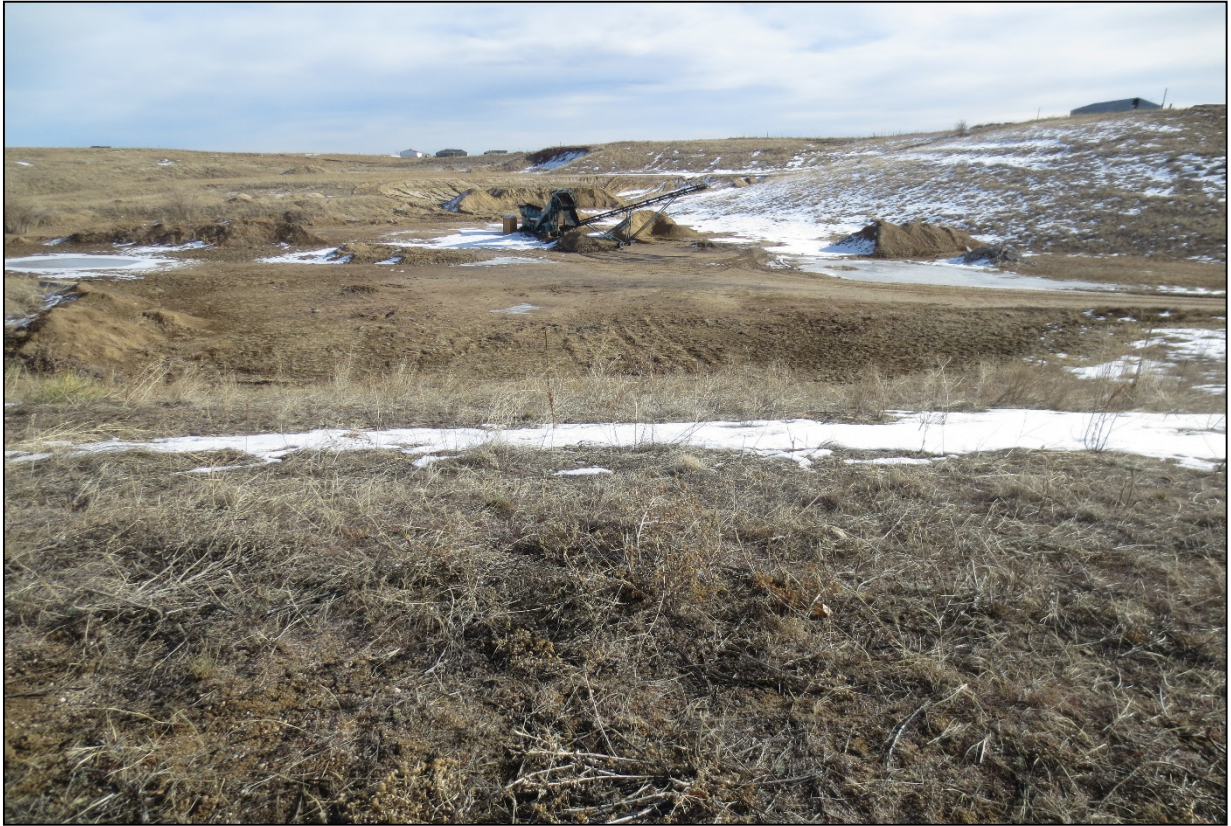
There was no evidence of excessive erosion (rills, gullies, or sediment fans). Some of the graded slopes have small rills beginning to form on the slopes. The Operator will need to repair and stabilize the erosion damage.

Photo 3: Active pit in the foreground. Partially reclaimed slope in the background. Minor rills will need to be repaired.

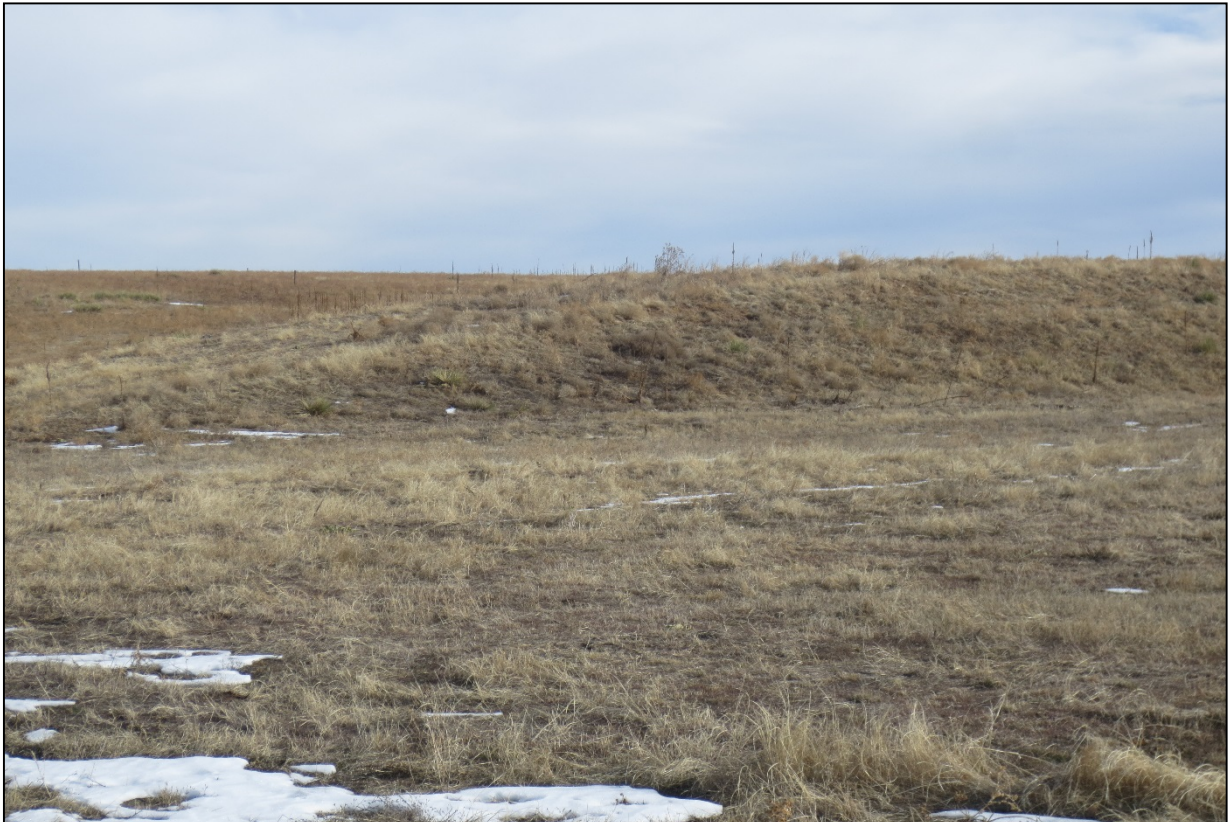
There was a well-vegetated topsoil stockpile located in the northern portion of the permitted site. It appears the topsoil stockpile has been idle for a while, no recent heavy equipment marks were observed in the stockpile. There appeared to be an adequate amount of topsoil to reclaim the site.

Photo 4: Adequate vegetative cover on the topsoil stockpile.
