COLORADO DIVISION OF RECLAMATION, MINING AND SAFETY
MINERALS PROGRAM INSPECTION REPORT
PHONE: (303) 866-3567

| MINE NAME: Pinon Mine | MINE/PROSPECTING ID#: M-1997-094 | MINERAL: Stone | COUNTY: Pueblo |
| INSPECTION TYPE: Monitoring | INSPECTOR(S): Tyler V. O'Donnell | INSP. DATE: November 13, 2015 | INSP. TIME: 14:15 |

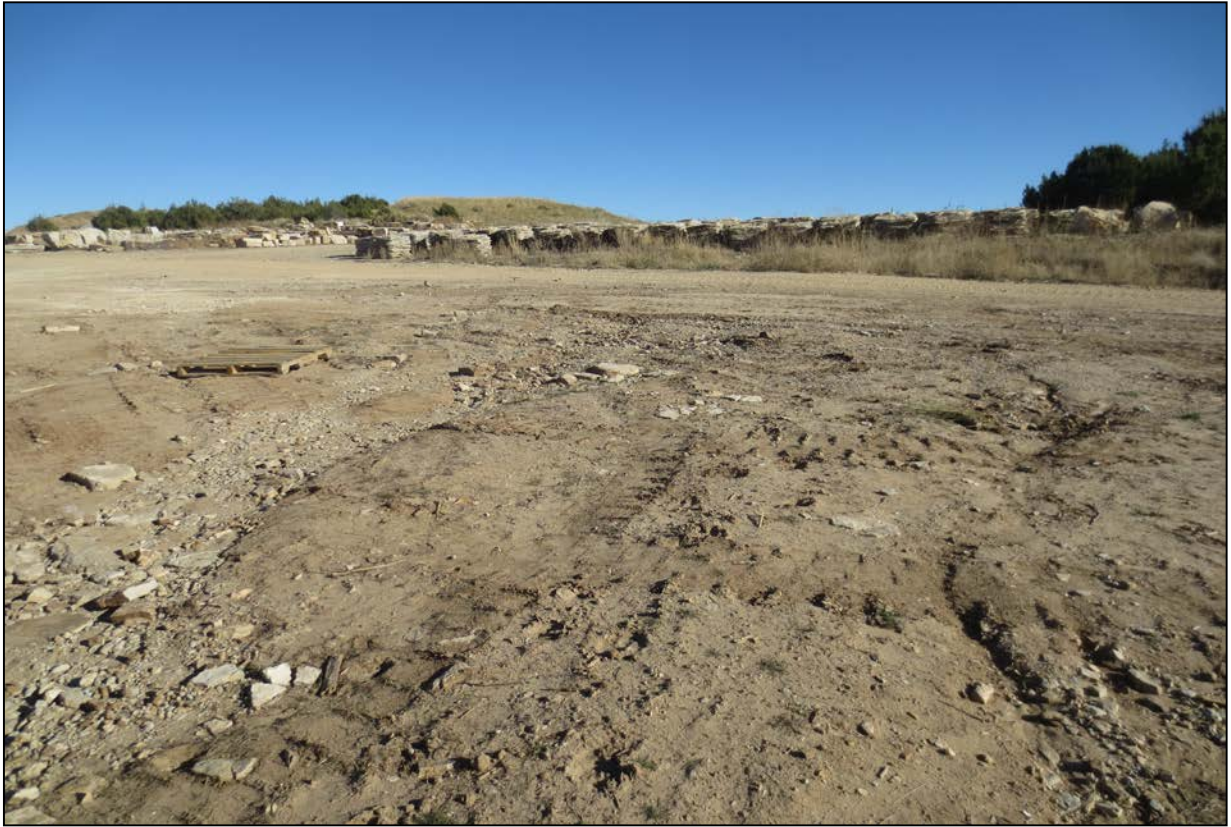
There was no active highwall observed during the inspection. Portions of the site have been backfilled with waste rock and graded.

Photo 1: Backfilled area in the foreground, stone yard in the background.

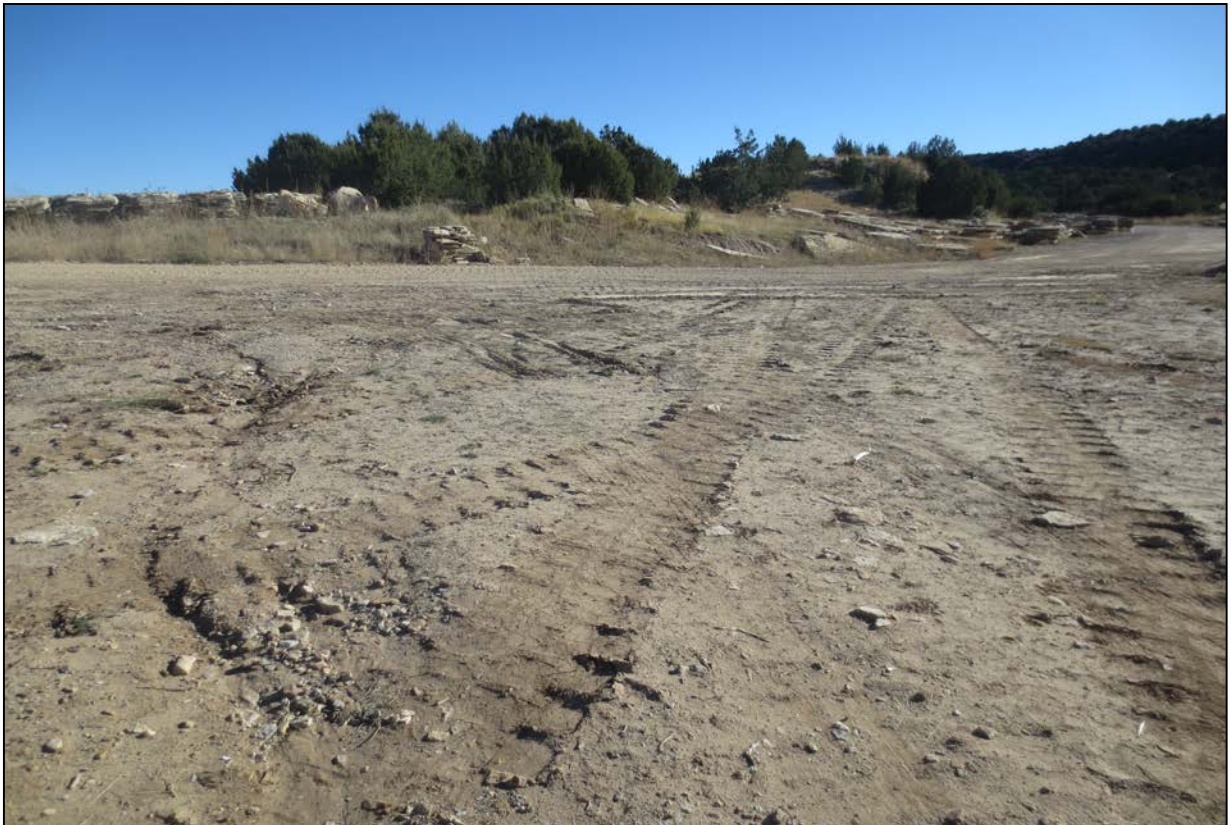
Photo 2: Backfilled area in the foreground, stone yard in the background. Area around the stone yard has filled in with native grasses.

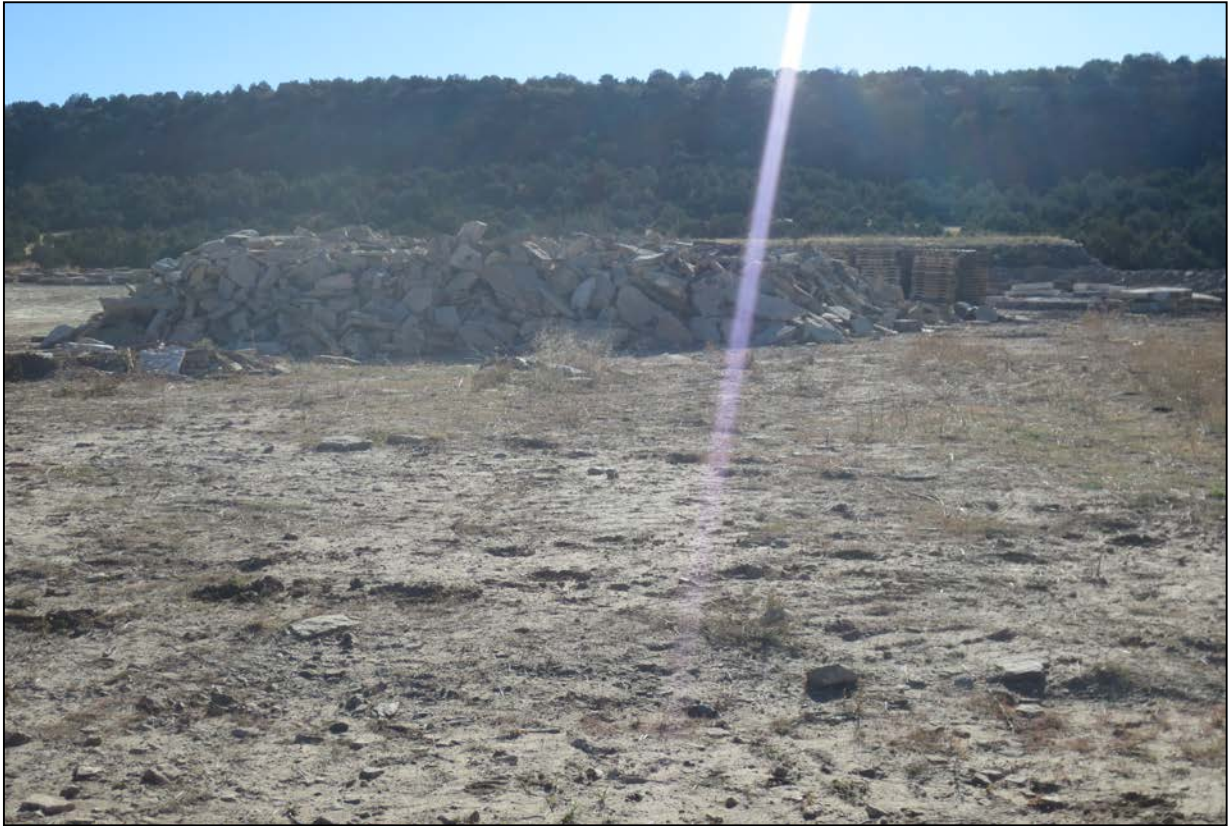
Photo 3: Backfilled area in the foreground, waste rock stockpile in the background.
