COLORADO DIVISION OF RECLAMATION, MINING AND SAFETY
MINERALS PROGRAM INSPECTION REPORT
PHONE: (303) 866-3567

MINE NAME: Siloam Mine	MINE/PROSPECTING ID#: M-1977-326	MINERAL: Clay (general) and ag	COUNTY: Pueblo
INSPECTION TYPE: Monitoring	INSPECTOR(S): Tyler V. O'Donnell	INSP. DATE: November 13, 2015	INSP. TIME: 14:35
OPERATOR: General Shale Brick, Inc.	OPERATOR REPRESENTATIVE: Jason McGraw	TYPE OF OPERATION: 110c - Construction Limited Impact

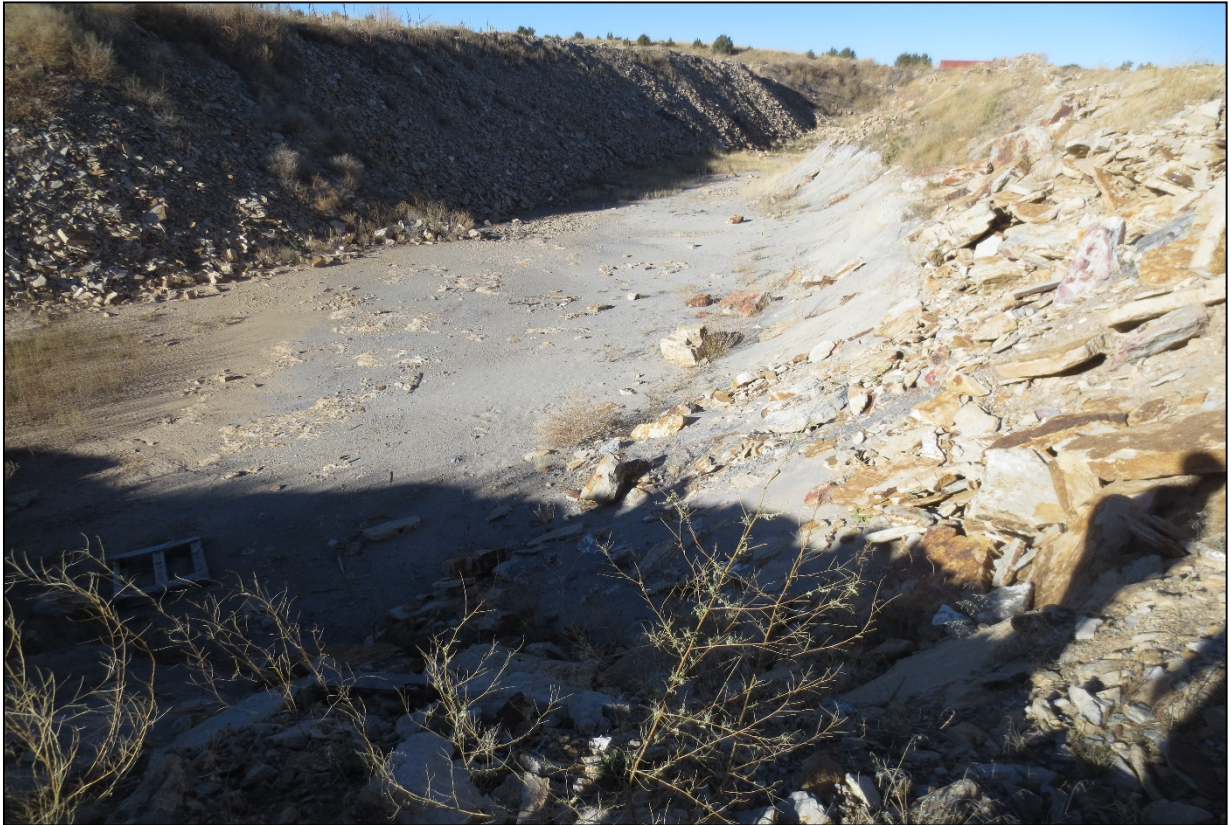
There was a highwall. The highwall was approximately 500 feet long and was approximately 10 to 15 feet high.

Photo 1: Highwall along the right-hand side of the photo.

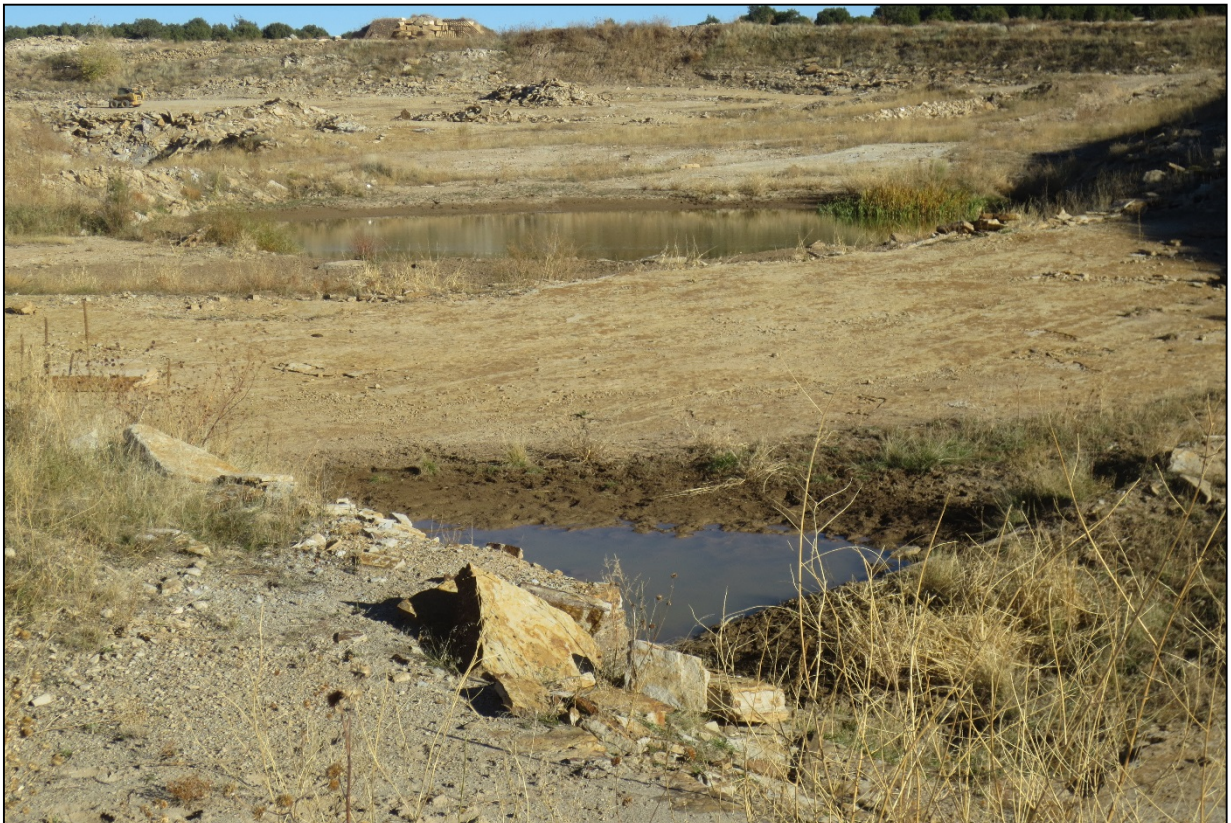
The site was dry, no exposed groundwater was observed during the inspection. There appeared to be no significant impacts to the prevailing hydrologic balance. A small pond of captured stormwater was observed on or near the boundary between the Siloam Mine and the Bedrock Mine No.1 (DRMS file No. M-1997-086). When conducting final reclamation the Operator is encouraged to work with Siloam Stone to reclaim the site to gain positive drainage.

Photo 2: Captured stormwater ponds in the southeast corner of the permit boundary.

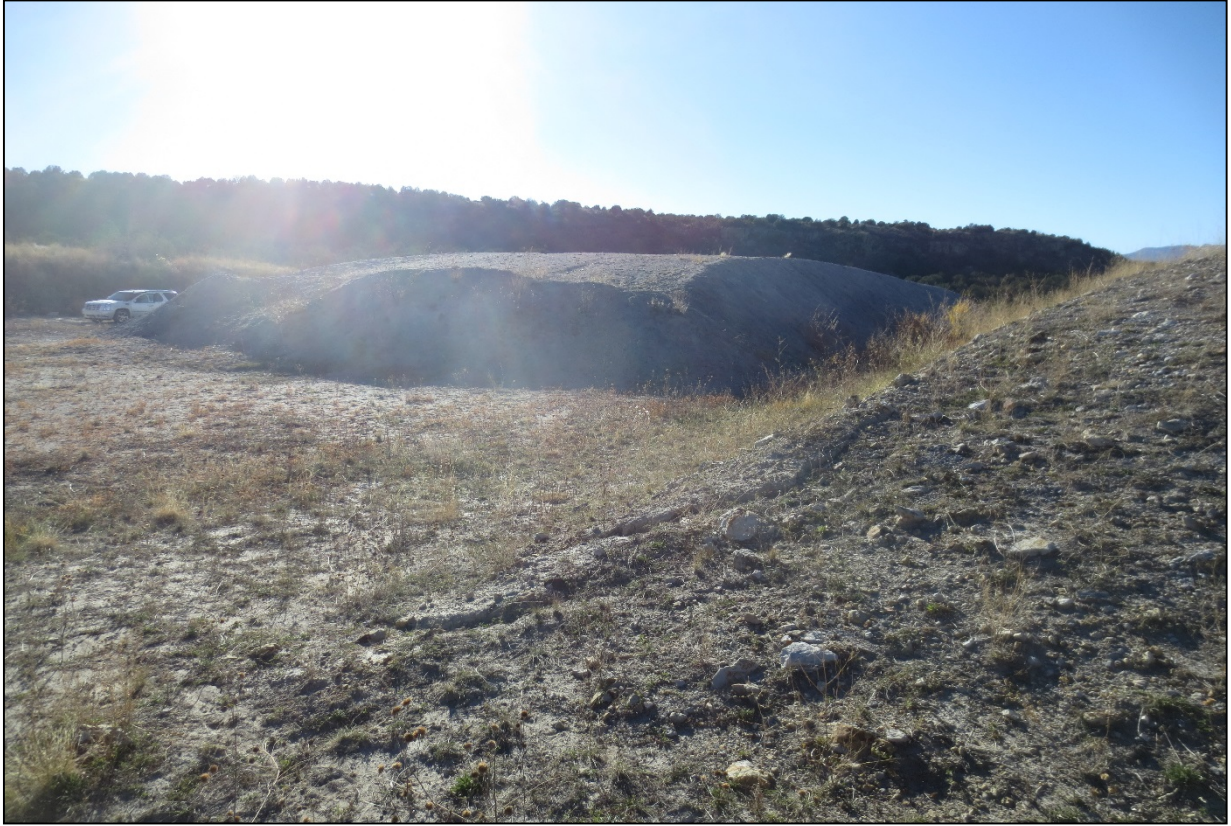
Photo 3: Product stockpiles.

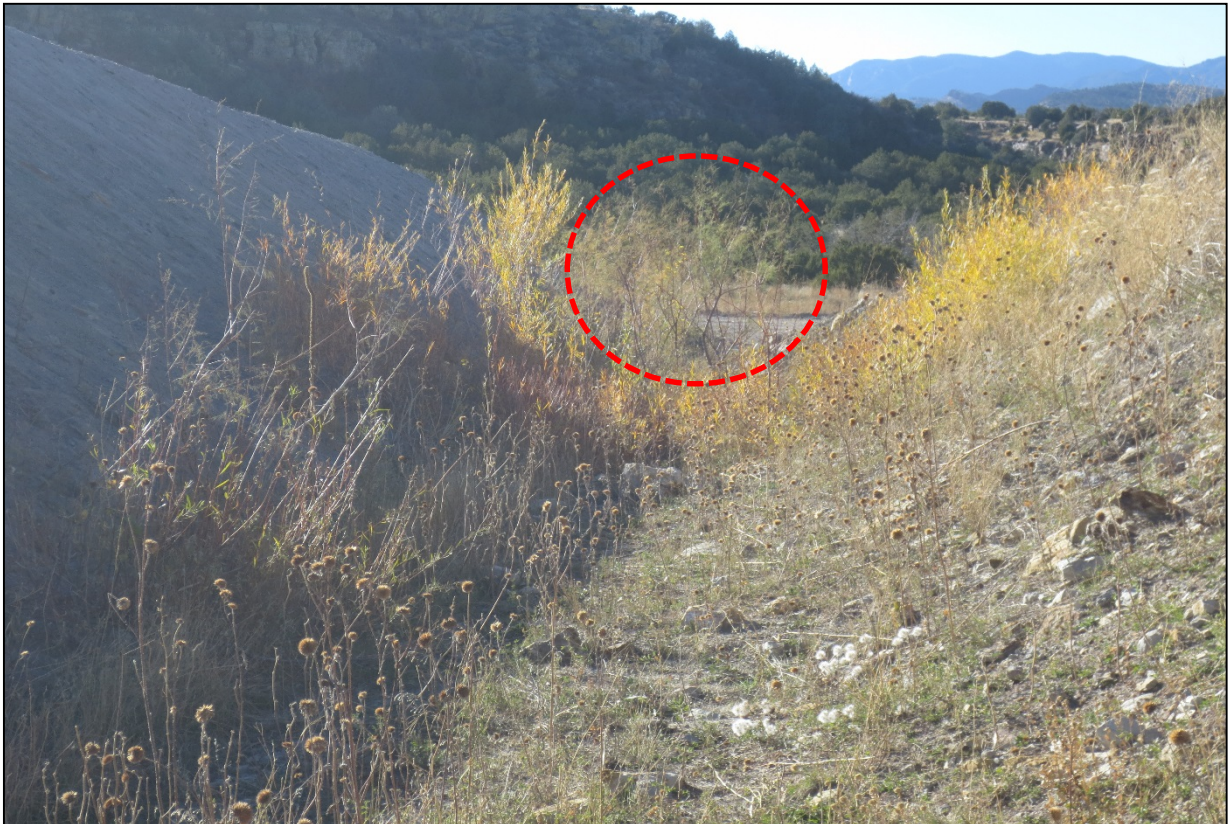
There was plant growth on the overburden and topsoil stockpiles, and throughout the rest of the affected lands. The growth in the affected areas appeared to be volunteer vegetation, comprised of annual weeds, and native grasses. A few tamarisk trees were observed around the product stockpiles. At the present time the presence of

Photo 4: Tamarisk trees circled with the red dashed line.

tamarisk trees will not be cited as a problem, due to the limited number of trees. The Operator is advised to continue to monitor and treat noxious weeds if the weeds appear within the permit boundary. The Operator should also consider mowing the annual weeds prior to seed production, to prevent the spread of annual weeds.
