COLORADO DIVISION OF RECLAMATION, MINING AND SAFETY
MINERALS PROGRAM INSPECTION REPORT
PHONE: (303) 866-3567

MINE NAME: Fryrear Gravel Pit	MINE/PROSPECTING ID#: M-1998-071	MINERAL: Sand, gravel, clay	COUNTY: Yuma
INSPECTION TYPE: Surety-Related Inspection	INSPECTOR(S): Elliott R. Russell	INSP. DATE: August 5, 2015	INSP. TIME: 09:30
OPERATOR: Tim & Justin Kuntz Trucking, LLC	OPERATOR REPRESENTATIVE: Tim & Justin Kuntz	TYPE OF OPERATION: 112c - Construction Regular Operation

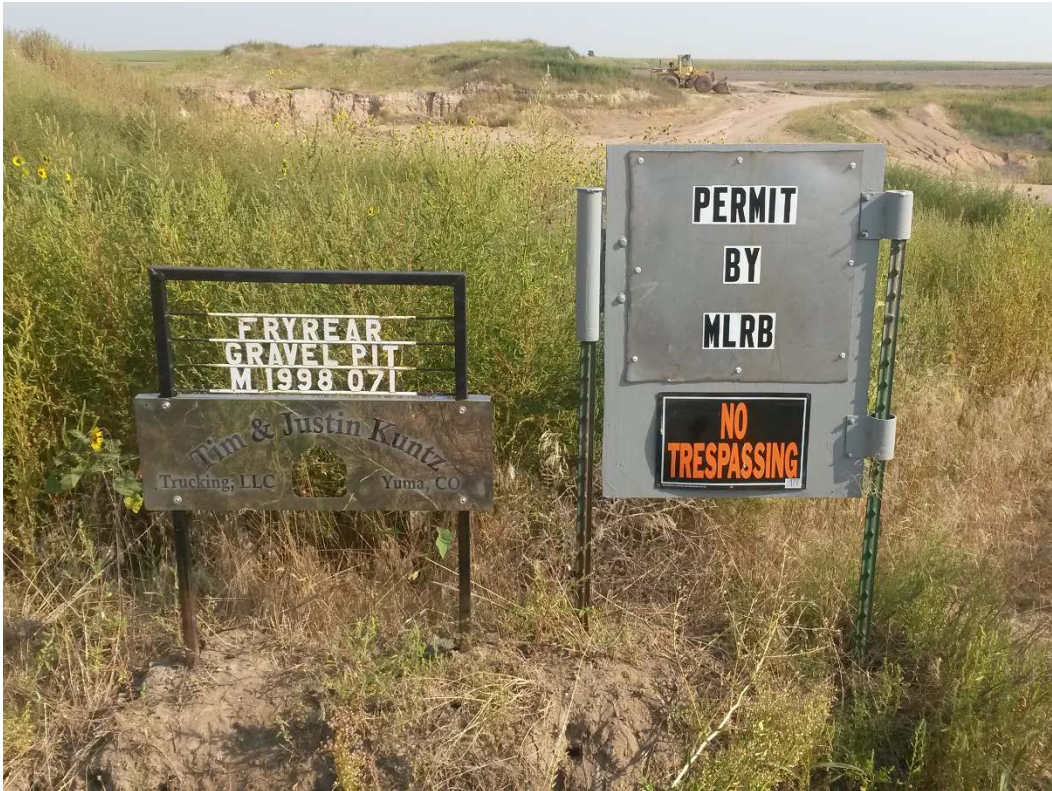
Permit identification signs (picture submitted by Operator on 8/24/15); looking north.

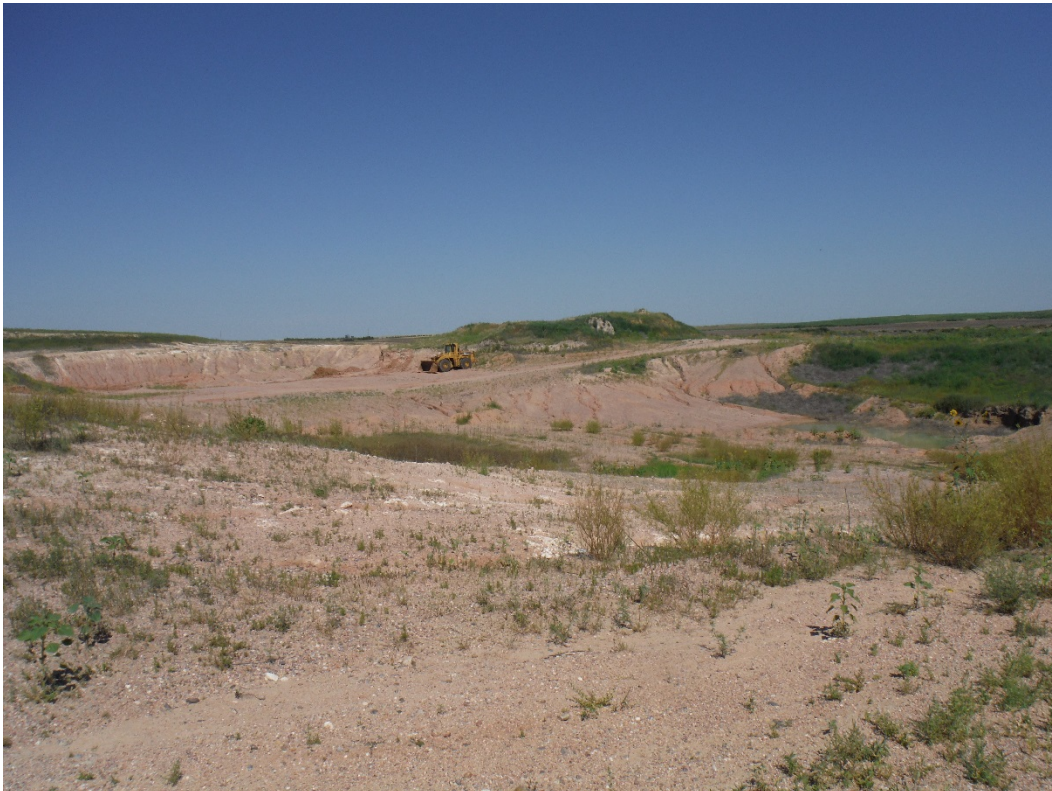
Overview of the older "southern pit" area; looking west.

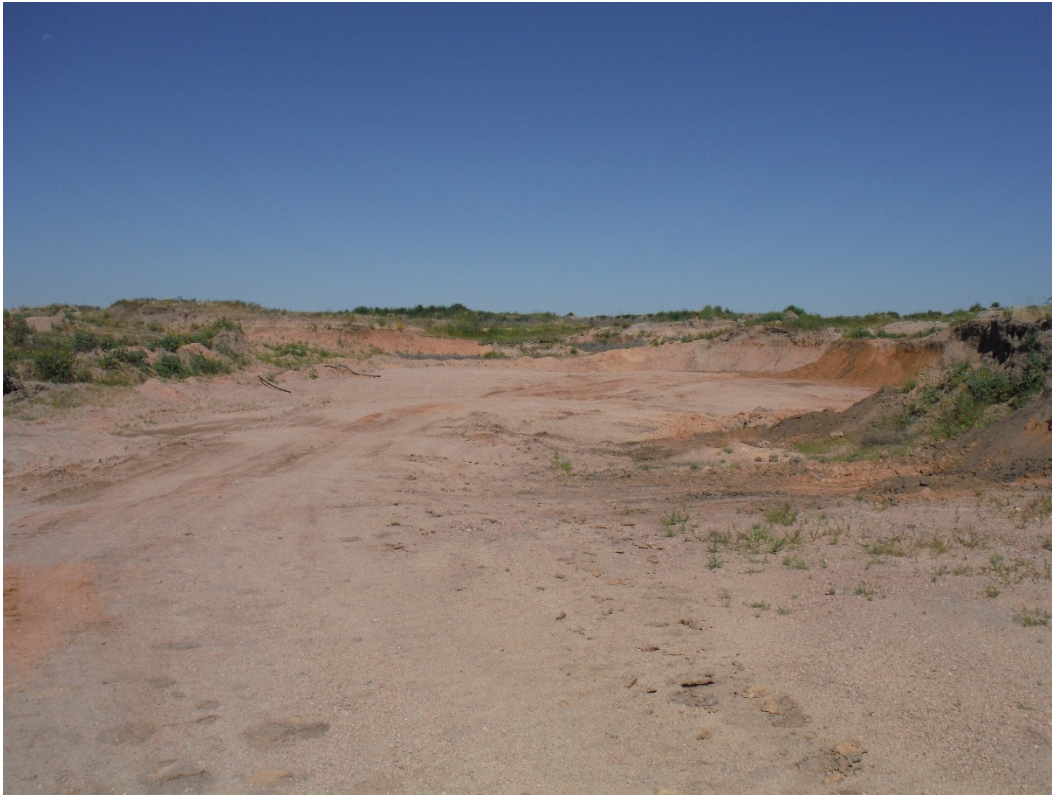
Overview of the newer “northern pit” area; looking northwest.
