**COLORADO DIVISION OF RECLAMATION, MINING AND SAFETY**  
**MINERALS PROGRAM INSPECTION REPORT**  
**PHONE: (303) 866-3567**

<b>MINE NAME:</b> Holyoke Gun Club Pit	<b>MINE/PROSPECTING ID#:</b> M-1977-075	<b>MINERAL:</b> Sand and gravel	<b>COUNTY:</b> Phillips
<b>INSPECTION TYPE:</b> Surety-Related Inspection	<b>INSPECTOR(S):</b> Elliott R. Russell	<b>INSP. DATE:</b> August 5, 2015	<b>INSP. TIME:</b> 12:00
<b>OPERATOR:</b> Phillips County	<b>OPERATOR REPRESENTATIVE:</b> Randy Schafer	<b>TYPE OF OPERATION:</b> 112c - Construction Regular Operation

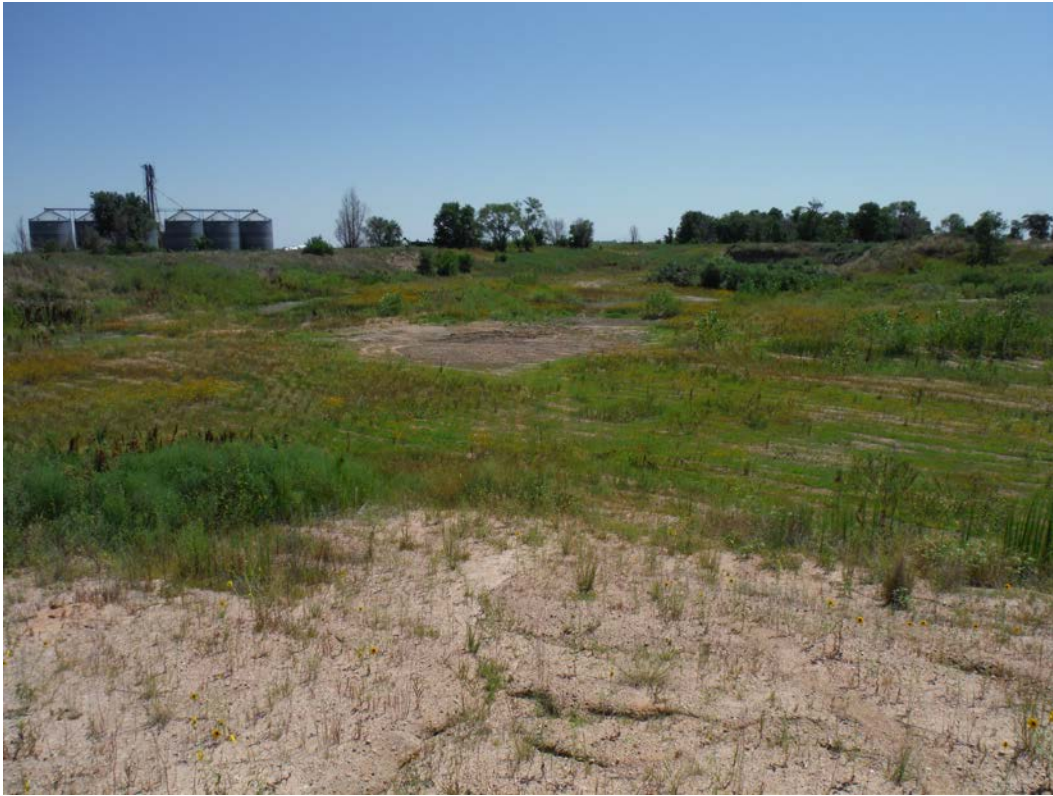
Overview of the original pit area; looking southeast.

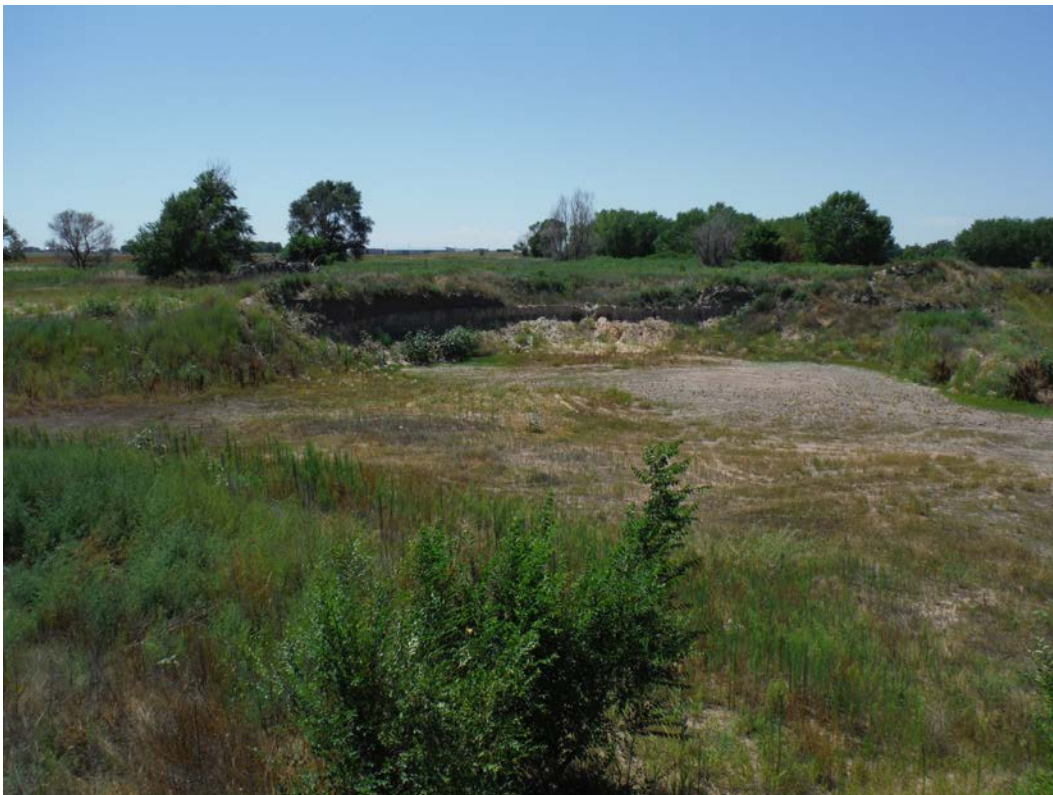
Active mining face/highwall; looking southwest into expansion area.

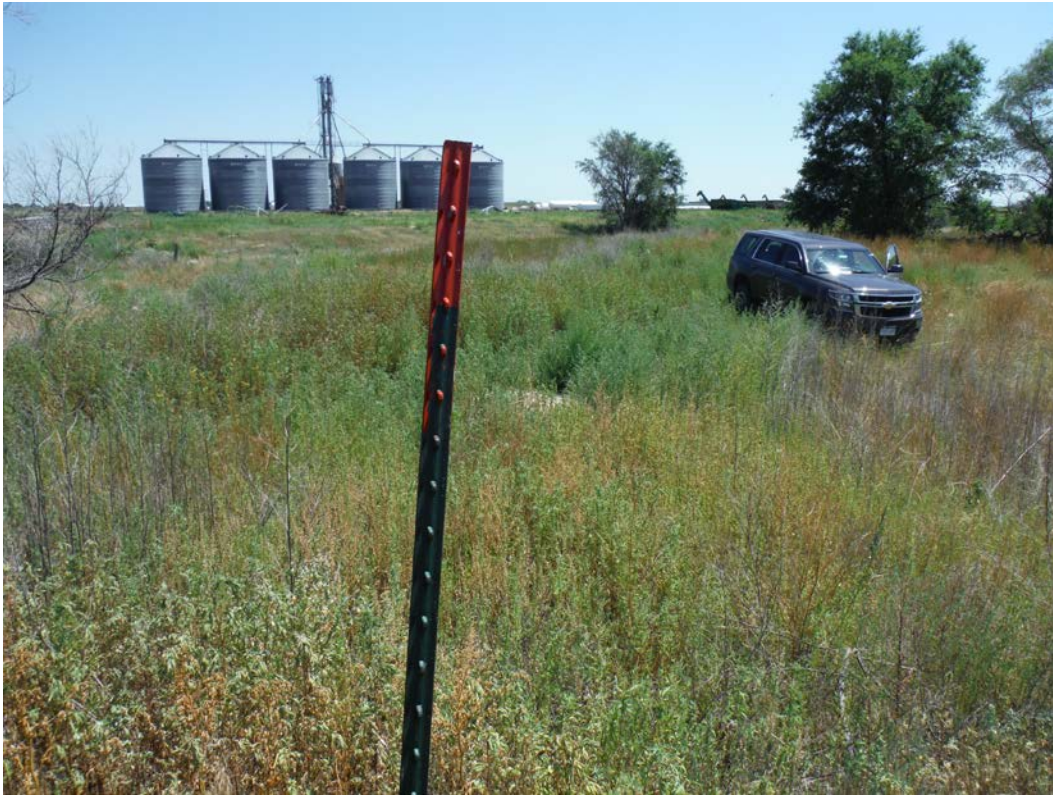
**PROBLEM/POSSIBLE VIOLATION:** Problem 2: The affected area boundary markers are missing or incorrectly placed. This is a problem for failure to maintain boundary markers around the affected area as required by Rule 3.1.12(2).

Eastern/central boundary marker; looking southeast.

**CORRECTIVE ACTIONS:** The operator shall conduct a survey and replace the boundary markers in the correct location(s). The operator shall provide photographic proof to the Division that this has been done by the corrective action date.

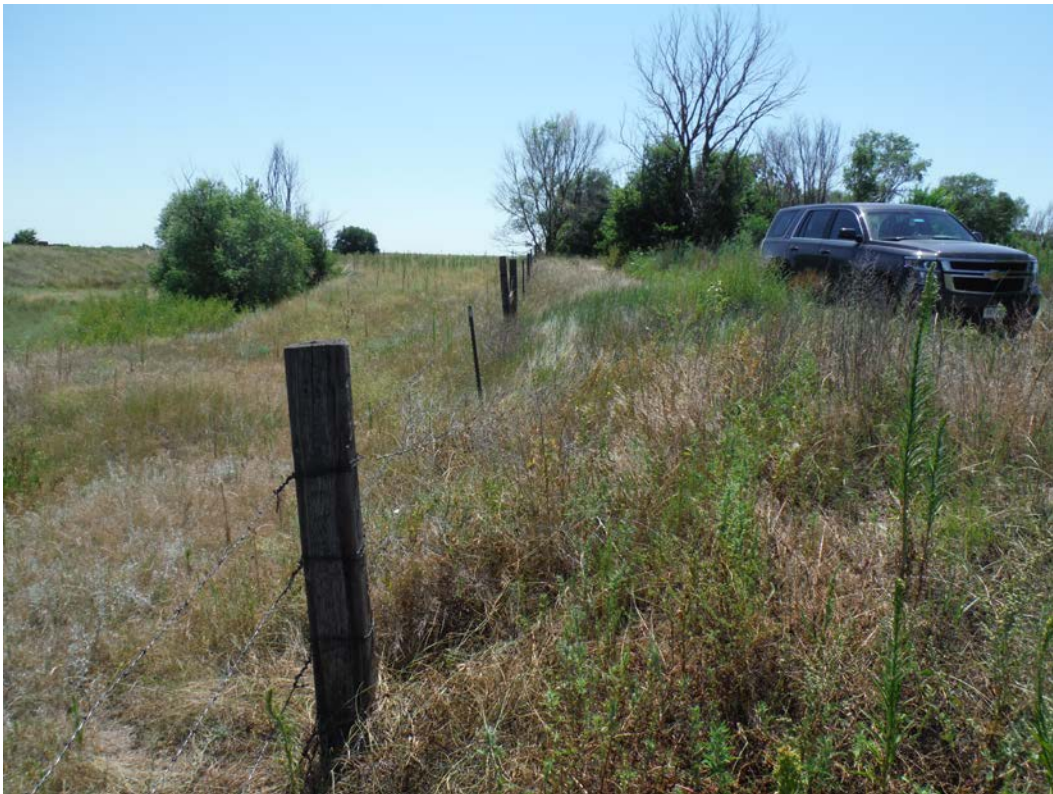
Eastern boundary marker; looking south.

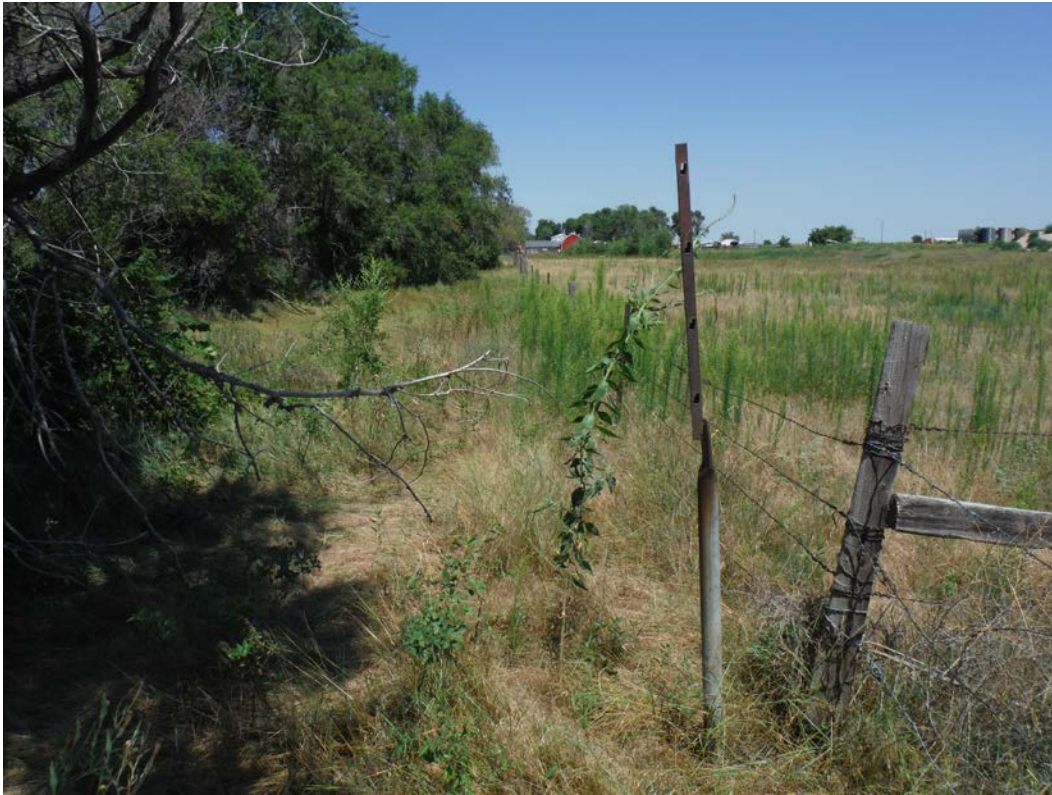
Southeastern boundary marker; looking north.
