COLORADO DIVISION OF RECLAMATION, MINING AND SAFETY
MINERALS PROGRAM INSPECTION REPORT
PHONE: (303) 866-3567

MINE NAME: Cresson Project	MINE/PROSPECTING ID#: M-1980-244	MINERAL: Gold	COUNTY: Teller
INSPECTION TYPE: Monitoring	INSPECTOR(S): Elliott R. Russell	INSP. DATE: October 21, 2015	INSP. TIME: 10:00
OPERATOR: Cripple Creek & Victor Gold Mining Company	OPERATOR REPRESENTATIVE: Chris Hanks	TYPE OF OPERATION: 112d-3 - Designated Mining Operation

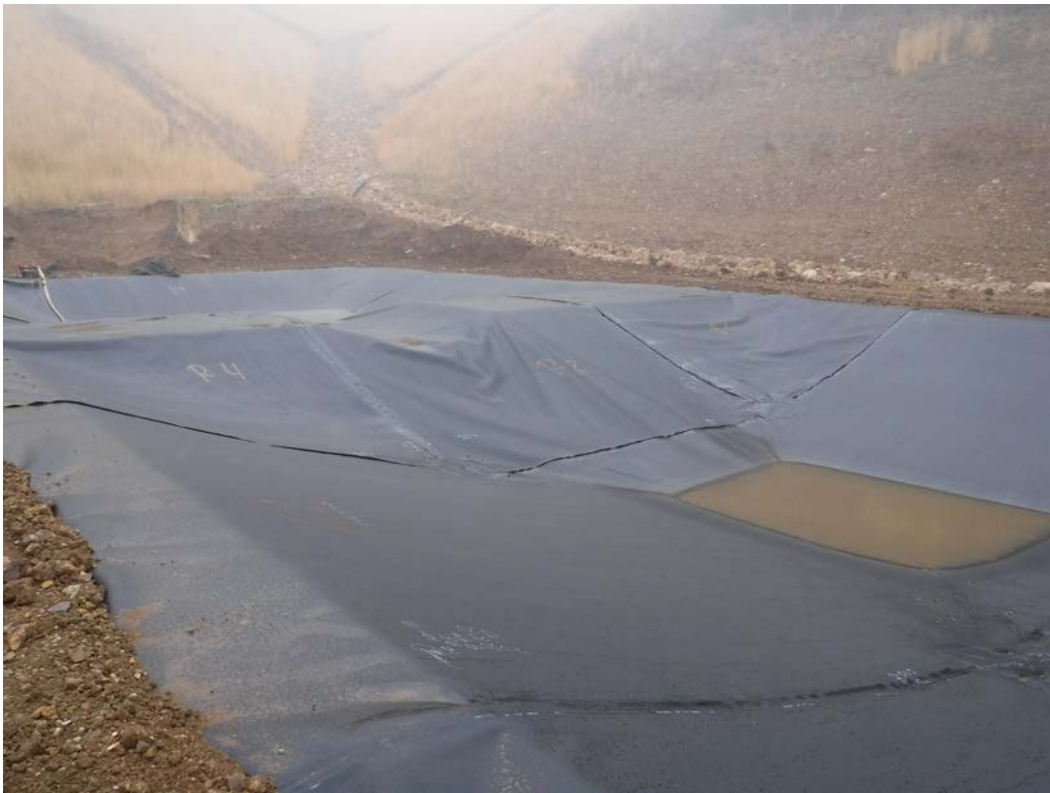
The on-going construction of the underdrain sump and ponds was observed. The underdrain pond geomembrane liner had recently been installed (**Photo 1**). The location for the sump had been excavated and the foundation for the sub-surface enclosure was being prepared (**Photo 2**). The enclosure was staged near where Squaw Gulch intersects Shelf Road.

Photo 1. Liner installed in the Squaw Gulch Underdrain Ponds; looking southeast.

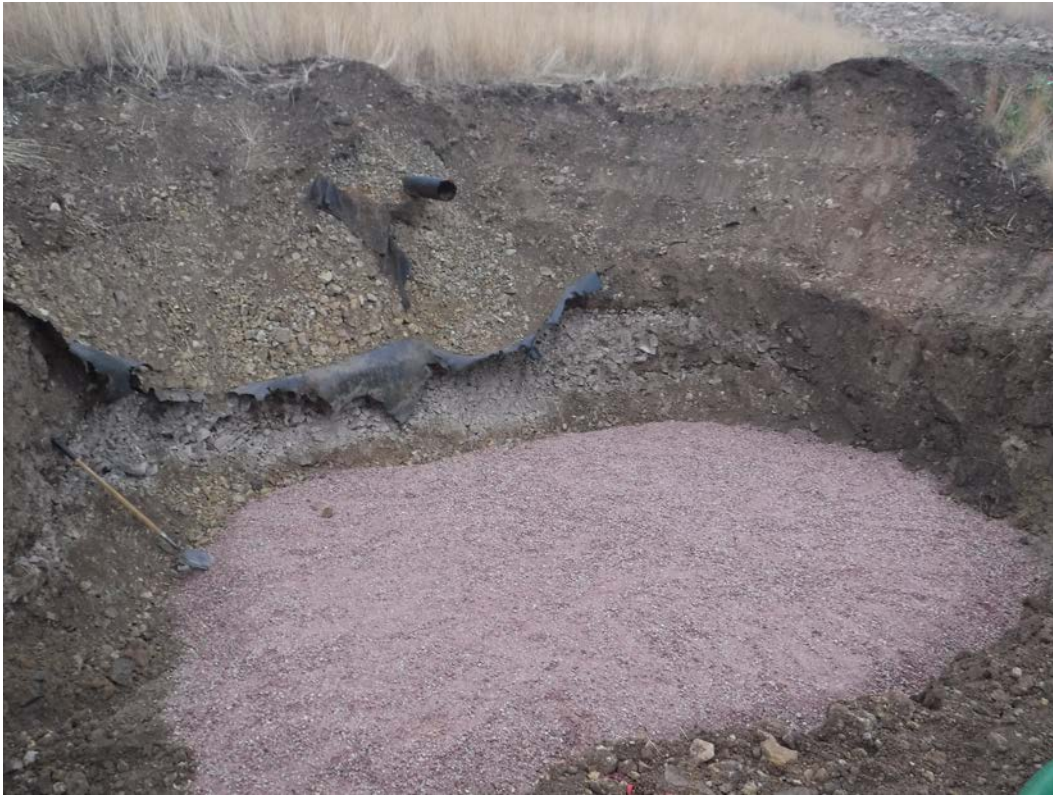
Photo 2. Excavation for the sub-surface enclosure for the underdrain pond sump; looking east.

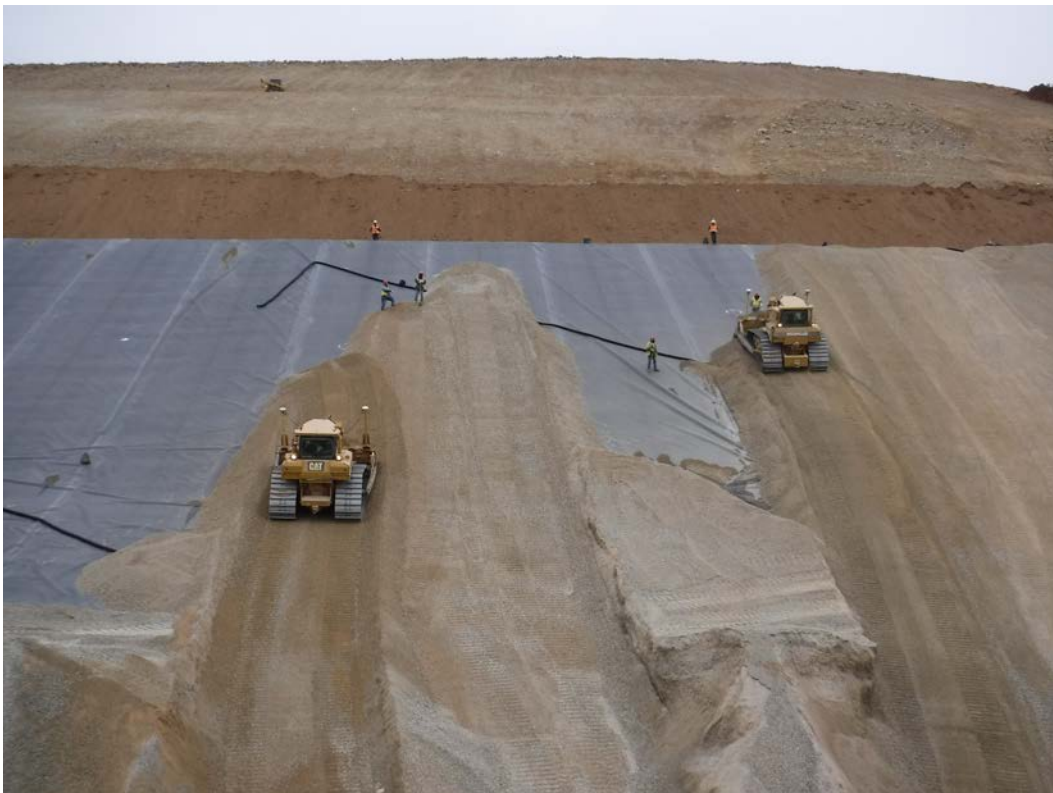
Photo 3. GPS bulldozers grading out DCF on the northeast slope of SGVLF; looking northeast.

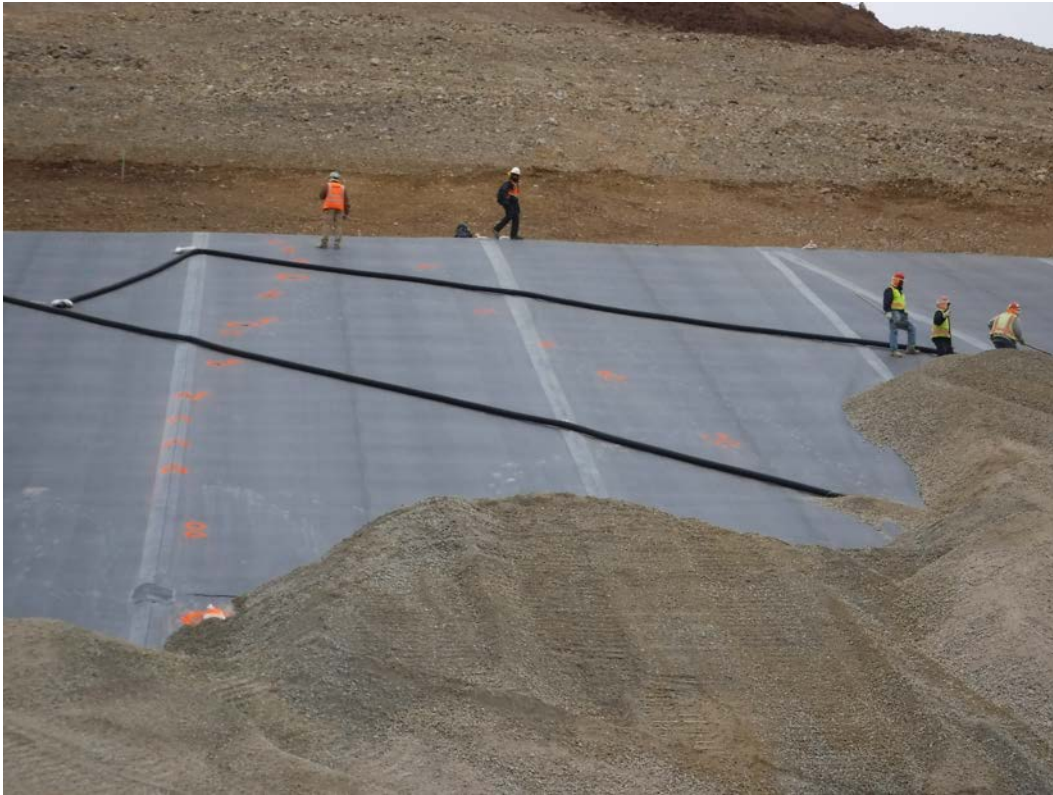
Photo 4. Areas on the geomembrane, identified by orange paint, that need to be tested for damage; looking east.

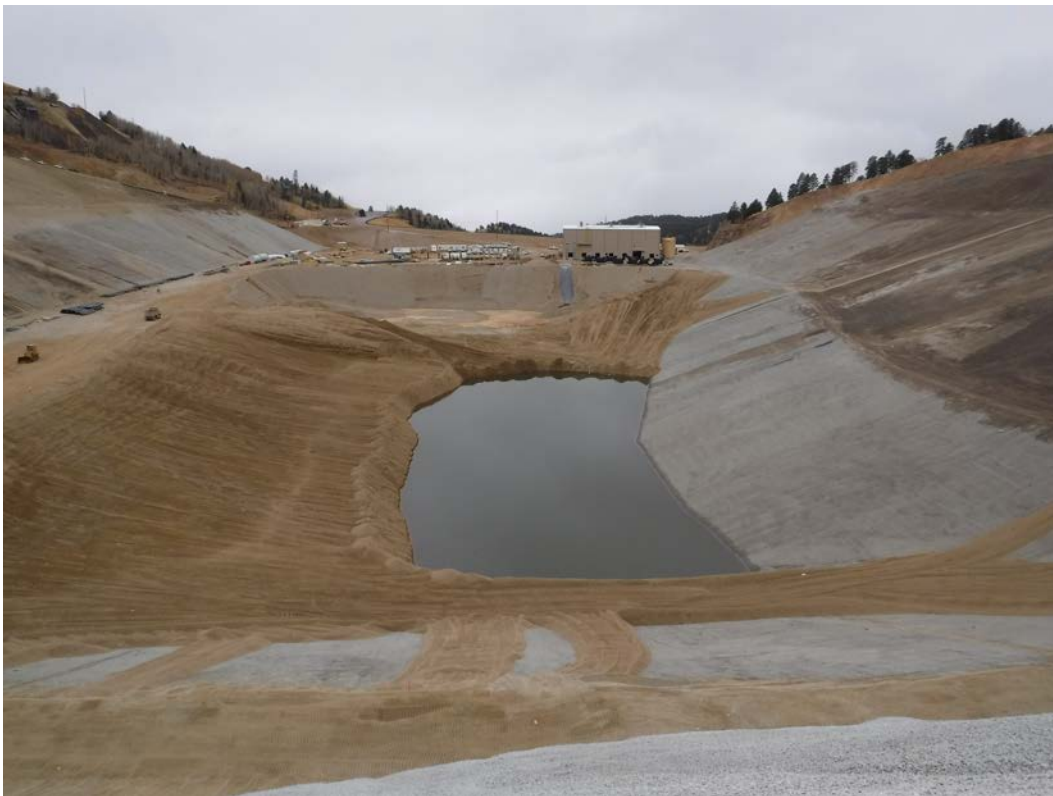
The Division and Mr. Hanks were accompanied by Ron DiDonato into the SGVLF. LLDPE geomembrane liner had been deployed to the 9,750' level and Drain Cover Fill (DCF) was staged and was being spread from the 9,550' to 9,650'; these activities were occurring on the northeast slope of the VLF at the time of the inspection (**Photo 3**). The Division observed personnel identifying potentially-damaged areas of the liner (**Photo 4**). Eroded DCF had been repaired in the PSSA and the southwest slope of the spent ore had been graded down to approximately 3.5H:1V (**Photo 5**).

Photo 5. Graded spent ore and repaired DCF in the SGVLF PSSA; looking southwest.

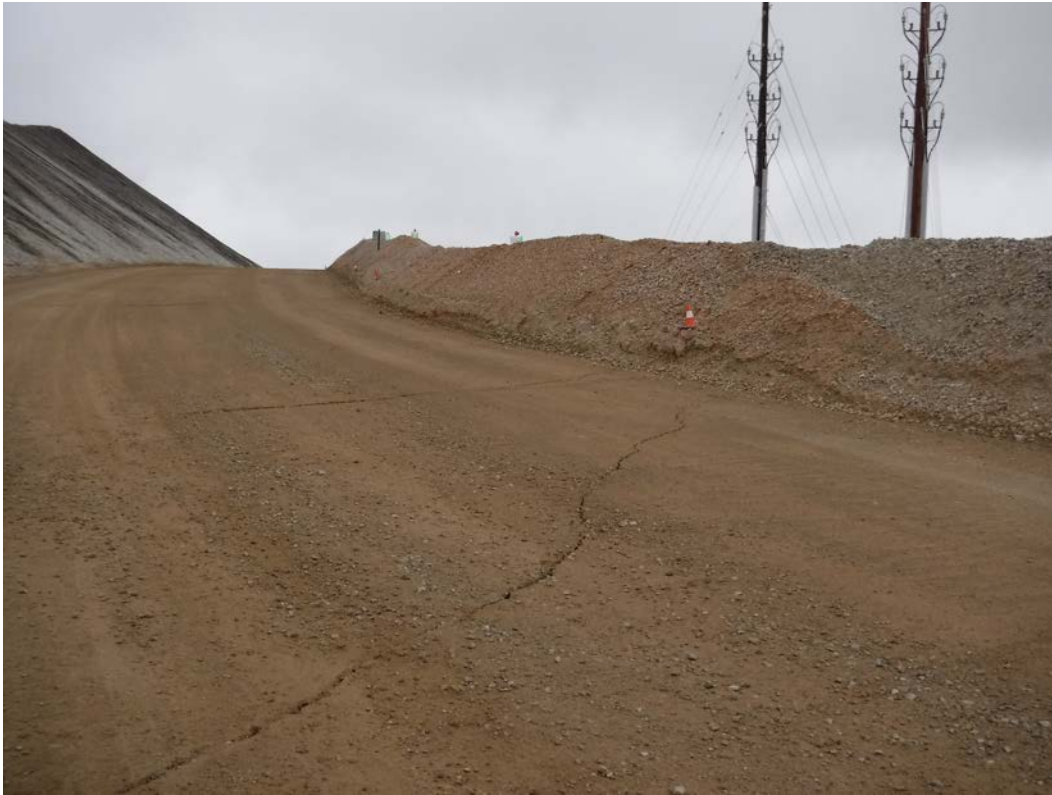
The Division observed several tension cracks on a section of haul road west of the Load out Bin (LOB) and east of the northern overlook (**Photo 6**). Within roughly 700 feet, thirteen 1-2" wide tension cracks spanned the haul road and were all approximately in the northwest to southeast direction. Mr. Hanks stated that these were just recently been discovered and CC&V was actively monitoring the area with a series of prisms and a total station. They also had geotechnical specialists scheduled to analyze the cracks in the next few days. After the inspection, CC&V stated they would provide the Division with a report addressing the tension cracks and it appeared that the cracks were a sign of settling, likely from the high precipitation received over the prior year and possibly the construction of the 10,200 lift just south of the haul road.

Photo 6. Tension across haul road west of LOB; looking west.

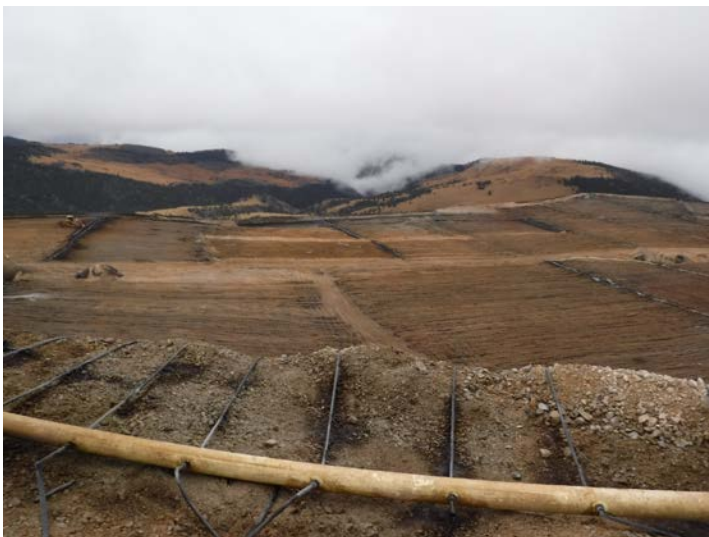
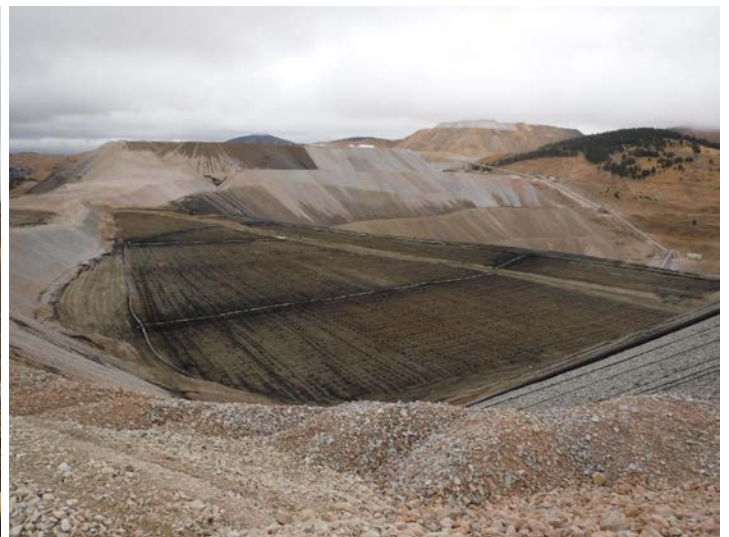
The current progress of resolving the issue of standing solution on various portions of the top of the pad, cited in the August 8, 2015 aerial inspection report, was checked. The Division observed no standing solution on top of the pad; the ripping efforts appear to have made all solution infiltrate into the pad (**Photos 7 & 8**).

Photos 7 & 8. No signs of standing solution on top of AGVLF Pad.

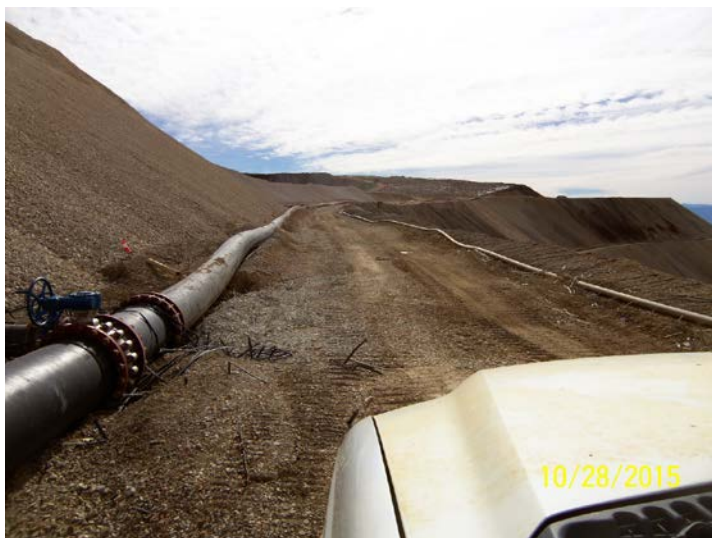
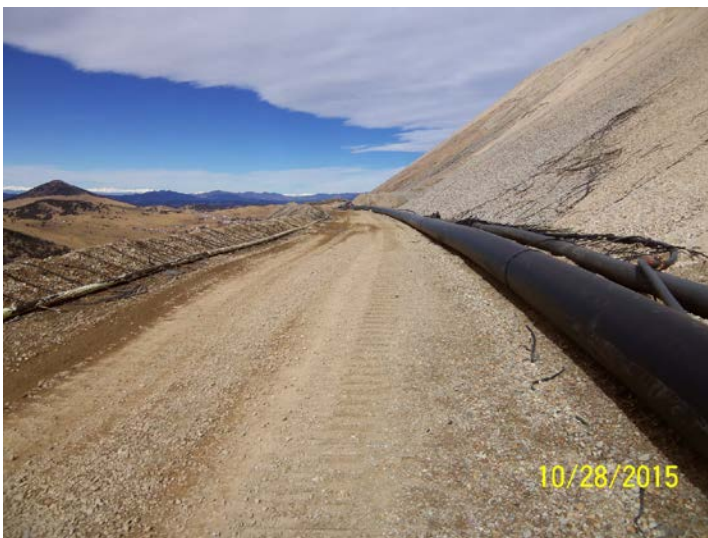
While traveling on the 10,100 access road, the Division observed a small area (approximately 150 sq. ft.) across the road that contained ponded solution, likely caused by a broken feeder line observed just above the road. On October 29, 2015, CC&V provided photo documentation that the area in question had been ripped, that the feeder line had been repaired, and all water had infiltrated the pad (**Photos 9 & 10**). Since the Operator has resolved this issue to the satisfaction of the Division prior to the date of this report, the ponded solution will not be cited as a problem in this inspection report.

Photos 9 & 10. Photos submitted by the Operator showing ponded solution on 10,100 access road has been resolved.

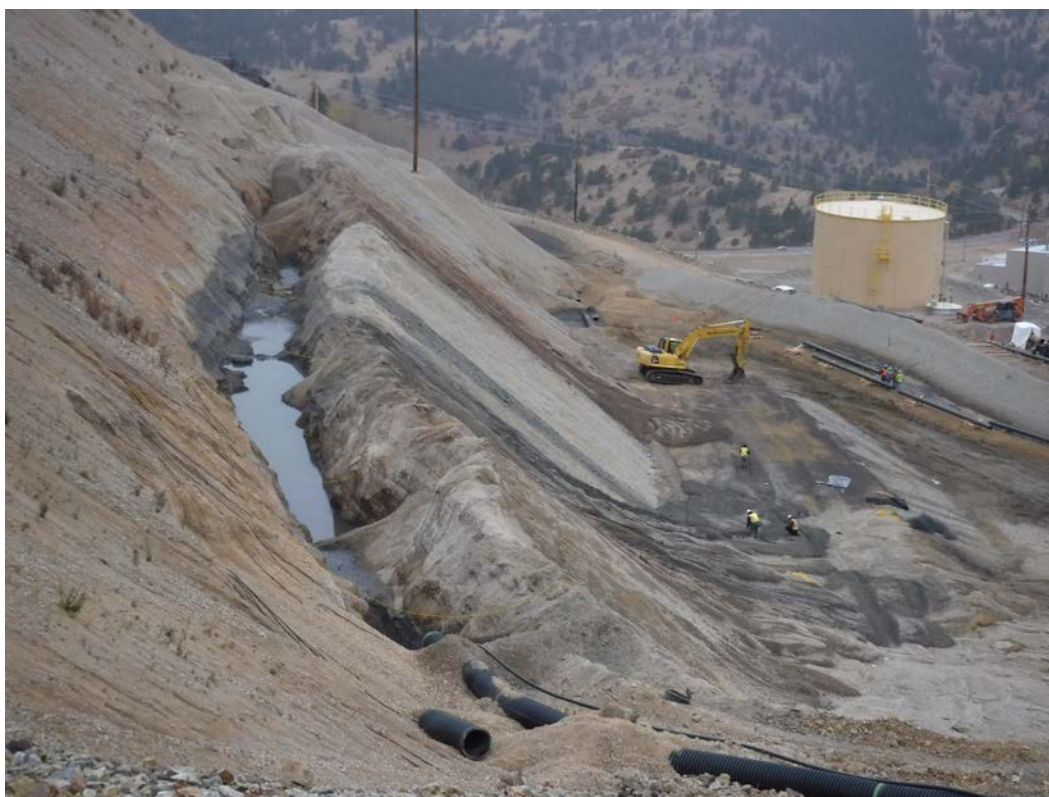
Temporary netting was being installed over a trench in the northern portion of the AGVLF where solution is allowed to infiltrate into the VLF from the High Grade Mill (**Photo 11**).

Photo 11. High Grade Mill water Infiltration trench on the north side of the AGVLF, workers installing temporary wildlife netting over it; looking west.
