COLORADO DIVISION OF RECLAMATION, MINING AND SAFETY
MINERALS PROGRAM INSPECTION REPORT
PHONE: (303) 866-3567

MINE NAME: LBC Bentonite Pit	MINE/PROSPECTING ID#: M-1977-231	MINERAL: Clay (general)	COUNTY: Fremont
INSPECTION TYPE: Monitoring	INSPECTOR(S): Timothy A. Cazier	INSP. DATE: April 28, 2015	INSP. TIME: 16:15
OPERATOR: First Bentonite Company Colorado	OPERATOR REPRESENTATIVE: Pam Wedge	TYPE OF OPERATION: 110c - Construction Limited Impact

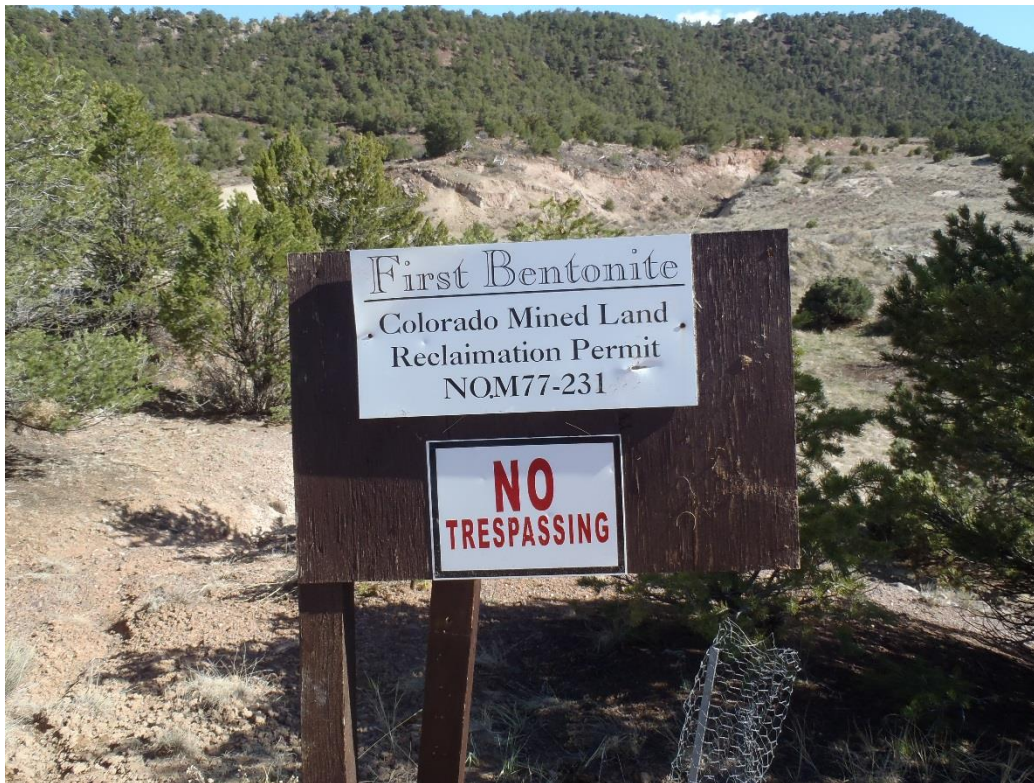
Markers & Boundary – A permit sign was displayed at the site entrance (see **Photo 1**). Permit boundaries were marked by corner posts and recorded using a hand held GPS unit (Trimble Juno 3B). The attached inspection map shows the location of the boundary markers and the disturbed area based on the September 24, 2013 Google Earth satellite image (see **Figure 1**).

Photo 1. Permit identification sign.

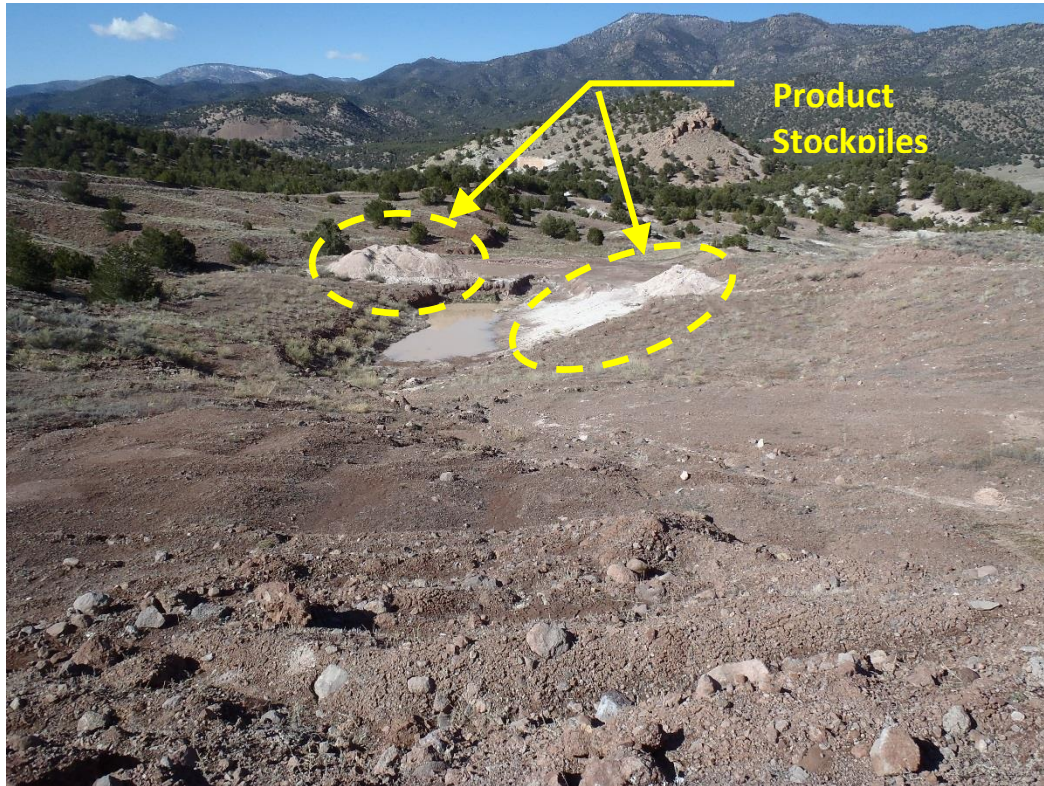
Mining Plan – Working faces were observed in general to be 3H:1V or flatter (see **Photo 2**) with a few shallow exceptions of near vertical faces, but not more than 4 to 6 feet high (see **Photo 3**). Product stockpiles (see **Photo 2**) and topsoil stockpiles (top of hill on east side) were observed.

Photo 2. View of the pit (looking NE).

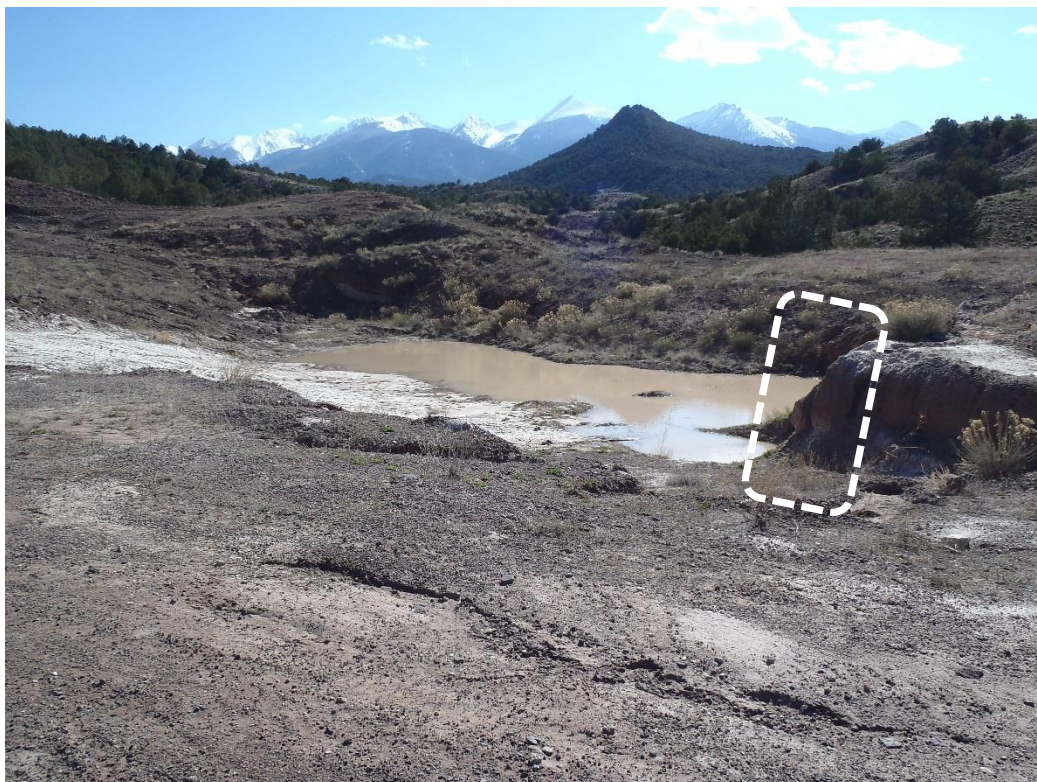
Environmental – A small amount of standing water was observed in the pit (see **Photo 3**). Ms. Wedige was informed that Colorado Division of Water Resources regulation may require standing water in the pit be pumped out if it does not infiltrate or evaporate within 72 hours. No noxious weeds were observed.

Photo 3. Shallow pit "highwall" (north side looking SW).

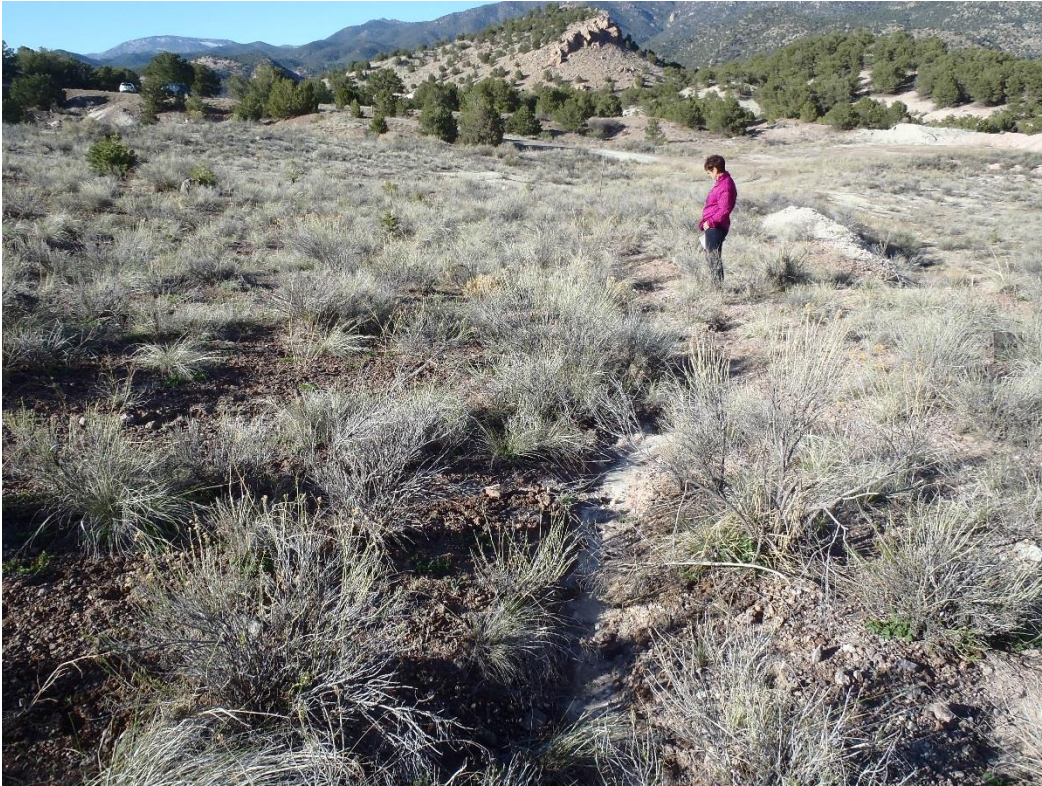
Reclamation – Some reclamation activity including grading to 3H:1V or flatter and Ms. Wedige indicated the vegetation in the center area of the permit boundary was seeded some time ago, and was observed to be established (see **Photo 4**). The area shown in **Photo 5** may be a natural gully or may be pre-law disturbance related to the mining activity discussed in Item 2.d of the February 27, 1979 letter included in **Attachment 1**. We discussed the reclamation required for final release. Ms. Wedige was informed that all areas disturbed by mining activity need to be reclaimed by completing the following:

Photo 4. Vegetated area near center of permit boundary and seeded some time ago (looking north).

- 1) slopes are required to be 3H:1V or flatter,
- 2) topsoil spread on the regraded slopes (12 inches per approved reclamation plan),
- 3) reseed*, and allow vegetation to become established,
- 4) product stockpiles need to be removed,
- 5) grading must allow free drainage so as to prevent impounding stormwater.

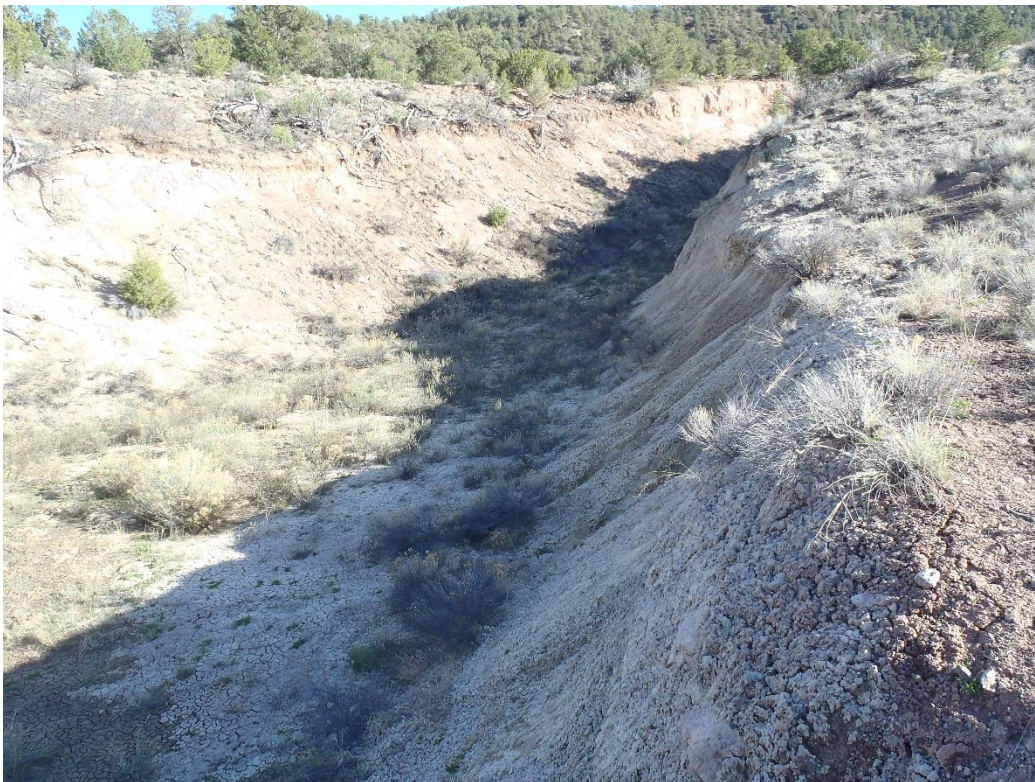
Photo 5. Pre-law disturbance/natural gully on east side of permit area (looking south).

1. If the Operator wishes to begin final reclamation, the reclamation plan outlined in **Attachment A** needs to be followed for final reclamation approval by the Division. The narrow area outlined in yellow near GPS Boundary Marker-2 on **Figure 1** that starts to the southwest, then turns south may be either be a natural gulley or pre-law disturbance and therefore not required to be reclaimed by the Division.
2. No problems were observed.

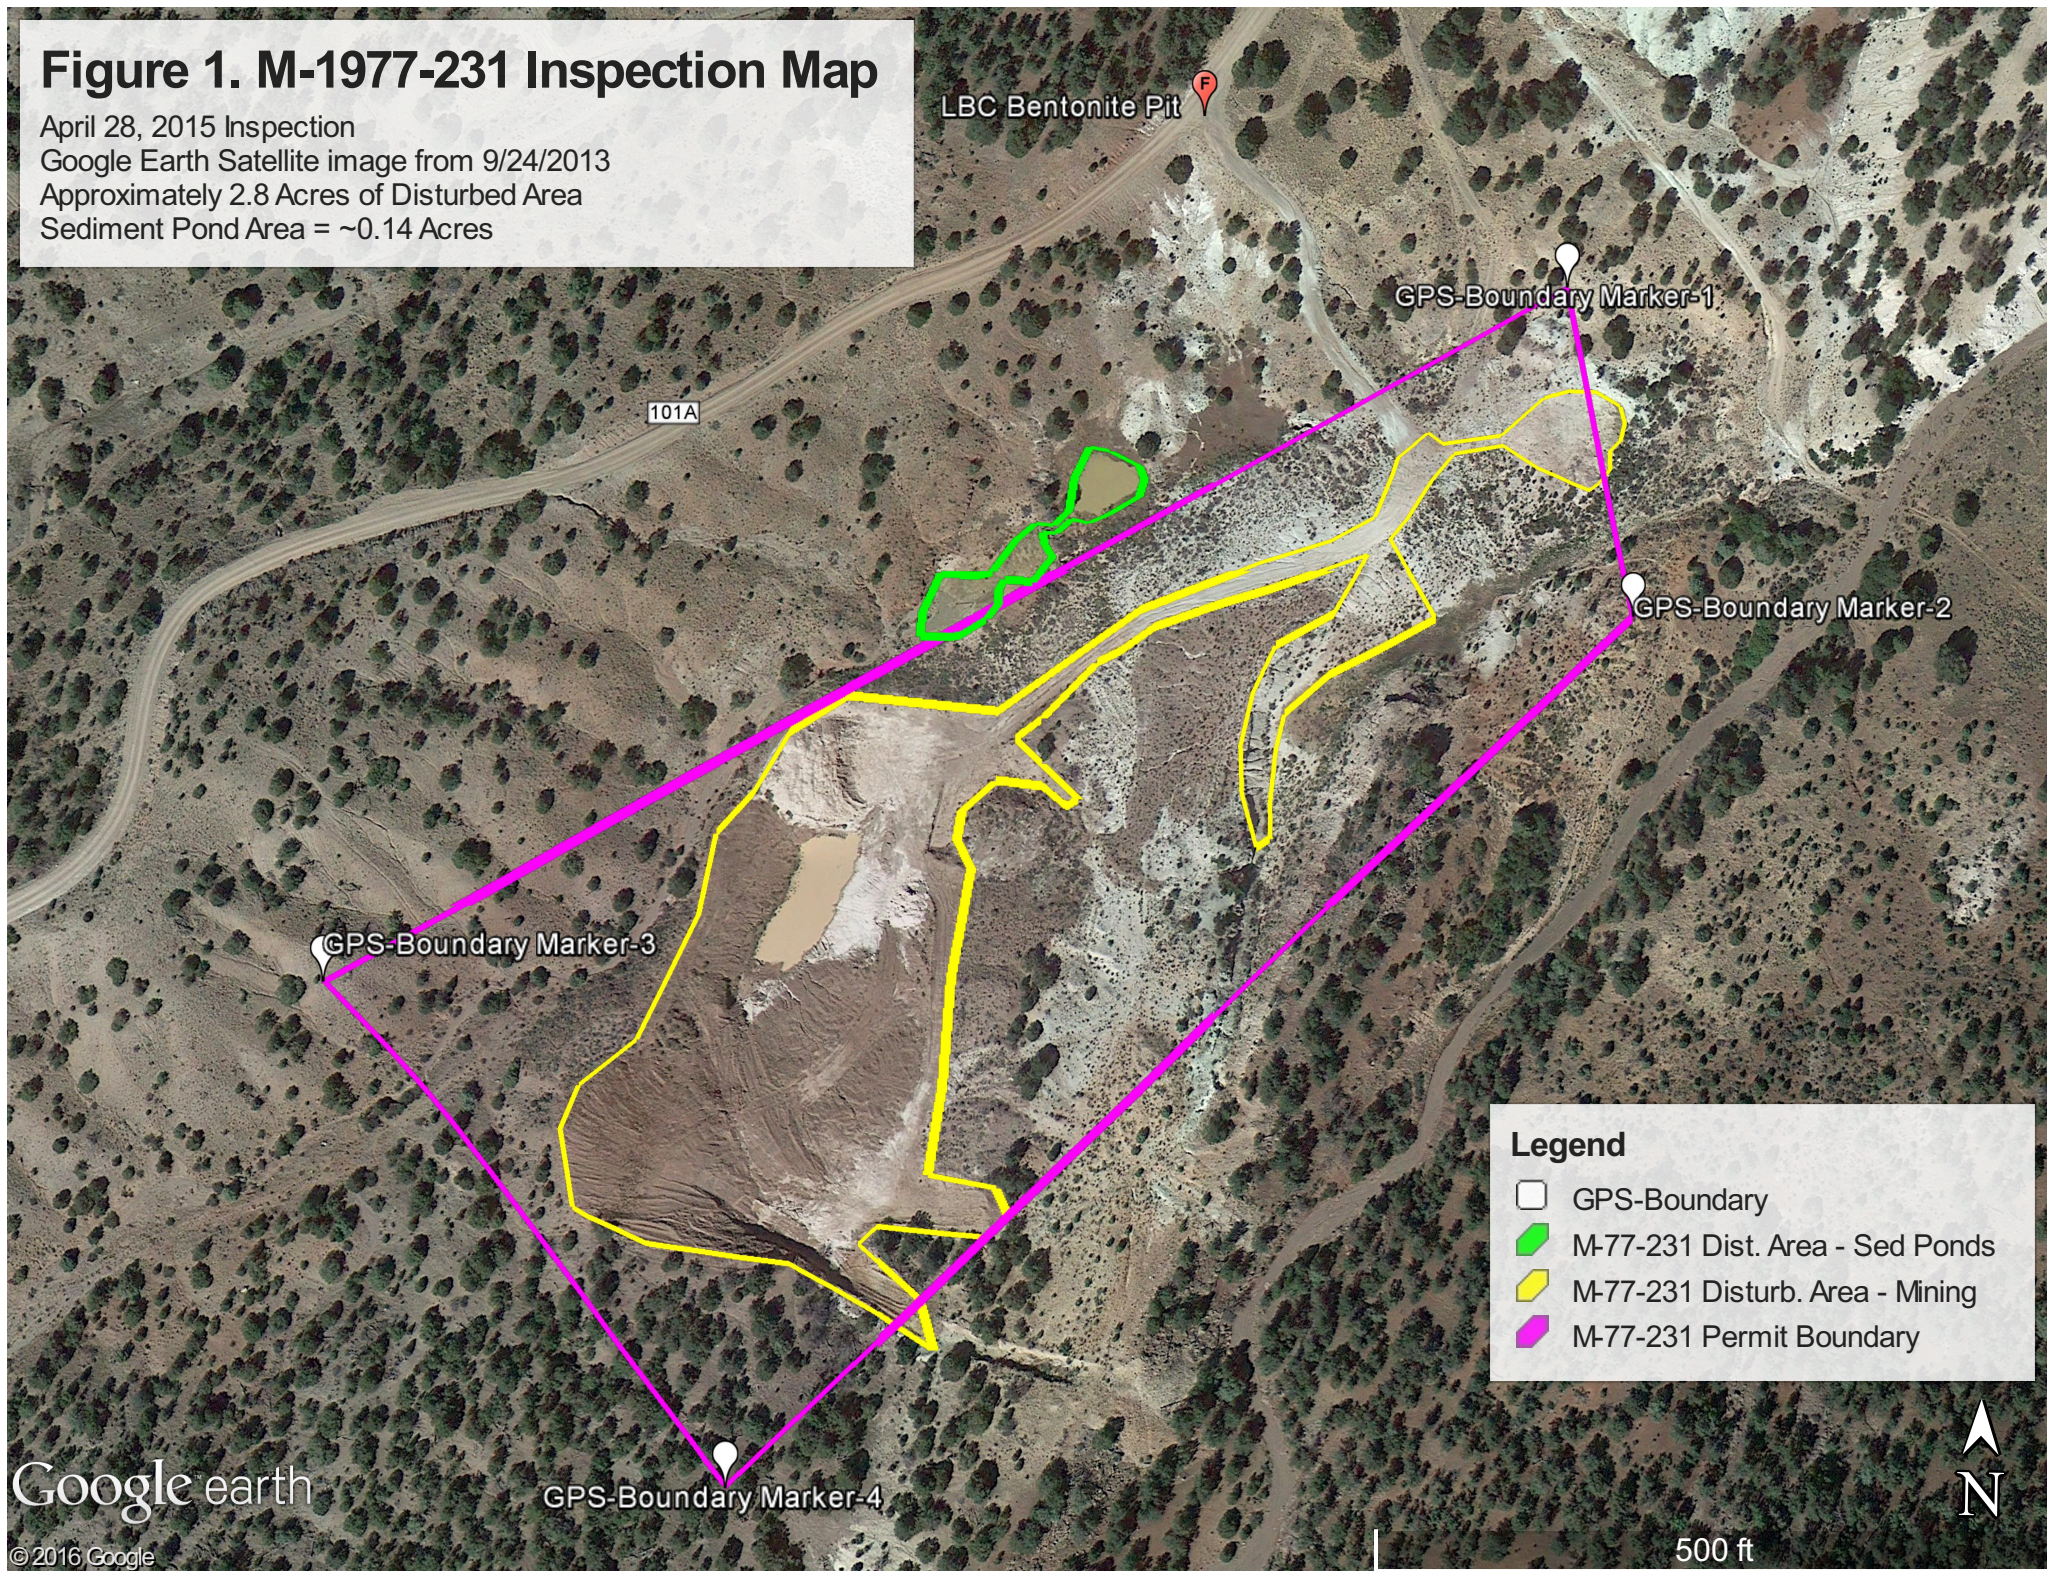
Figure 1. M-1977-231 Inspection Map

- **Revisions:** **Surety Increase** (SI-01) in 1993; the permit was transferred (HR-01) from First Land Co of Howard to First Bentonite Company of Colorado in 1984.
- **Commitments/Stipulations:** No open commitments or stipulations.
- **Other Records**
 - a) The total permitted area is 8.0 acres. The Division's disturbed area estimate is approximately 3 acres (including the ~0.14 area associated with the sediment ponds). The original permit describes creating water ponds as part of the reclamation plan. It is unclear if these are the ponds outlined in green on **Figure 1**.
 - b) The previous inspection was performed on 6/13/2010. No problems were cited.

April 28, 2015 Inspection
Google Earth Satellite image from 9/24/2013
Approximately 2.8 Acres of Disturbed Area
Sediment Pond Area = ~0.14 Acres
