COLORADO DIVISION OF RECLAMATION, MINING AND SAFETY
MINERALS PROGRAM INSPECTION REPORT
PHONE: (303) 866-3567

MINE NAME: Mitchell Pit	MINE/PROSPECTING ID#: M-1987-023	MINERAL: Sand and gravel	COUNTY: Adams
INSPECTION TYPE: Monitoring	INSPECTOR(S): Tyler V. O'Donnell	INSP. DATE: December 7, 2015	INSP. TIME: 12:30
OPERATOR: Ricky W. Mitchell	OPERATOR REPRESENTATIVE: Ricky Mitchell	TYPE OF OPERATION: 110c - Construction Limited Impact

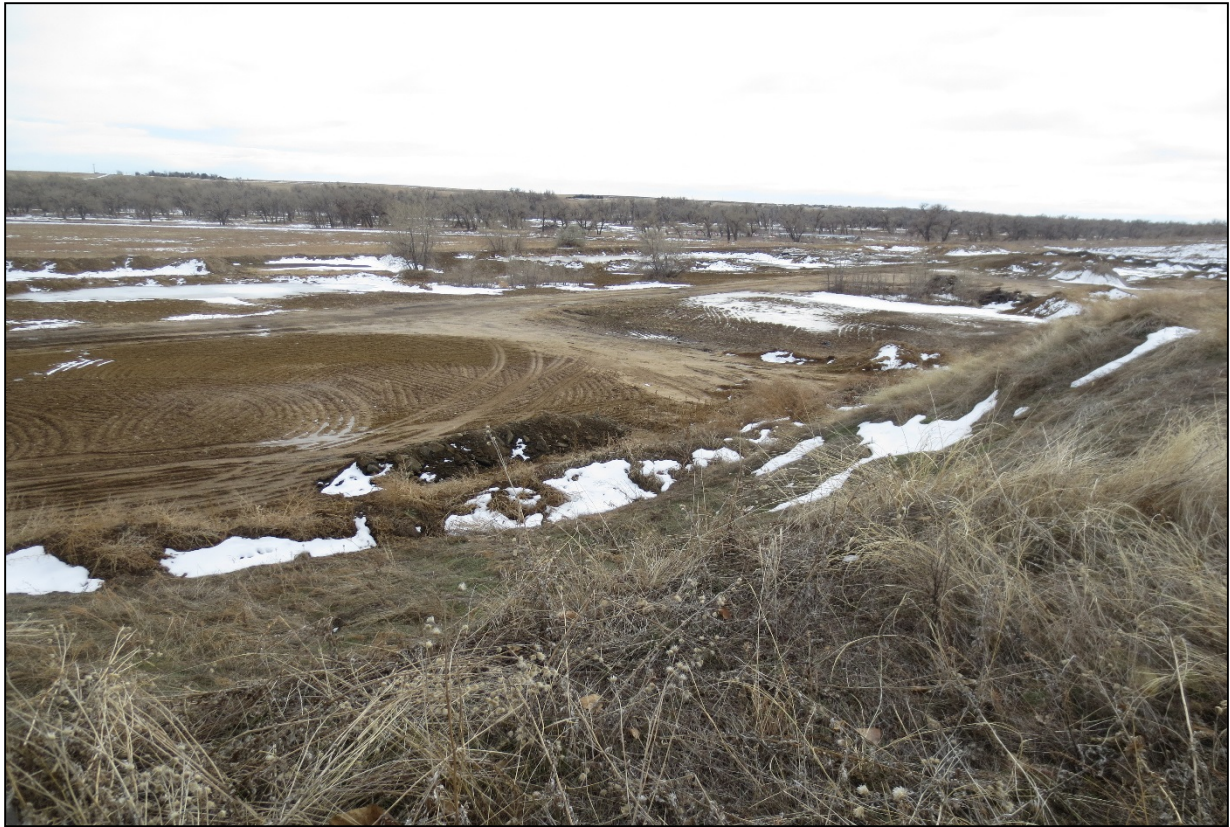
Photograph 1: Photo take from on top of the highwall looking southeast at the pit floor.

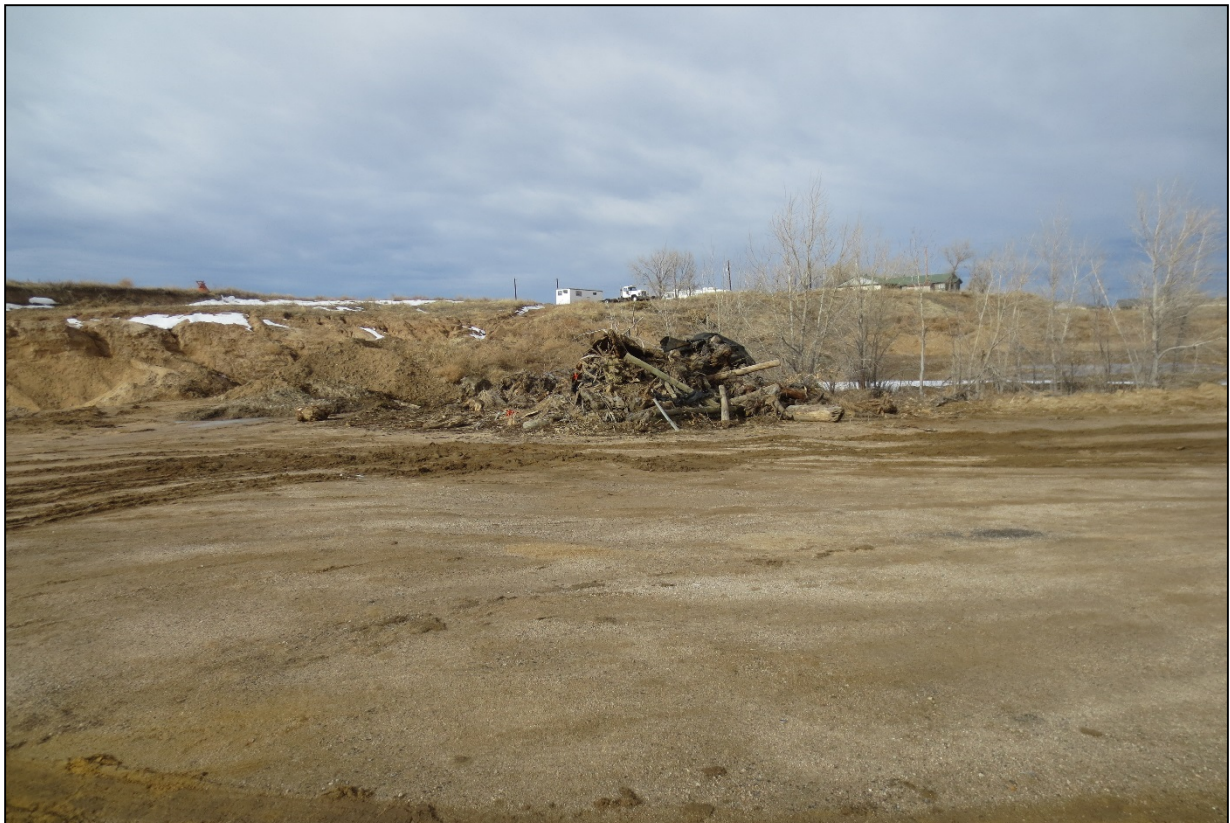
During a previous inspection, the Division observed the Operator importing inert fill. The Division required the Operator to provide a notice of inert fill as required by Rule 3.1.5(9). Since the previous inspection the Operator has been accepting mixed inert material. Broken up concrete, asphalt, and general fill dirt were observed during the inspection. The Operator has been recycling some of the imported inert fill and selling the material as a usable product.

Photograph 2: Imported woody debris. This material cannot be used for backfill. During the inspection the Operator stated that this material would be shredded to create landscaping mulch.

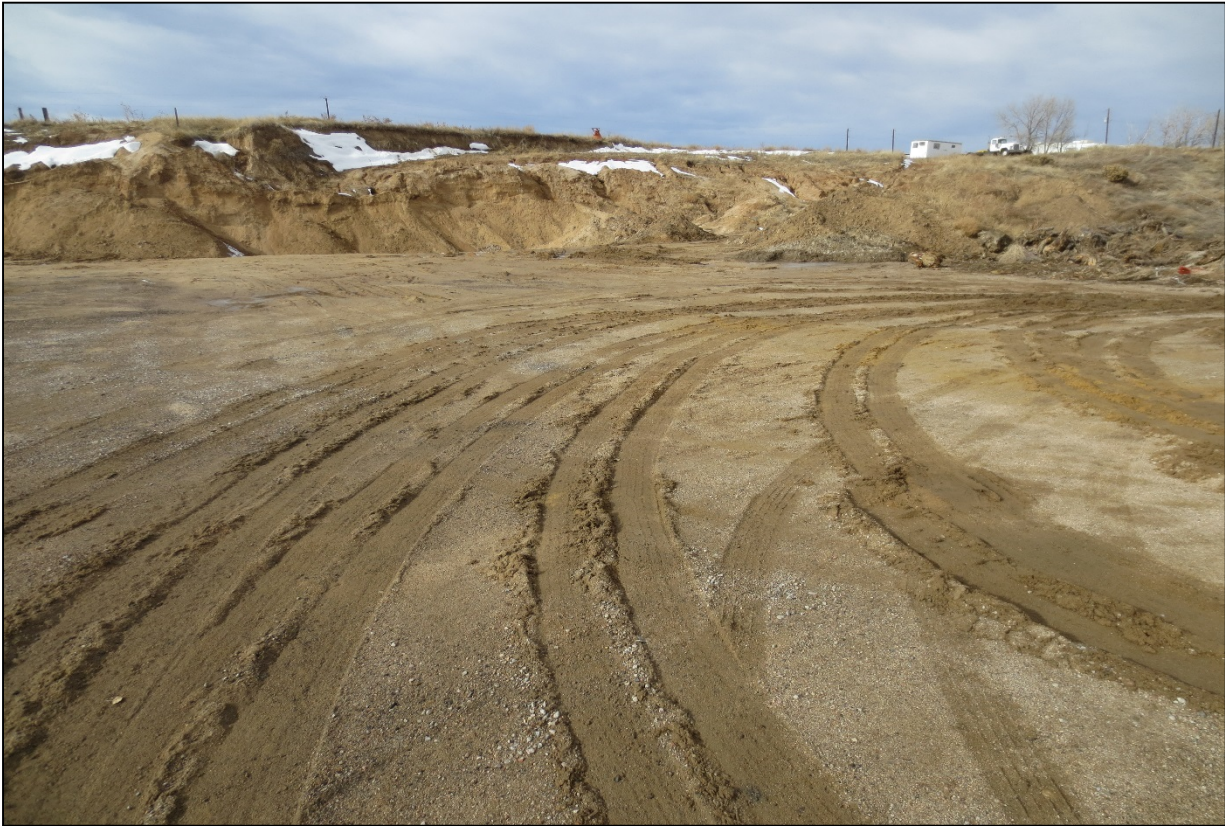
Photograph 3: Active mining face.

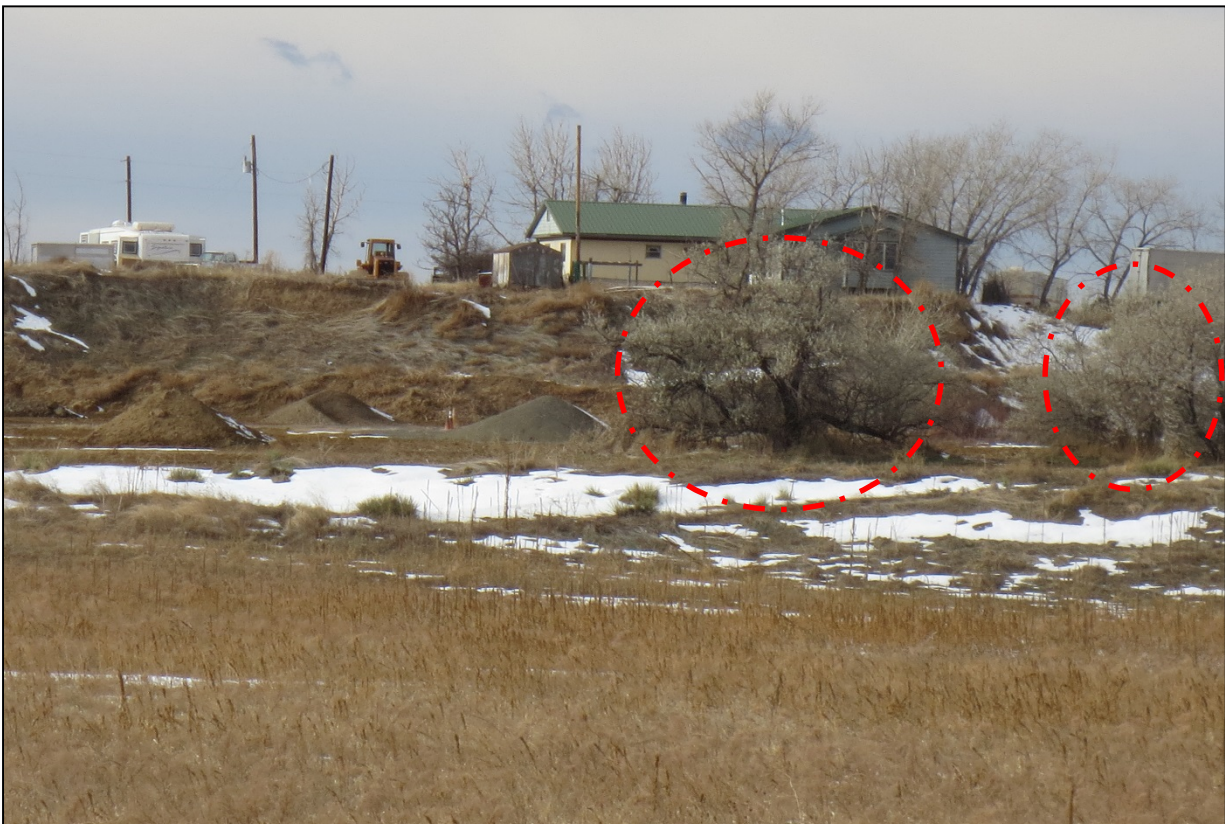
There was some plant growth on the stockpiles and throughout the western mining face. Very little vegetation growth was observed on the pit floor because the Operator has cultivated the entire pit floor. The growth observed in the disturbed area appeared to be volunteer vegetation, comprised of grasses and a few annual weeds. There were a handful of mature Russian Olive trees scattered throughout the pit. Russian Olive trees are a list B species on the Colorado Noxious Weed list. At the present time the presence of Russian Olive trees will not be cited as a problem due to the limited number observed trees. The Operator will need to take measures to prevent the spread of the trees, and the trees will need to be eradicated during final reclamation. The Operator is advised to continue to monitor and treat other noxious weeds as the weeds appear within the permit boundary.

Photograph 4: Product stockpiles. Russian Olive trees circled with the red dashed line.
