COLORADO DIVISION OF RECLAMATION, MINING AND SAFETY
MINERALS PROGRAM INSPECTION REPORT
PHONE: (303) 866-3567

MINE NAME: Lee No 2 Placer	MINE/PROSPECTING ID#: M-1987-072	MINERAL: Gold	COUNTY: Gilpin
INSPECTION TYPE: Surety-Related Inspection	INSPECTOR(S): Michael A. Cunningham	INSP. DATE: January 21, 2016	INSP. TIME: 10:00
OPERATOR: Thomas Musch and Valerie Musch	OPERATOR REPRESENTATIVE: None	TYPE OF OPERATION: 110(2) - Hard Rock Limited Impact	
REASON FOR INSPECTION: Surety Related	BOND CALCULATION TYPE: Complete Bond	BOND AMOUNT: \$1,200.00	
DATE OF COMPLAINT: NA	POST INSP. CONTACTS: None	JOINT INSP. AGENCY: None	
WEATHER: Clear	INSPECTOR'S SIGNATURE:

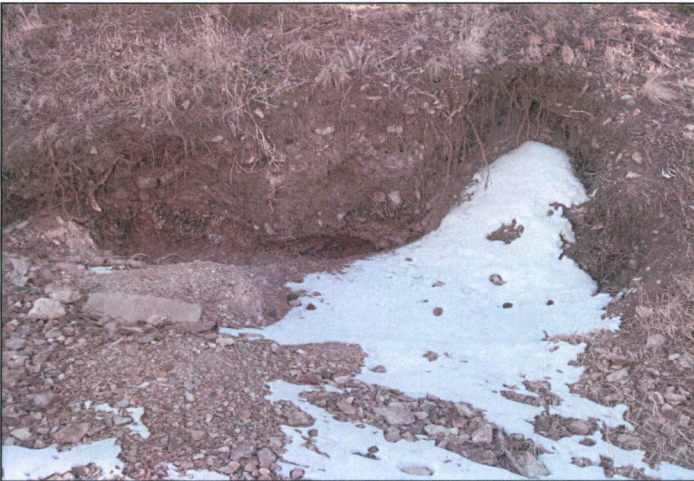
1. Excavation on northern bank of Russell Gulch.

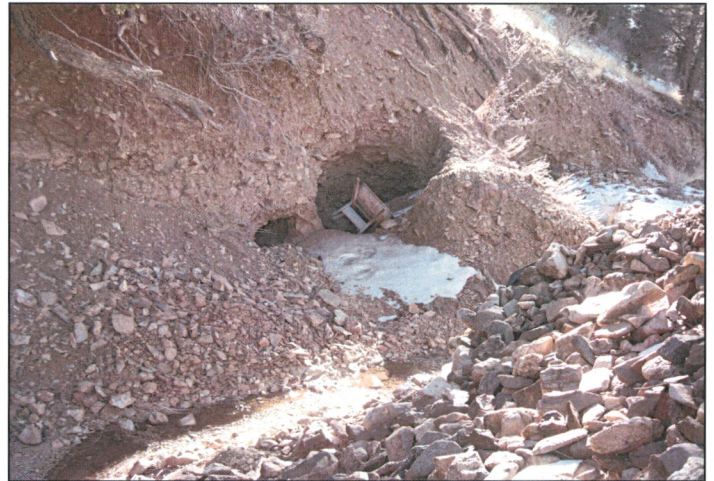
2. Excavation on northern bank of Russell Gulch.

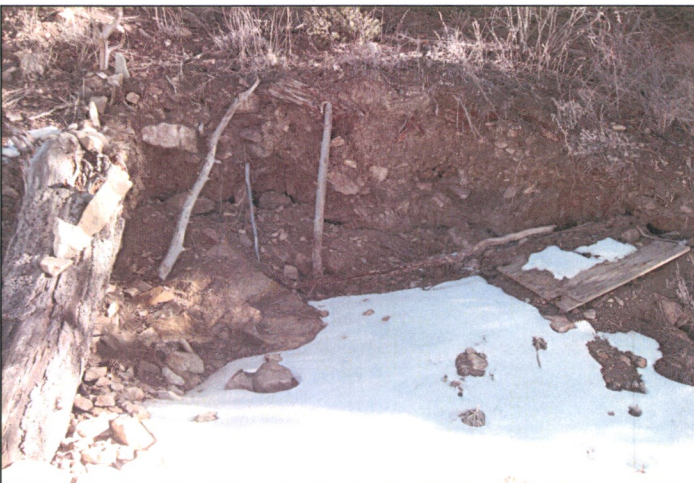
3. Excavation on northern bank of Russell Gulch.

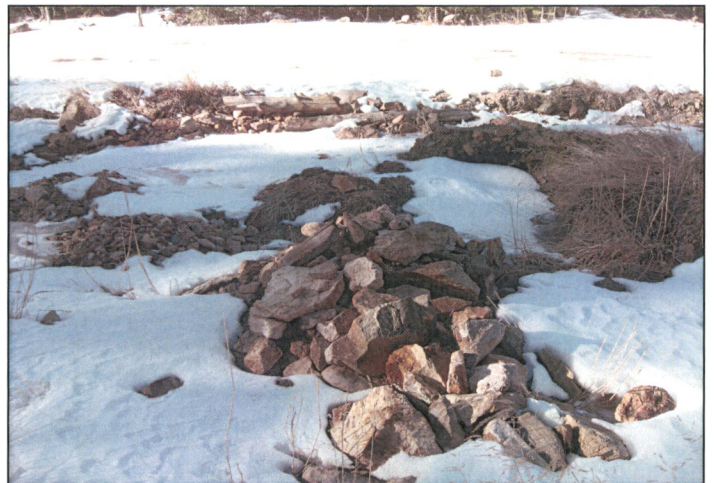
4. Rock check dam within Russell Gulch.
