**COLORADO DIVISION OF RECLAMATION, MINING AND SAFETY**  
**MINERALS PROGRAM INSPECTION REPORT**  
**PHONE: (303) 866-3567**

<b>MINE NAME:</b> Mitchell Pit #2	<b>MINE/PROSPECTING ID#:</b> M-1990-131	<b>MINERAL:</b> Gravel	<b>COUNTY:</b> Adams
<b>INSPECTION TYPE:</b> Monitoring	<b>INSPECTOR(S):</b> Tyler V. O'Donnell	<b>INSP. DATE:</b> December 7, 2015	<b>INSP. TIME:</b> 12:45
<b>OPERATOR:</b> Ricky W. Mitchell	<b>OPERATOR REPRESENTATIVE:</b> Ricky Mitchell	<b>TYPE OF OPERATION:</b> 110c - Construction Limited Impact

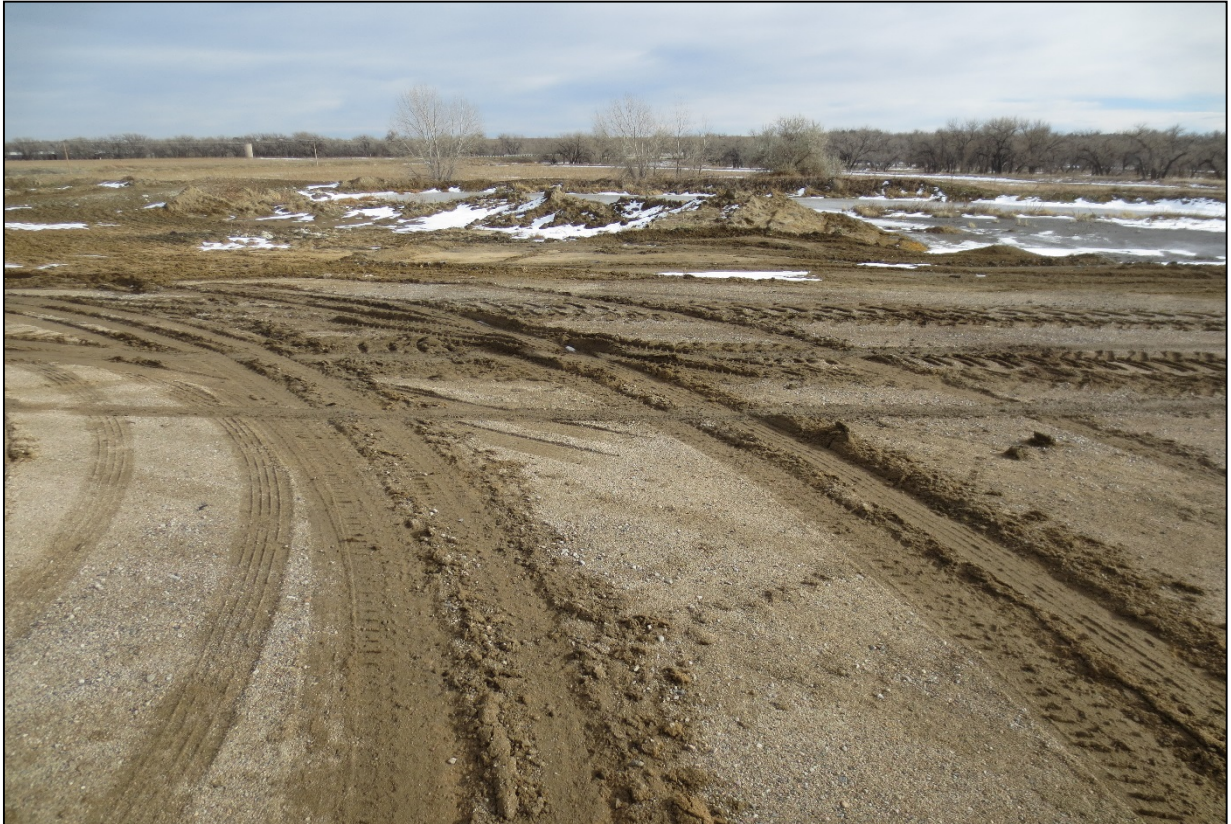
**Photograph 1:** Area where the Operator has accepted residential water well drilling mud. The Operator stated that this material is being dried out and being recycled and sold as a usable product.

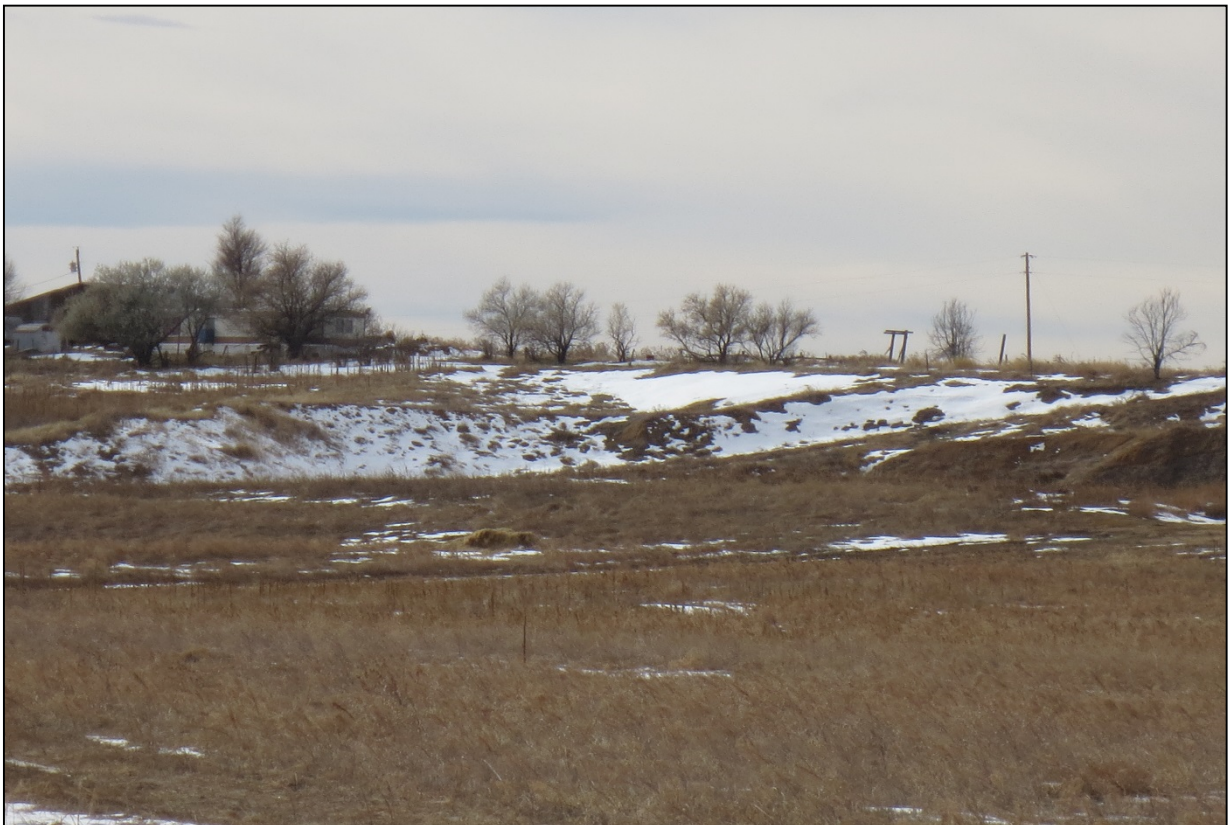
The Operator has mined the pit from southeast to northwest leaving a highwall along the southern and western portions of the pit, daylighting the pit floor to the north and east. The Operator has graded the majority of the eastern portion of the pit floor to 3H:1V or flatter. There were several stockpiles of product scattered throughout the affected area. There was a highwall along the entire length of the western pit boundary. The highwall had an average height of approximately 10 feet. The highwall had a slope ranging from near vertical to 2H:1V. When completing final reclamation, the Operator will need to grade all slopes to 3H:1V or flatter to comply with the approved reclamation plan.

**Photograph 2:** Southern portion of the pit, this area was mined after the permit was issued. Slopes are approximately 2H:1V, the Operator will need to graded the slopes to 3H:1V or flatter and reseed the entire area.

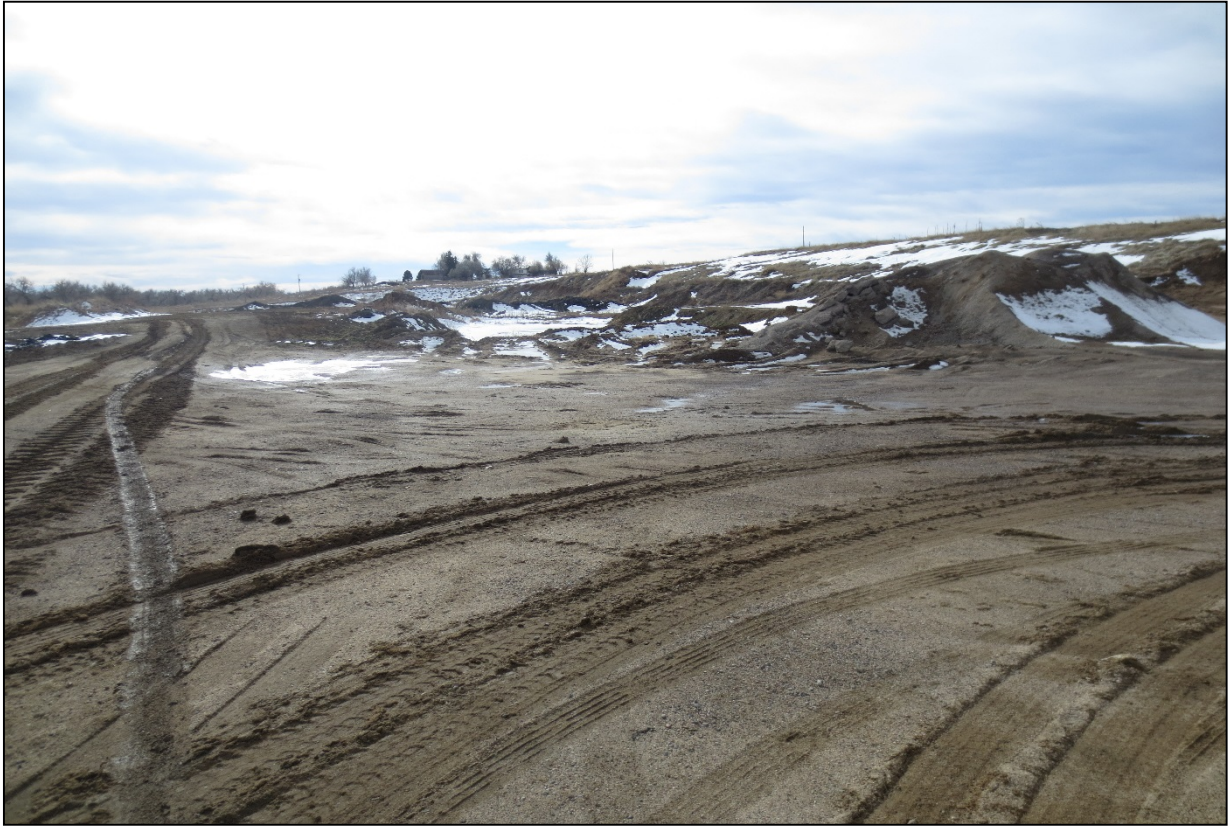
The Division required the Operator to provide a notice of inert fill as required by Rule 3.1.5(9). Since the previous inspection the Operator has been accepting mixed inert material. Broken up concrete, asphalt, and general fill dirt were observed during the inspection. The Operator has been recycling some of the imported inert fill and selling the material as a usable product.

**Photograph 3:** Stockpiles of imported fill, the Division observed concrete, asphalt and general fill dirt.

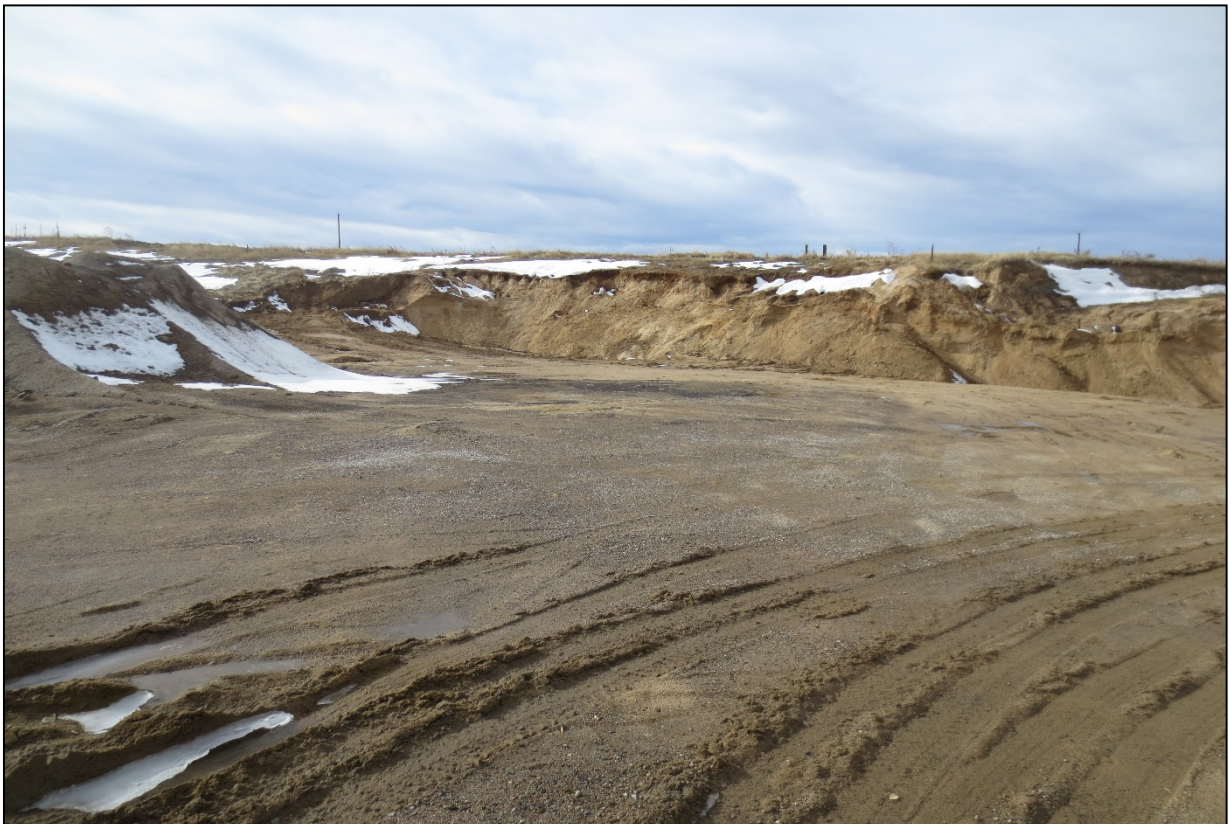
**Photograph 4:** active mining Face along the western portion of the permitted site.
