COLORADO DIVISION OF RECLAMATION, MINING AND SAFETY
MINERALS PROGRAM INSPECTION REPORT
PHONE: (303) 866-3567

MINE NAME: Coaldale Quarry	MINE/PROSPECTING ID#: M-1977-247	MINERAL: Anhydrite, gypsum	COUNTY: Fremont
INSPECTION TYPE: Monitoring	INSPECTOR(S): Timothy A. Cazier	INSP. DATE: April 28, 2015	INSP. TIME: 13:30
OPERATOR: Holcim (US) Inc.	OPERATOR REPRESENTATIVE: Joe Lamanna	TYPE OF OPERATION: 112c - Construction Regular Operation

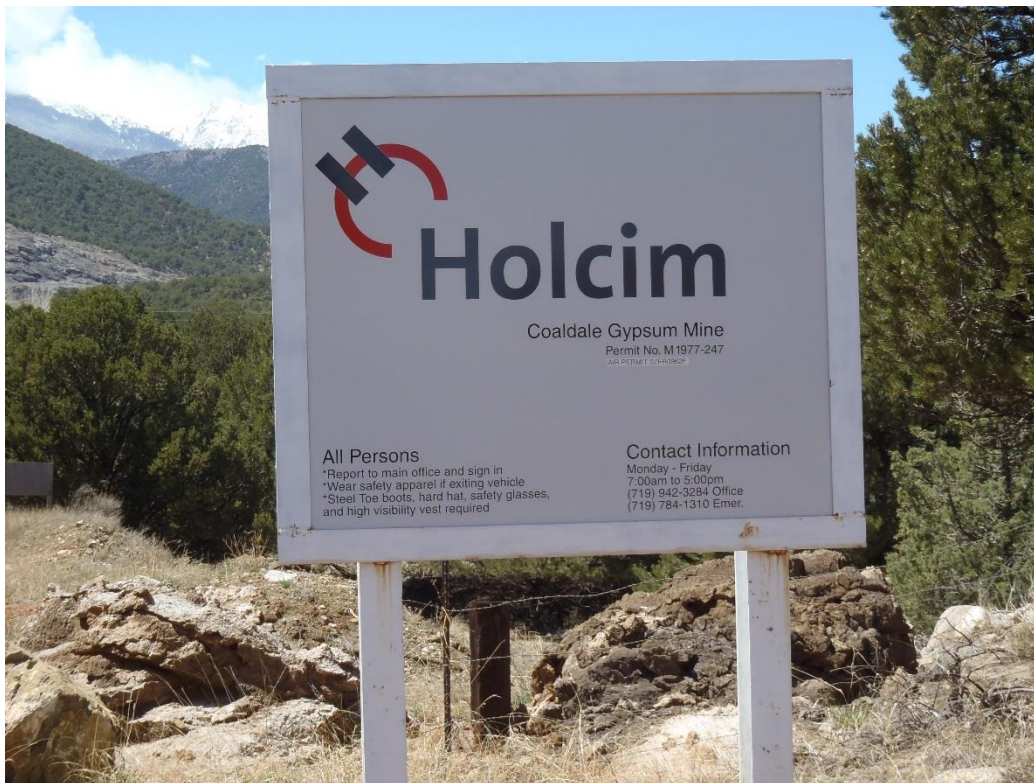
Markers & Boundary – A permit sign was displayed at the site entrance (see **Photo 1**). Mr. Lamanna pointed out a typical survey lath marking a boundary corner (see **Photo 2**). This inspector suggested a more durable marker might be advantageous for long term use.

Photo 1. Permit identification sign.

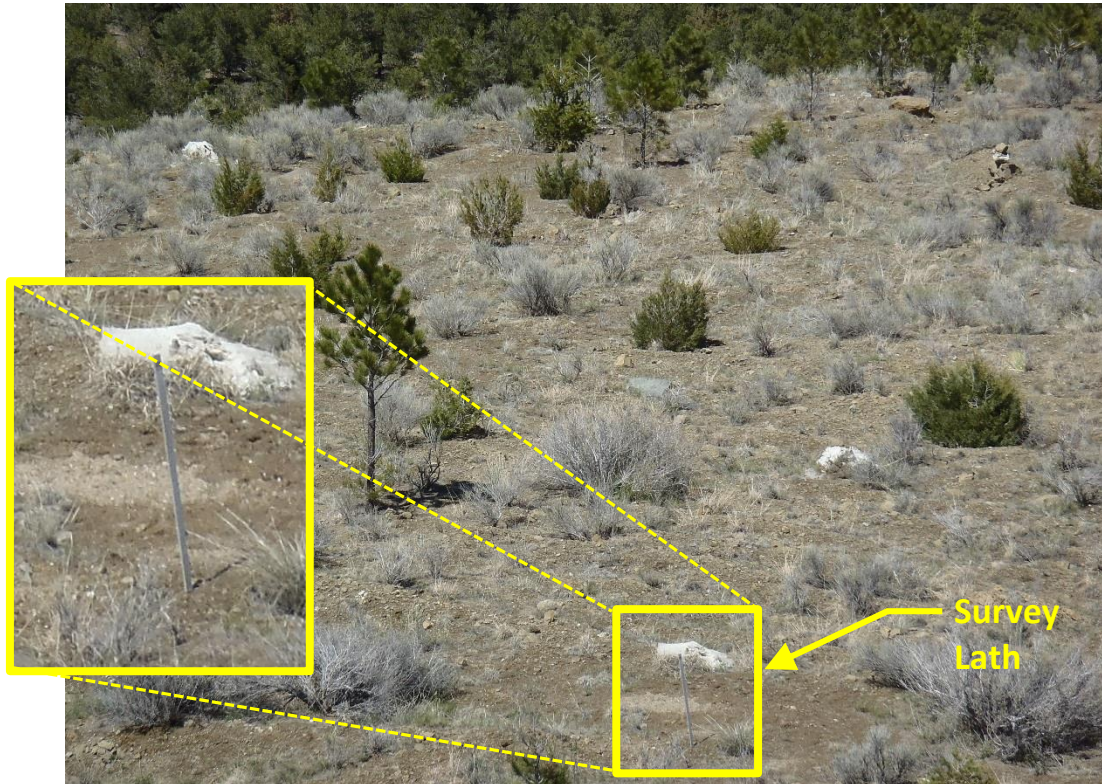
Photo 2. North corner boundary marker (looking NE).

1. The Division recommends the mine use more durable boundary markers than survey lath.
2. No problems or concerns were observed during the inspection.
3. The bond appears adequate for the current disturbance.

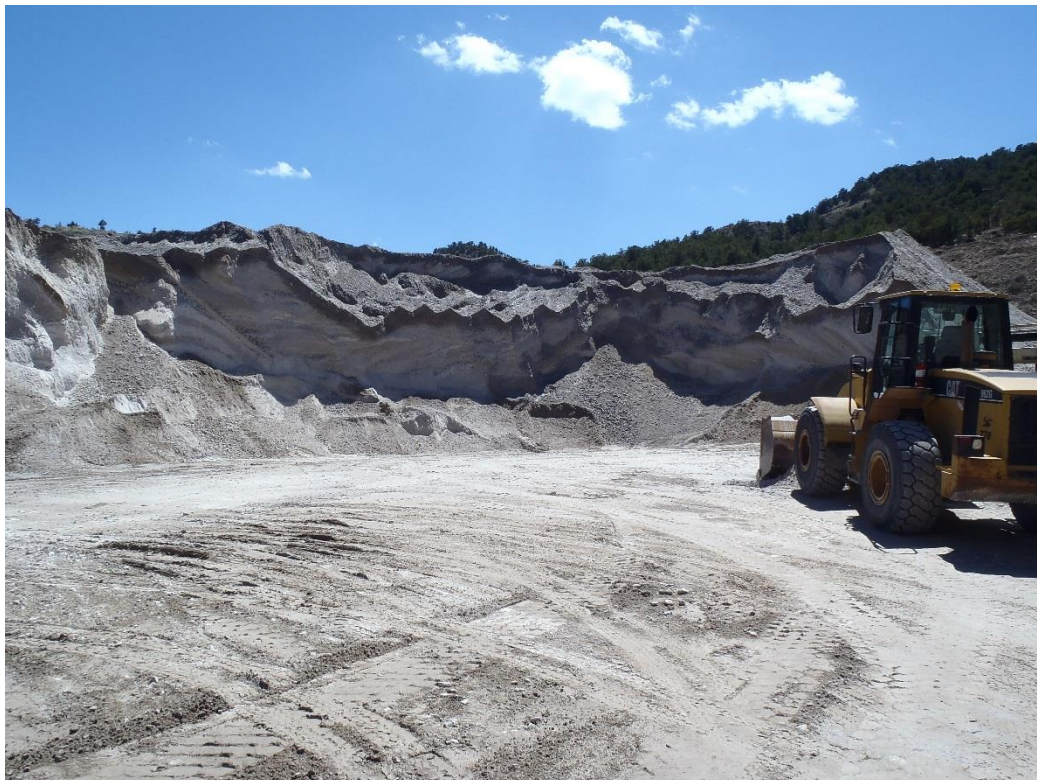
Mining Plan – The mine operation appeared to be following the approved mine plan. Stockpiled product was observed (see **Photo 3**) near the pit entrance on the east end of the mine. Most highwalls appeared stable (see **Photo 4**), however excavations in the Copper Hill pit (west end) appear to be undermining areas reclaimed in the 1980's above the highwall (see **Photo 5**). Mr. Lamanna explained the mine intends to expand this pit and it is expected to disturb previously reclaimed areas.

Photo 3. Product stockpile (south end, looking south).

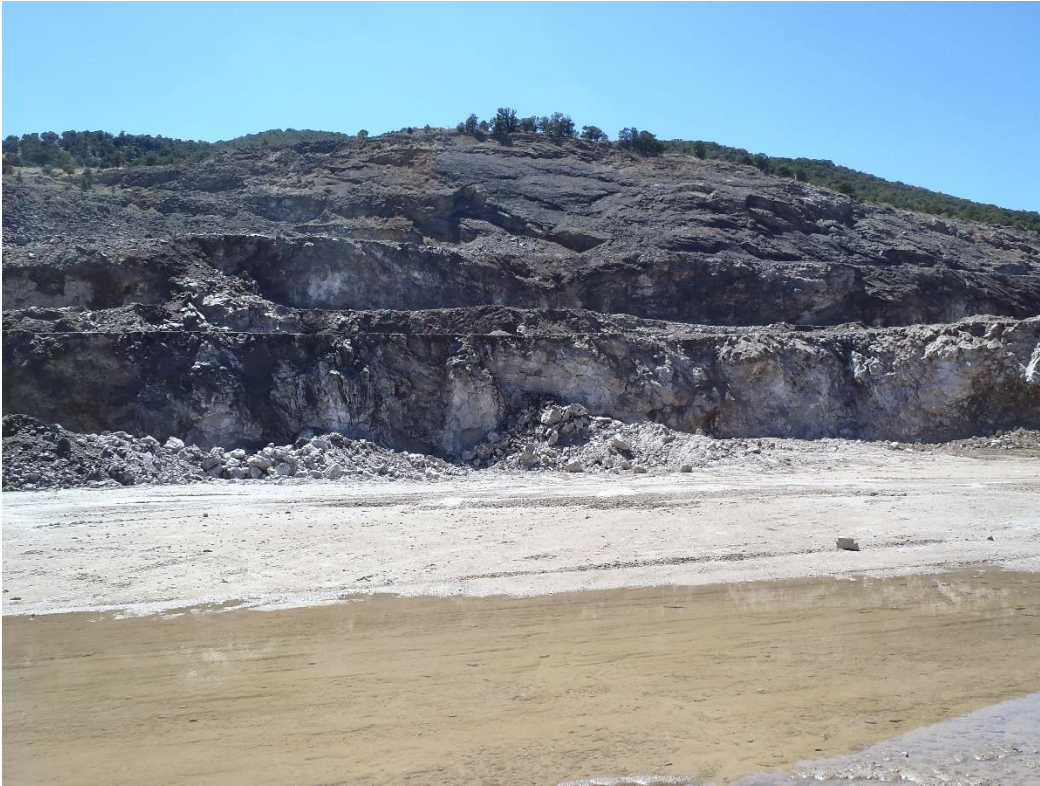
Photo 4. Highwall – near center of active pit (looking SW).

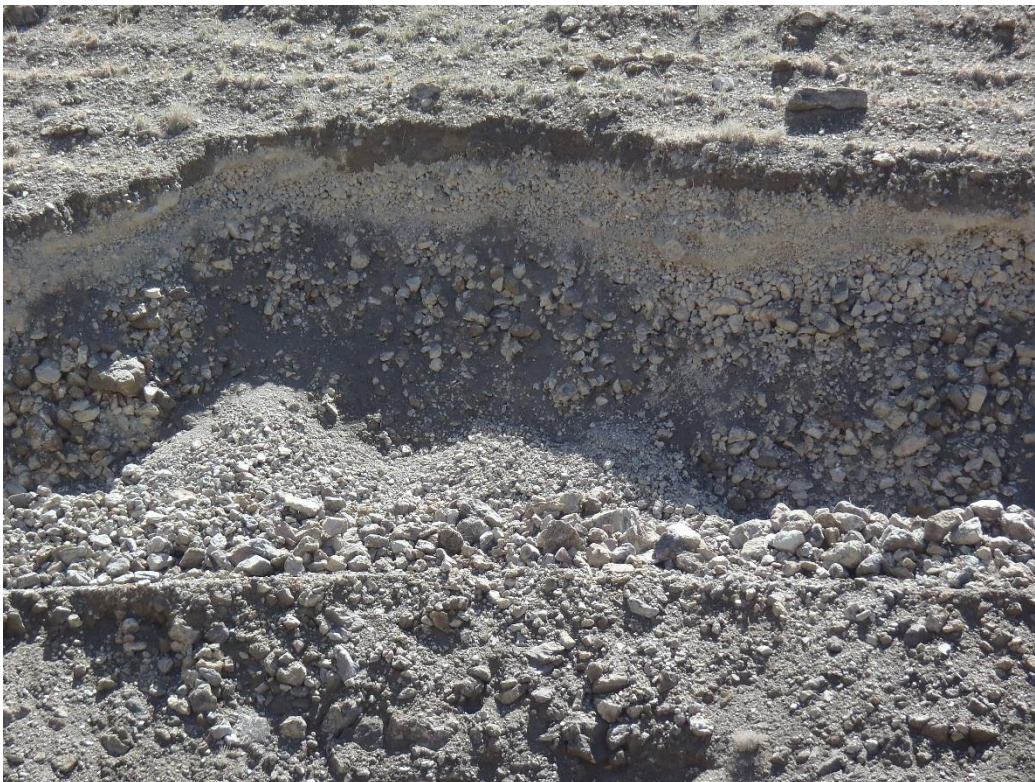
Photo 5. Highwall undermining 1980's reclaimed area (looking south).

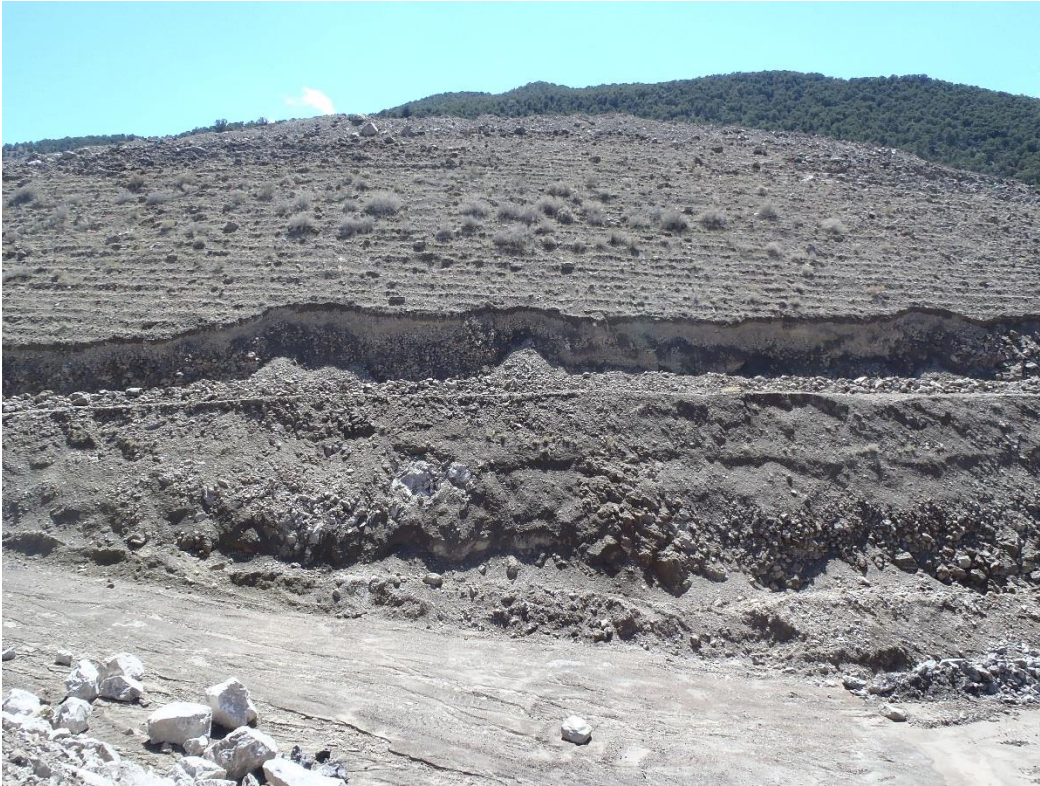
Reclamation – No reclamation had been initiated or completed since the 1980's. This area was reclaimed with deep furrows and appeared well vegetated and stable (see **Photo 6**).

Photo 6. 1980's reclaimed area (looking south).
