**COLORADO DIVISION OF RECLAMATION, MINING AND SAFETY**  
**MINERALS PROGRAM INSPECTION REPORT**  
**PHONE: (303) 866-3567**

<b>MINE NAME:</b> Pit 29	<b>MINE/PROSPECTING ID#:</b> M-1980-183	<b>MINERAL:</b> Sand and gravel	<b>COUNTY:</b> Adams
<b>INSPECTION TYPE:</b> Monitoring	<b>INSPECTOR(S):</b> Tyler V. O'Donnell	<b>INSP. DATE:</b> December 7, 2015	<b>INSP. TIME:</b> 14:30
<b>OPERATOR:</b> Brannan Sand and Gravel Company, L.L.C.	<b>OPERATOR REPRESENTATIVE:</b> Alex Schatz and Josh Oliver	<b>TYPE OF OPERATION:</b> 112c - Construction Regular Operation

## **OBSERVATIONS**

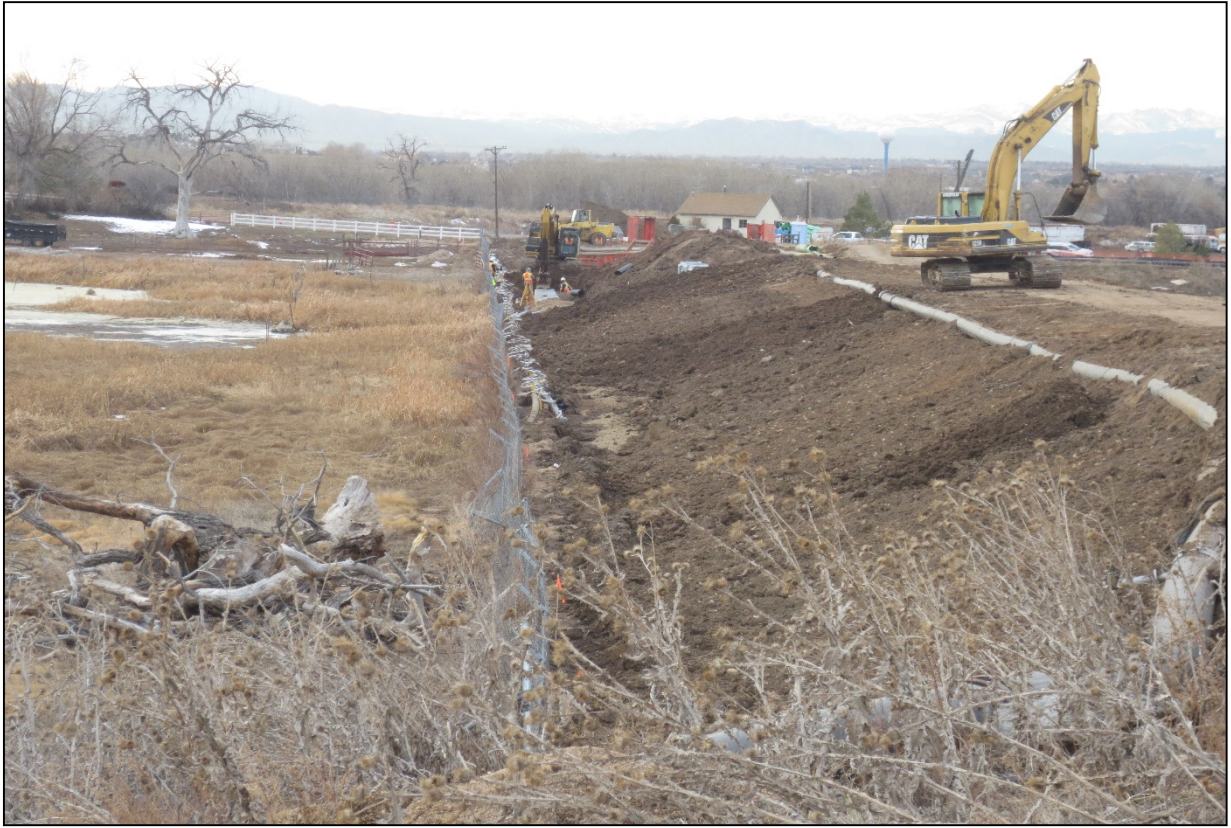
The inspection began at the eastern corner of Pit 29 along Brighton Road, the Division conducted the inspection to observe the construction of the french drain. At the time of the inspection approximately half of the french drain paralleling the Einspahr pasture had been constructed (see photos 1 and 2). Construction began at the furthest upgradient side, progressing down gradient. At the time of the inspection the french drain had been constructed to the mid-point man hole (see photos 3 and 4). The Operator was in the process of constructing the french drain from the mid-point manhole to the manhole at the northwest corner of the Einspahr pasture and Brighton Road. The Operator was using an engineer's level to control the gradient of the french drain. The Operator had also installed sections of the french drain that run parallel to Brighton Road. At the time of the inspection the Operator had not constructed the pipe bore underneath Brighton Road.

**Photograph 1:** View looking west at the construction of the french drain.

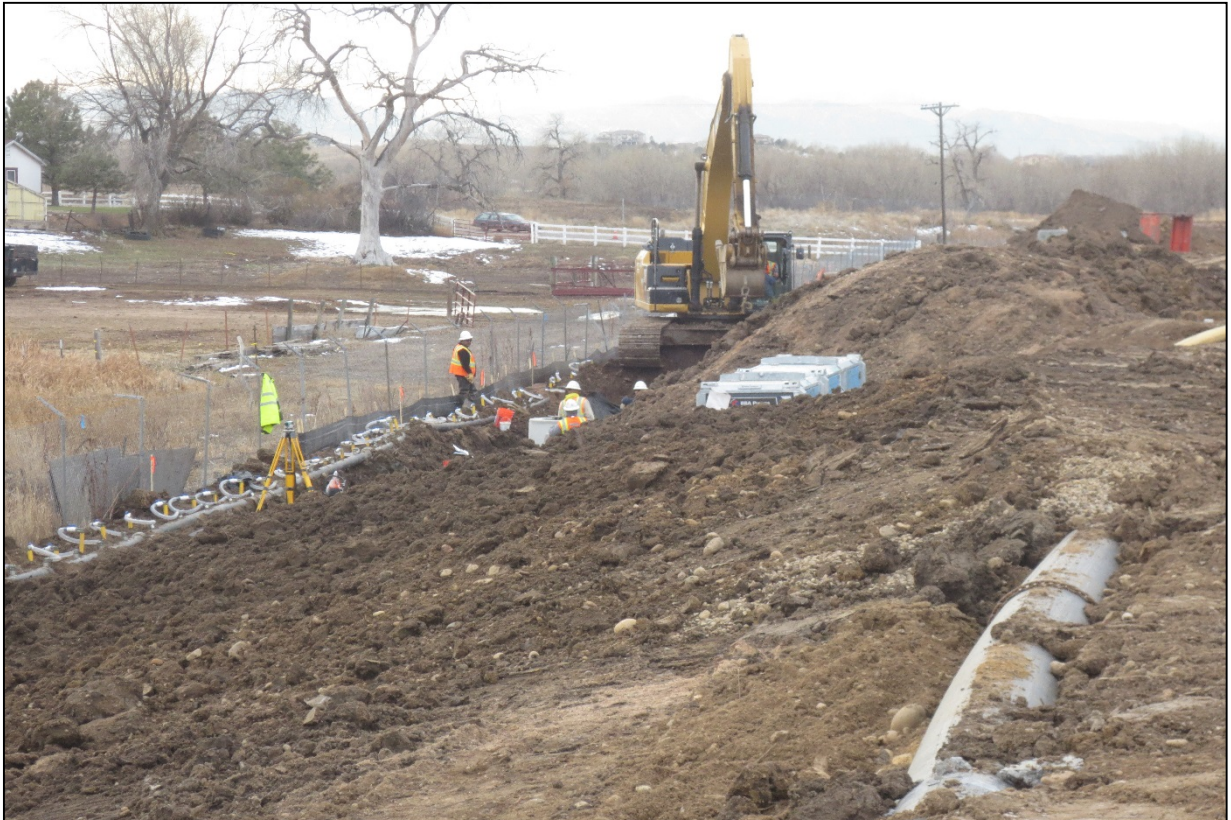
**Photograph 2:** View looking west at the construction of the french drain at the mid-point man hole. Dewatering system along the left hand side of the photo, the dewatering system was located between the fence and the excavation.

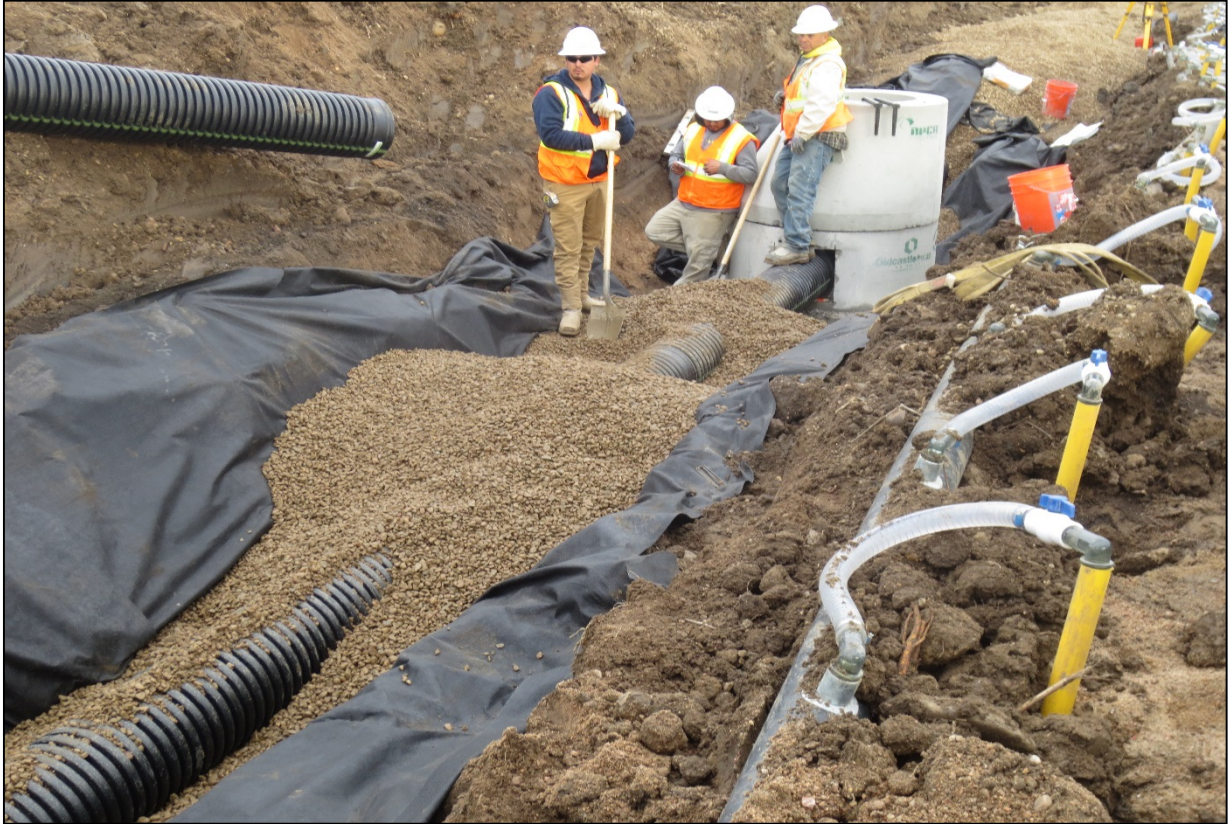
**Photograph 3:** Construction of the french drain on the west side of the mid-point man hole. Dewatering system along the right hand side of the photo.

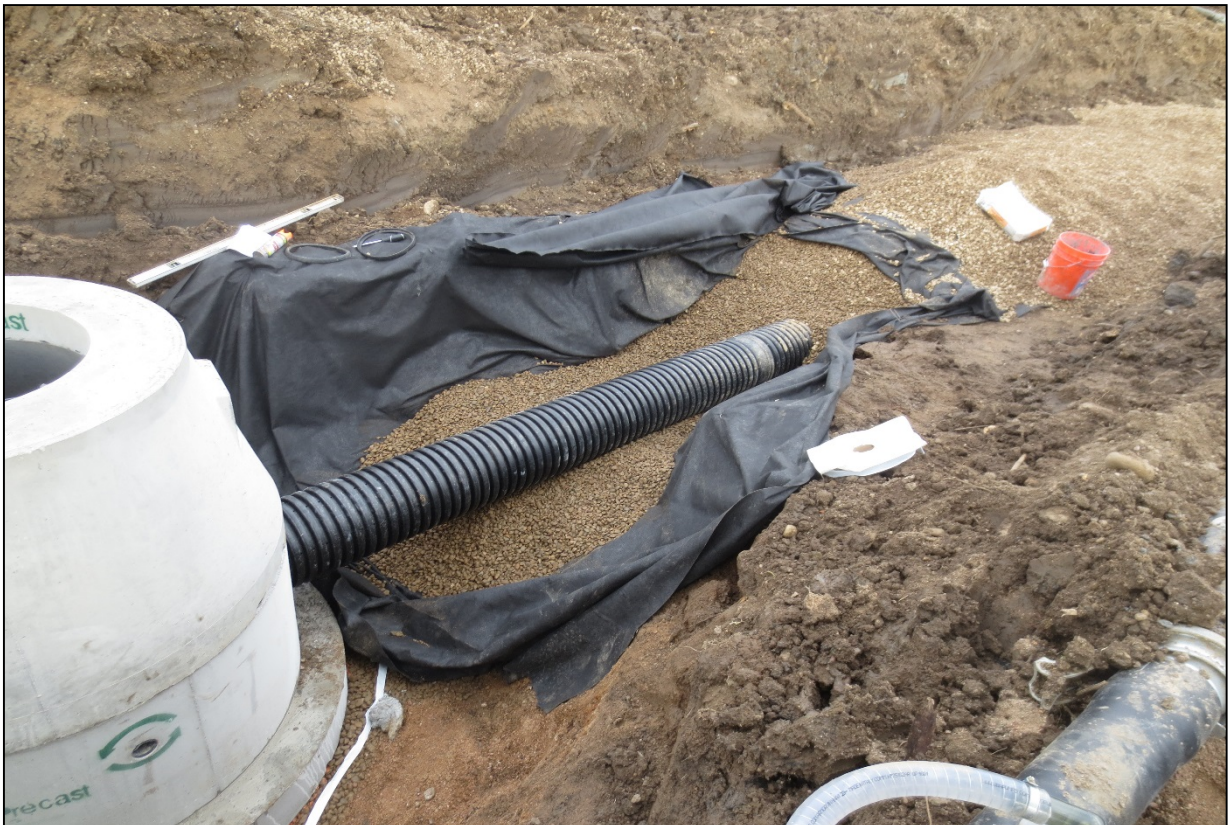
**Photograph 4:** Construction of the french drain on the east side of the mid-point man hole.

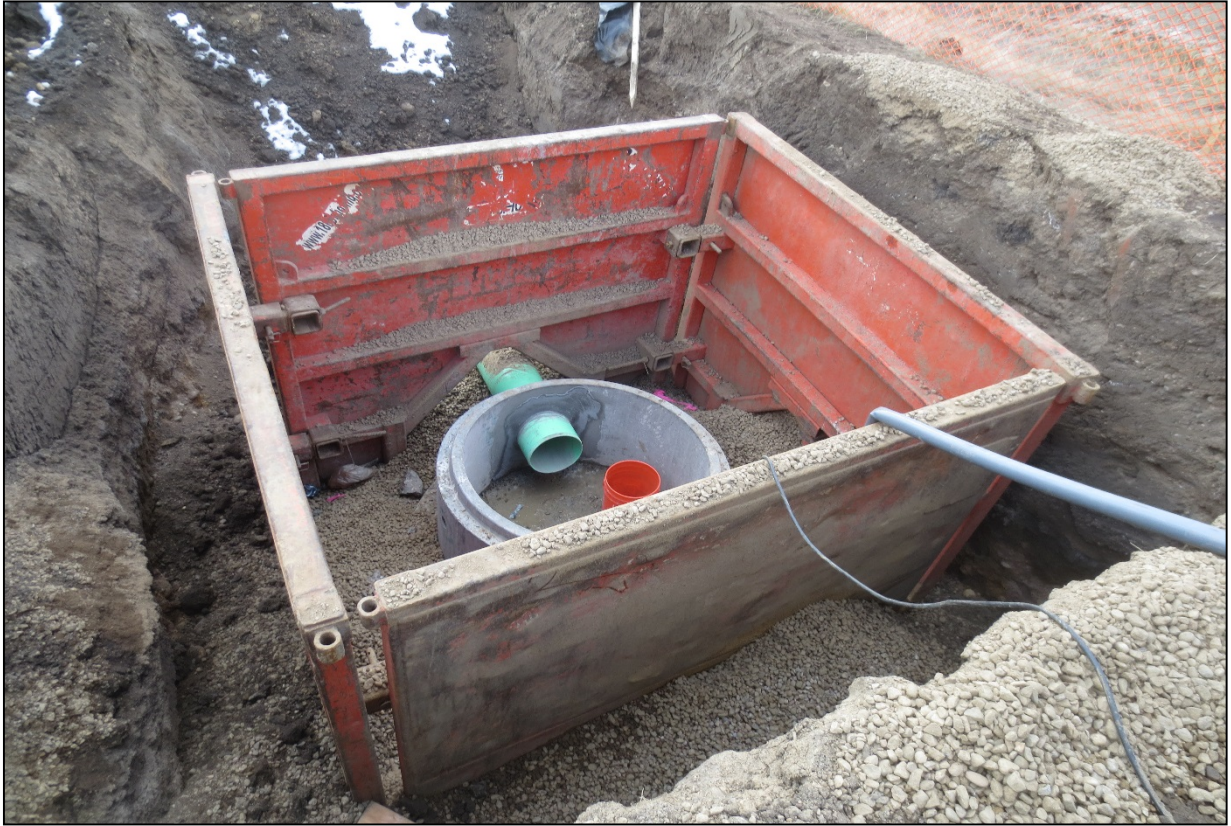
**Photograph 5:** Construction of the mid-point man hole located on the section of the french drain parallel to Brighton Road.

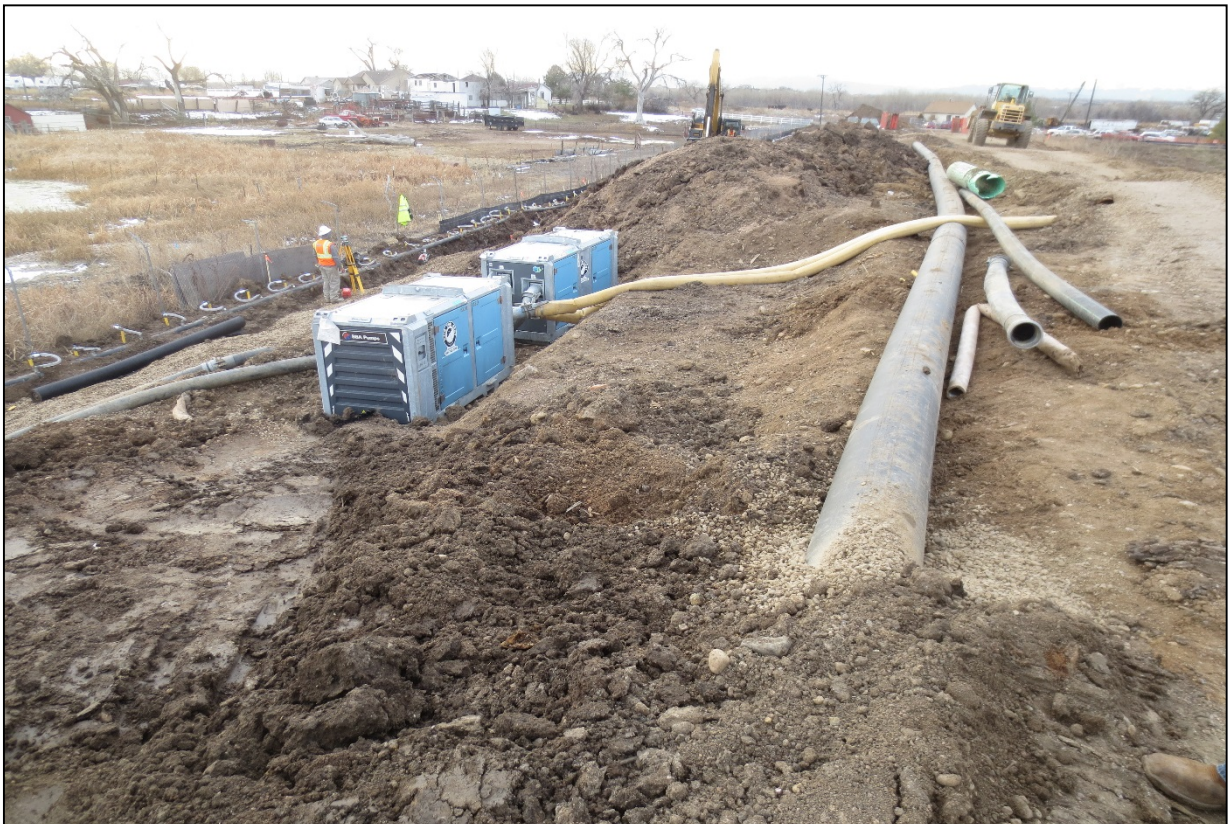
**Photograph 6:** Dewatering system's pumps, the water was being discharged into Pit 29.

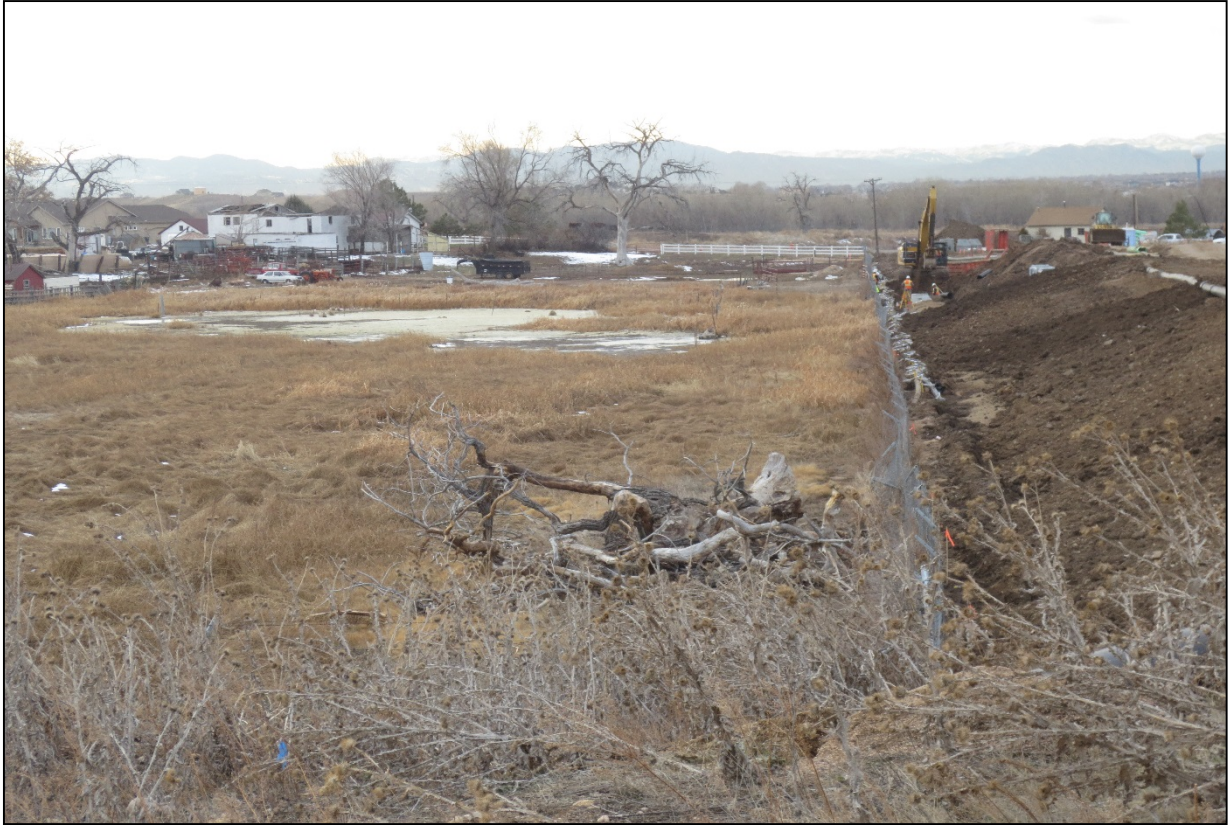
During the inspection, the Division also observed the present conditions in the Einspahr pasture via looking over the fence from Pit 29 (see photos 7 and 8). It appears that the Einspahr pasture had nearly completely dried out; however, the Operator had a dewatering system that had artificially lowered the groundwater level lower than the elevation of the french drain (see photos 1, 2, and 6). It appears that the Einspahr pasture had begun to dry out, only a few low spots had standing water, the standing water appeared to be residual water collecting in the low spots that had not evaporated or infiltrated yet. The Division believes it will take several months for the soil in the pasture to dry out entirely. The Division will need to continue to monitor the conditions through the spring and summer.

**Photograph 7:** View looking west at the Einspahr pasture taken from within the boundary of Pit 29. The Pasture appeared nearly completely dry. The Division believes it will take several months for the soil in the pasture to dry out entirely.

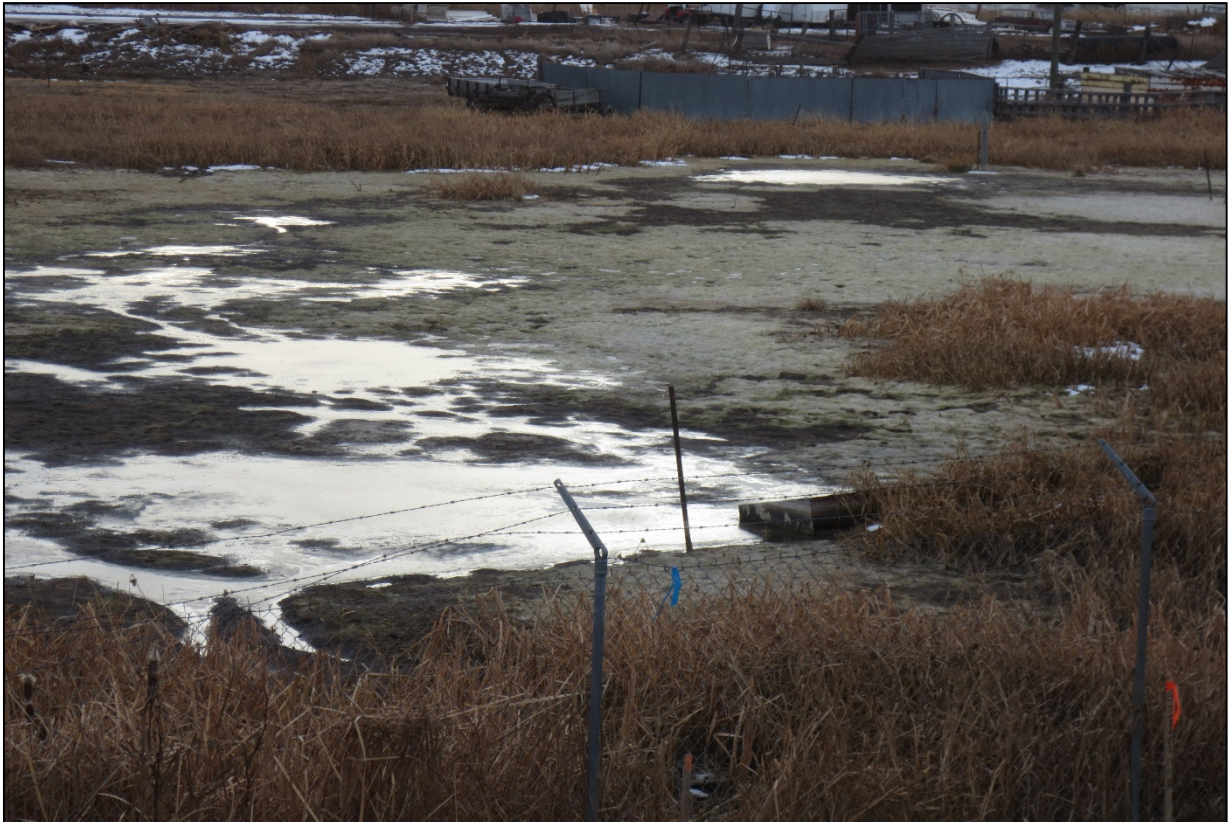
**Photograph 8:** View looking at the Einspahr pasture taken from within the boundary of Pit 29. The Pasture appeared nearly completely dry. Standing water was observed in the low spots, the standing water appeared to be residual water collecting in the low spots that had not evaporated or infiltrated yet. The Division believes it will take several months for the soil in the pasture to dry out entirely.
