**COLORADO DIVISION OF RECLAMATION, MINING AND SAFETY**  
**MINERALS PROGRAM INSPECTION REPORT**  
**PHONE: (303) 866-3567**

<b>MINE NAME:</b> High Mesa Gravel Pit	<b>MINE/PROSPECTING ID#:</b> M-2000-067	<b>MINERAL:</b> Sand and gravel	<b>COUNTY:</b> Delta
<b>INSPECTION TYPE:</b> Monitoring	<b>INSPECTOR(S):</b> Stephanie J. Mitchell	<b>INSP. DATE:</b> January 12, 2016	<b>INSP. TIME:</b> 10:15
<b>OPERATOR:</b> Beavers Construction Co./High Mesa Gravel	<b>OPERATOR REPRESENTATIVE:</b> Phil Bouroussa	<b>TYPE OF OPERATION:</b> 112c - Construction Regular Operation	
<b>REASON FOR INSPECTION:</b> Normal I&E Program	<b>BOND CALCULATION TYPE:</b> Complete Bond	<b>BOND AMOUNT:</b> \$65,790.00	
<b>DATE OF COMPLAINT:</b> NA	<b>POST INSP. CONTACTS:</b> None	<b>JOINT INSP. AGENCY:</b> None	
<b>WEATHER:</b> Clear	<b>INSPECTOR'S SIGNATURE:</b>

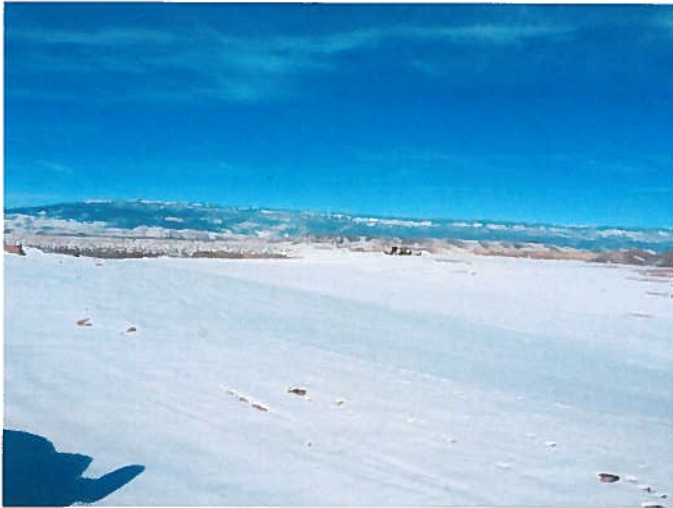
Looking to the NW

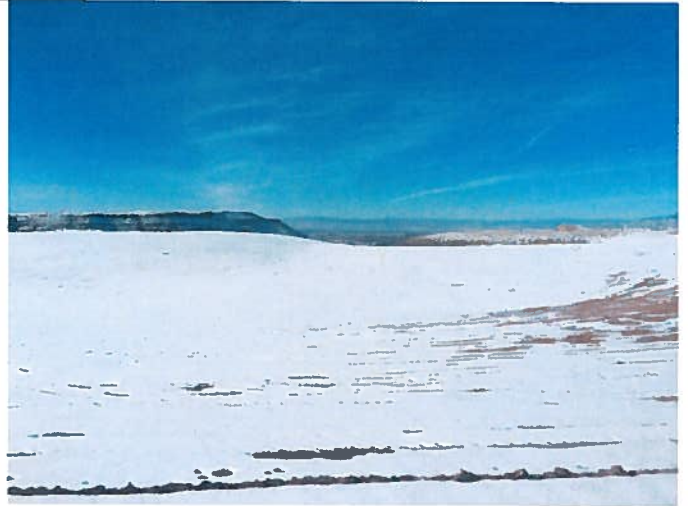
Pit area- reclaimed

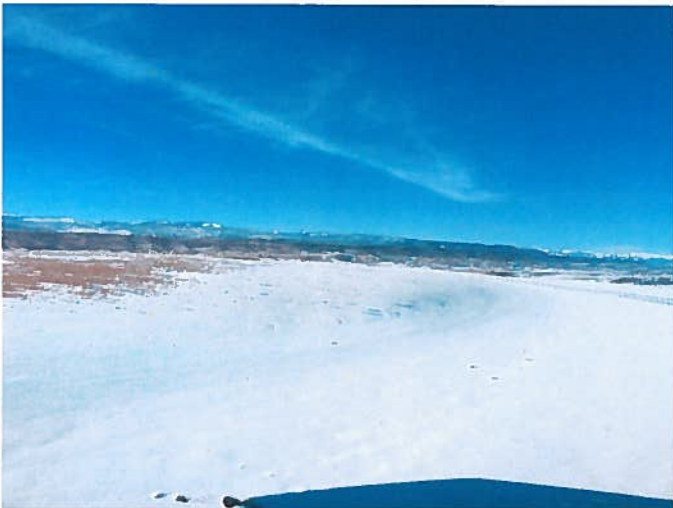
Mining is complete and final grading has also been completed. The current approved post mining land use is Wildlife. The Operator had expressed interest in turning the permit area into a subdivision. An amendment to the permit is required to change the post mining land use to Residential and reclamation plan to account for the reclamation proposed, such as leaving permanent roads and a privacy berm. Just to the north, near the current haul road, a large stockpile of topsoil is in place as a privacy berm. This pile had grassy and weedy vegetation established preventing wind and water erosion. The south and east pit slopes has been graded to a 3:1-4:1 slope.

Graded Slope

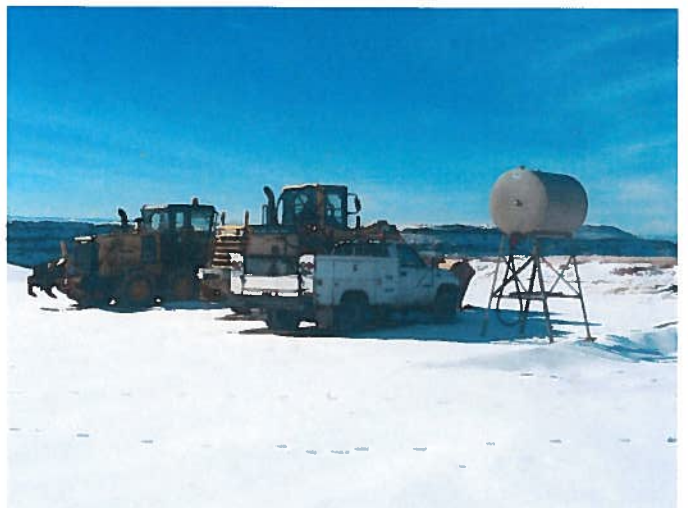
**PROBLEM/POSSIBLE VIOLATION:** Problem: Improper storage and containment of fuels and/or other hazardous materials was present on site.

A fuel tank was observed without secondary containment. This is cited as a problem at the beginning of this inspection report.

Fuel inadequately contained

**CORRECTIVE ACTIONS:** All storage tanks, petroleum and any hazardous materials on site for any period of time shall have appropriate secondary containment. The site will also have to comply with all applicable SPCC requirements. Please supply photo documentation that any fuel or hazardous materials containers are stored properly - including applicable secondary containment structures by the corrective action date. Note that secondary containment structures shall consist of an impermeable containment which could contain all contents of the tanks and various containers (when full) plus 10% of the total capacity. The operator may also provide photo documentation that all containers have been removed from the site on or before the corrective action date.

**CORRECTIVE ACTION DUE DATE:** 3/23/16

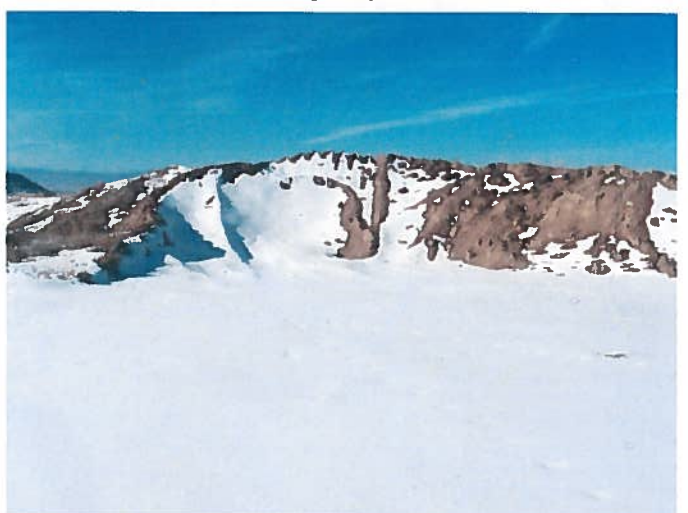
Topsoil Berm

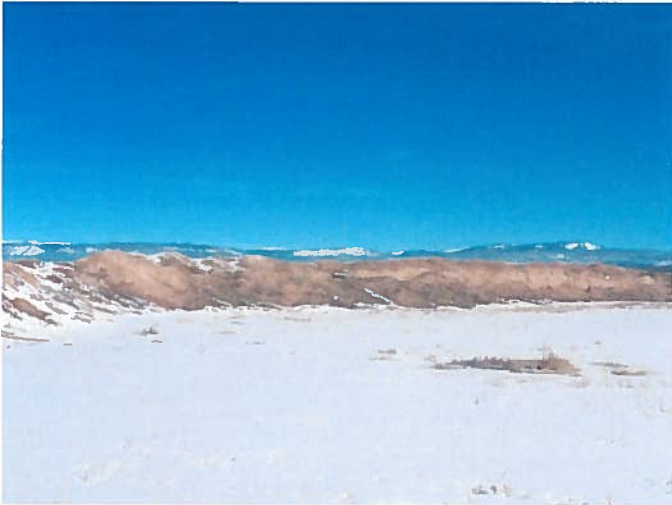
Topsoil Berm

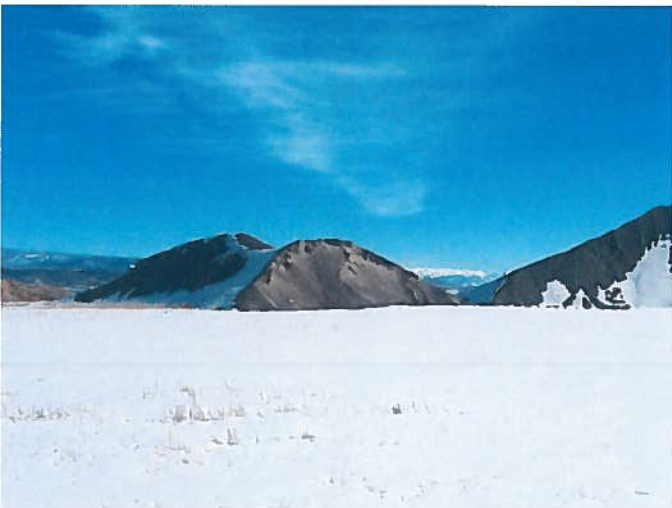
There were two material stockpiles remaining on the site. The Operator expressed hat he would like to use them for road base once the subdivision is approved and the post mining land use was changed via an amendment with the Division.

Material Stockpile

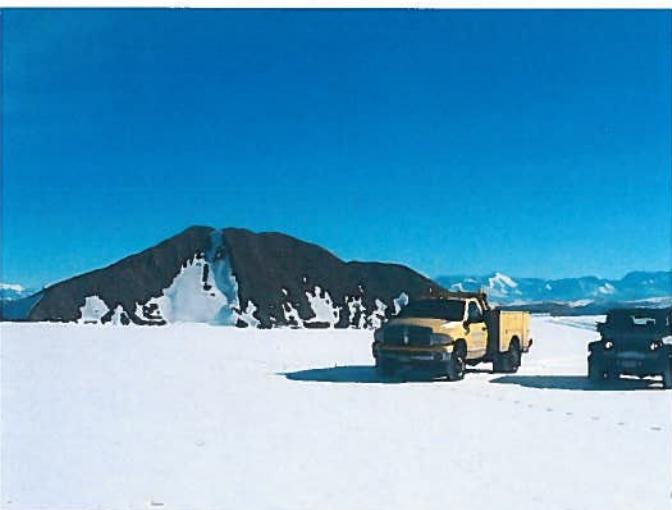
Material Stockpile
