COLORADO DIVISION OF RECLAMATION, MINING AND SAFETY
MINERALS PROGRAM INSPECTION REPORT
PHONE: (303) 866-3567

MINE NAME: Pikeview Quarry	MINE/PROSPECTING ID#: M-1977-211	MINERAL: Limestone (general), granite, and dolomite	COUNTY: El Paso
INSPECTION TYPE: Monitoring	INSPECTOR(S): Timothy A. Cazier	INSP. DATE: May 14, 2015	INSP. TIME: 13:00
OPERATOR: Continental Materials Corporation	OPERATOR REPRESENTATIVE: Chris Usry & Mac Shafer	TYPE OF OPERATION: 112c - Construction Regular Operation

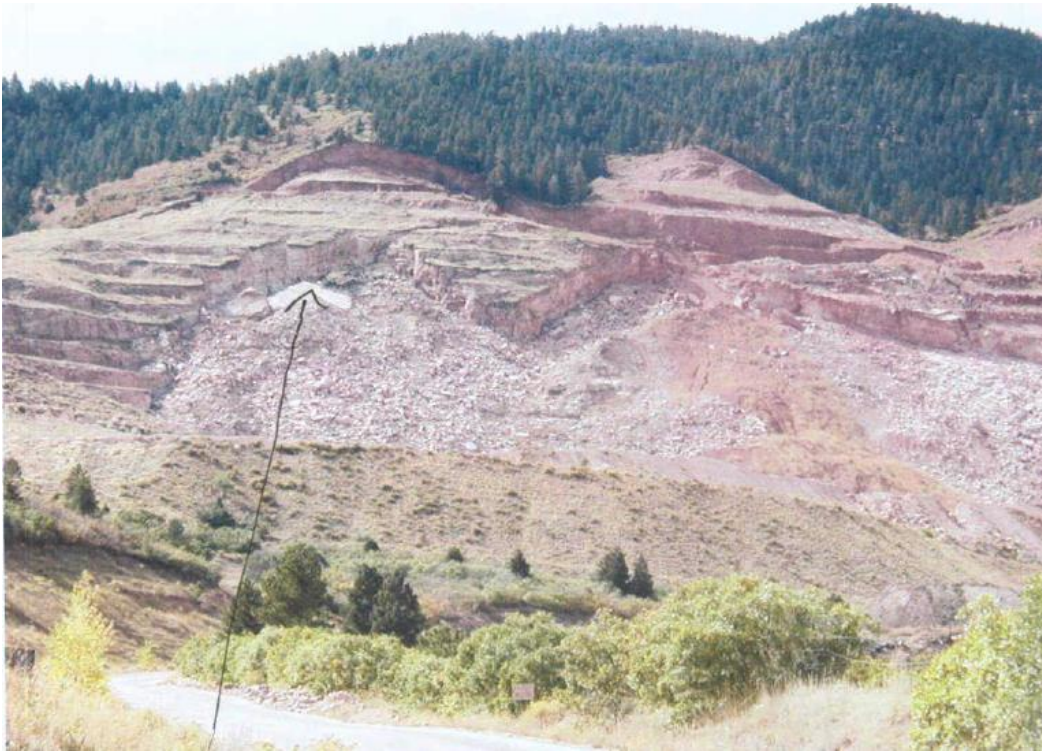
The portion of the slide that moved can be seen by comparing a photo taken by the DRMS on May 10, 2010 (**Photo 1**) with a photo taken during this 2015 inspection (**Photo 2**). **Photo 3** shows the toe of the slide area, including the sediment pond at the toe. Meteoric water was observed entering the upper portion of the pit as runoff or expression from shallow seeps (**Photo 4**).

Photo 1. Slide/scarp from May 10, 2010 inspection.

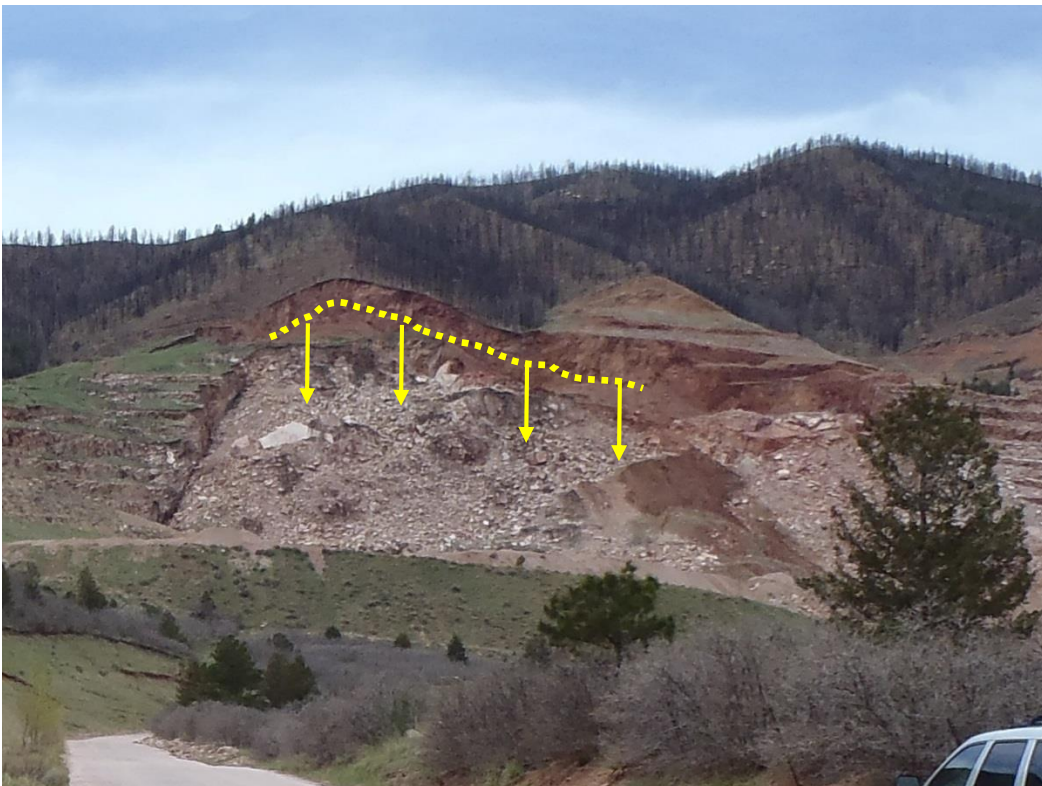
Photo 2. Slide/scarp from current inspection.

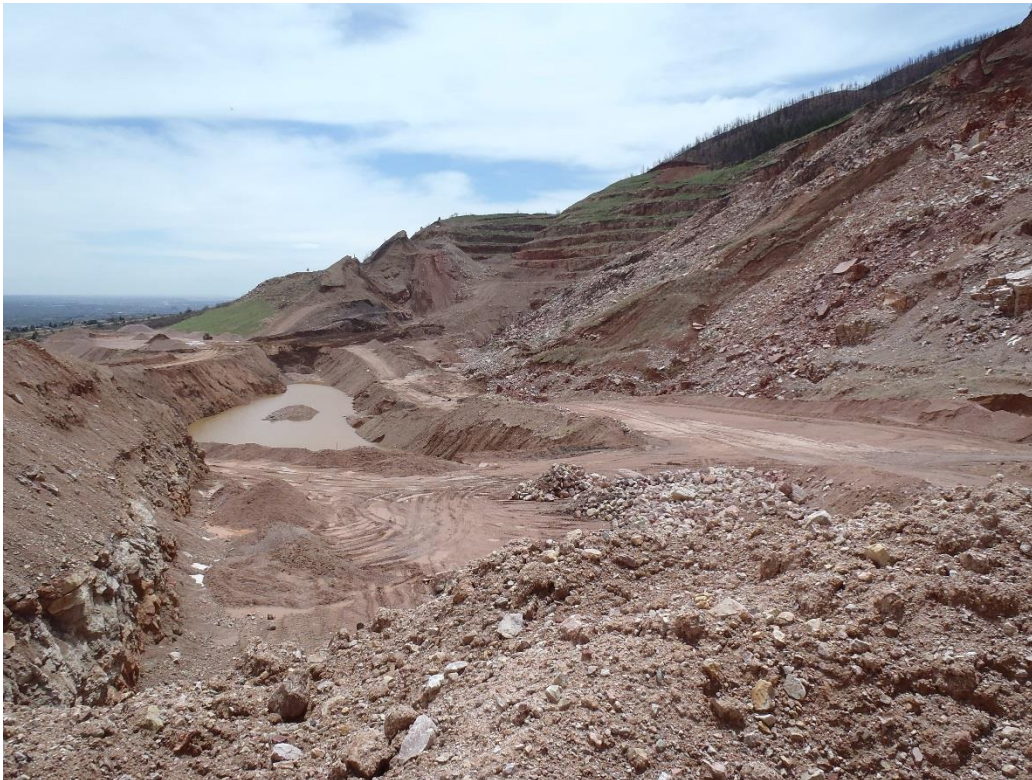
Photo 3. Toe of the slide area, including the sediment pond (looking south).

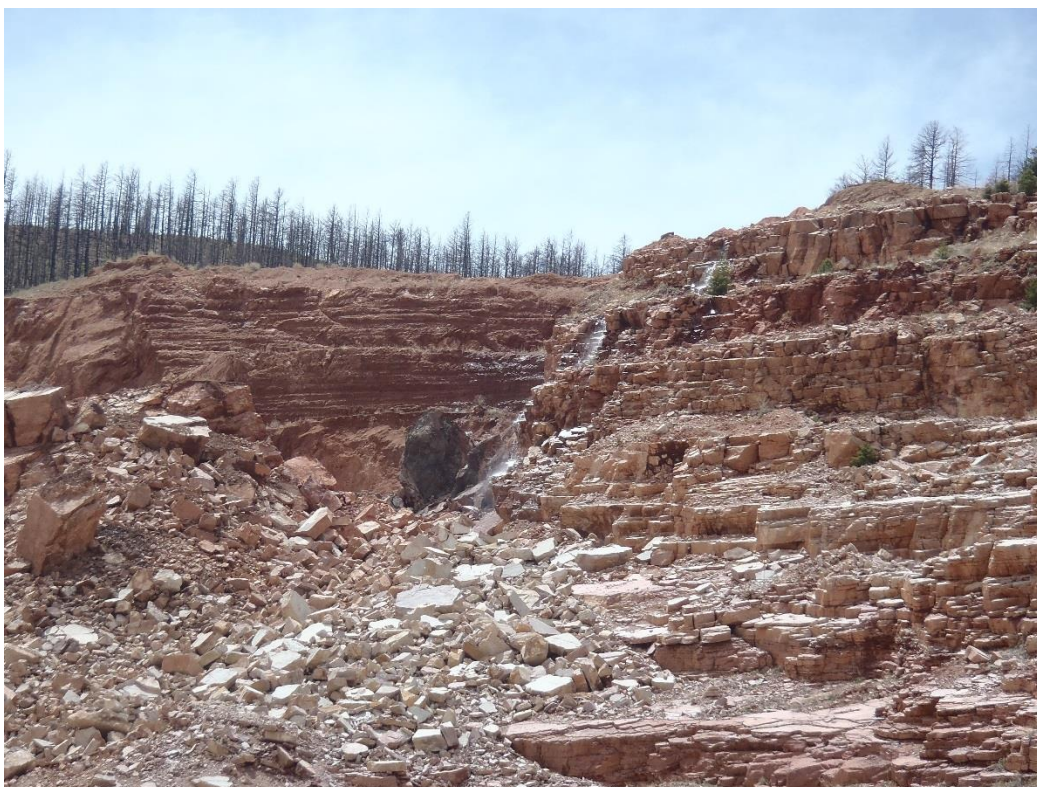
Photo 4. Water entering pit at top of highwall – near center pit (looking SW).

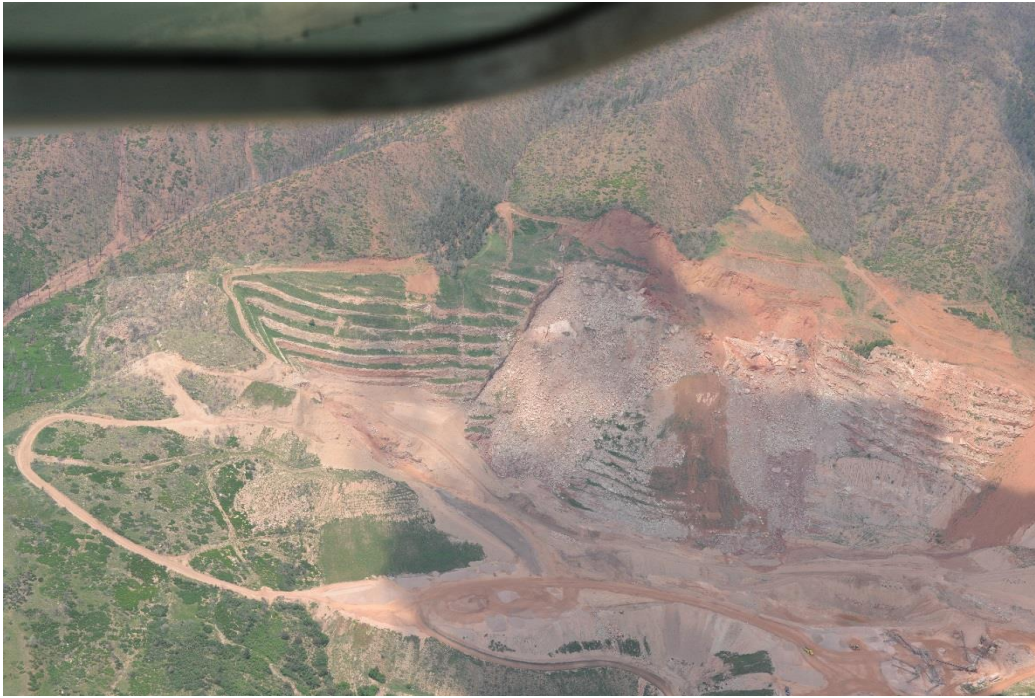
Photos 5, 6 and 7 show the slide and the mine site from an aerial perspective on June 26, 2015.

Photo 5. Aerial - Pit area (looking SW).

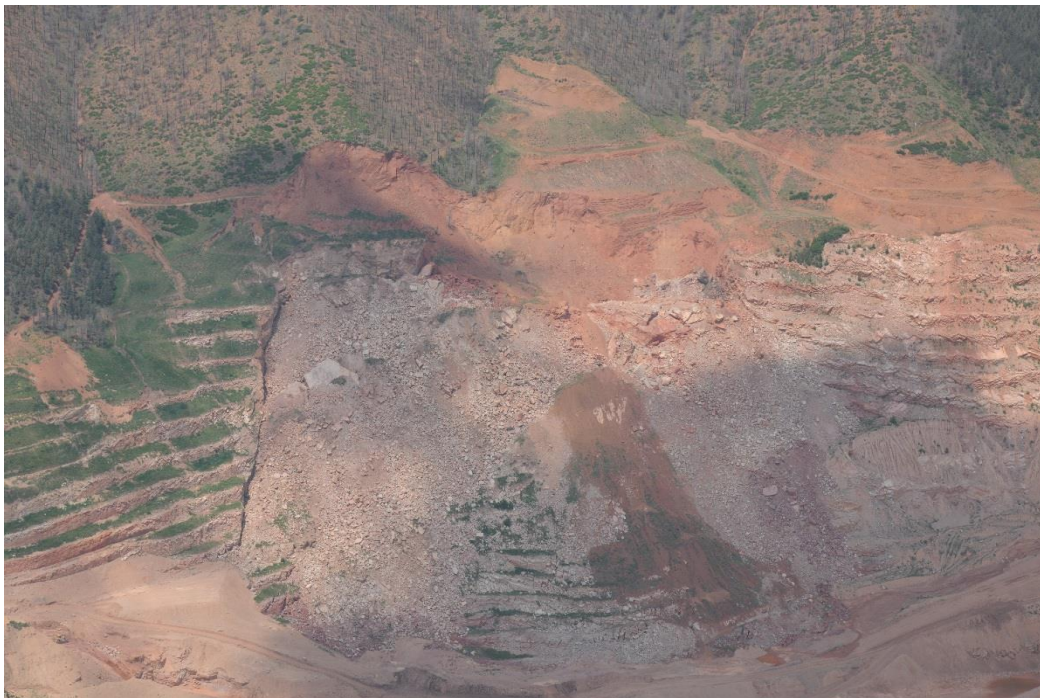
Photo 6. Aerial close-up – Slide and scarp area (looking west).

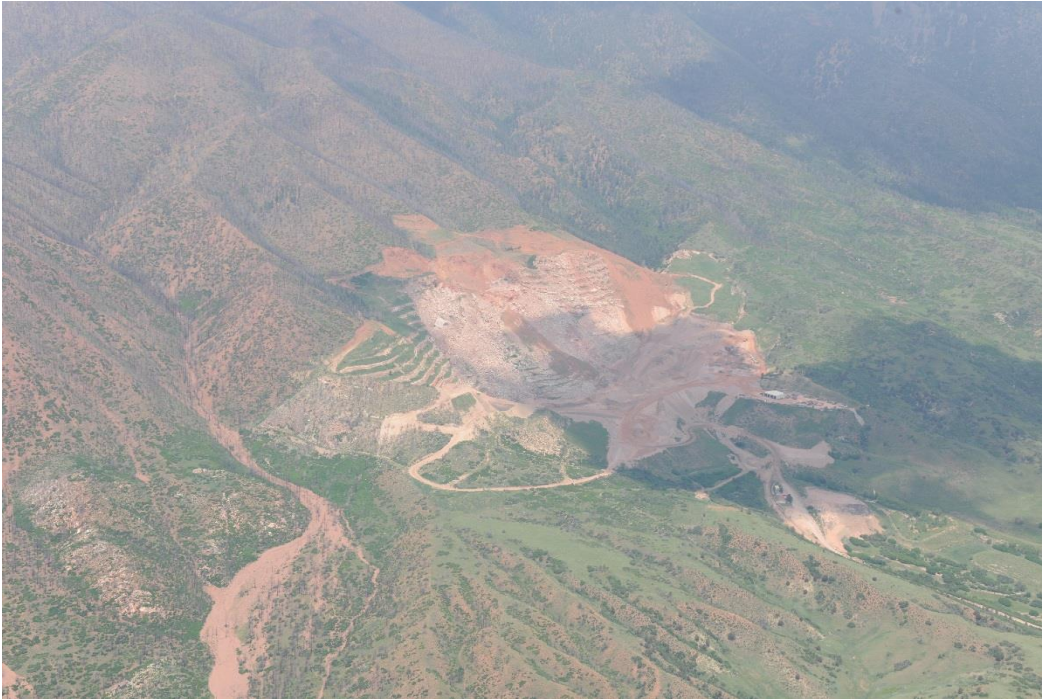
Photo 7. Aerial - Pit area (looking NW).
