COLORADO DIVISION OF RECLAMATION, MINING AND SAFETY
MINERALS PROGRAM INSPECTION REPORT
PHONE: (303) 866-3567

MINE NAME: Lawrence Pit	MINE/PROSPECTING ID#: M-1974-041	MINERAL: Sand and gravel	COUNTY: Douglas
INSPECTION TYPE: Monitoring	INSPECTOR(S): Tyler V. O'Donnell	INSP. DATE: December 8, 2015	INSP. TIME: 09:00
OPERATOR: Lawrence Construction Company, Inc.	OPERATOR REPRESENTATIVE: Dave Morris	TYPE OF OPERATION: 112c - Construction Regular Operation

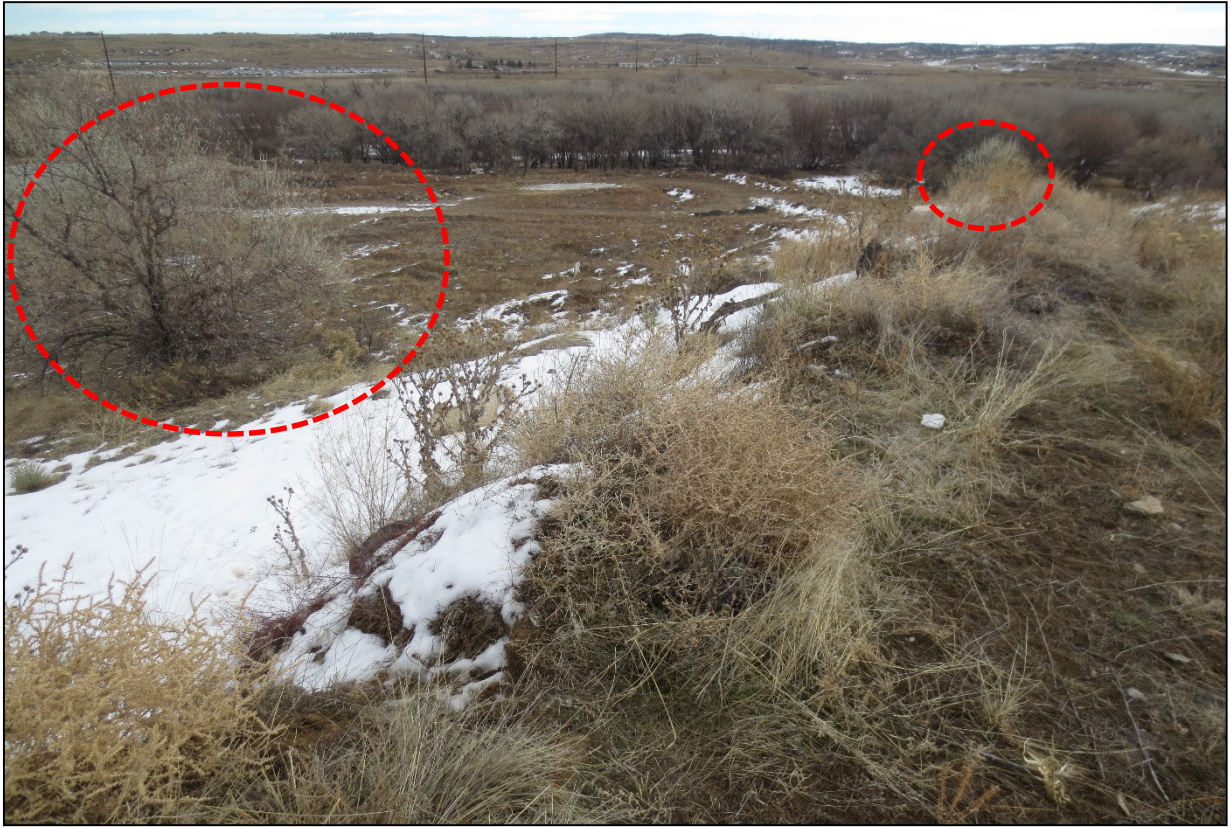
There was some plant growth on the stockpiles and throughout the rest of the disturbed area. Very little vegetation growth was observed on the pit floor. The growth observed in the disturbed area appeared to be volunteer vegetation, comprised of grasses and a few annual weeds. There were a handful of mature Russian Olive trees

scattered throughout the pit. Russian Olive trees are a list B species on the Colorado Noxious Weed list. At the present time the presence of Russian Olive trees will not be cited as a problem due to the limited number observed trees. The Operator will need to take measures to prevent the spread of the trees, and the trees will need to be eradicated during final reclamation. There were several other species of noxious weeds observed within the affected area. The Division has attached the 11th edition of the Noxious Weeds of Colorado Identification book. The Operator is advised to continue to monitor and treat all noxious weeds as the weeds appear within the permit boundary.

Photograph 1: Photo Take from on top of the highwall, Russian Olive trees circled in the red dashed line.

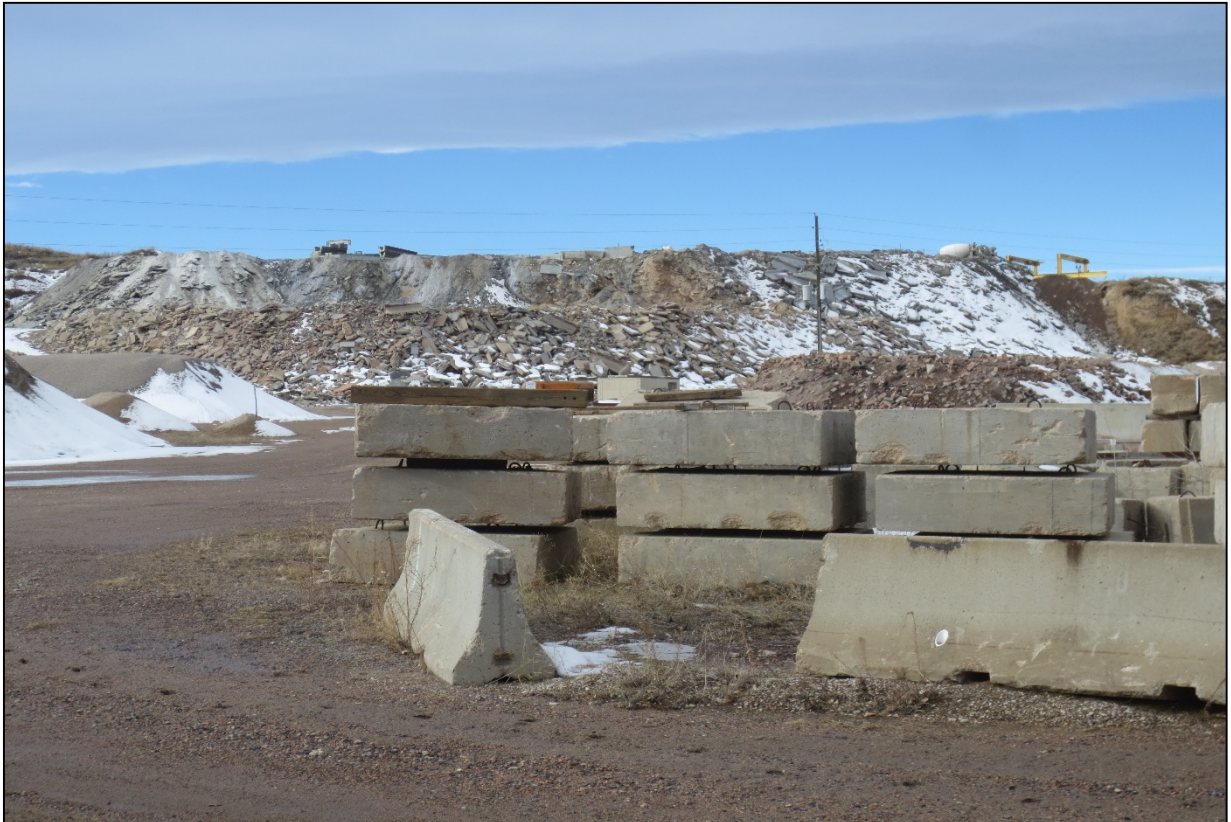
The Operator has mined the pit from northeast to the west and south, leaving a highwall along the western and southern portions of the site. The pit primarily daylights to the north and east into the flood play of Plume Creek. There were several stockpiles of product, concrete and asphalt scattered throughout the affected area. There was a highwall along the entire length of the western pit boundary and the majority of the southern pit boundary. The western highwall had areas where broken up concrete had been end dumped off the highwall. The highwall had an average height of approximately 35 feet. The highwall had a slope ranging from near vertical to 2H:1V. When completing final reclamation, the Operator will need to grade all slopes to 3H:1V or flatter to comply with the approved reclamation plan.

Photograph 2: Photo Take from the pit floor, large stockpile of end dumped broken up concrete.

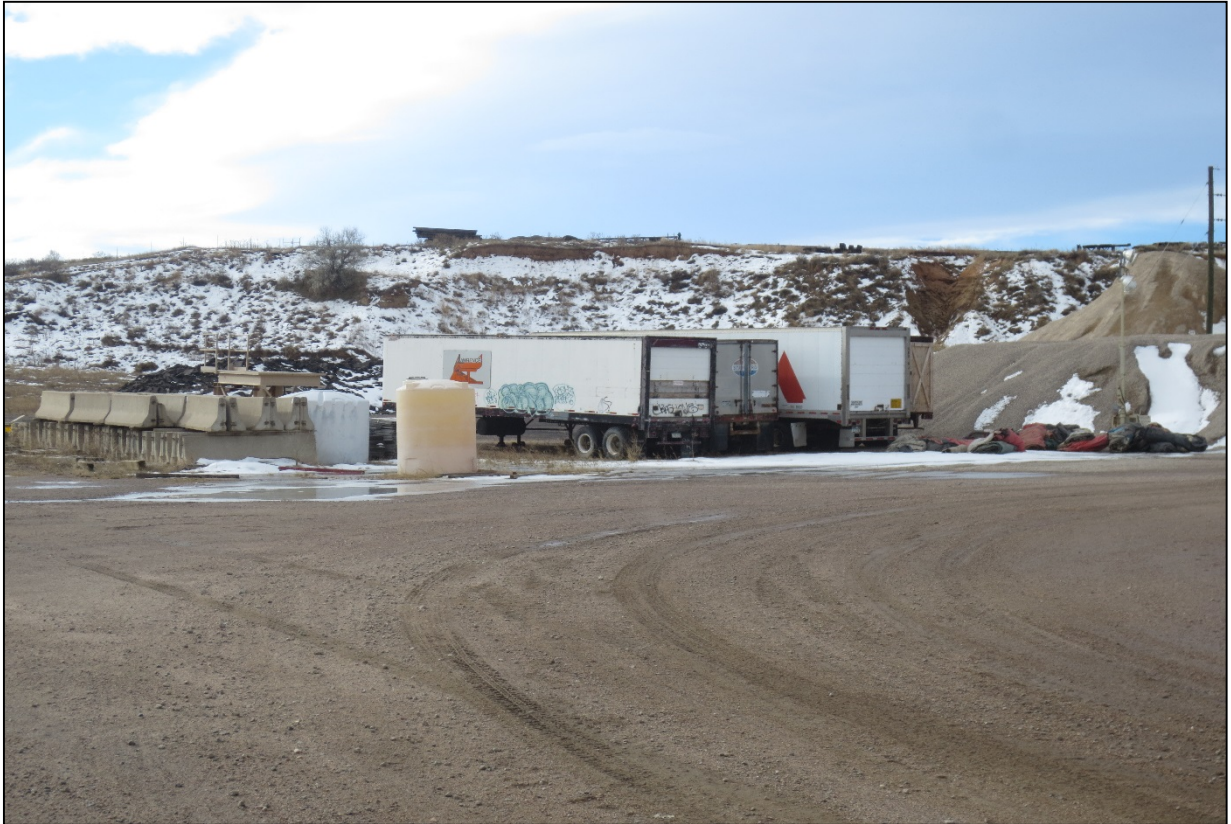
There was one large gully observed in the southern highwall. The gully drains into the bottom of the pit. The gully will need to be repaired during final reclamation. There was no other evidence of excessive erosion (rills, gullies, or sediment fans).

Photograph 3: Photo Take from the pit floor, southern highwall in the background.

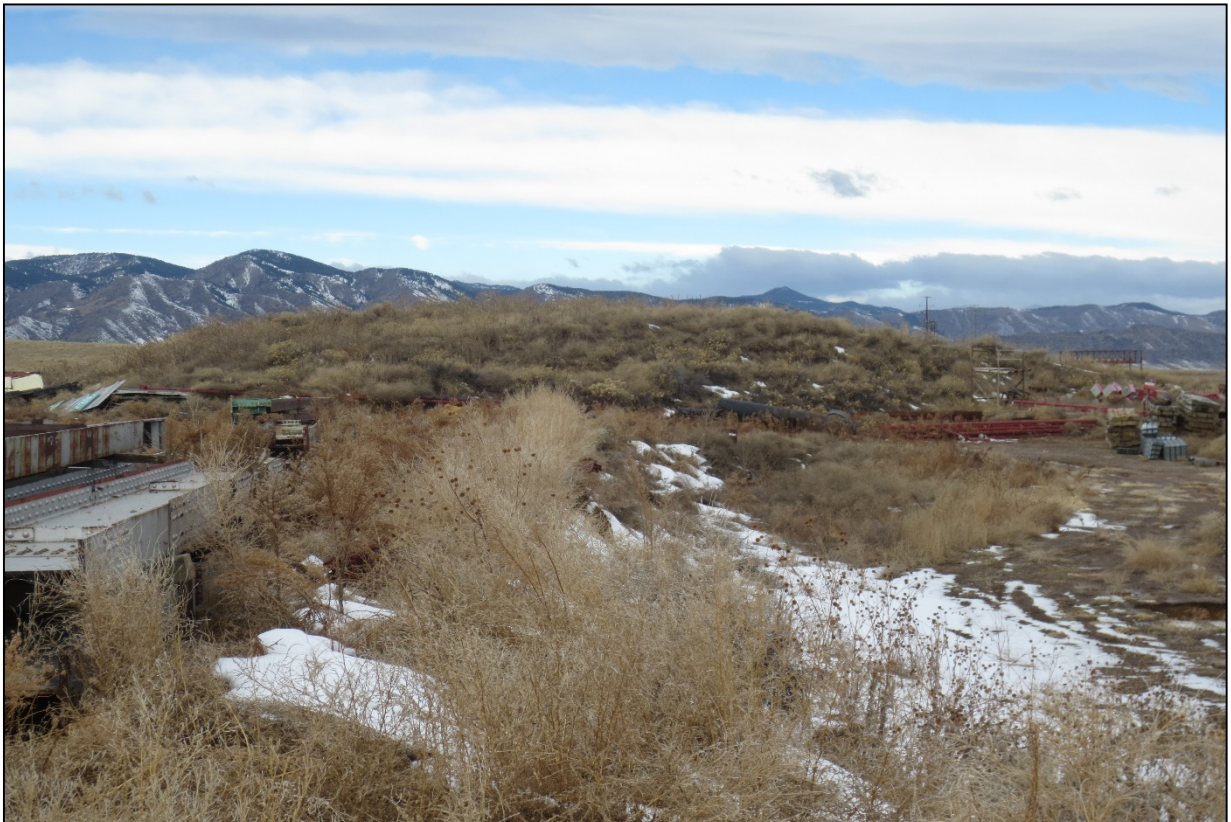
There was a well-vegetated topsoil stockpile located near the southwest corner of the permitted site. It appears the topsoil stockpile has been idle for a while, no recent heavy equipment marks were observed in the stockpile. There appeared to be an adequate amount of topsoil to complete the approved reclamation plan.

Photograph 4: Well Vegetated topsoil stockpile.
