COLORADO DIVISION OF RECLAMATION, MINING AND SAFETY
MINERALS PROGRAM INSPECTION REPORT
PHONE: (303) 866-3567

MINE NAME: Platte Valley Operation	MINE/PROSPECTING ID#: M-1989-120	MINERAL: Sand and gravel	COUNTY: Weld
INSPECTION TYPE: Monitoring	INSPECTOR(S): Peter S. Hays	INSP. DATE: February 24, 2016	INSP. TIME: 14:30
OPERATOR: Aggregate Industries - WCR, Inc.	OPERATOR REPRESENTATIVE: Connie Davis	TYPE OF OPERATION: 112c - Construction Regular Operation

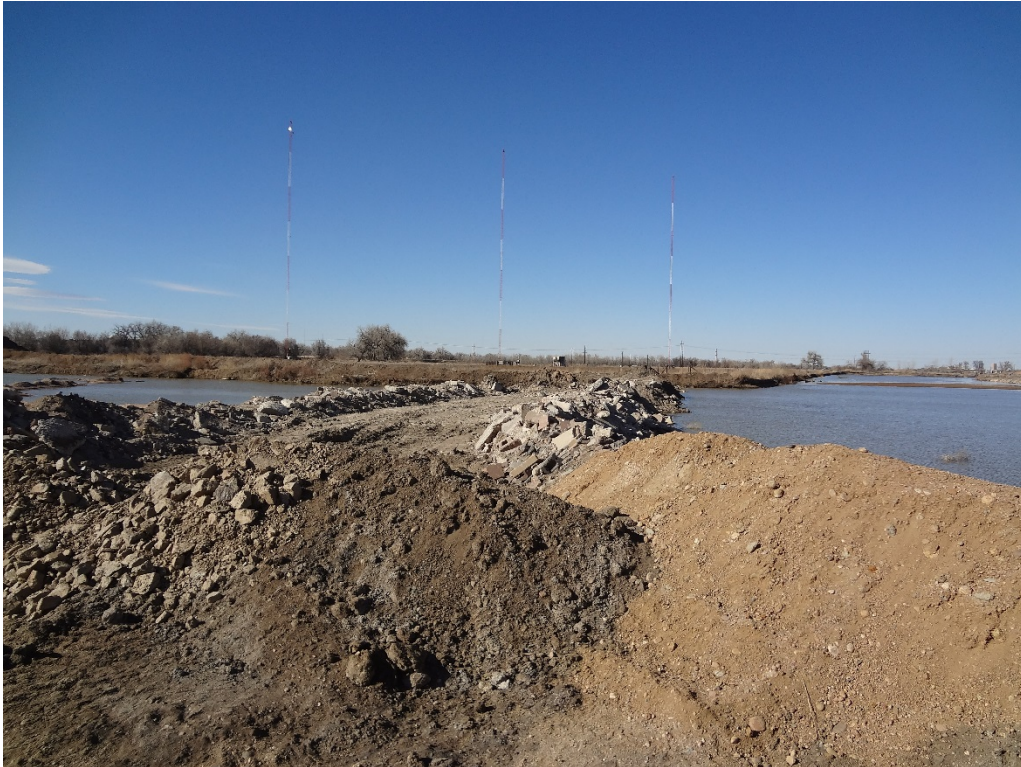
A haul road was constructed across the Phase 3 pond to access the overburden stockpile located north of the phase. The road divided the "L" shaped pond into 2 rectangular ponds. The Operator started using the east pond as a wash fines pond, which will backfill the pond. It is unknown if the west pond will be backfilled with wash fines in the future. The majority of the overburden stockpile was used for the flood and breach repair work.

Looking NW at haul road through the Phase 3 pond

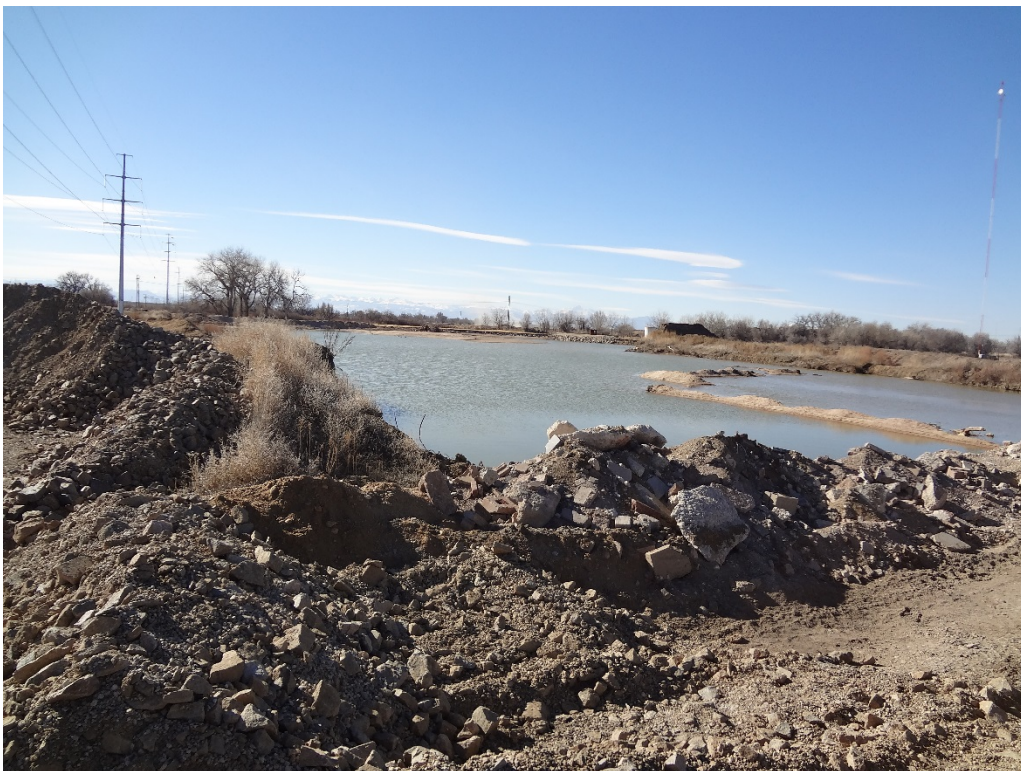
Looking west at the western portion of the Phase 3 pond

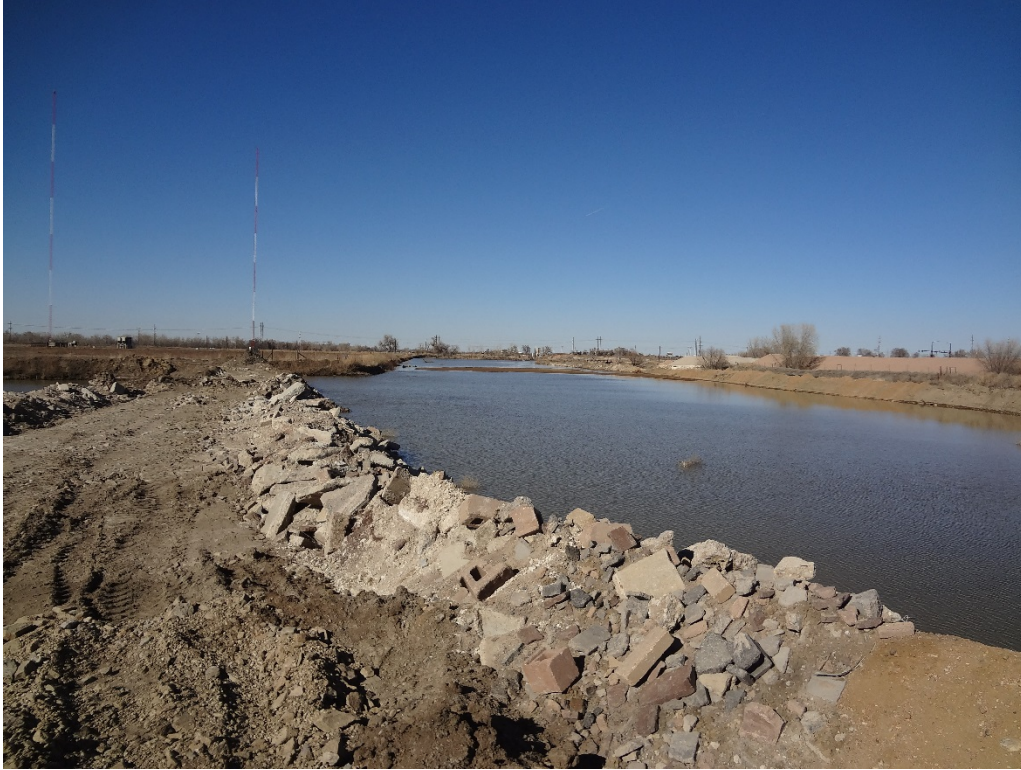
Looking north at the eastern portion of the Phase 3 pond

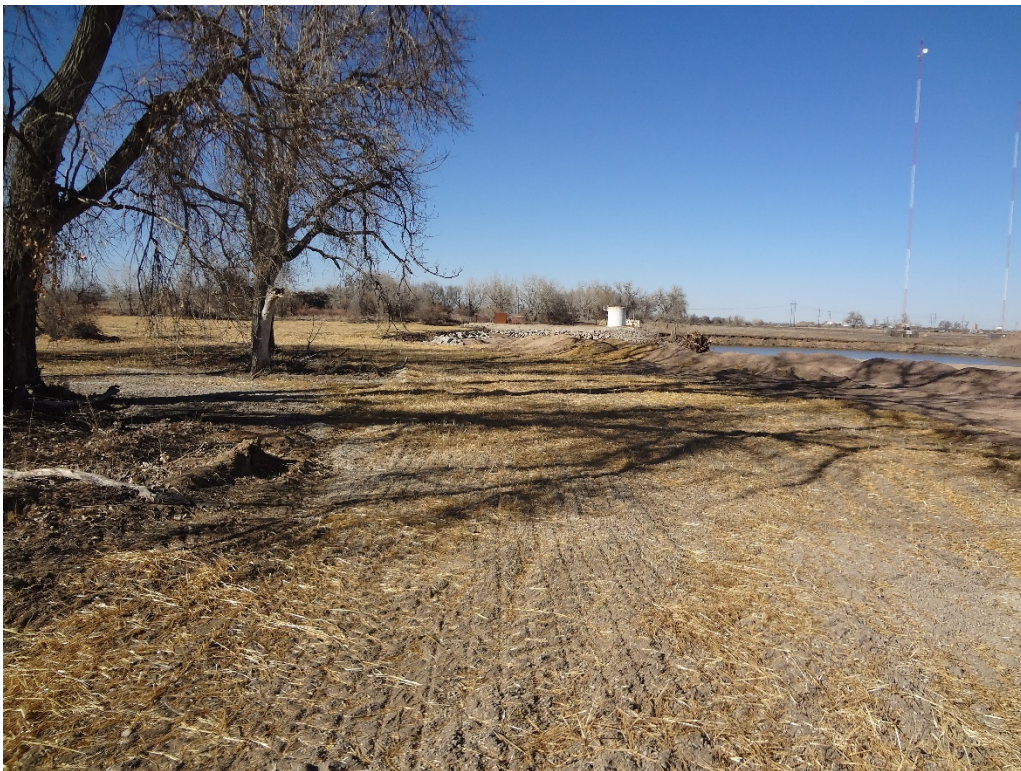
PROBLEM/POSSIBLE VIOLATION: Problem: The repaired river bank did not appear to extend past the shared Consolidated Mutual and Aggregate Industries property line and did not appear to restore the required Aggregate Industries offset from the property line and pond slope in Phase 3 to the required grade.

It appeared the grading work did not extend past the shared property line and did not restore the AI offset and Phase 3 pond slope to the required grade. This is cited as a problem requiring corrective action by the Operator by the due date. The Division contacted Mr. York, the consultant for the Perry Pit, regarding as-built survey data for the grading work. Mr. York stated the survey work would be completed soon and would include the property line and toe of slope on the AI property.

Looking north at breach repair from SW corner of Phase 3

CORRECTIVE ACTIONS: Provide as-built survey data for the breach area grading work indicating the property line and toe of slope on the Aggregate Industries property.

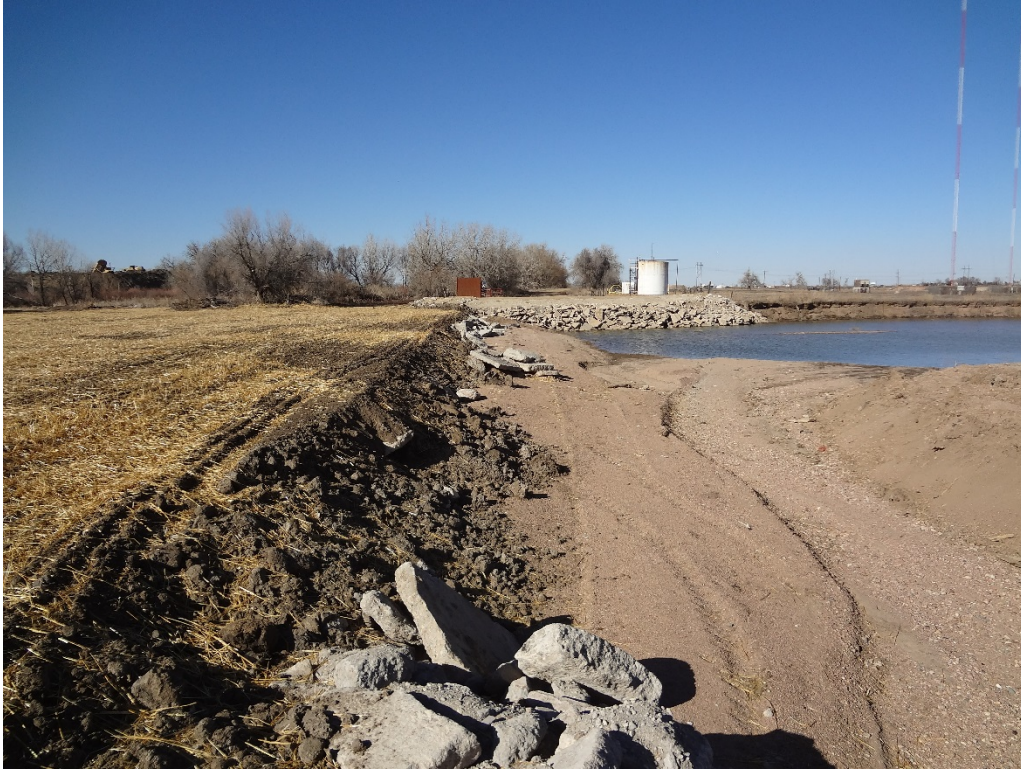
Looking at the toe of slope along the western shoreline of Phase 3
