**COLORADO DIVISION OF RECLAMATION, MINING AND SAFETY**  
**MINERALS PROGRAM INSPECTION REPORT**  
**PHONE: (303) 866-3567**

<b>MINE NAME:</b> Sunnyside Gold Mine	<b>MINE/PROSPECTING ID#:</b> M-1977-378	<b>MINERAL:</b> Au, Ag, Pb, Zn, Cu	<b>COUNTY:</b> San Juan
<b>INSPECTION TYPE:</b> Multi Person Inspection	<b>INSPECTOR(S):</b> T.Waldron, R.Means, W.Erickson, L.West	<b>INSP. DATE:</b> August 28, 2015	<b>INSP. TIME:</b> 09:00
<b>OPERATOR:</b> Sunnyside Gold Corp	<b>OPERATOR REPRESENTATIVE:</b> Larry Perino	<b>TYPE OF OPERATION:</b> 112 - Hard Rock Regular Operation	
<b>REASON FOR INSPECTION:</b> Normal I&E Program	<b>BOND CALCULATION TYPE:</b> Partial Bond	<b>BOND AMOUNT:</b> \$60,534.00	
<b>DATE OF COMPLAINT:</b> NA	<b>POST INSP. CONTACTS:</b> None	<b>JOINT INSP. AGENCY:</b> None	
<b>WEATHER:</b> Cloudy	<b>INSPECTOR'S SIGNATURE:</b>

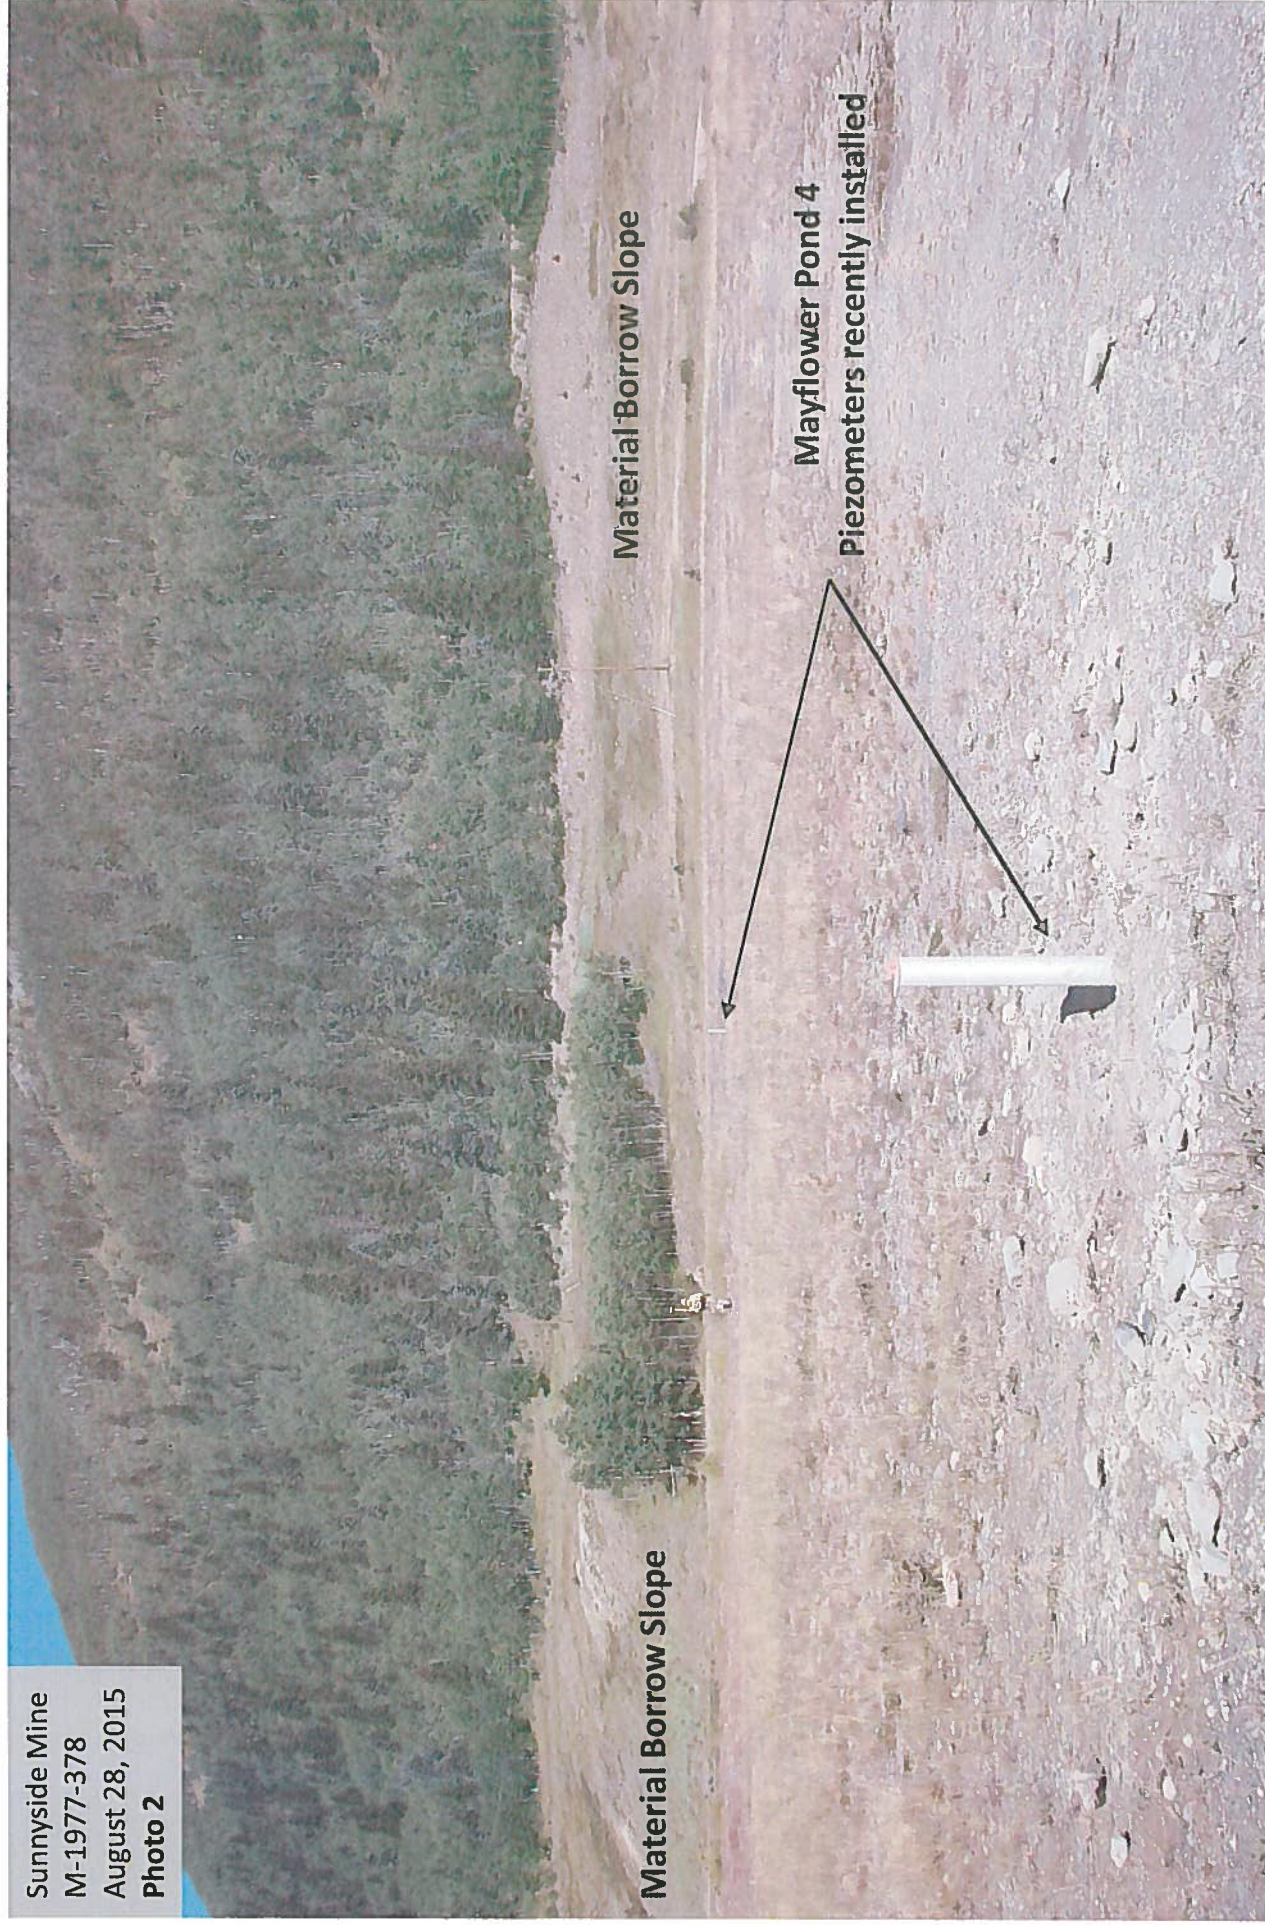
Sunnyside Mine  
M-1977-378  
August 28, 2015  
**Photo 2**

View northwest, taken from the central portion of the Mayflower Tailings Pond #4. During the time of this inspection, 12 piezometers were being installed at Mayflower Tailing Pond #4. The Operator indicated the piezometers were completed through the tailings and underlying alluvium, to the bedrock contact. The wells were installed by Cascade Drilling, QA/QC provided by Formation Environmental, and surveyed by Monadnock Mineral Services. Preliminary results indicate groundwater was encountered in the alluvium underlying the tailings.

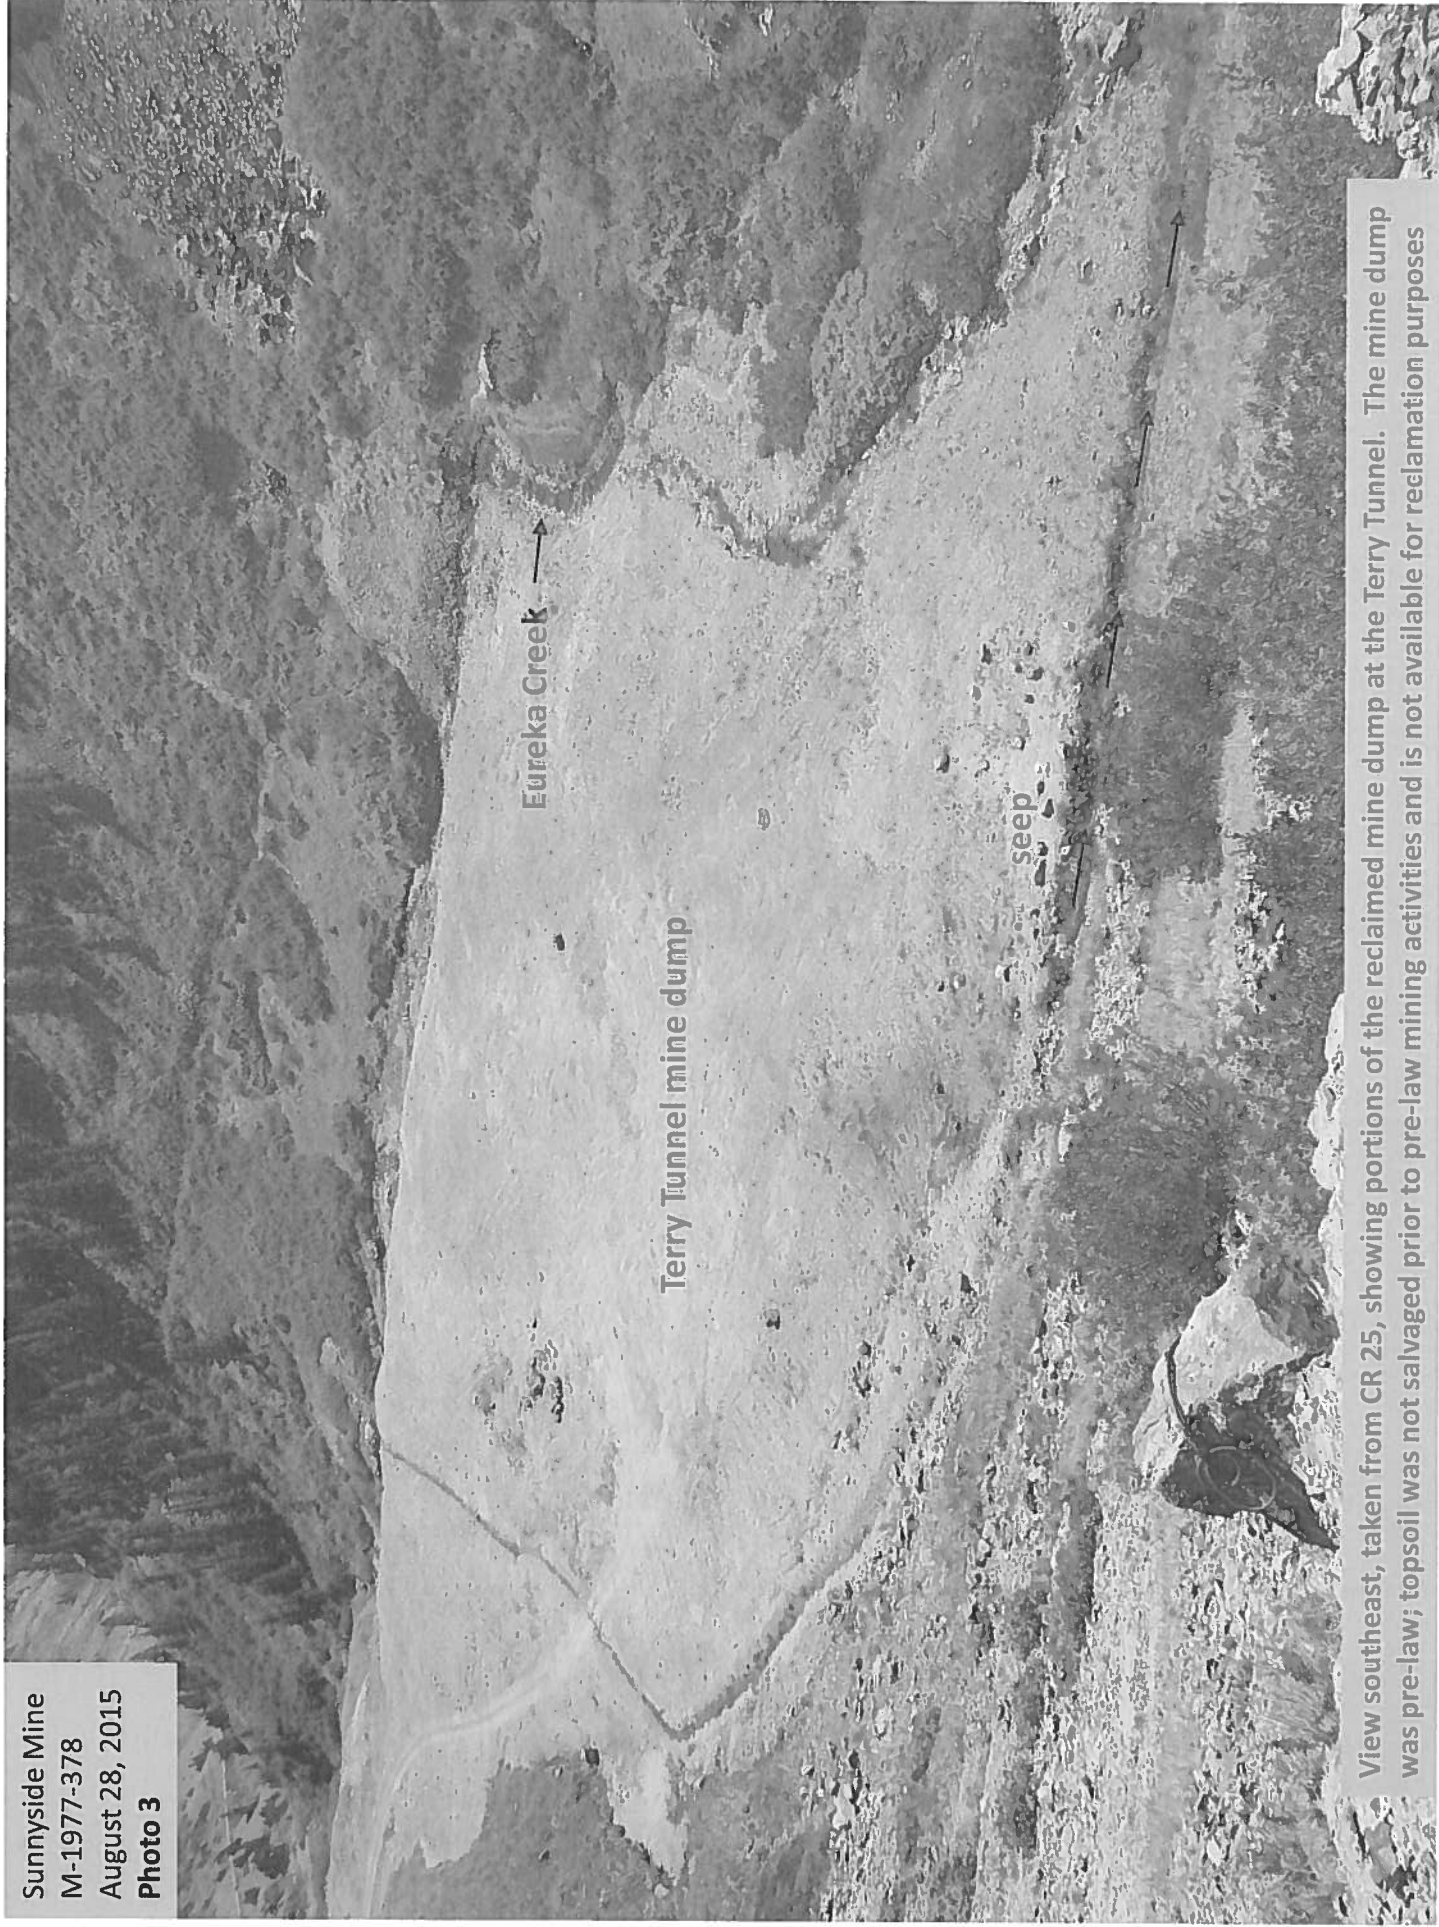
Sunnyside Mine  
M-1977-378  
August 28, 2015  
Photo 3

Reclaimed lands appeared stable and well maintained. As shown in Photo 3, vegetative cover is establishing. Previous occurrence of regulated noxious weeds have been eradicated. The trend towards the establishment of an appropriate vegetative cover appears positive.

View southeast, taken from CR 25, showing portions of the reclaimed mine dump at the Terry Tunnel. The mine dump was pre-law; topsoil was not salvaged prior to pre-law mining activities and is not available for reclamation purposes

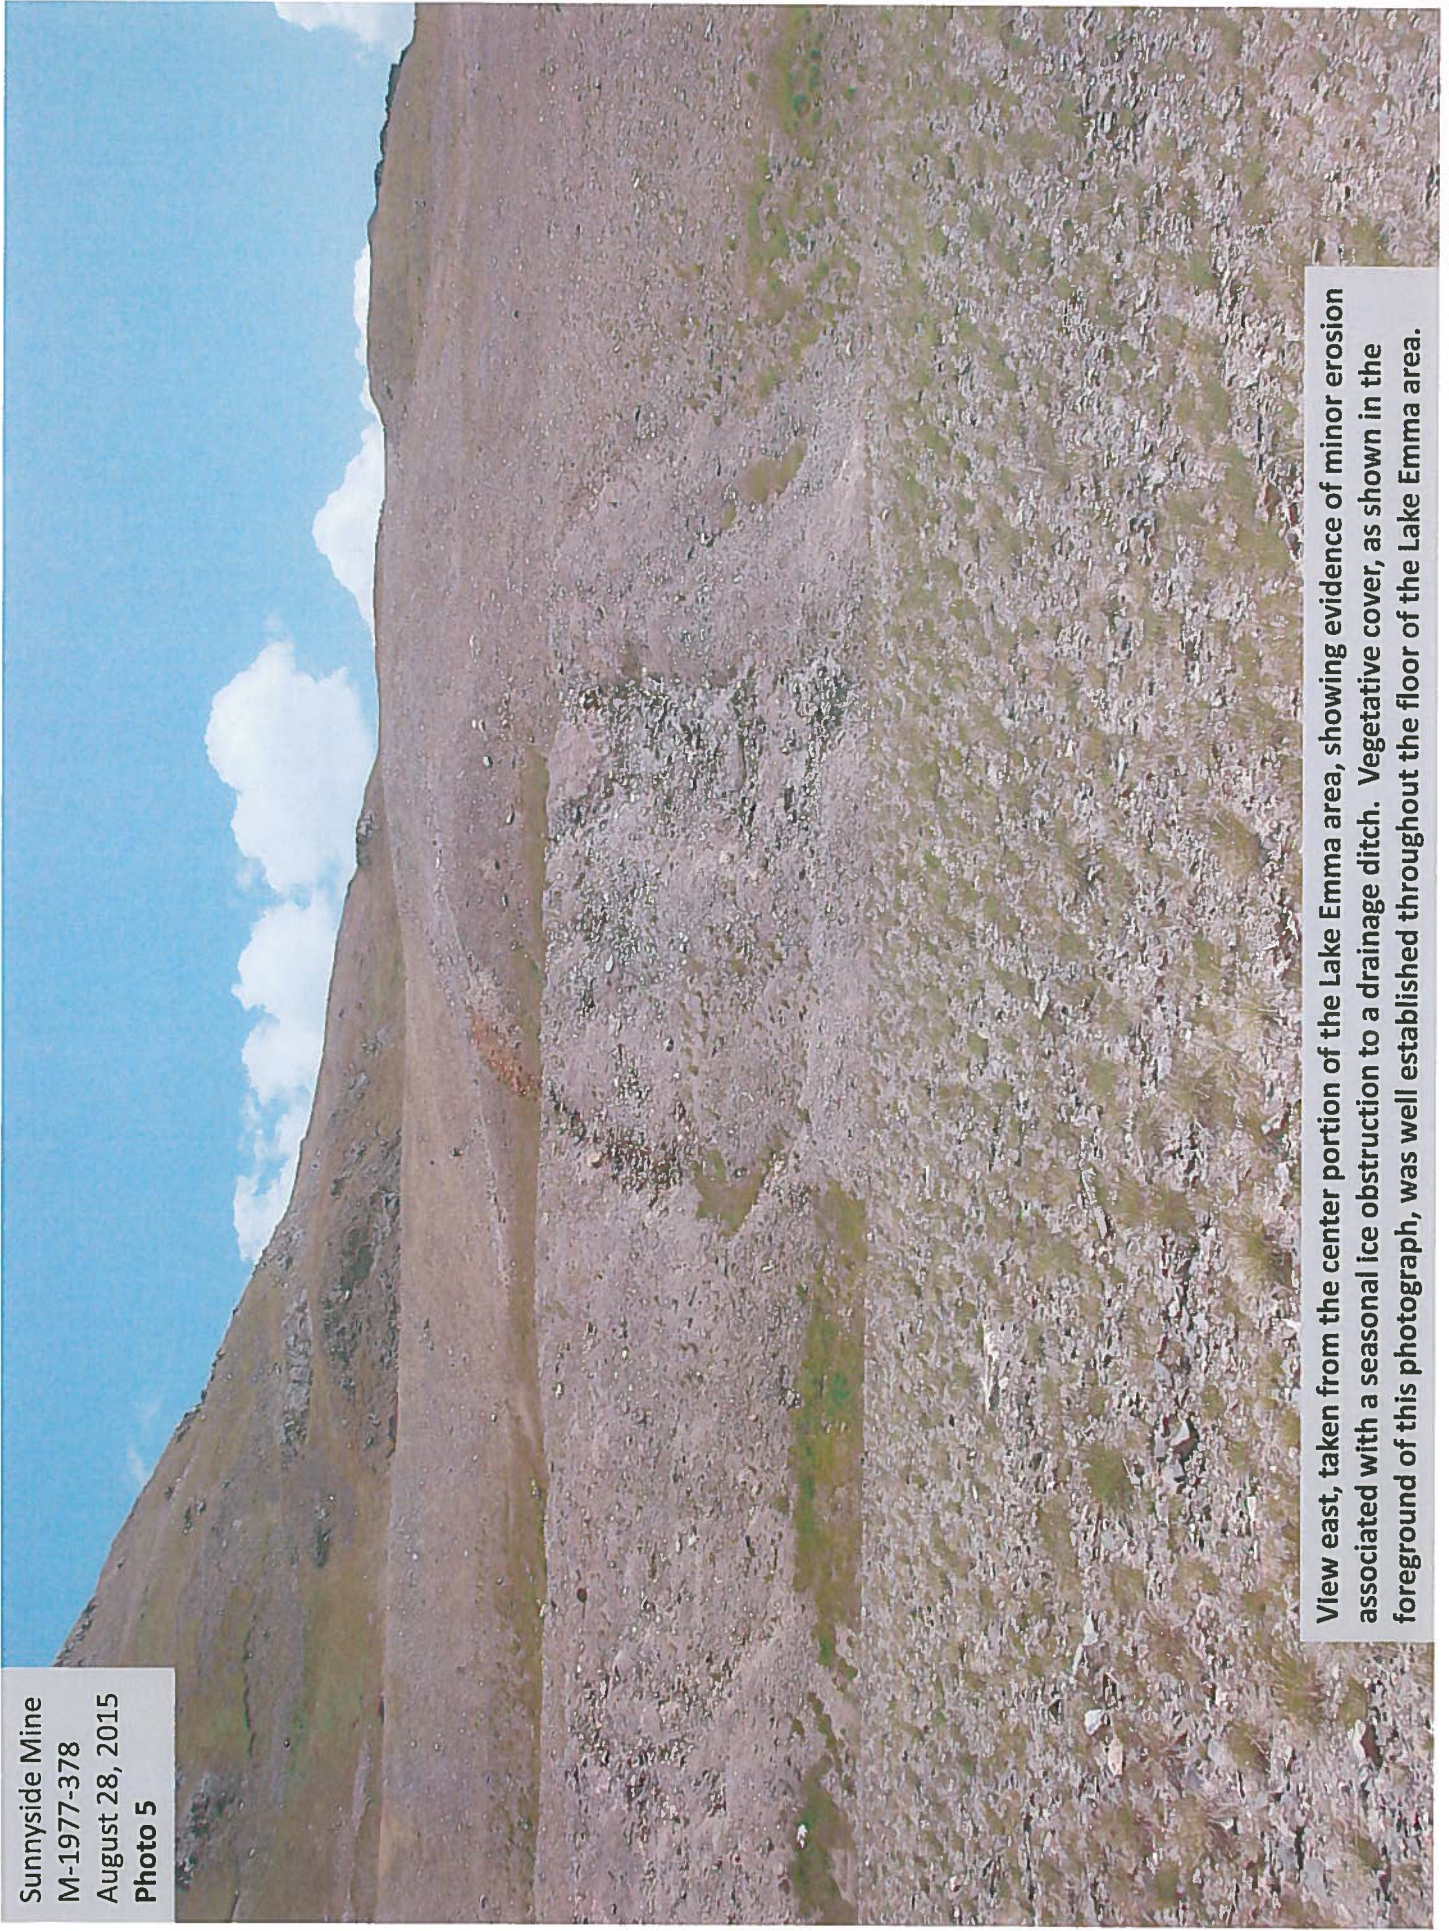
Sunnyside Mine  
M-1977-378  
August 28, 2015  
**Photo 5**

View east, taken from the center portion of the Lake Emma area, showing evidence of minor erosion associated with a seasonal ice obstruction to a drainage ditch. Vegetative cover, as shown in the foreground of this photograph, was well established throughout the floor of the Lake Emma area.

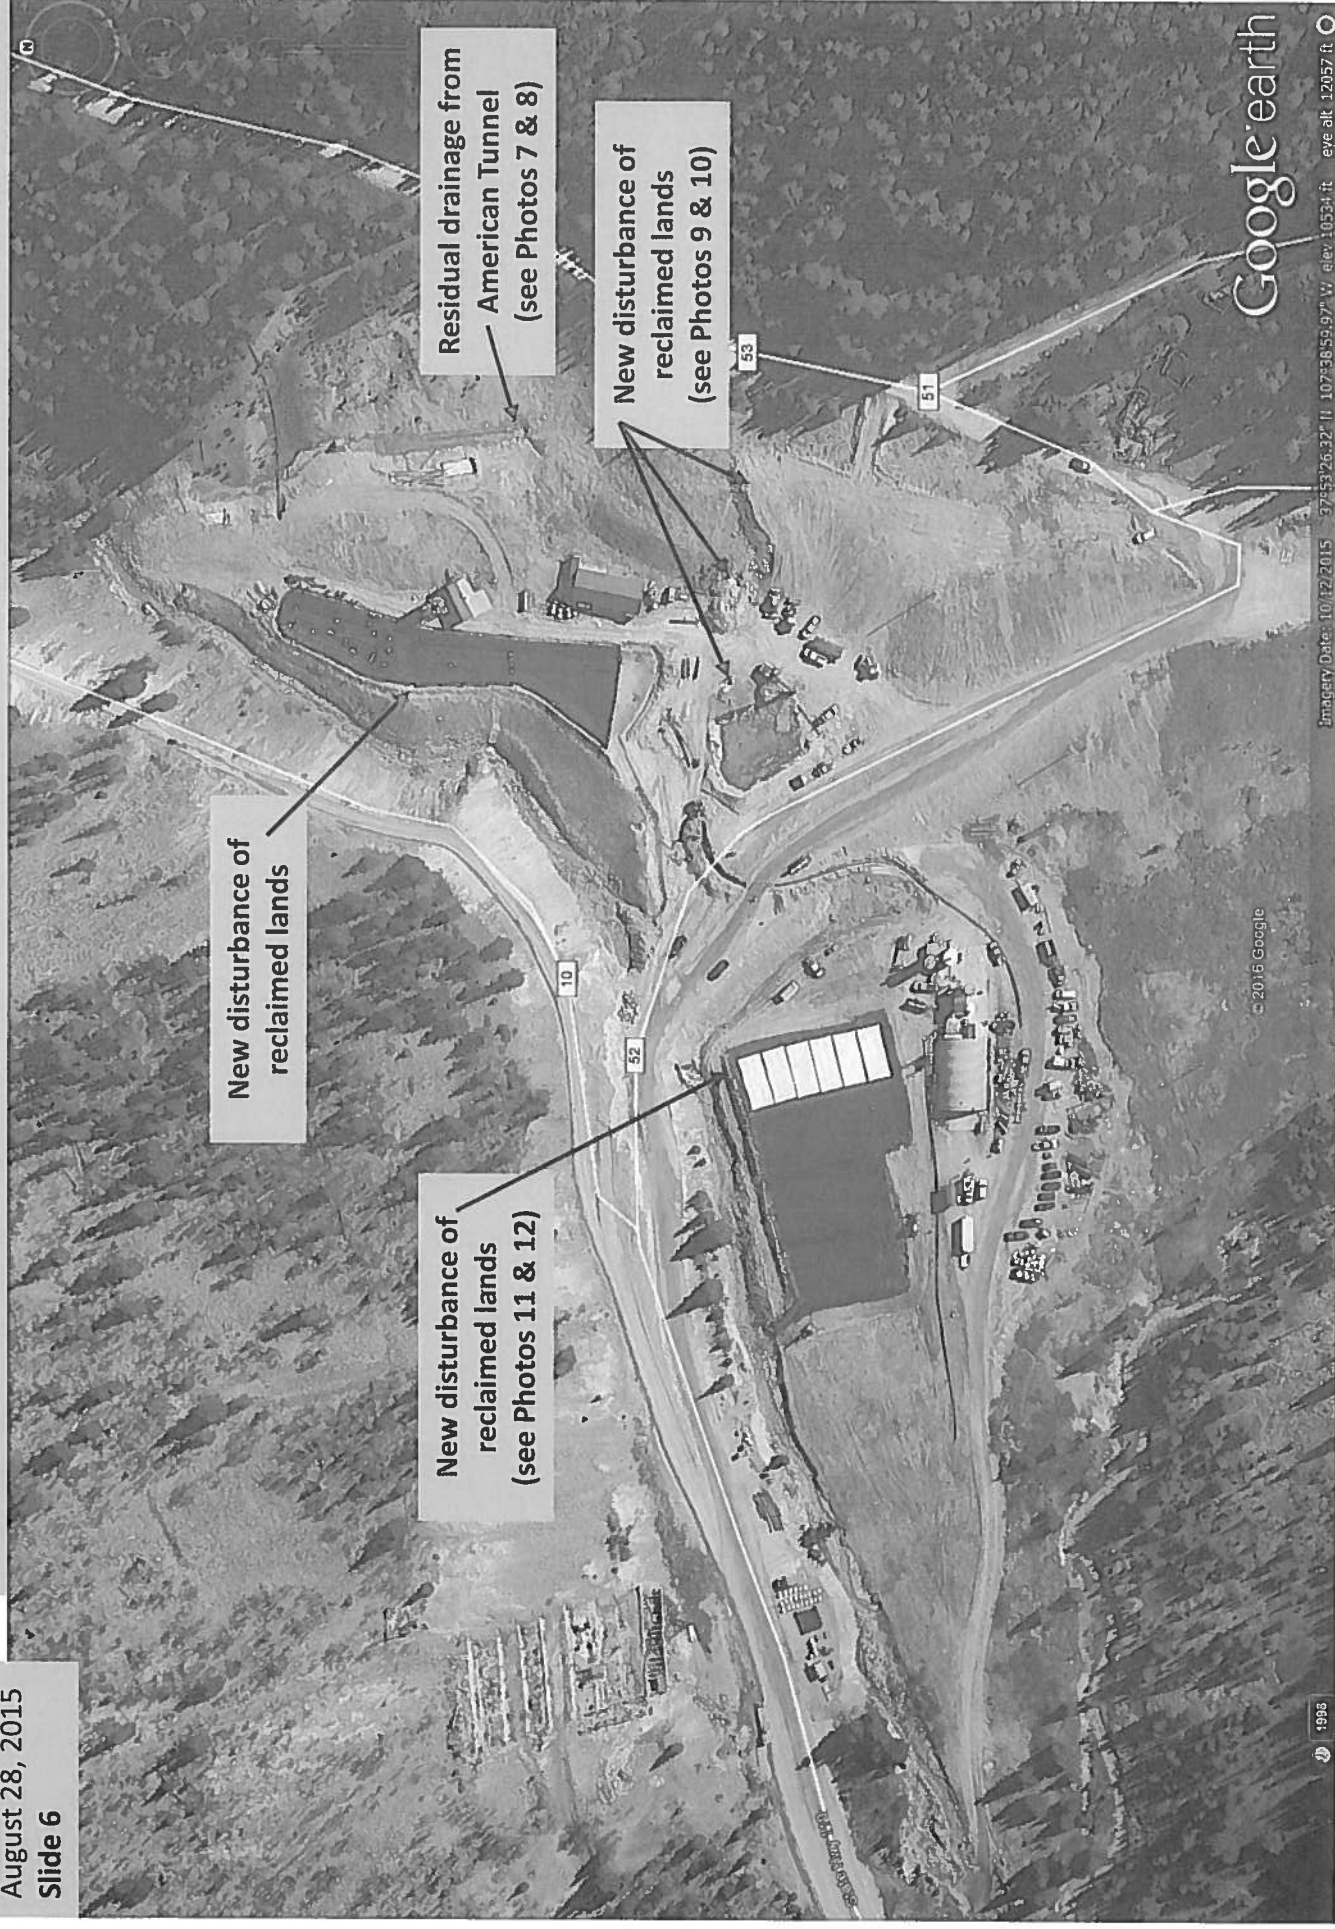
Google Earth image date October 12, 2015, showing recent alterations to the reclaimed lands at Gladstone. Some of the alterations shown on this Google Earth image occurred after the August 28, 2015 inspection.

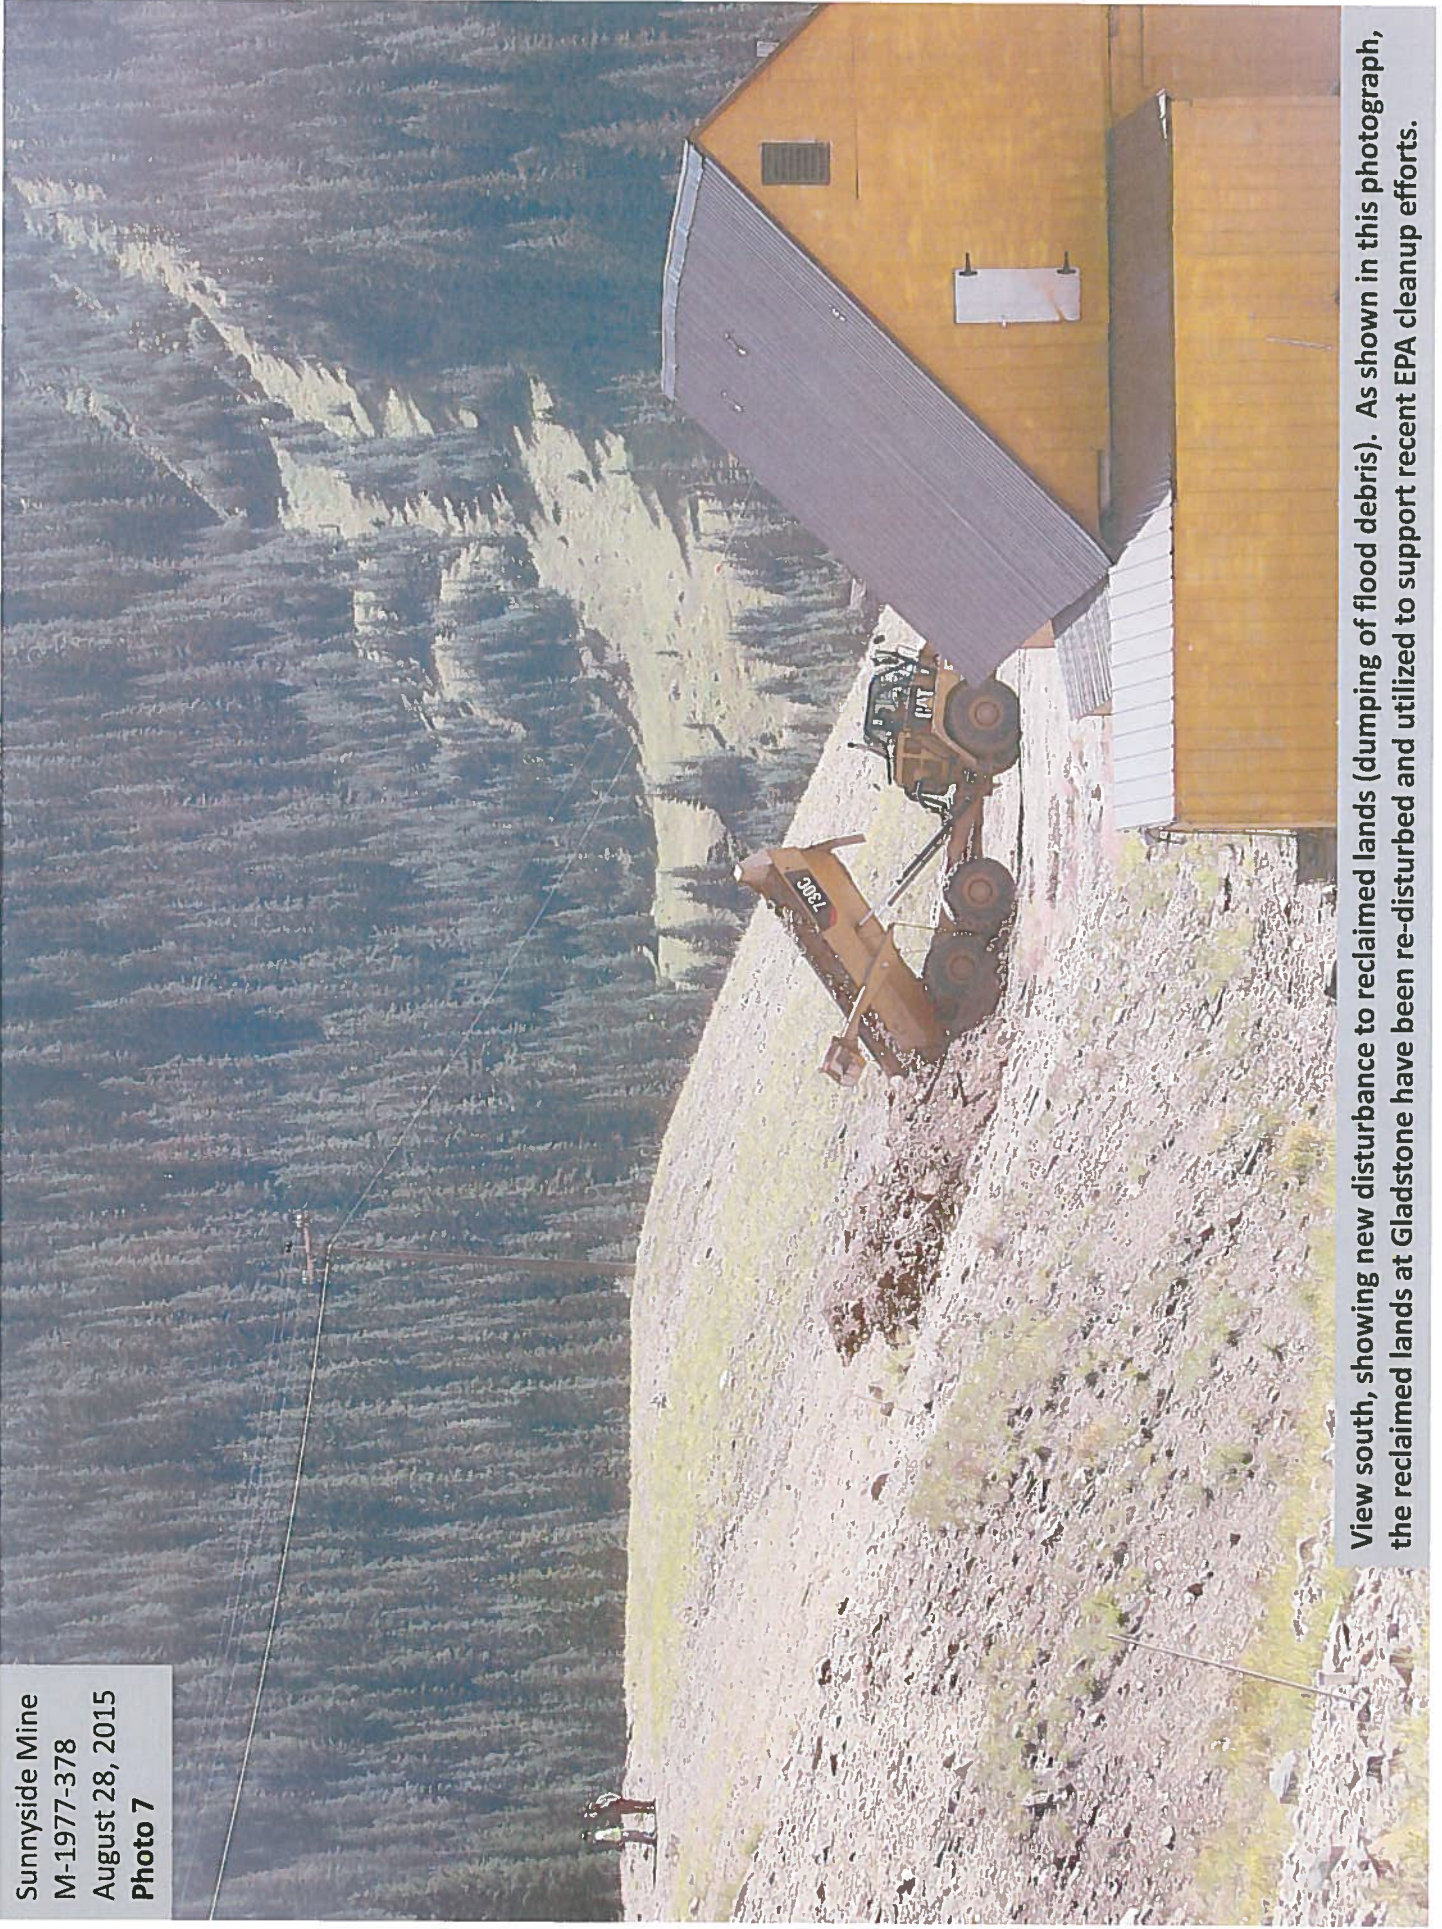
Sunnyside Mine  
M-1977-378  
August 28, 2015  
**Photo 7**

View south, showing new disturbance to reclaimed lands (dumping of flood debris). As shown in this photograph, the reclaimed lands at Gladstone have been re-disturbed and utilized to support recent EPA cleanup efforts.

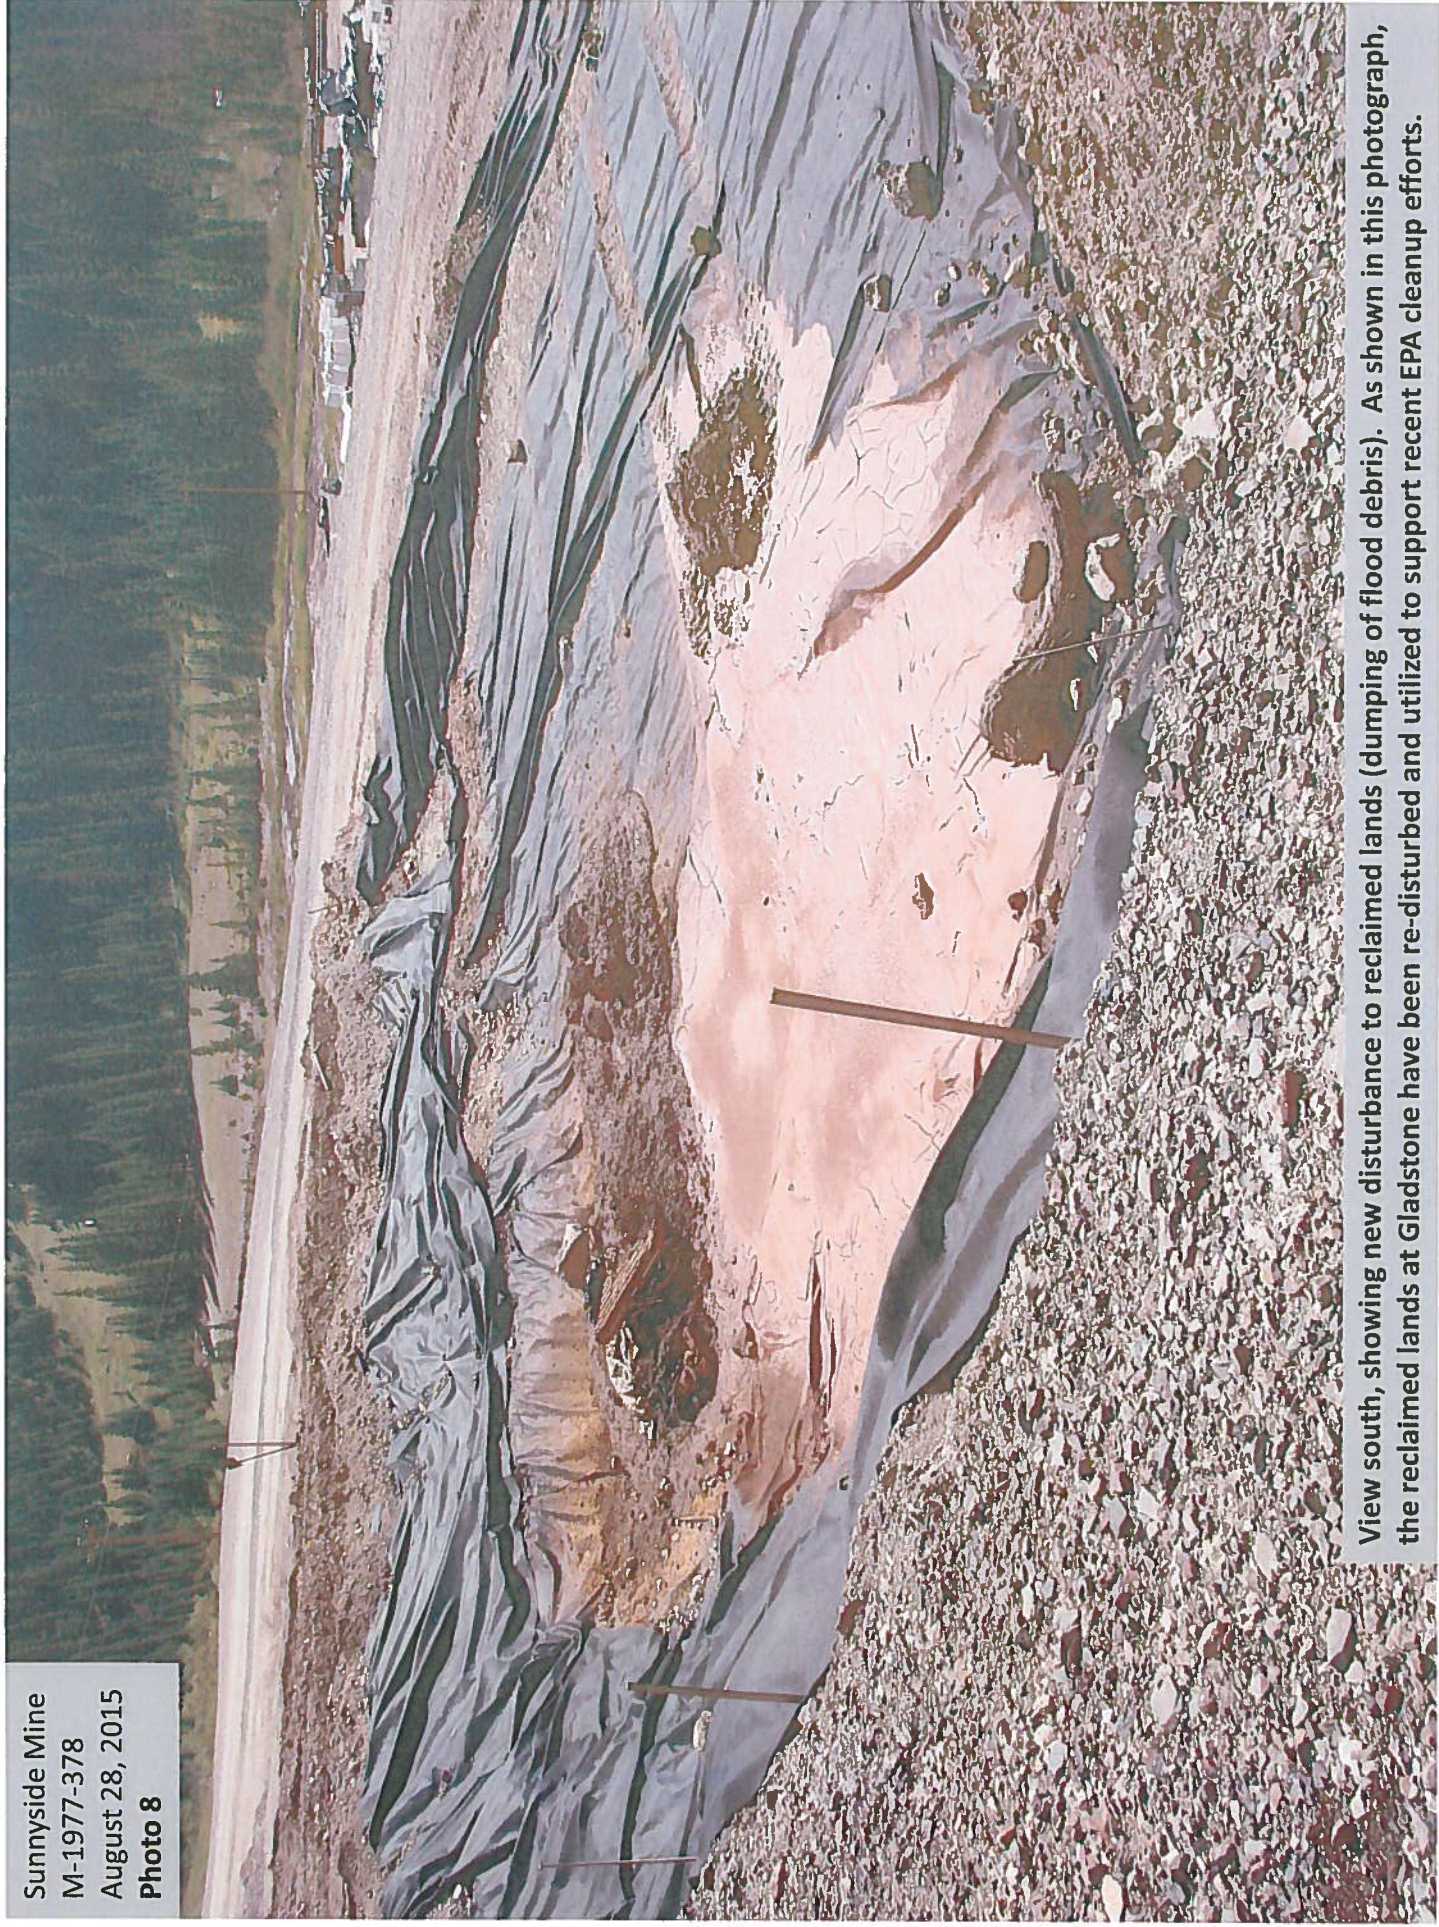
Sunnyside Mine  
M-1977-378  
August 28, 2015  
**Photo 8**

View south, showing new disturbance to reclaimed lands (dumping of flood debris). As shown in this photograph, the reclaimed lands at Gladstone have been re-disturbed and utilized to support recent EPA cleanup efforts.

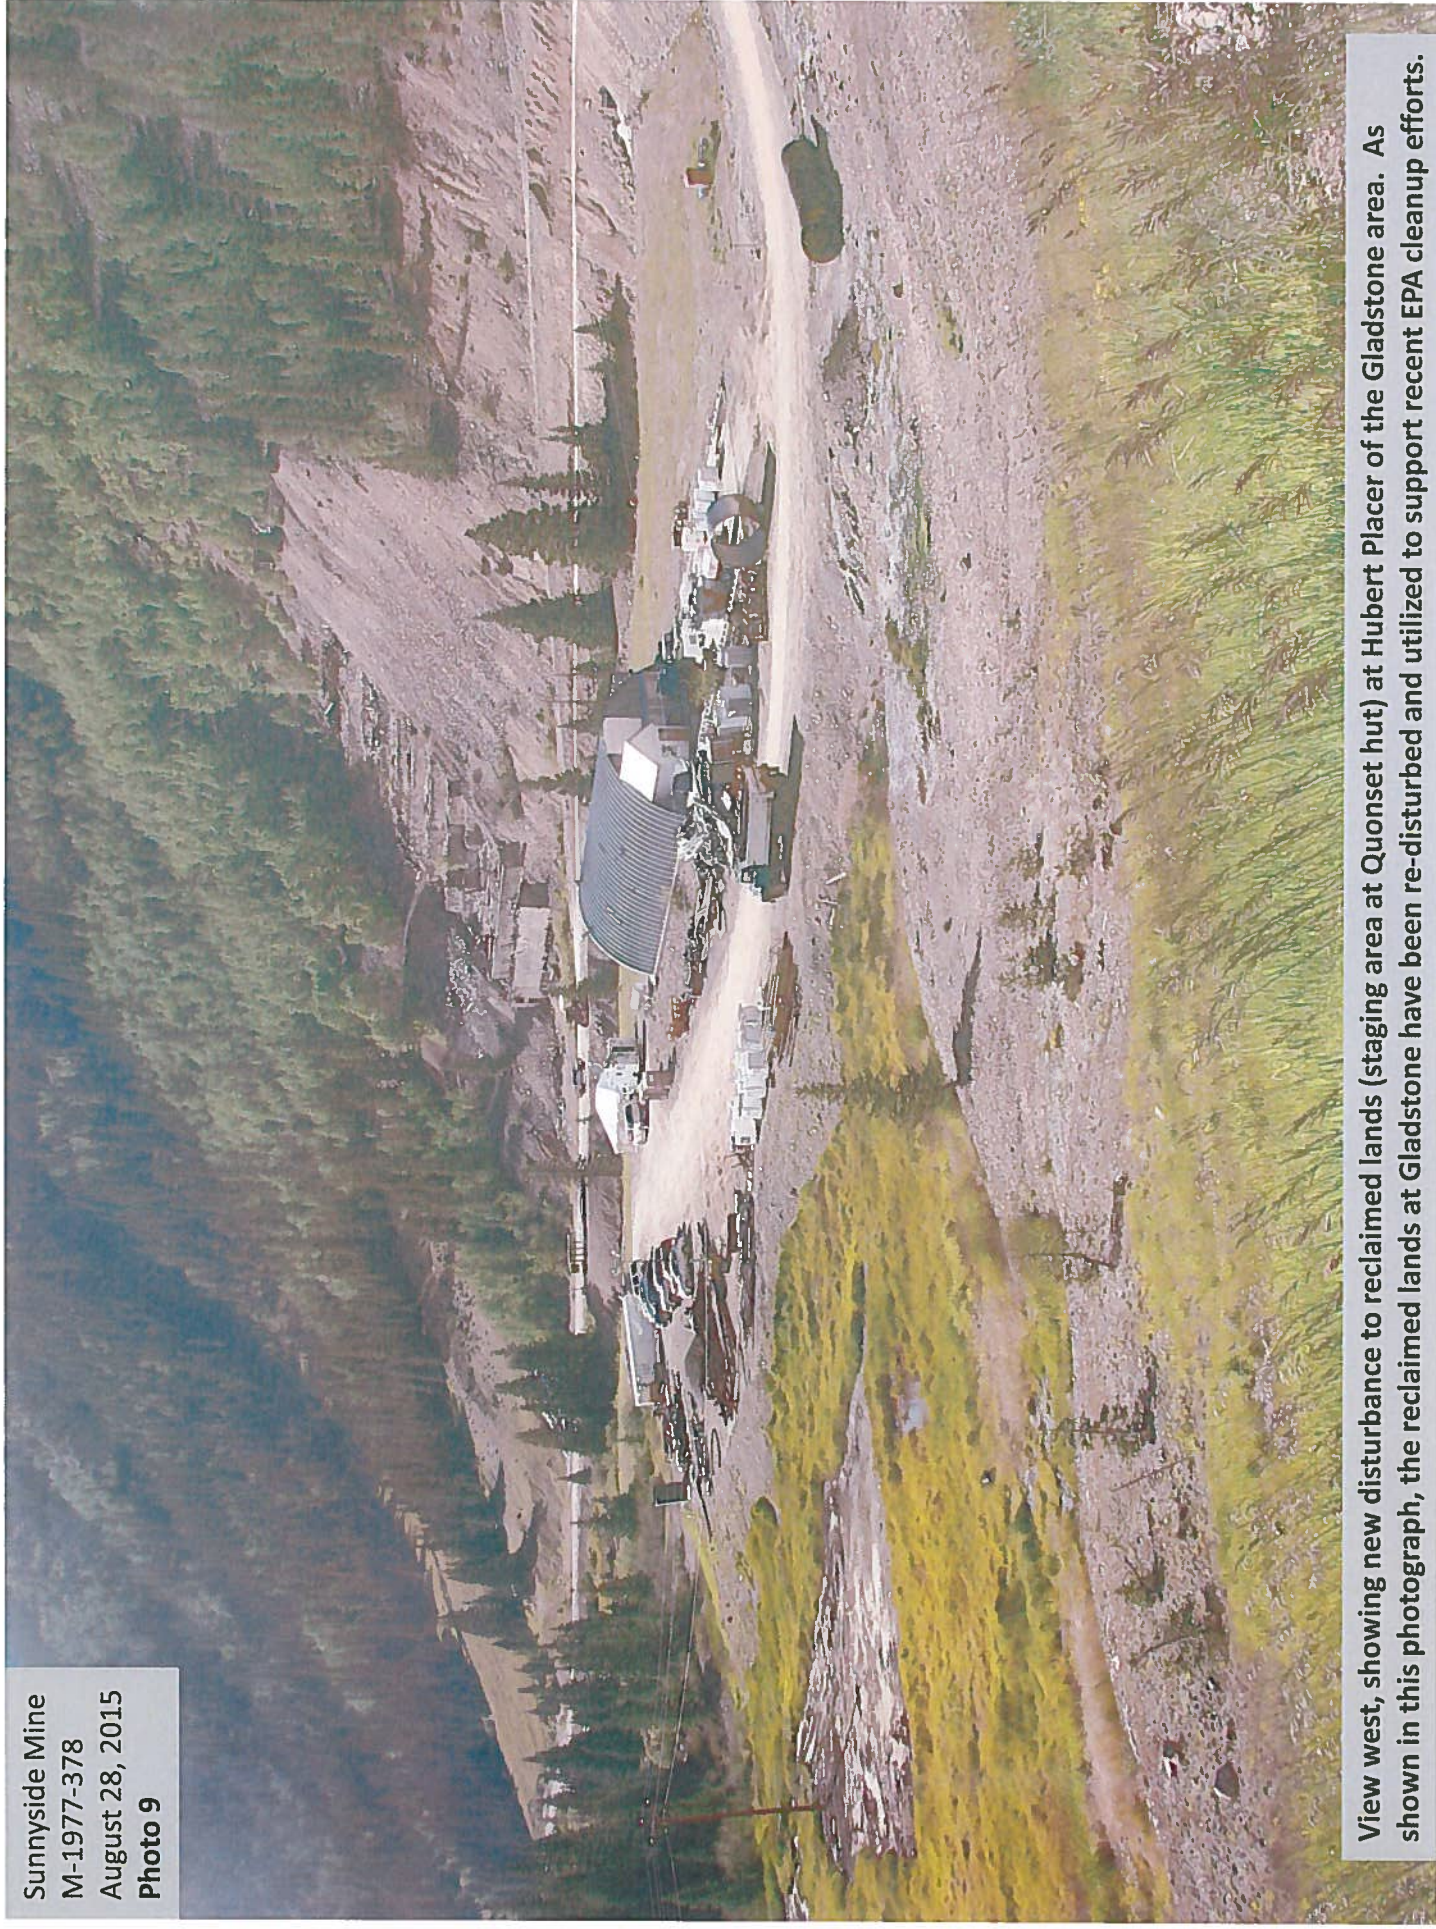
Sunnyside Mine  
M-1977-378  
August 28, 2015  
Photo 9

View west, showing new disturbance to reclaimed lands (staging area at Quonset hut) at Hubert Placer of the Gladstone area. As shown in this photograph, the reclaimed lands at Gladstone have been re-disturbed and utilized to support recent EPA cleanup efforts.

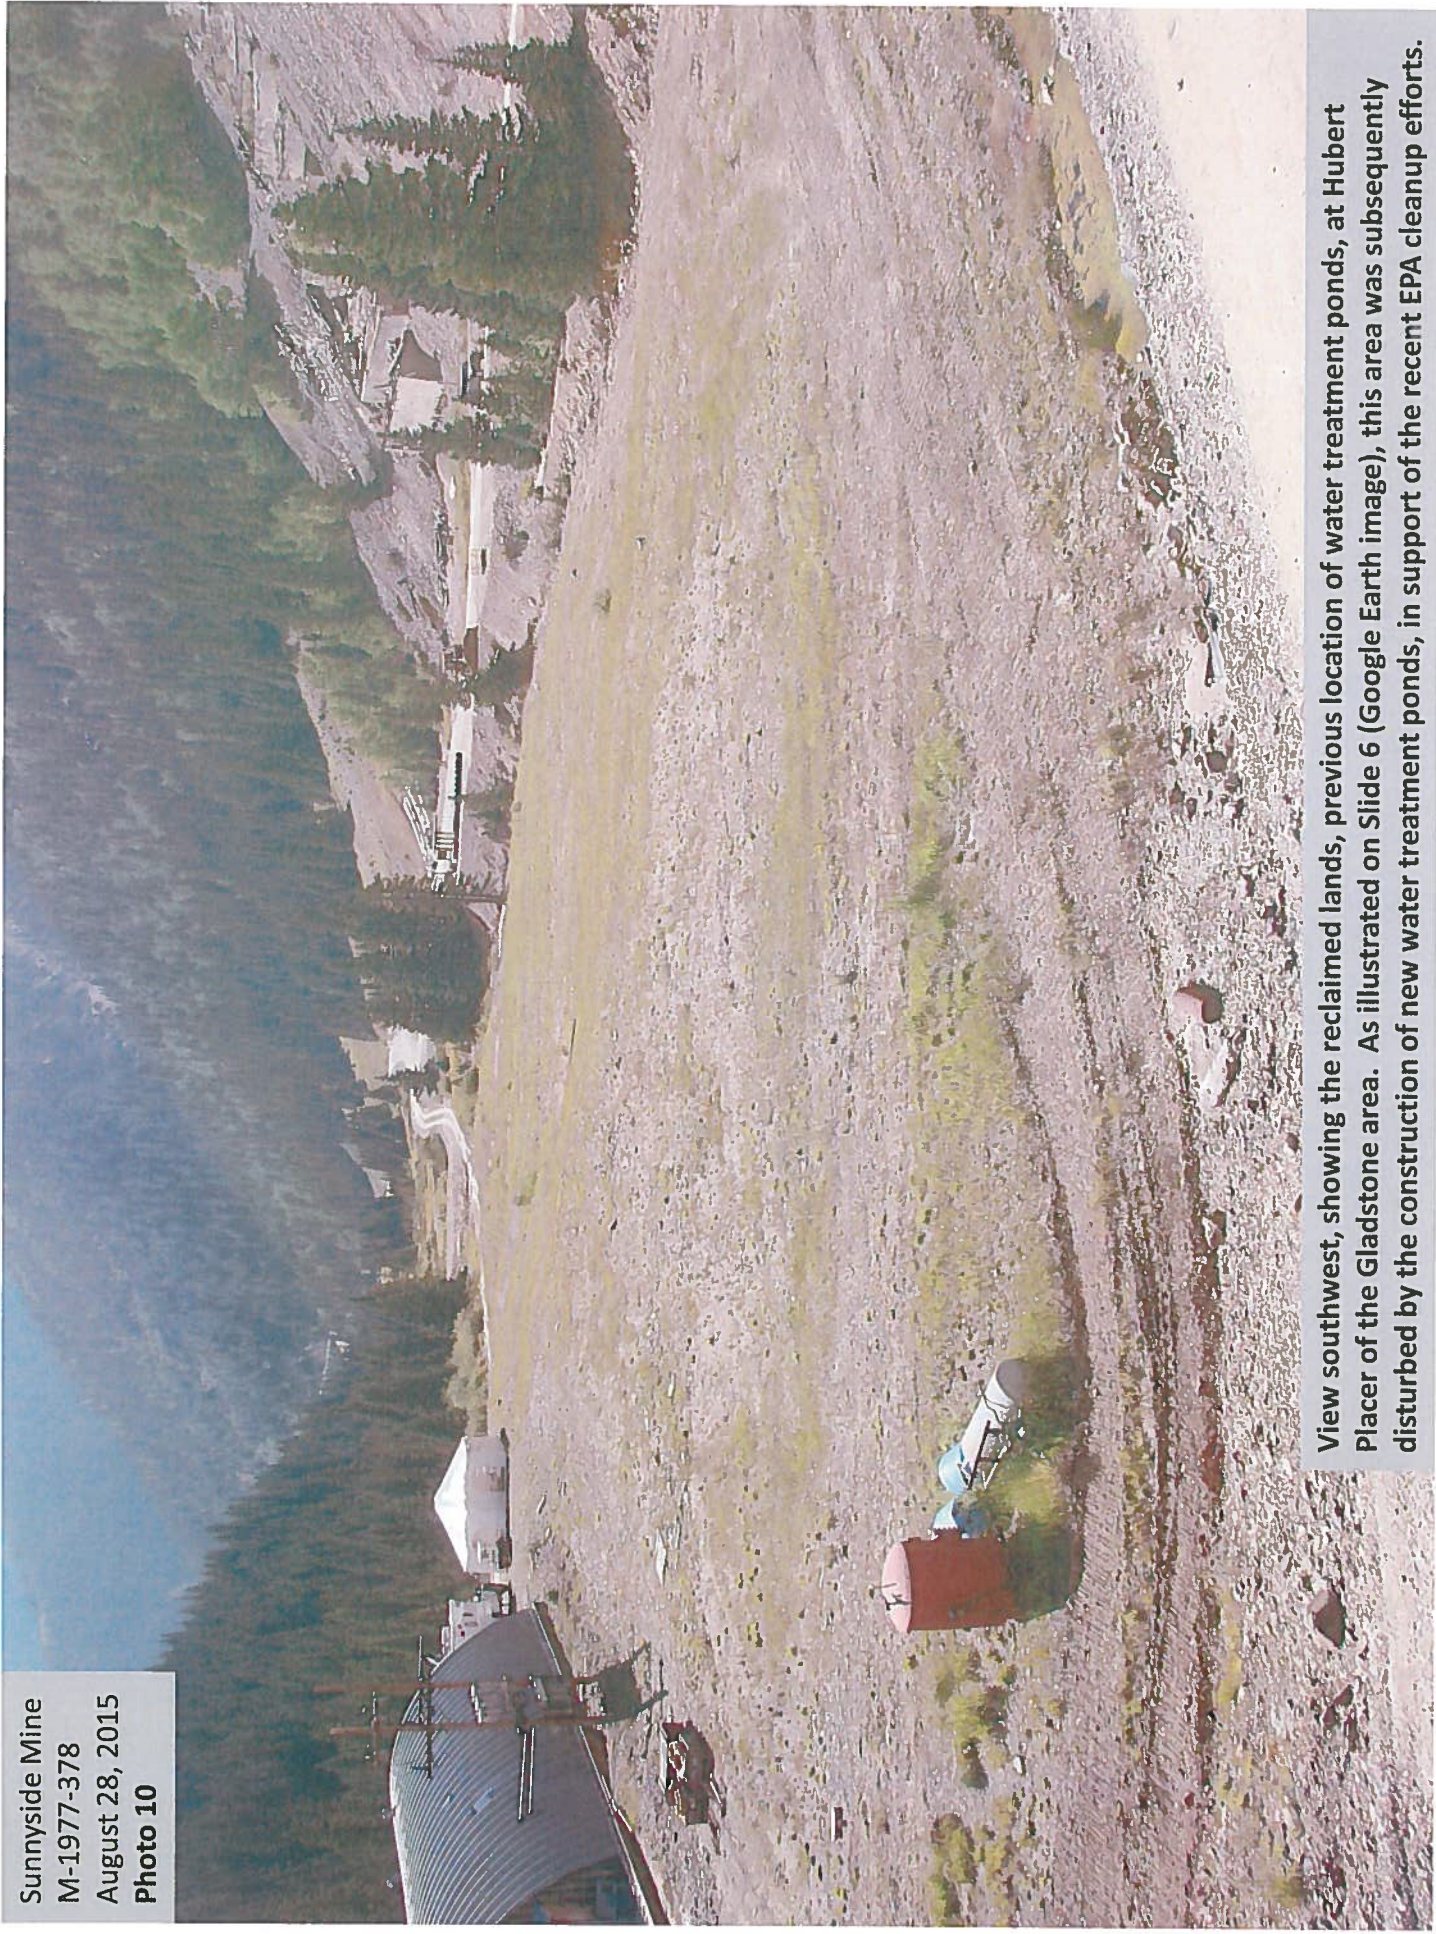
Sunnyside Mine  
M-1977-378  
August 28, 2015  
**Photo 10**

View southwest, showing the reclaimed lands, previous location of water treatment ponds, at Hubert Placer of the Gladstone area. As illustrated on Slide 6 (Google Earth image), this area was subsequently disturbed by the construction of new water treatment ponds, in support of the recent EPA cleanup efforts.
