COLORADO DIVISION OF RECLAMATION, MINING AND SAFETY
MINERALS PROGRAM INSPECTION REPORT
PHONE: (303) 866-3567

MINE NAME: Longmont Distel Operations	MINE/PROSPECTING ID#: M-1989-029	MINERAL: Sand and gravel	COUNTY: Weld
INSPECTION TYPE: Monitoring	INSPECTOR(S): Peter S. Hays	INSP. DATE: February 16, 2016	INSP. TIME: 09:00
OPERATOR: Aggregate Industries - WCR, Inc.	OPERATOR REPRESENTATIVE: Connie Davis, Mike Refer	TYPE OF OPERATION: 112c - Construction Regular Operation

Longmont Distil Operations
M-1989-029
February 16, 2016

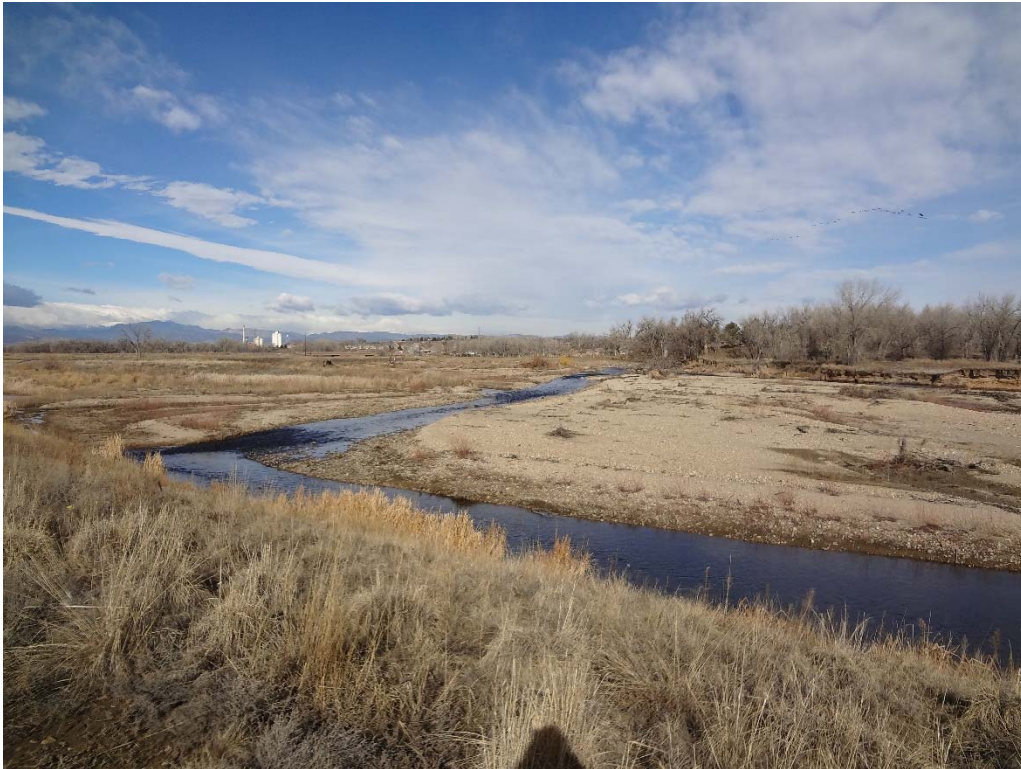
Five areas of the flood damaged site were observed during the inspection. The Breach No. 1 area was observed from the Peschel driveway. The creek has migrated approximately one thousand feet south of the historic channel, consisted of multiple braids and vertical cut banks were observed in the new stream bed. The north portion of the driveway had been temporarily backfilled to protect the structure. Additional backfilling and grading is proposed as part of the proposed Minor Stabilization approach. The City stated the south braid of the St. Vrain River along the north Peschel property boundary would be moved to the north to protect the property in the future. The FEMA funds acquired for the site cannot be used for this propose since the funds cannot be used on private property. The eagle nest northeast of the Peschel residence would also be protected as part of the Minor Stabilization approach plan.

Looking NW at Breach No. 1 area from Peschel driveway

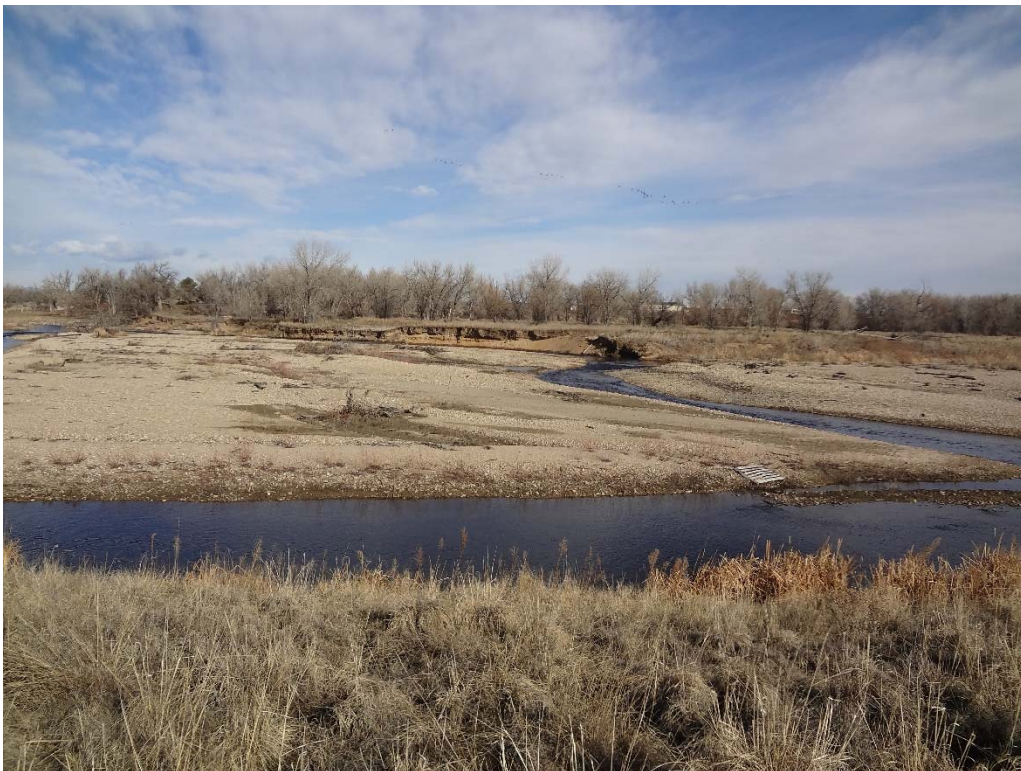
Looking north at Breach No. 1 area from Peschel driveway

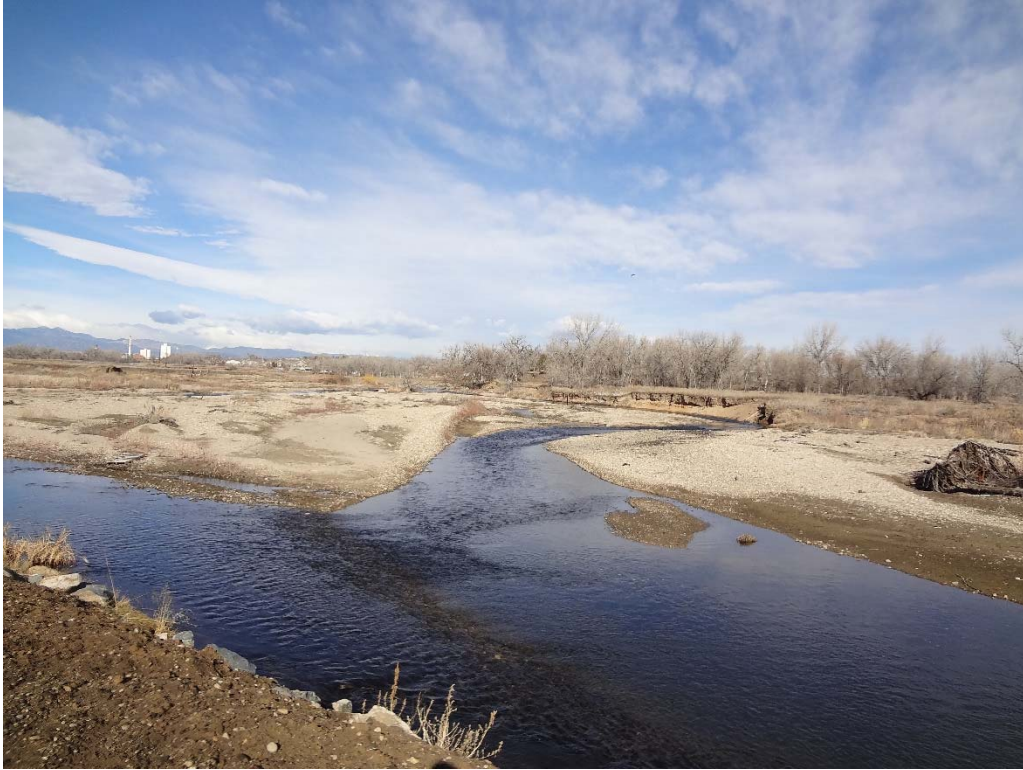
Looking NW at Breach No. 1 area from Peschel driveway

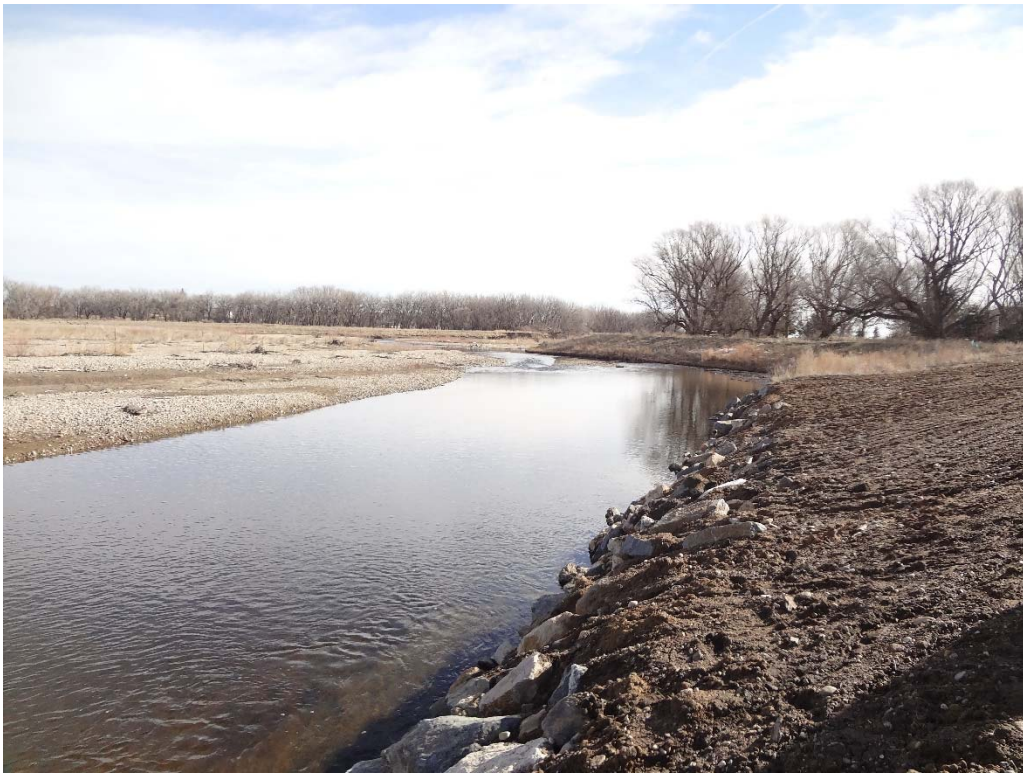
Looking east at Breach No. 1 area from Peschel driveway

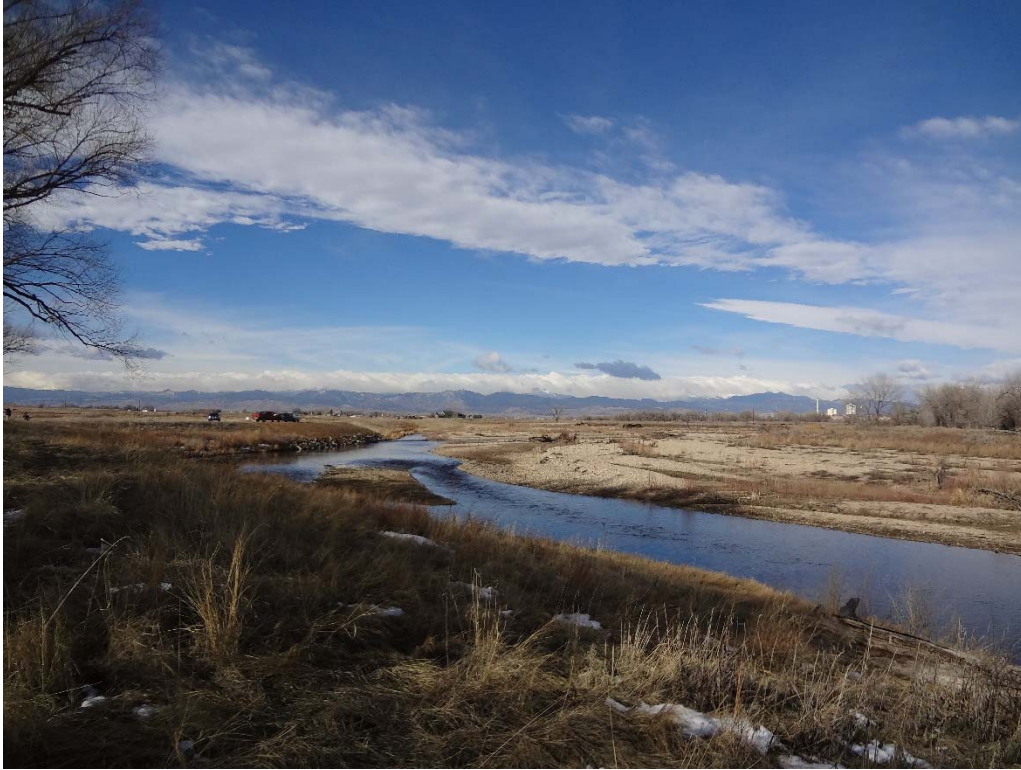
Looking west at Breach No. 1 area from south of Peschel house

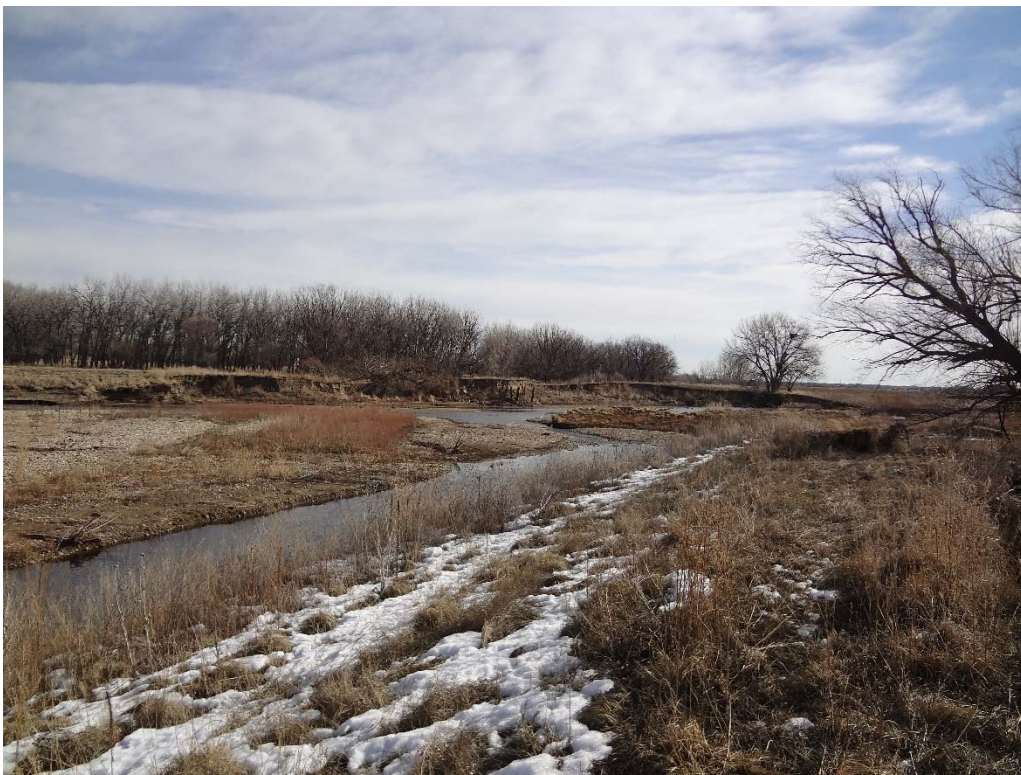
Looking NE at Breach No. 1 area from south of Peschel house

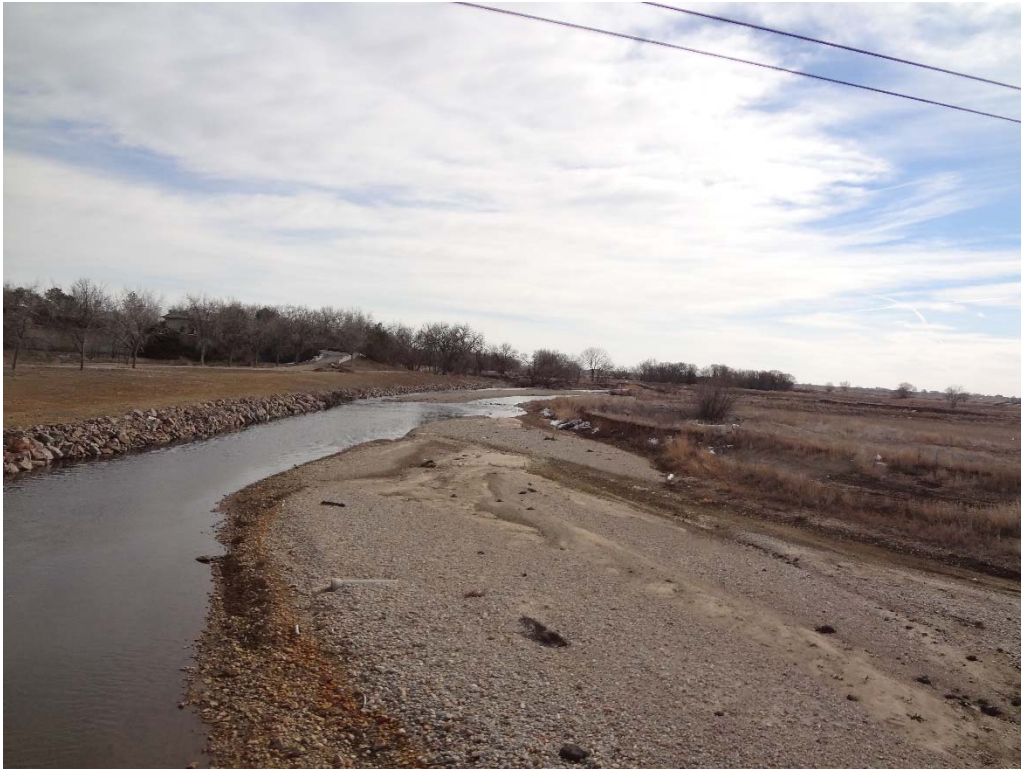
The St. Vrain Creek was observed from the bridge over the creek from Weld County Road 1. The first breach location and the dry historic channel and flood damage west of the site were observed.

Looking east from WCR No. 1 bridge

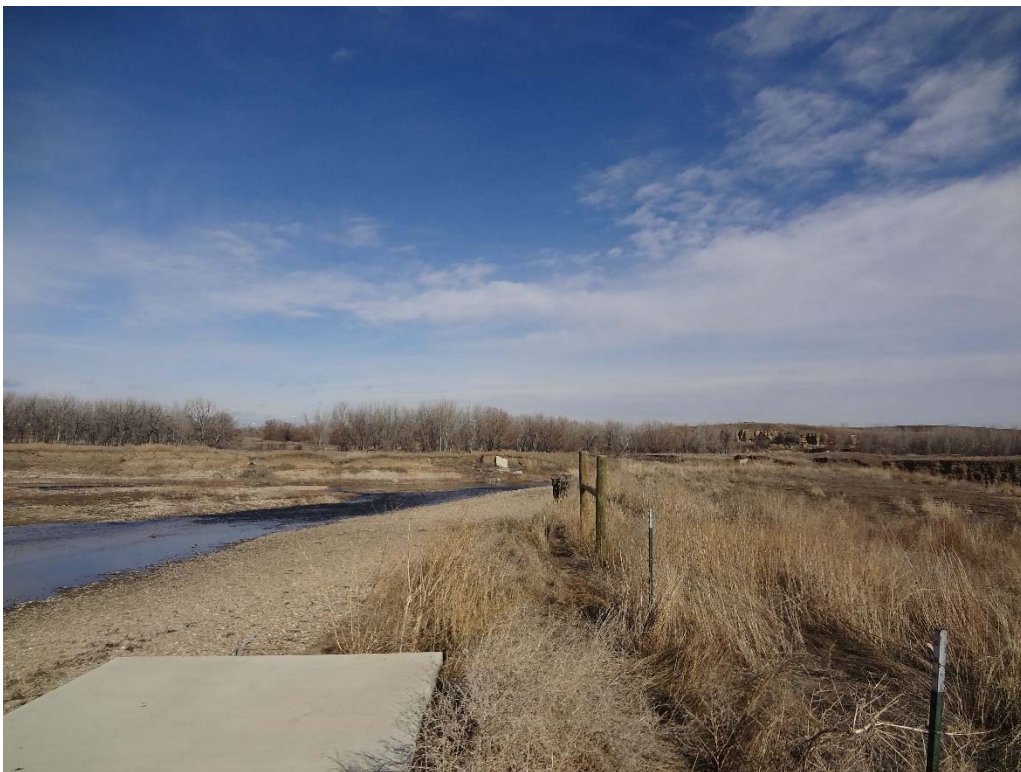
The No. 1 and No. 2 breach locations were observed from the end of the damaged St. Vrain Trail between the Sherwood and Bigelow properties. Sections of the St. Vrain trail were undermined and destroyed during the 2013 flood event. The pedestrian bridge over St. Vrain Creek in the Bigelow property was damaged during the flood. The remaining portions of the trail will be protected as part of the Minor Stabilization approach plan. A berm will be constructed in the Bigelow property east of the old trail alignment. A new trail and pedestrian bridge will be constructed over the new St. Vrain Creek channel.

Looking north at Breach No. 1 and 2 areas from end of damaged trail.

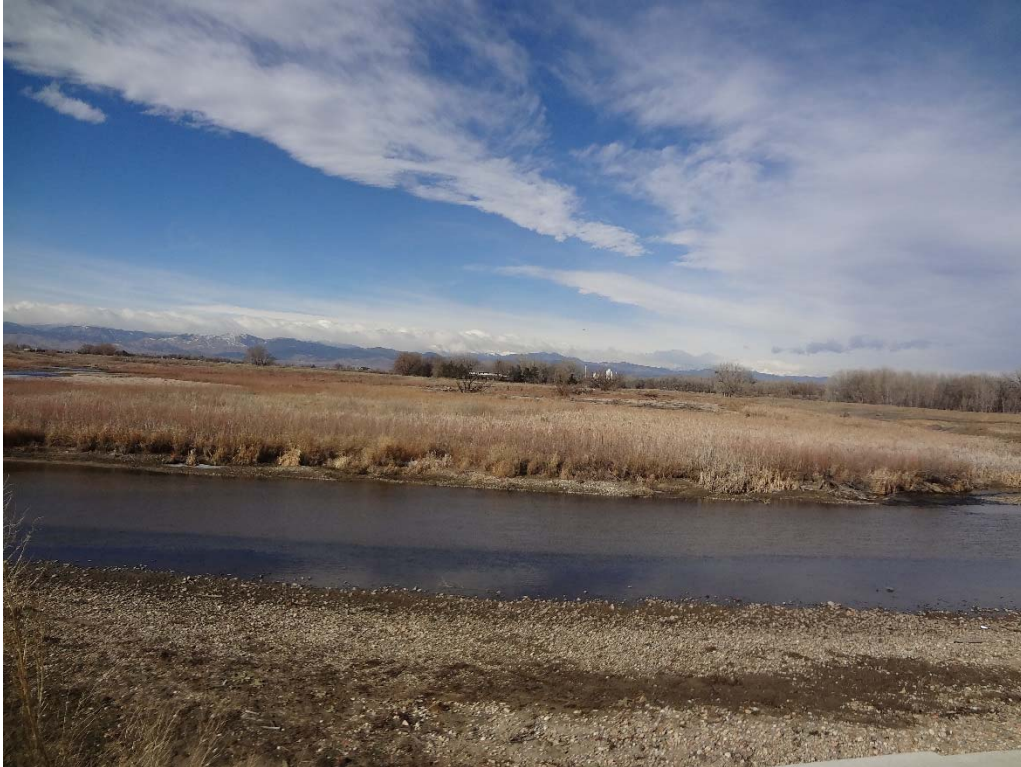
Looking west at Breach No. 1 and 2 areas from end of damaged trail.

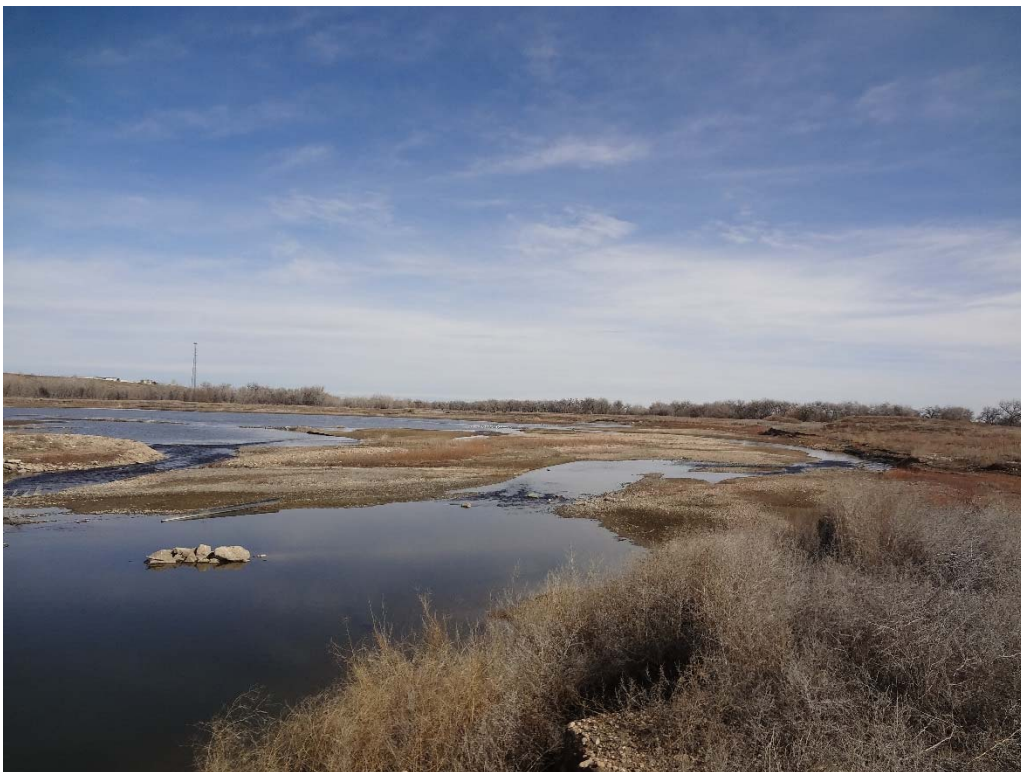
The northeast portion of the site was observed from the northeast corner of the Distel property. The flood event destroyed the access road to the oil and gas well located on the property. The new St. Vrain Creek channel is constricted in this area. The constricted channel will be protected as part of the Minor Stabilization approach plan. Vertical erosion cut banks were observed at this location. The flow of the creek from the Distel property towards the east, the confluence with South Boulder Creek and the second eagle nest on the site were observed from this location.

Looking NE from the NE corner of the Distel Property.

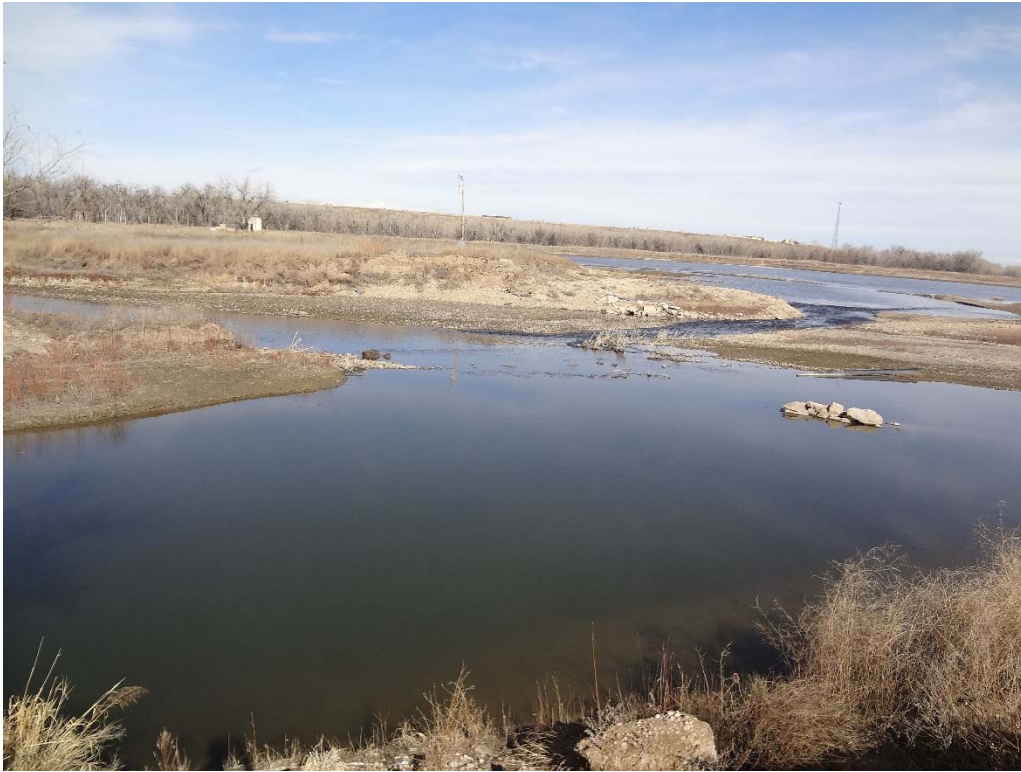
Looking north from the NE corner of the Distel Property.

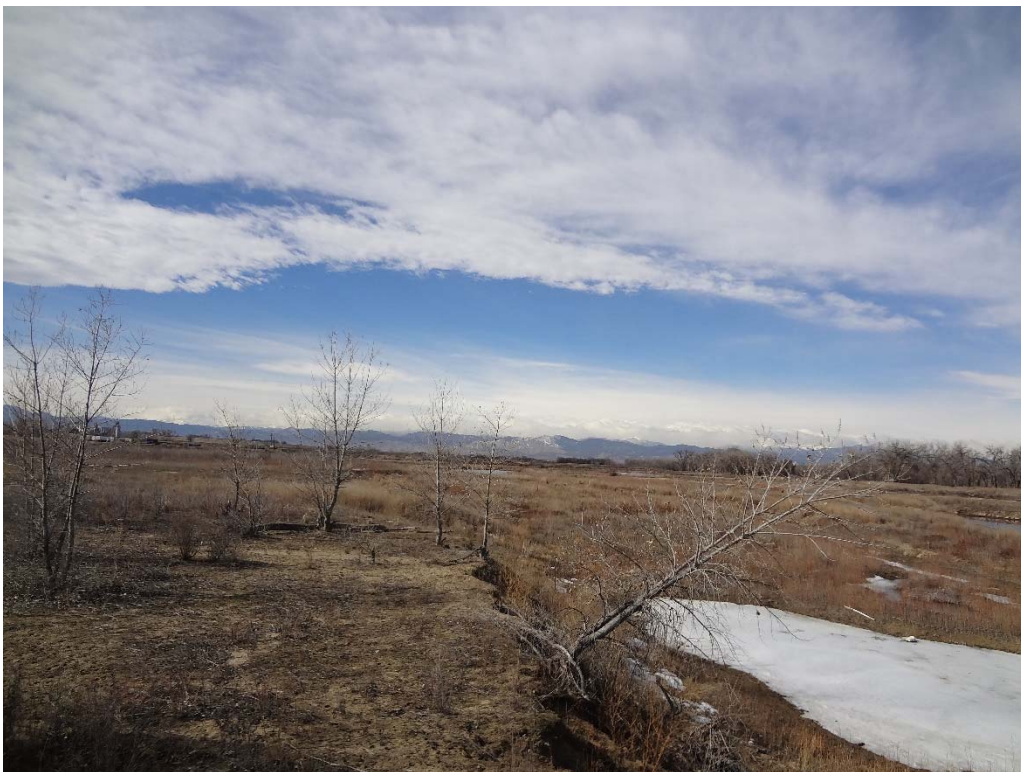
Looking east from the NE corner of the Distel Property.

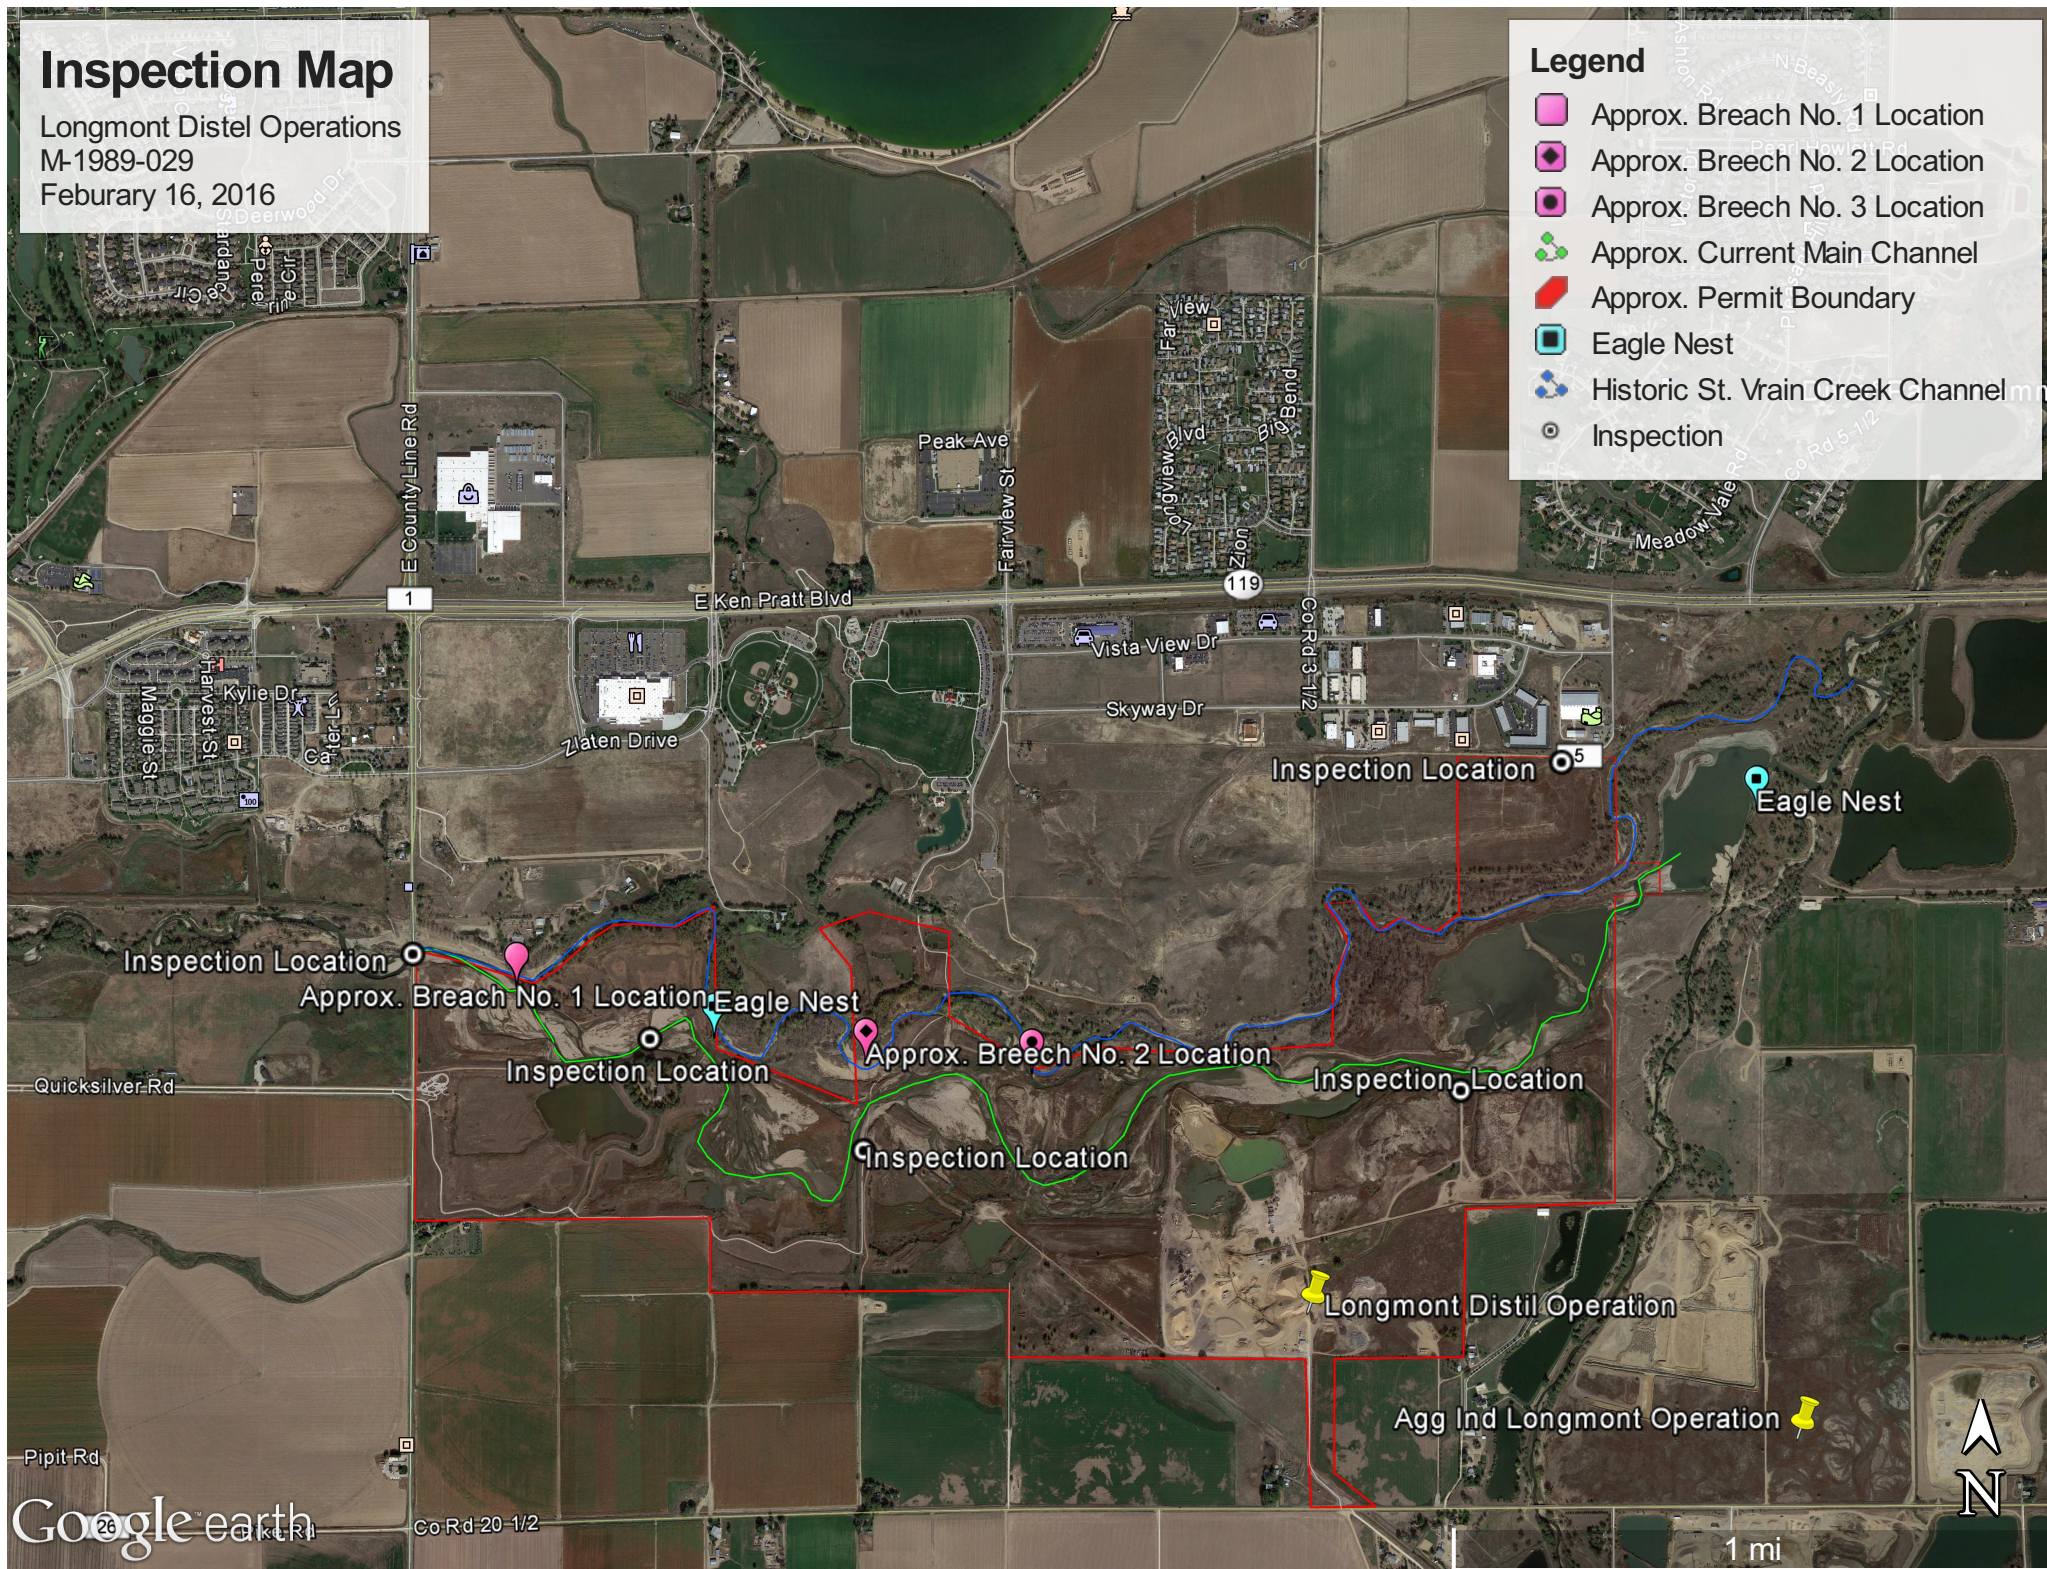
Inspection Map

The St. Vrain Creek breached the site in at least 3 locations and remains flowing through the Longmont Distel site. The approximate locations of the breaches are indicated on the attached inspection map. The Operator and the City of Longmont, the owner of a majority of the site, have stated the Army Corps of Engineers has determined the Creek should remain flowing through the site and the historic channel will be abandoned, except during high flow events when an estimated 100 CFS will flow in the historic channel. The site is incorporated into the City's open space master plan.
