COLORADO DIVISION OF RECLAMATION, MINING AND SAFETY
MINERALS PROGRAM INSPECTION REPORT
PHONE: (303) 866-3567

MINE NAME: Pit No 1	MINE/PROSPECTING ID#: M-1977-020	MINERAL: Sand and gravel	COUNTY: Delta
INSPECTION TYPE: Monitoring	INSPECTOR(S): Stephanie J. Mitchell	INSP. DATE: February 17, 2016	INSP. TIME: 11:00
OPERATOR: Keys Blue Haven LLC	OPERATOR REPRESENTATIVE: Bill St. James	TYPE OF OPERATION: 112c - Construction Regular Operation

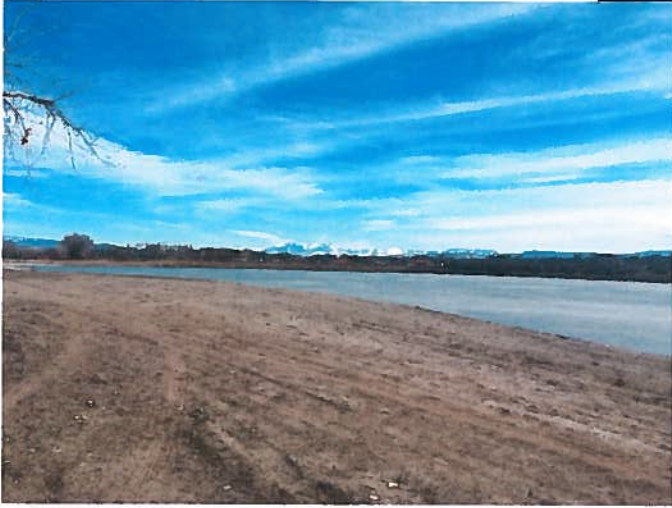
Mining has ceased at the site. The permitted area has 3 ponds impounding water. The Black pond slopes have been graded exceptionally well and have no invasive weed species. The Loughrey pond has little or no noxious weed species. The Pit No. 1 pond has been completely regraded to 4H:1V to 3H:1V slopes after all of the Tamarisk and Russian Olive trees were removed earlier in the Fall of 2015.

Pit No. 1 pond- Looking East

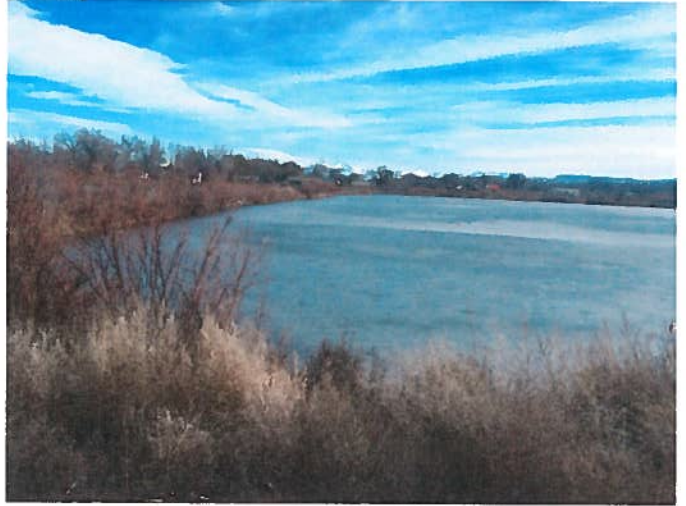
Lake Loughrey- Looking East

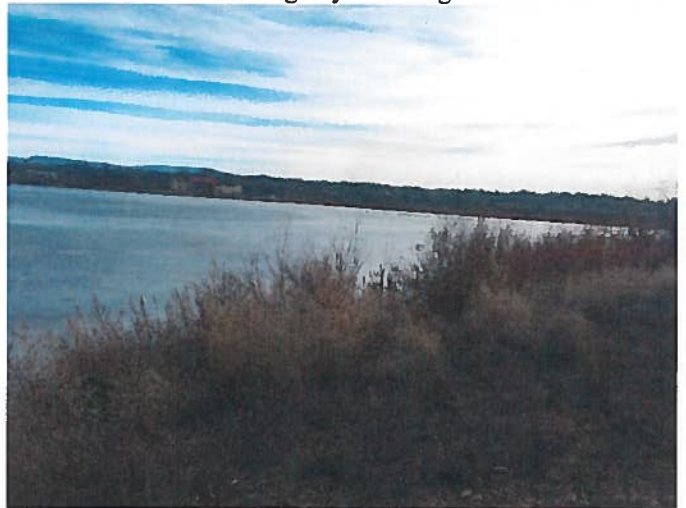
Black Lake- Looking SE
