COLORADO DIVISION OF RECLAMATION, MINING AND SAFETY
MINERALS PROGRAM INSPECTION REPORT
PHONE: (303) 866-3567

MINE NAME: Stone Gravel Pit	MINE/PROSPECTING ID#: M-1997-089	MINERAL: Sand and gravel	COUNTY: Montezuma
INSPECTION TYPE: Multi Person Inspection	INSPECTOR(S): Lucas J. West	INSP. DATE: March 2, 2016	INSP. TIME: 11:45
OPERATOR: Daren Stone	OPERATOR REPRESENTATIVE: Daren Stone	TYPE OF OPERATION: 112c - Construction Regular Operation	
REASON FOR INSPECTION: Normal I&E Program	BOND CALCULATION TYPE: None	BOND AMOUNT: \$17,232.00	
DATE OF COMPLAINT: NA	POST INSP. CONTACTS: None	JOINT INSP. AGENCY: U.S.BLM	
WEATHER: Clear	INSPECTOR'S SIGNATURE:

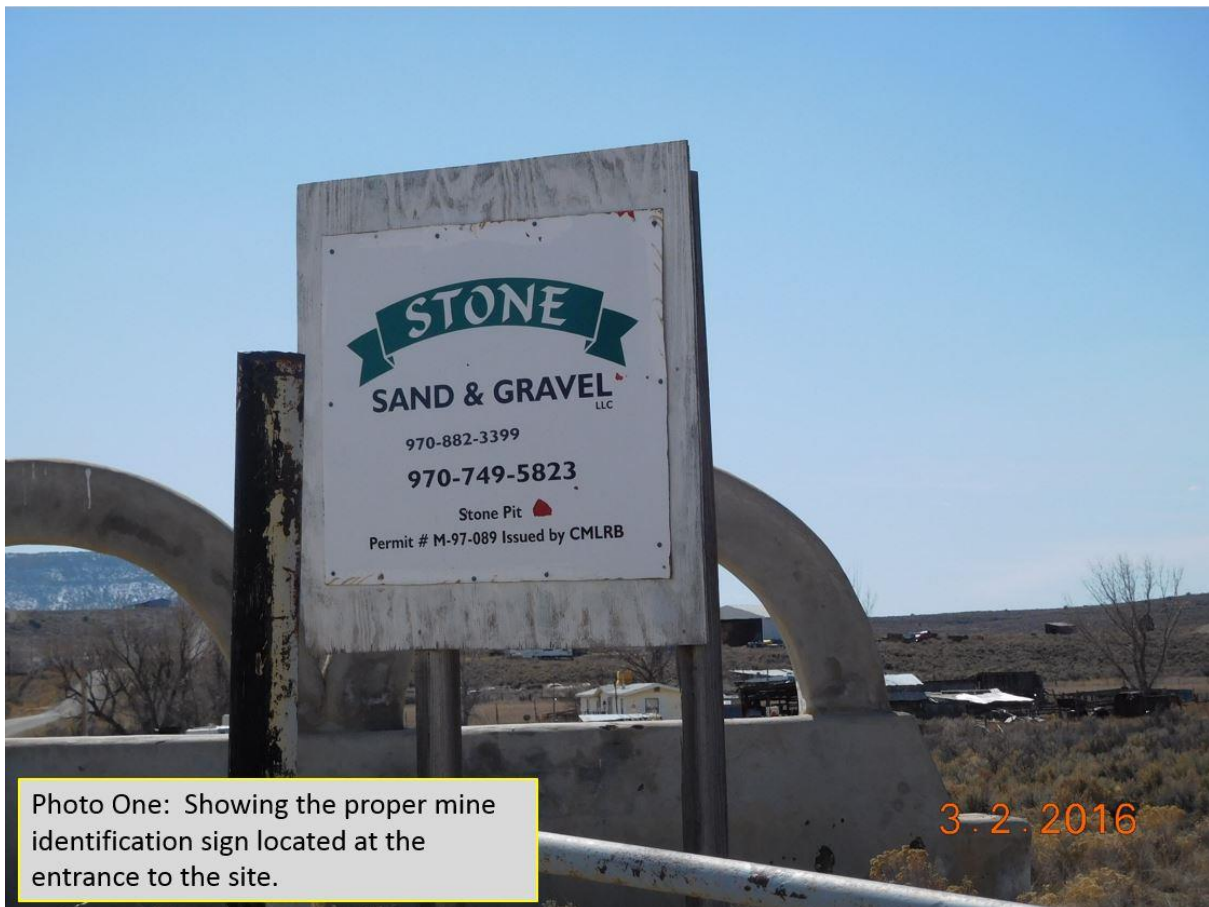
The site consists of 158.2 permitted acres that will be reclaimed to support a post mining land use of rangeland. Proper mine identification signage was observed at the entrance to the site, seen in Photo One. The site was not active during the time of the inspection. Mining was completed around 2013 and little activity has taken place since then. On site discussions with the Operator indicated that they have scheduled to begin final reclamation 6-8 weeks from the date of this inspection. The Operator is reminded to send us written notification when final reclamation has begun. A reclamation cost update was not done on the assumption that final reclamation is forthcoming. Should reclamation not commence within 8 weeks of the date of this report, the Division will complete a reclamation cost update.

Photo One: Showing the proper mine identification sign located at the entrance to the site.

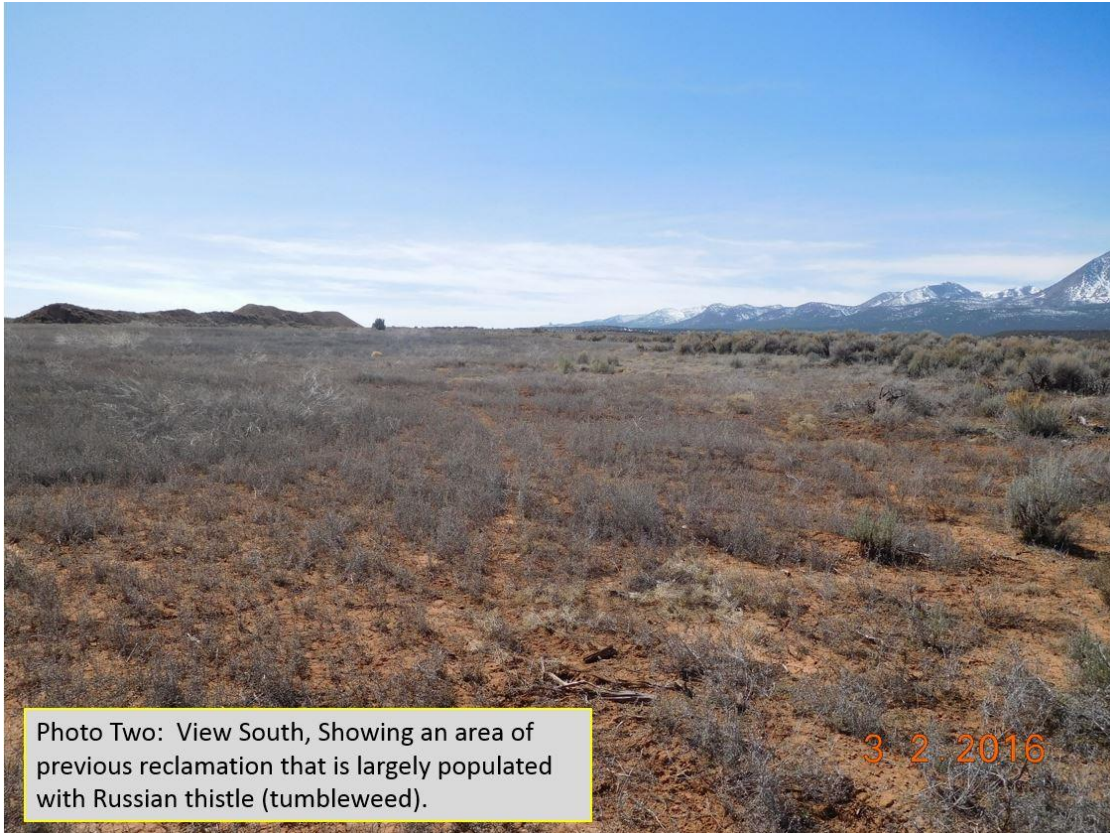
A large majority of the site has been reclaimed and was done so prior to the previous inspection made by the Division. The backfilled areas however are exhibiting poor reclamation success and are mostly vegetated with Russian thistle (Tumbleweed) shown in Photo Two. A large source population of what appeared to be Plumeless thistle was observed along the access road within the permit boundary seen in Photo Three. Due to the season of the inspection it is unclear if they had been treated, however small sprouts of new growth was observed. Annual reports indicate that the Operator is continually treating for noxious weeds, and is encouraged to do so early and often. Reseeding of areas with poor vegetation success is highly recommended at the time other tasks are undertaken in 6 to 8 weeks.

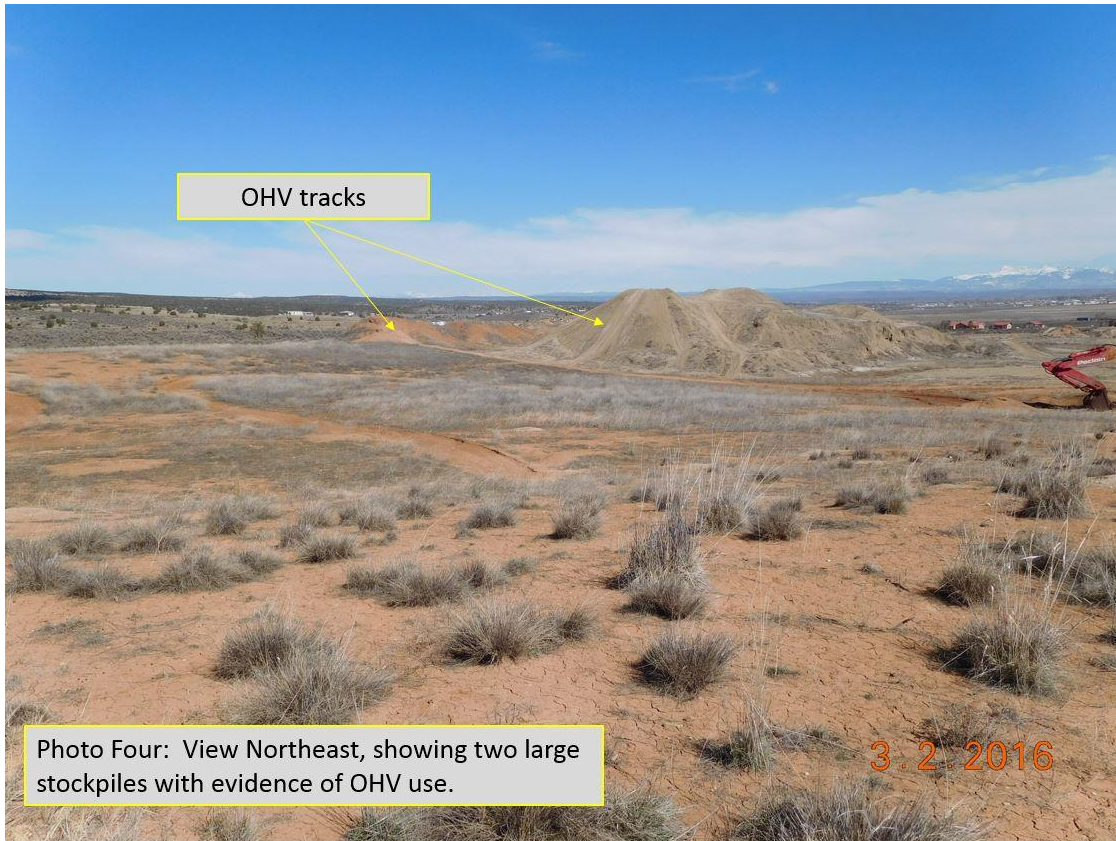
Several stockpiles were observed throughout the site. The permitted area borders a BLM OHV area, and it is apparent that OHV users have been utilizing the site and its stockpiles excessively. Photo Four, shows two such stockpiles on site with visible use by dirt bikes and other OHVs. Various equipment, both mining related and non-mining related including a broken down excavator, cement truck, conveyor parts and various other scrap metal was observed on site. While this is not being listed as a problem due to the imminent reclamation, the Operator is reminded that those items will need to be removed prior to reclamation.

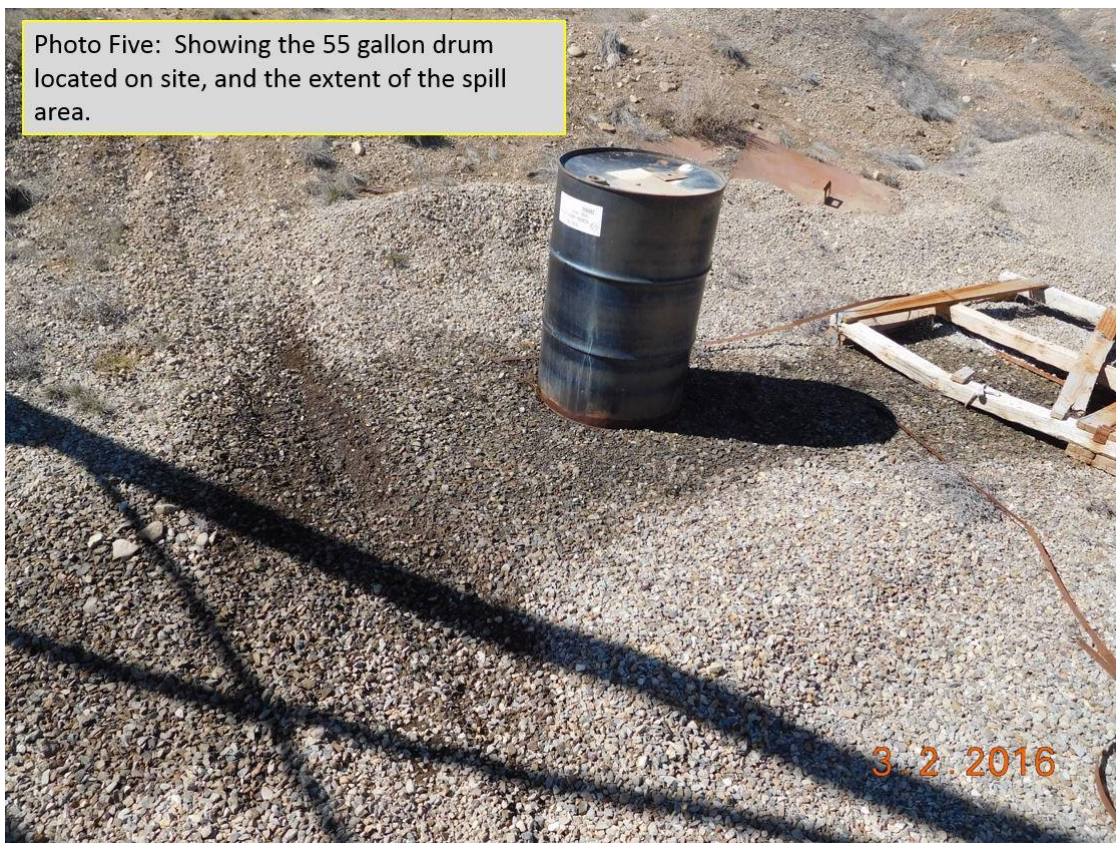
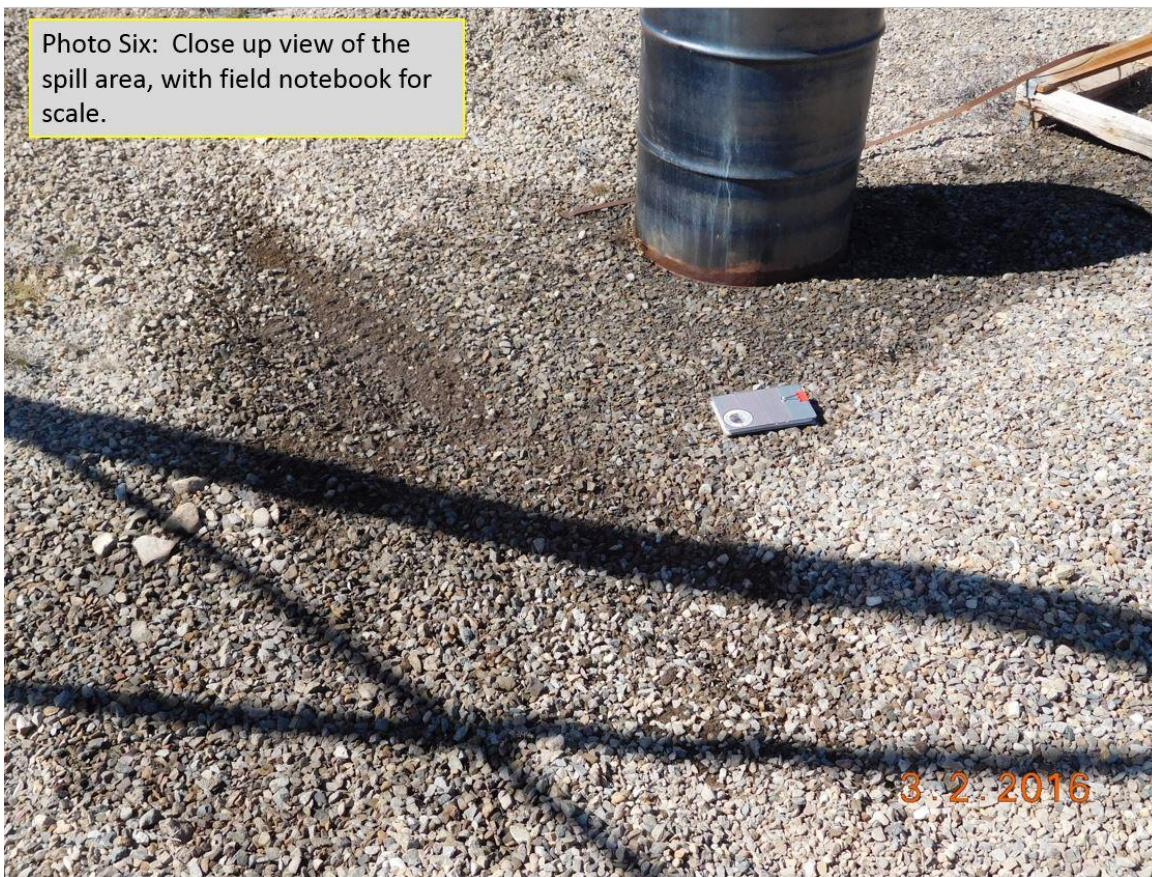
PROBLEM/POSSIBLE VIOLATION: Problem: An engine oil spill has occurred at the site which has impacted soils in the immediate area.

Along with the various other trash and debris located within the permitted area, a 55 gallon drum of what is labeled as engine oil was observed with obvious leakage. Photos Five and Six show the barrel and the affected soils around it. Photo Six contains a Field Notebook for scale that measures approximately 4.5 inches wide and 7.5 inches long for a reference to the size of the spill. The cause of the leak appeared to be a bullet hole approximately $\frac{1}{4}$ of the way up the barrel, possibly causing $\frac{3}{4}$ of the contents of the barrel to be spilled. Discussions with the Operator indicated that he was not aware of the spill or the barrel, suggesting that some unauthorized person or persons entered the site and disposed of the barrel. The barrel, along with along with all of the affected soils must be removed from the site and properly disposed of.

The Operator shall immediately remediate the spill and submit a final report to the Division containing at least

the following information:

- 1.) A description of how the spill was cleaned up containing at a minimum - the appropriate maps showing the location of the spill, approximate volumes removed, and photo documentation of the cleanup.
- 2.) Evidence in the form of a receipt that the contaminated soil was disposed of by an approved method (such as sent to an approved landfill, land farming, recycling center, etc.) or a written narrative describing the steps taken to properly remediate the soils.

Evidence of compliance must be received by the Division's Denver Office no later than April 8, 2016.
