**COLORADO DIVISION OF RECLAMATION, MINING AND SAFETY**  
**MINERALS PROGRAM INSPECTION REPORT**  
**PHONE: (303) 866-3567**

<b>MINE NAME:</b> Douglas County Sand & Gravel	<b>MINE/PROSPECTING ID#:</b> M-1983-089	<b>MINERAL:</b> Sand and gravel and	<b>COUNTY:</b> Douglas
<b>INSPECTION TYPE:</b> Monitoring	<b>INSPECTOR(S):</b> Tyler V. O'Donnell	<b>INSP. DATE:</b> January 14, 2016	<b>INSP. TIME:</b> 11:15
<b>OPERATOR:</b> Douglas County Sand & Gravel, LLC	<b>OPERATOR REPRESENTATIVE:</b> John Miner	<b>TYPE OF OPERATION:</b> 112c - Construction Regular Operation

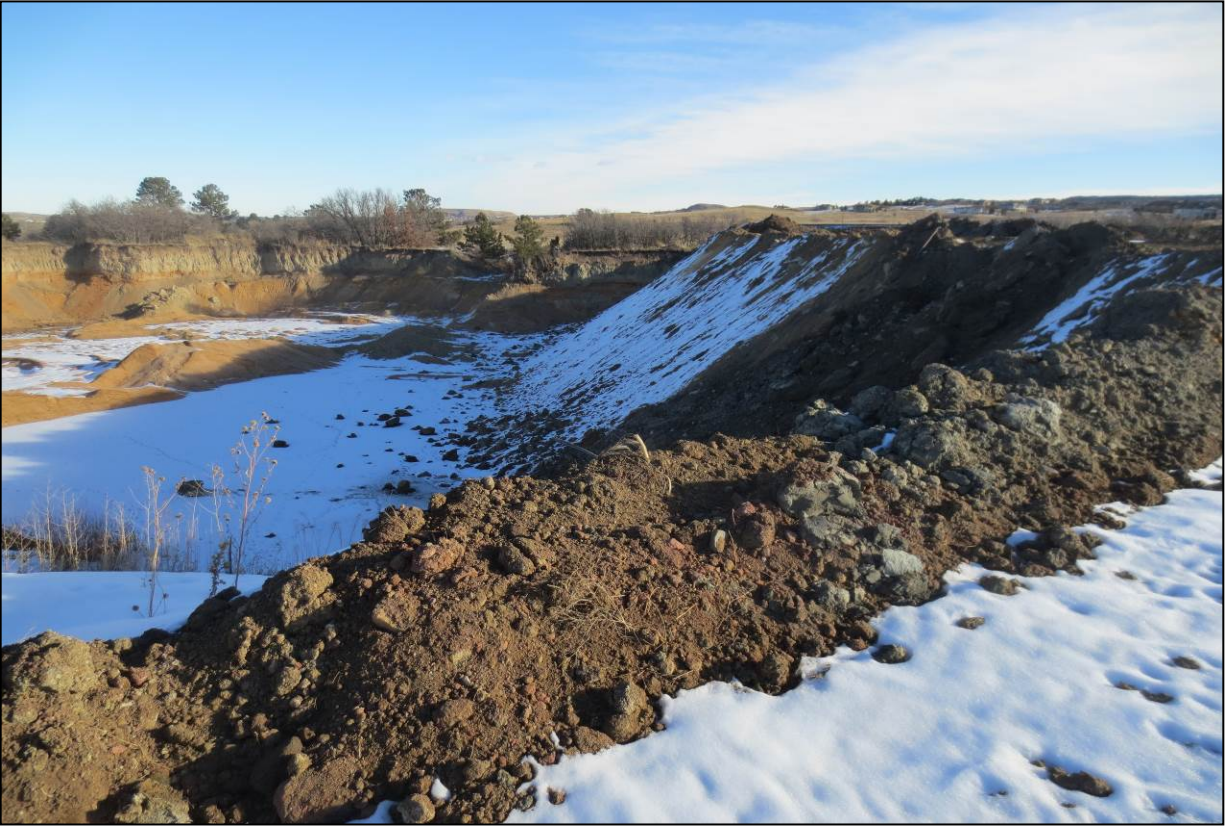
The Operator is in the process of backfilling the deep excavation in the northern portion of the site (see photo 1). The Operator's representative stated they hoped to backfill the deep excavations by the end of this year. The Operator has graded portions of the pit to 2H:1V or flatter. There were several stockpiles of product scattered throughout the affected area and around the processing plant. There was a highwall along the eastern permit boundary. The highwall had an average height of approximately 20 feet. The highwall had an approximant slope of 1H:1V to just flatter than 1.5H:1V. When completing final reclamation, the Operator will need to grade all slopes to 3H:1V or flatter to comply with the approved reclamation plan.

**Photo 1:** Northern pit being backfilled.

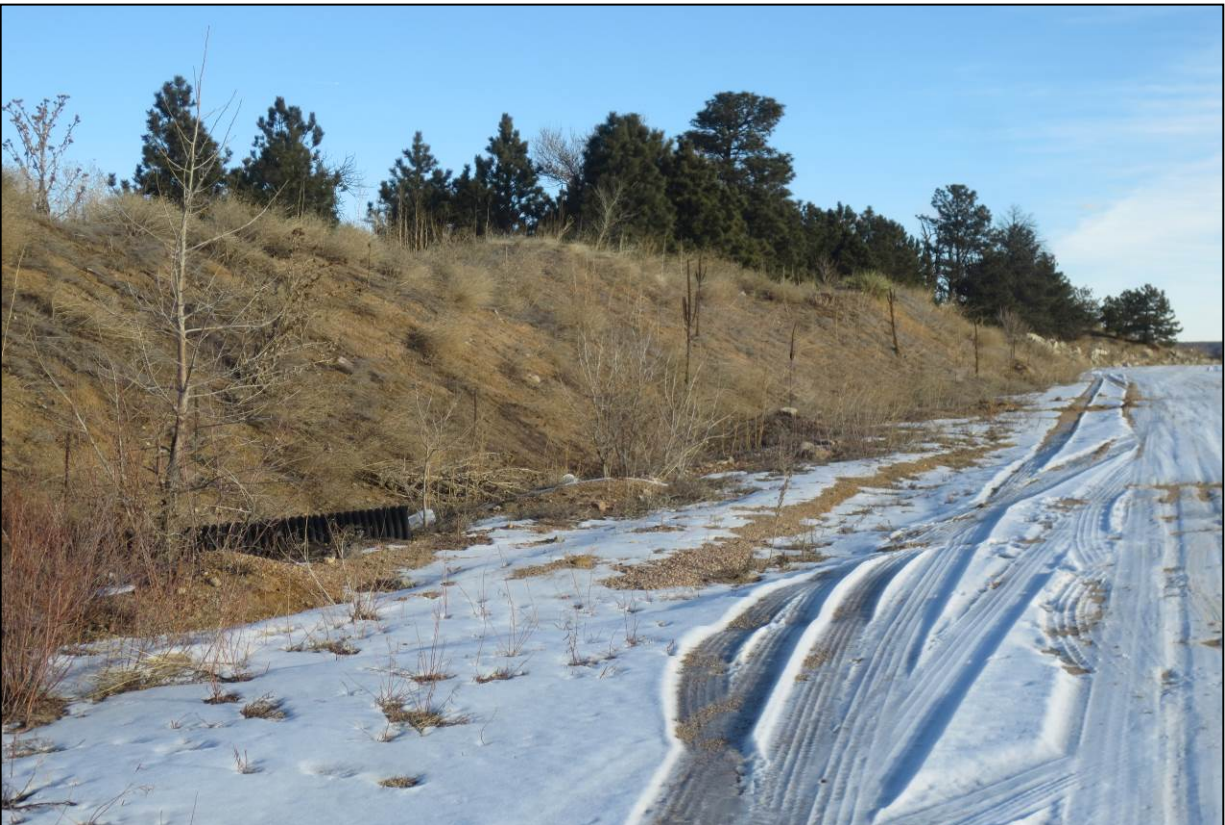
**Photo 2:** Topsoil Berm along the western affected land boundary.

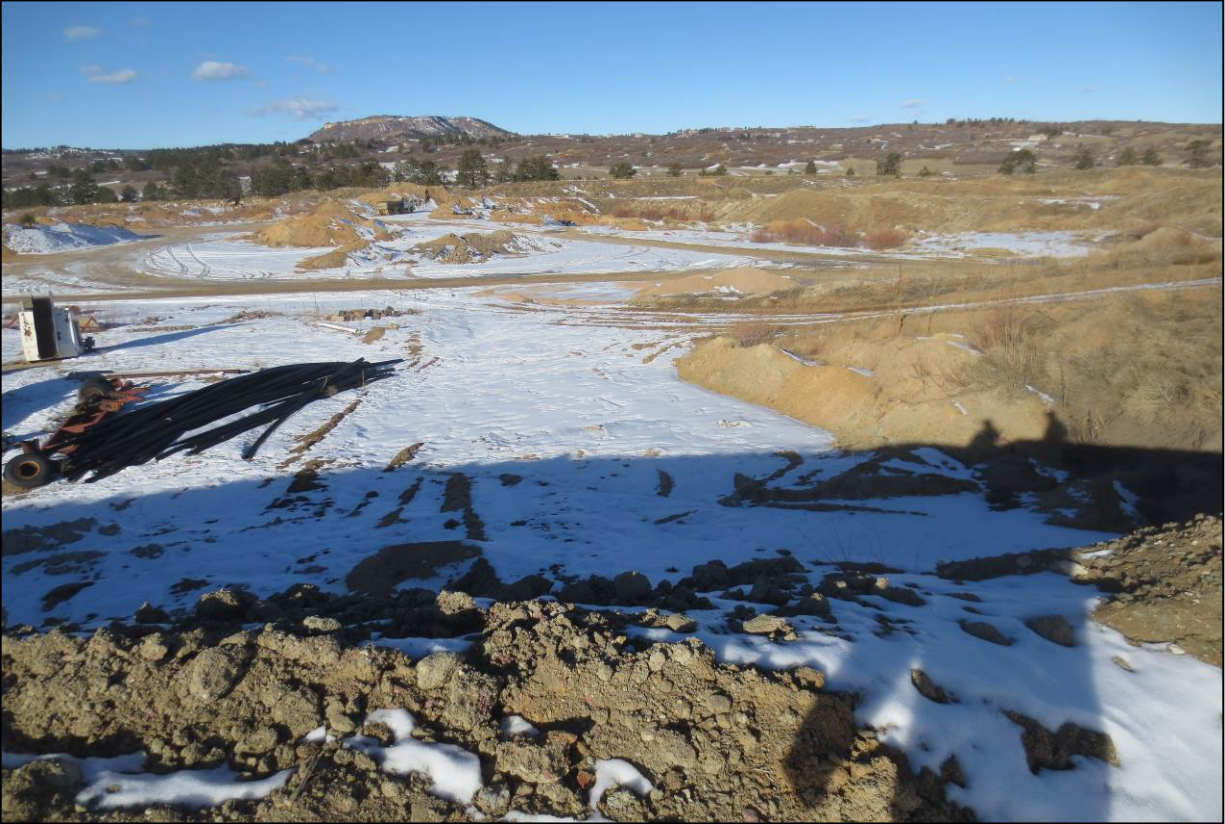
**Photo 3:** Overview of the active mining area.

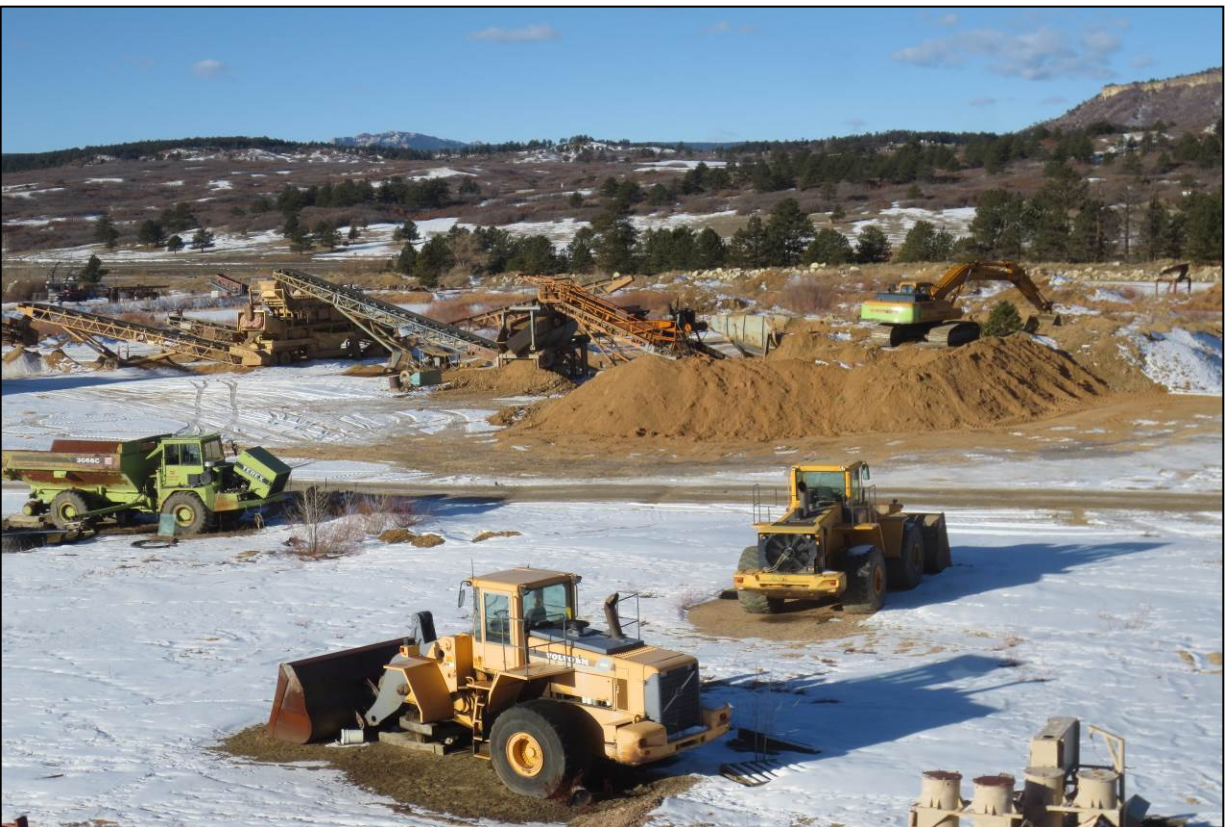
**Photo 4:** processing plant.
