COLORADO DIVISION OF RECLAMATION, MINING AND SAFETY
MINERALS PROGRAM INSPECTION REPORT
PHONE: (303) 866-3567

MINE NAME: Rough Cut Pit	MINE/PROSPECTING ID#: M-2001-033	MINERAL: Sand and gravel	COUNTY: Otero
INSPECTION TYPE: Monitoring	INSPECTOR(S): Amy Eschberger	INSP. DATE: January 13, 2016	INSP. TIME: 13:00
OPERATOR: Rough Cut, L.L.C.	OPERATOR REPRESENTATIVE: Keith Tucker	TYPE OF OPERATION: 112c - Construction Regular Operation

INSPECTION TOPIC: Gen. Compliance With Mine Plan

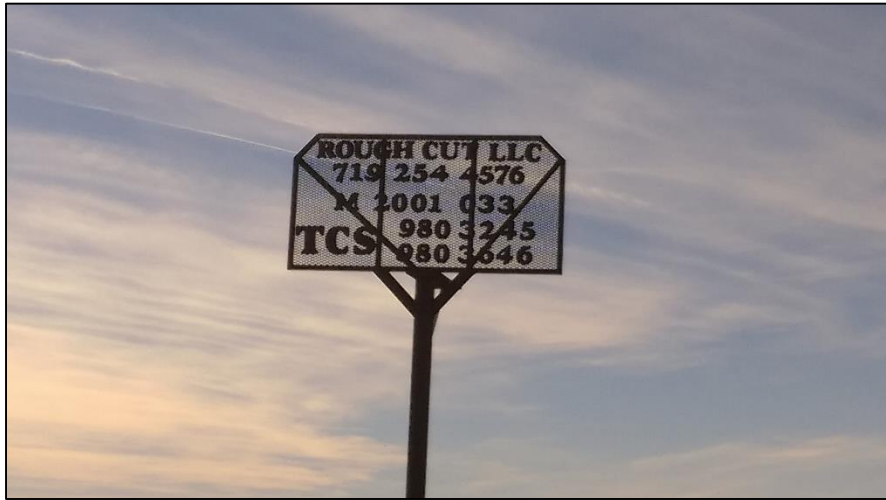
Photo 1. View of permit sign posted at main site entrance off of Co Rd GG 75.

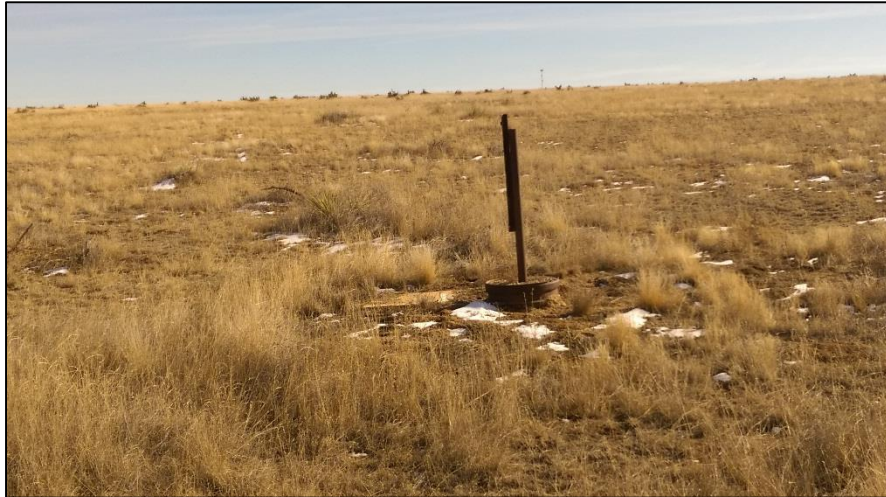
Photo 2. View of metal post marking southeastern permit boundary.

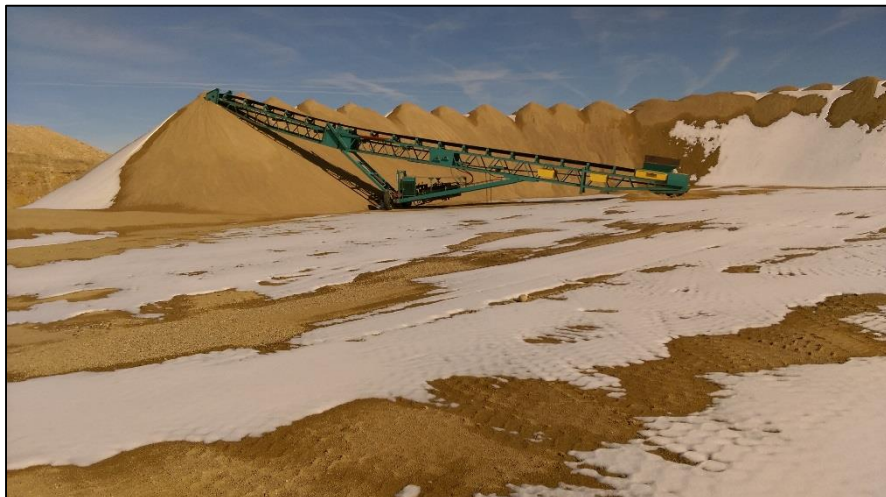
Photo 3. View showing conveyor present in stockpiling/processing area located in phase 1 mining area.

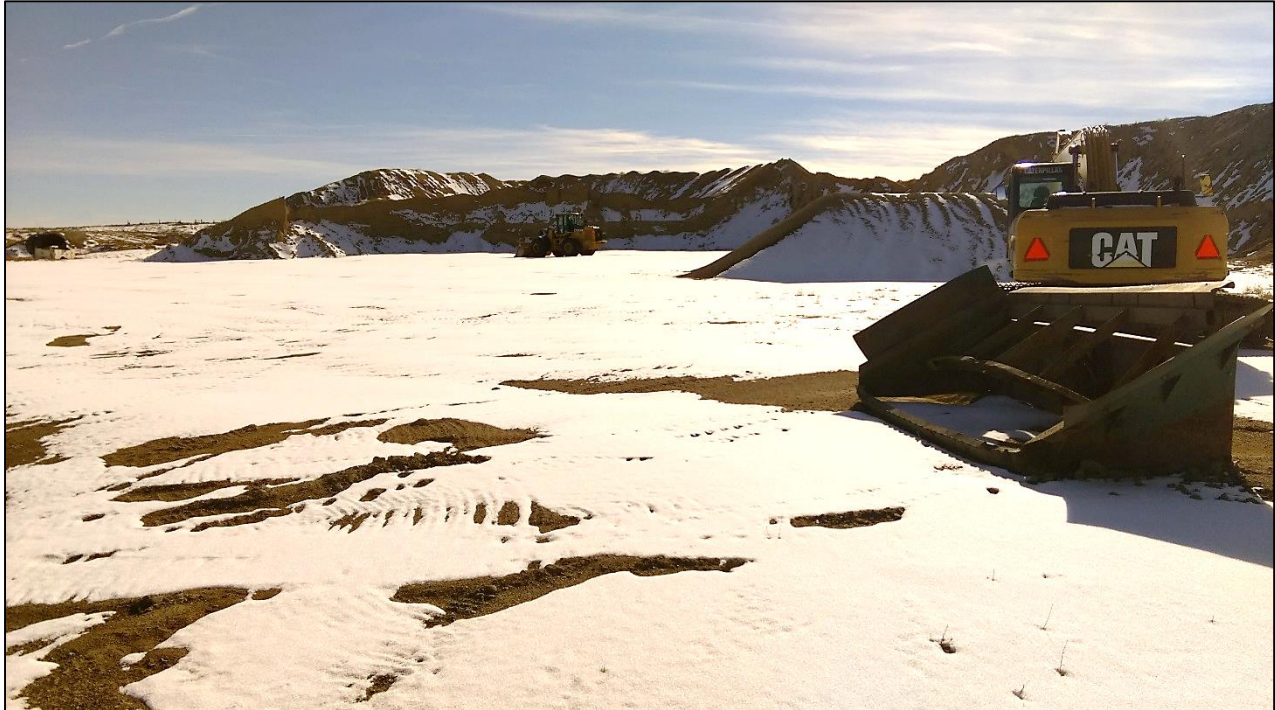
Photo 4. View showing loaders and screen present in stockpiling/processing area located in phase 1 mining area.

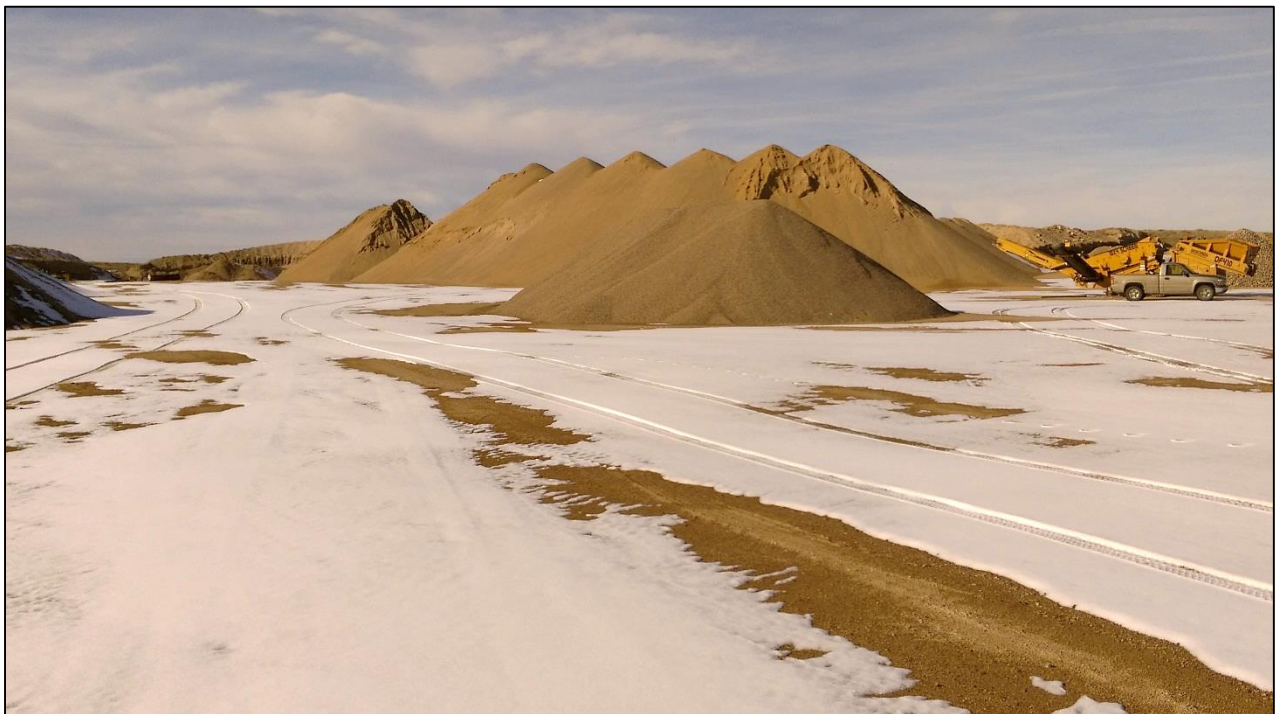
Photo 5. View showing material stockpiles present in stockpiling/processing area located in phase 1 mining area.

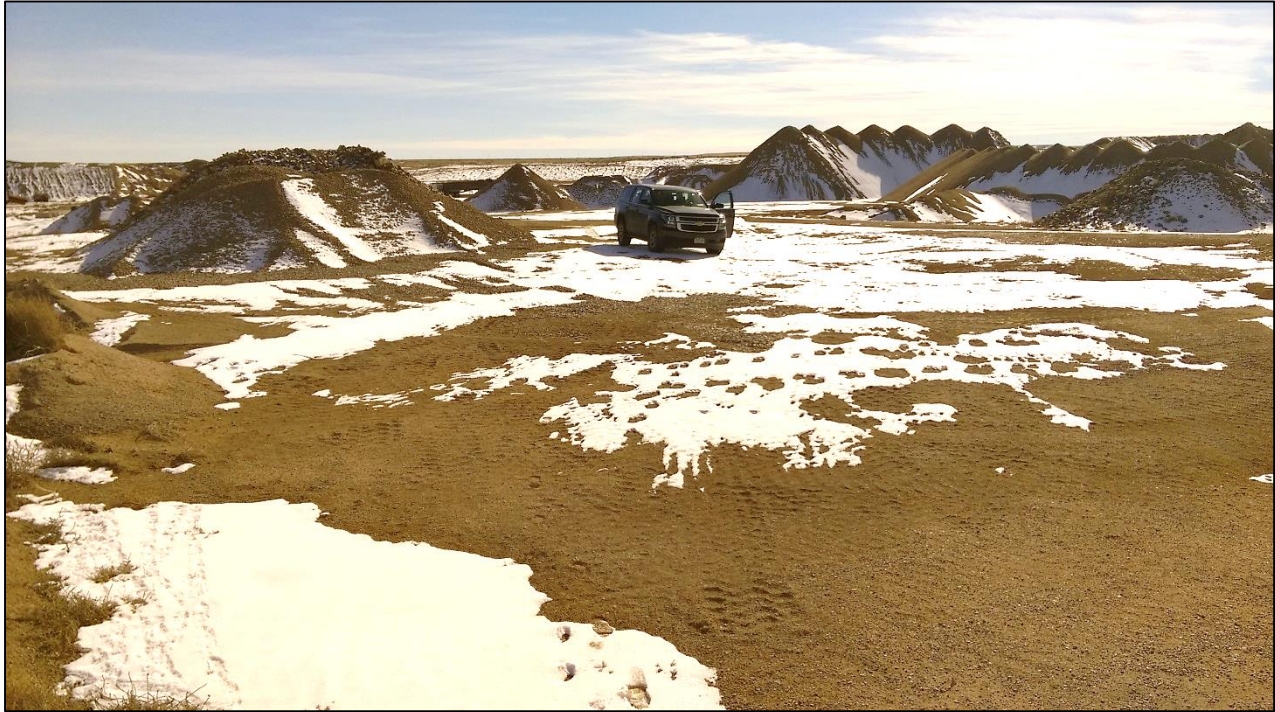
Photo 6. View showing material stockpiles present in stockpiling/processing area located in phase 1 mining area.

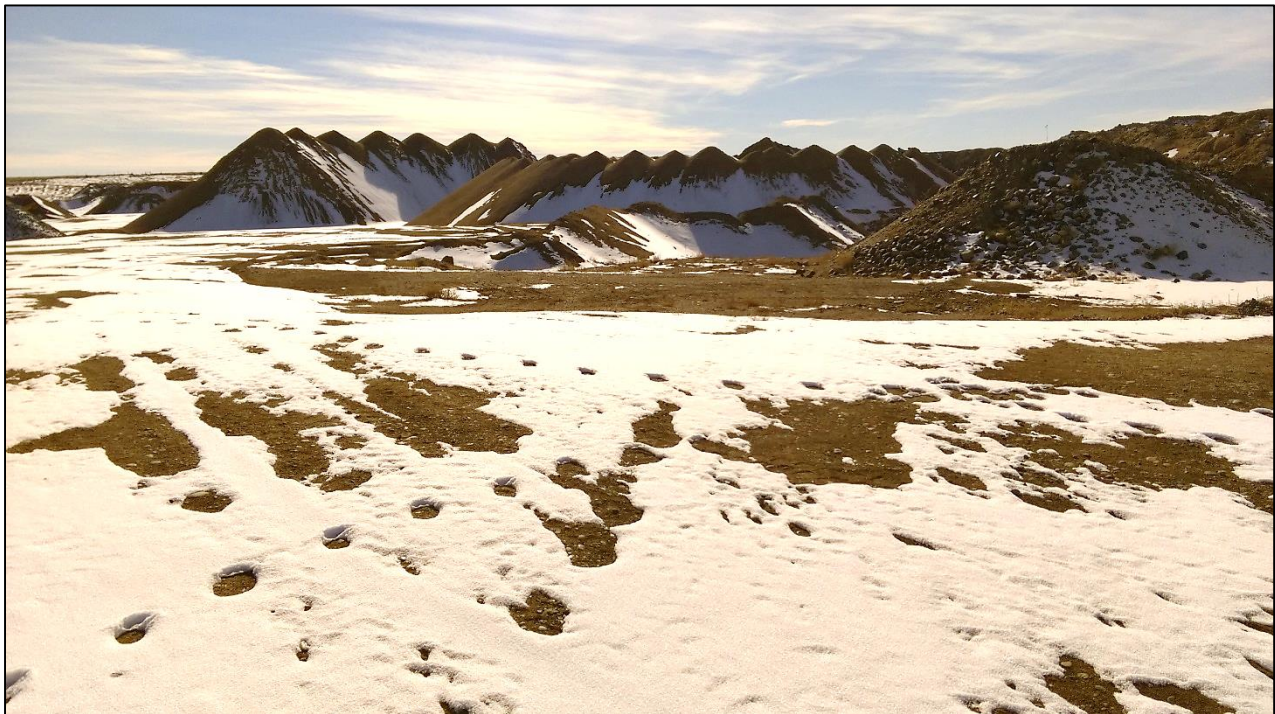
Photo 7. View showing material stockpiles present in stockpiling/processing area located in phase 1 mining area.

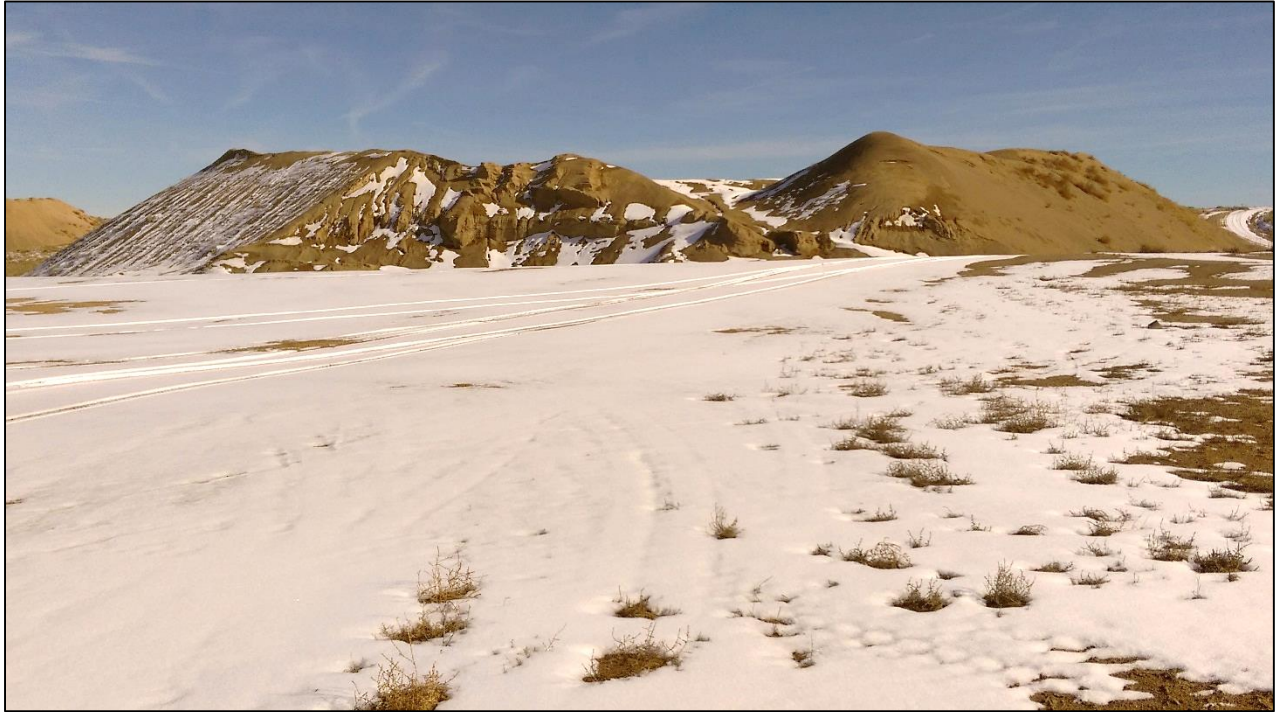
Photo 8. View showing material stockpiles present in stockpiling/processing area located in phase 1 mining area.

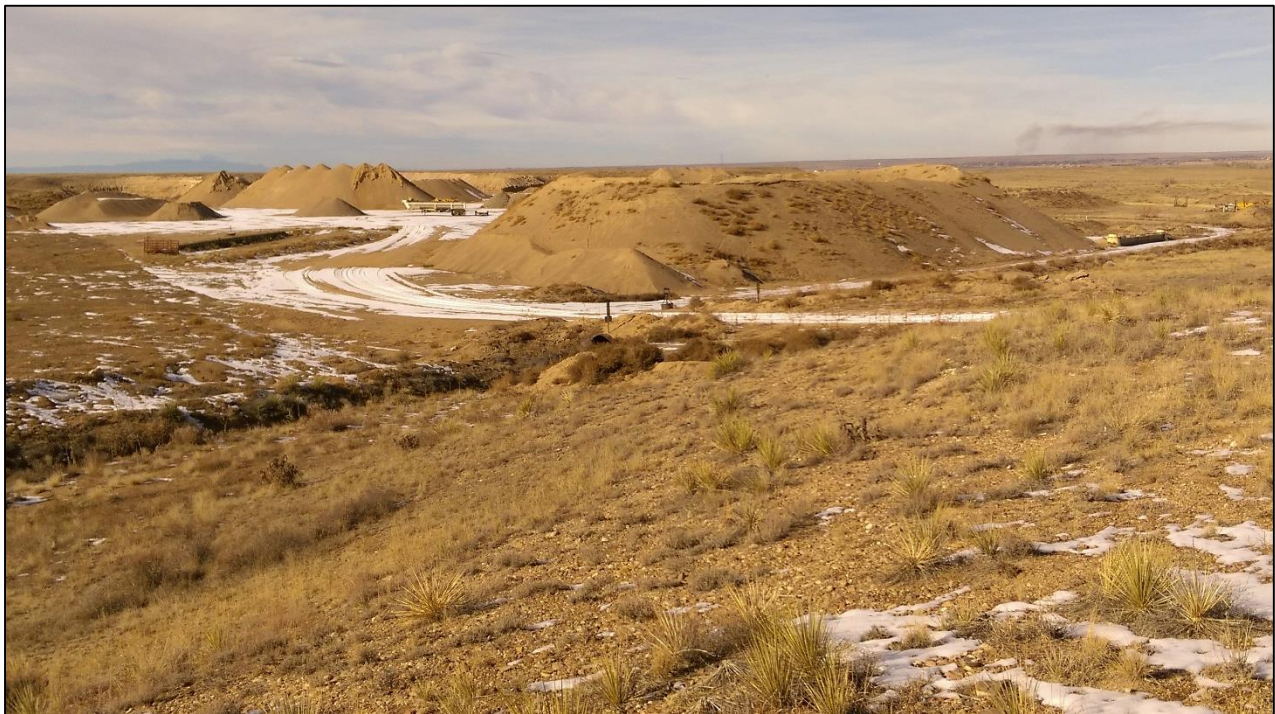
Photo 9. View showing material stockpiles present in stockpiling/processing area located in phase 1 mining area.

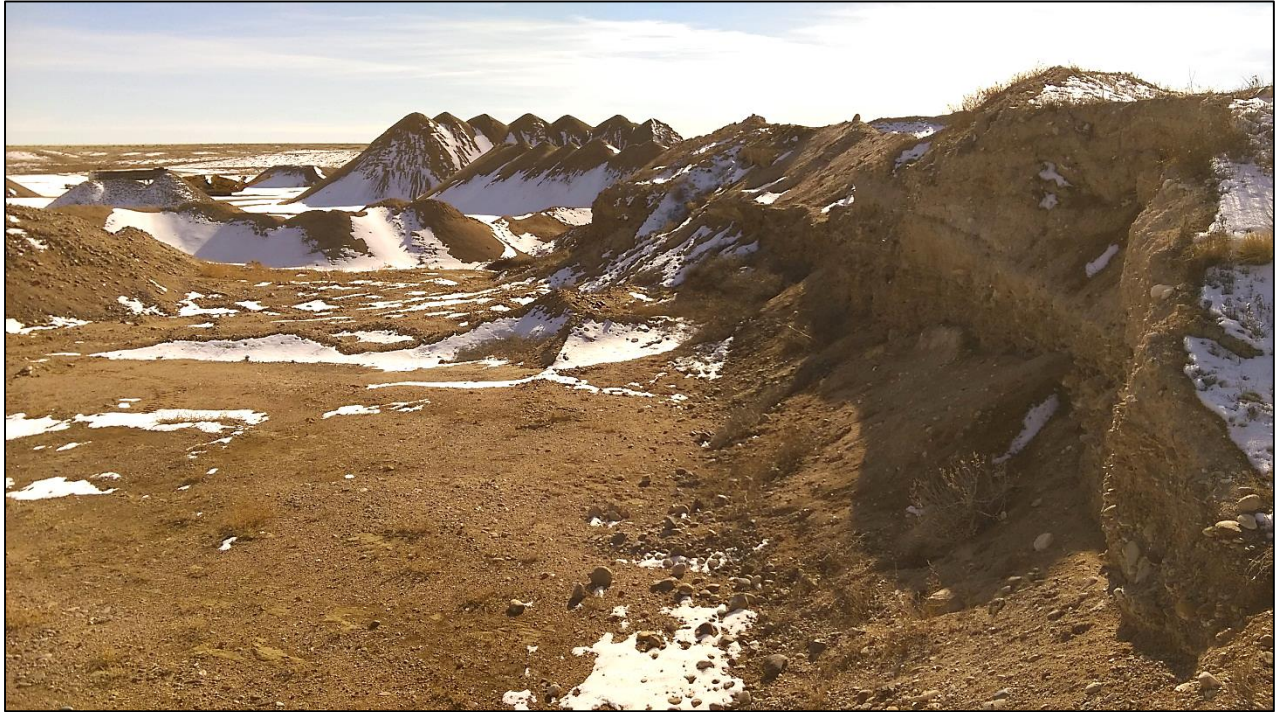
Photo 10. View looking south from northern edge of pit, showing east-facing portion of mined wall (at right) in phase 1 mining area. Note mined wall approximately 20 feet in height with near vertical slope gradients.

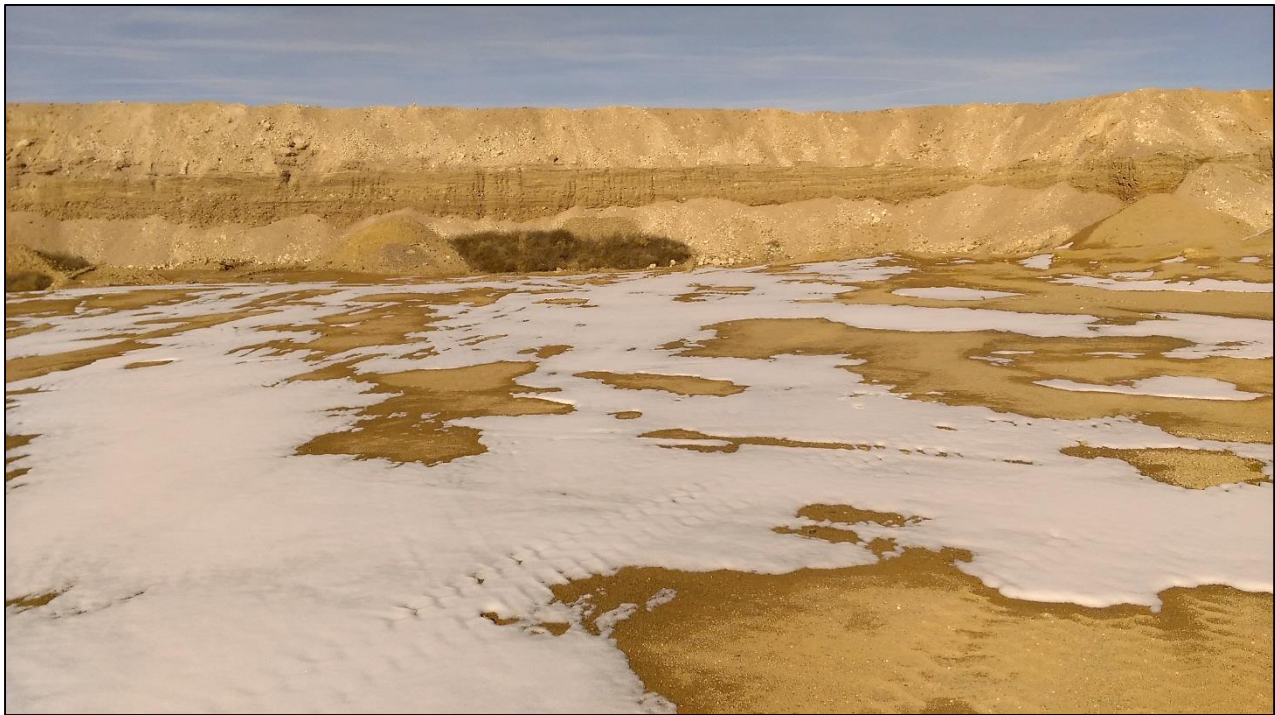
Photo 11. View looking north from pit floor, showing south-facing portion of mined wall in phase 1 mining area. Note mined wall approximately 20 feet in height with near vertical slope gradients.

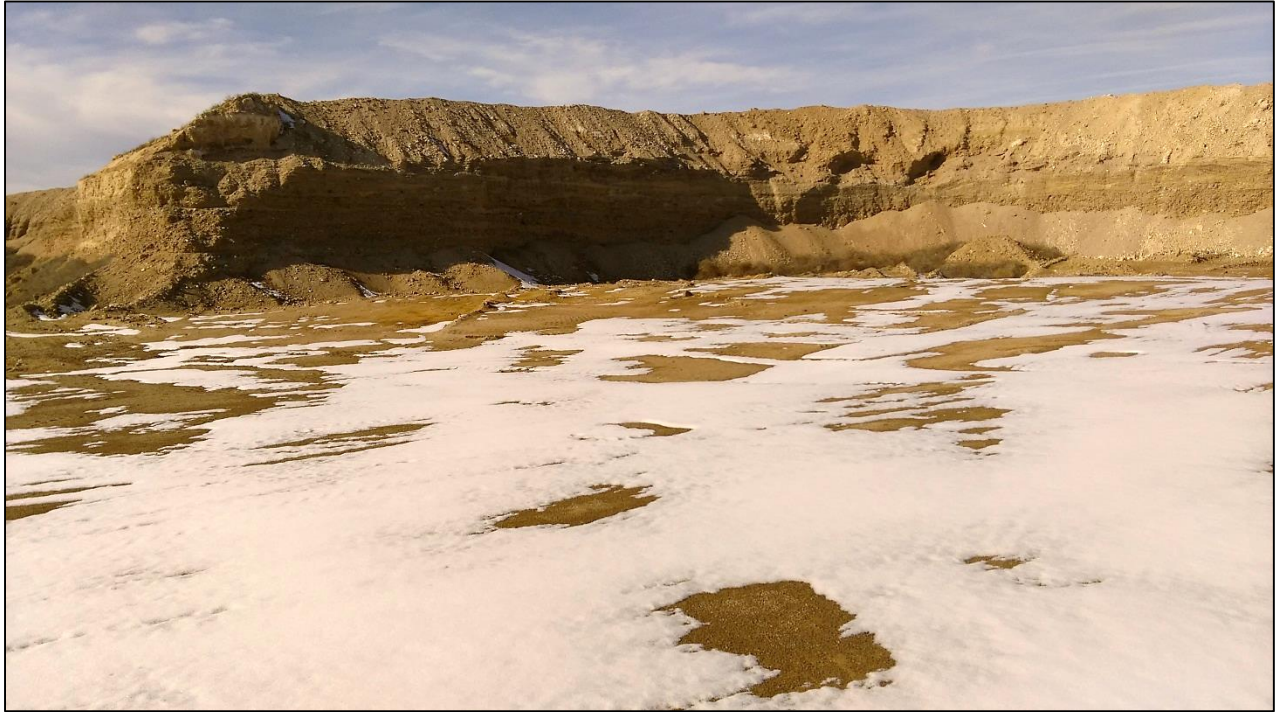
Photo 12. View looking northwest from pit floor, showing east-facing portion of mined wall in phase 1 mining area. Note mined wall approximately 20 feet in height with near vertical slope gradients.

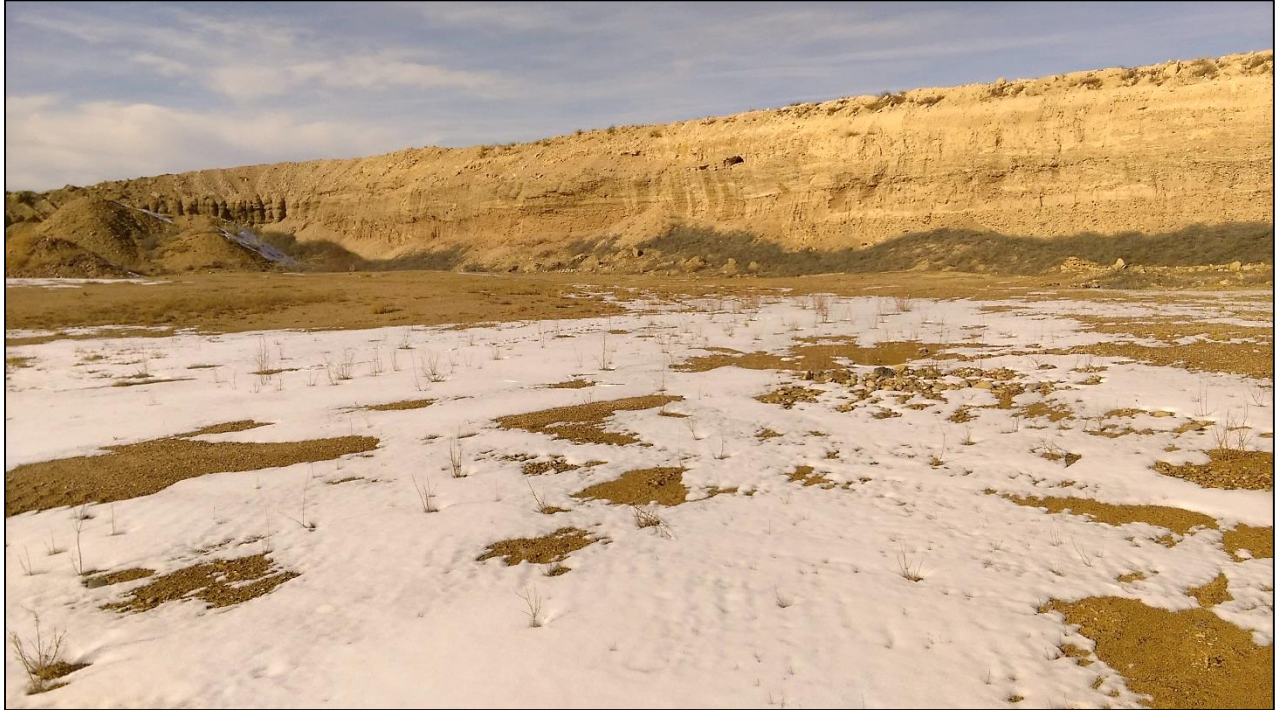
Photo 13. View looking north from pit floor, showing south-facing portion of mined wall in phase 1 mining area. Note mined wall approximately 20 feet in height with near vertical slope gradients.

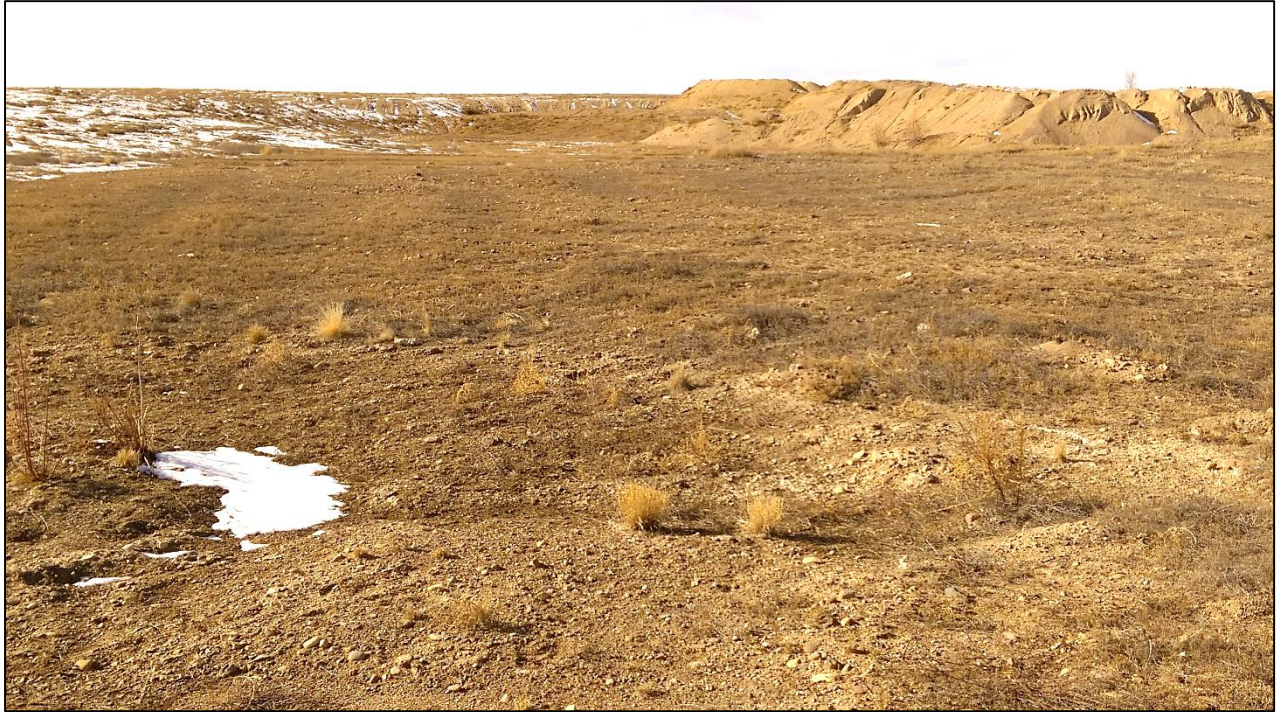
annual reports submitted by the operator, this area was backfilled, graded, and retopsoiled in 2011, and seeded in 2013. It is unclear whether the area has been reseeded since that time. Despite the fairly rocky topsoil in this area, some patches of native grasses were observed. The operator should continue to closely monitor this area and continue revegetation efforts as needed to establish the approved grass species.

Photo 14. View looking northwest across area in reclamation located in previously mined southern portion of phase 1 mining area. Note area graded to flatter than 3H:1V, backfilled, and retopsoiled, with very sparse vegetation present.

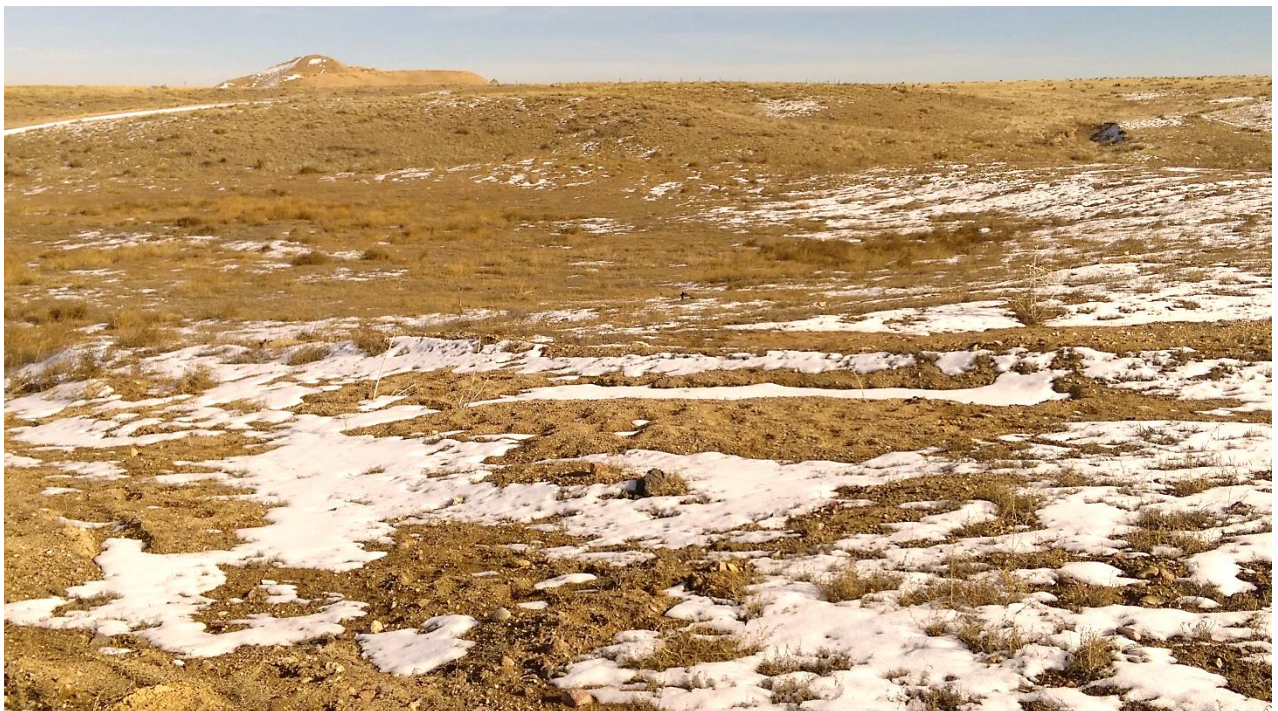
Photo 15. View looking west across area in reclamation located in previously mined southern portion of phase 1 mining area. Note area graded to 3H:1V or flatter, backfilled, and retopsoiled, with very sparse vegetation present.

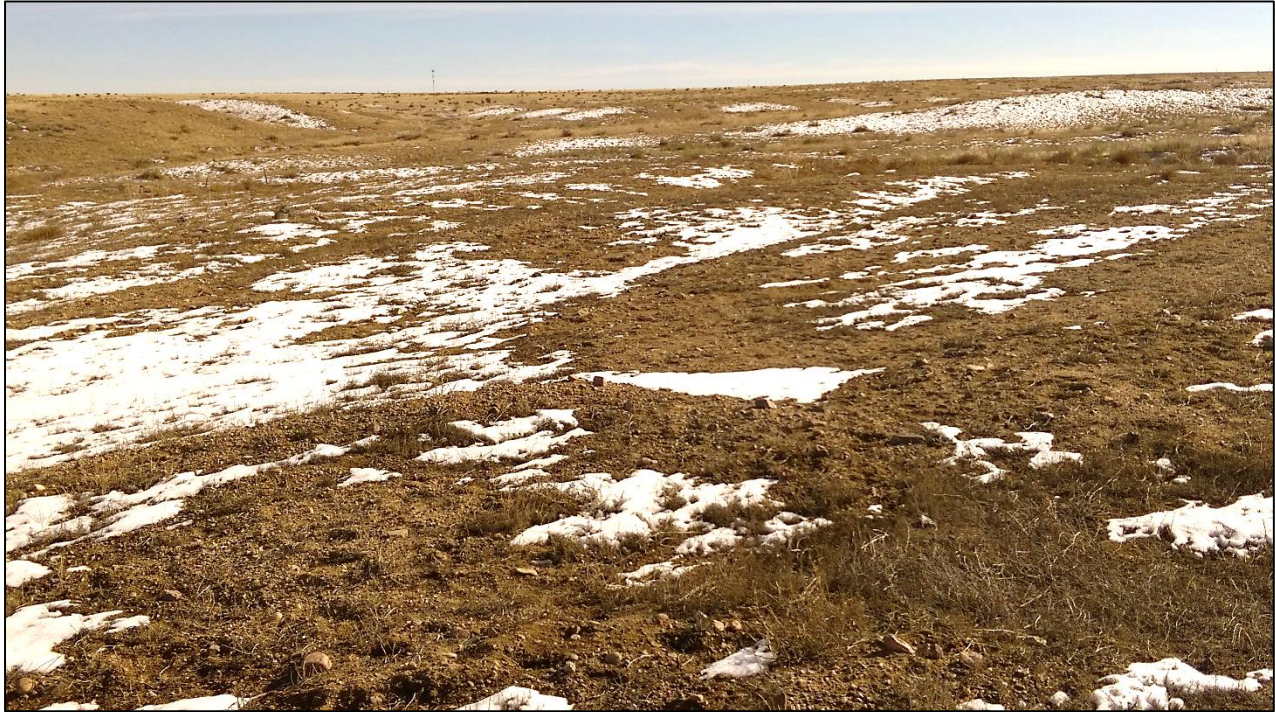
Photo 16. View looking southwest across area in reclamation located in previously mined southern portion of phase 1 mining area. Note area graded to 3H:1V or flatter, backfilled, and retopsoiled, with very sparse vegetation present.

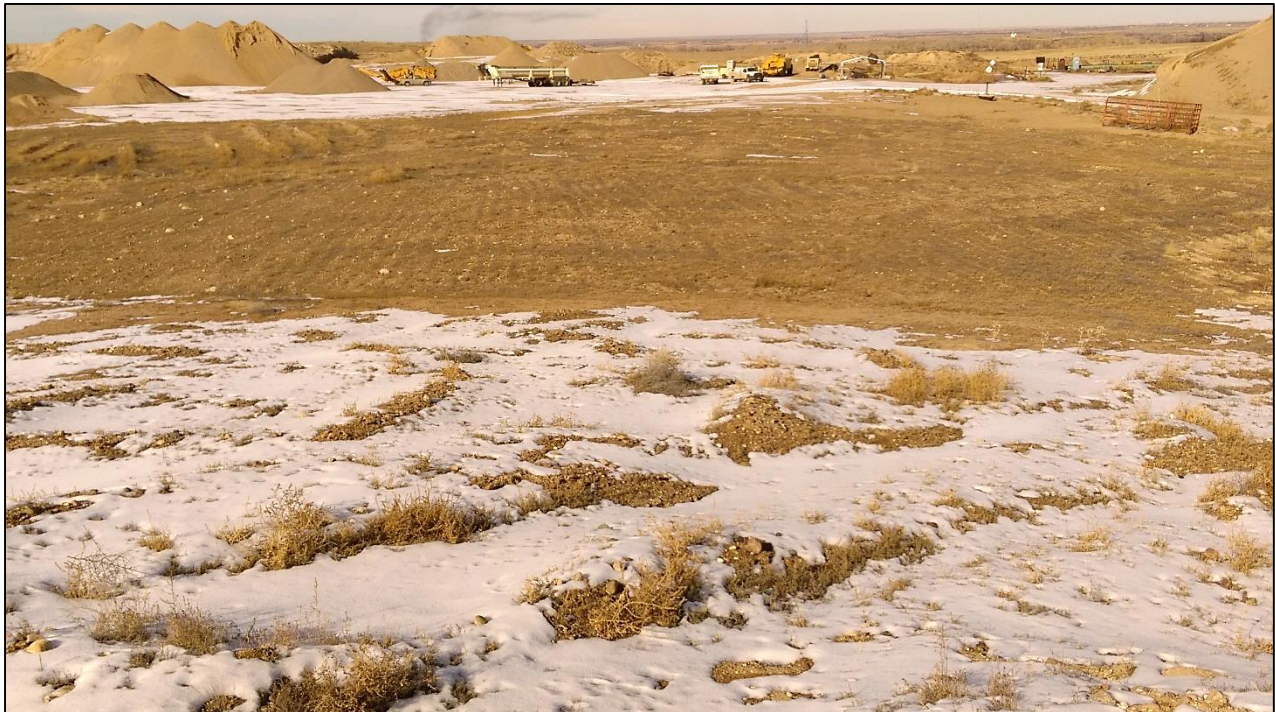
Photo 17. View looking north across area in reclamation located in previously mined southern portion of phase 1 mining area. Note area graded to flatter than 3H:1V, backfilled, and retopsoiled, with very sparse vegetation present.

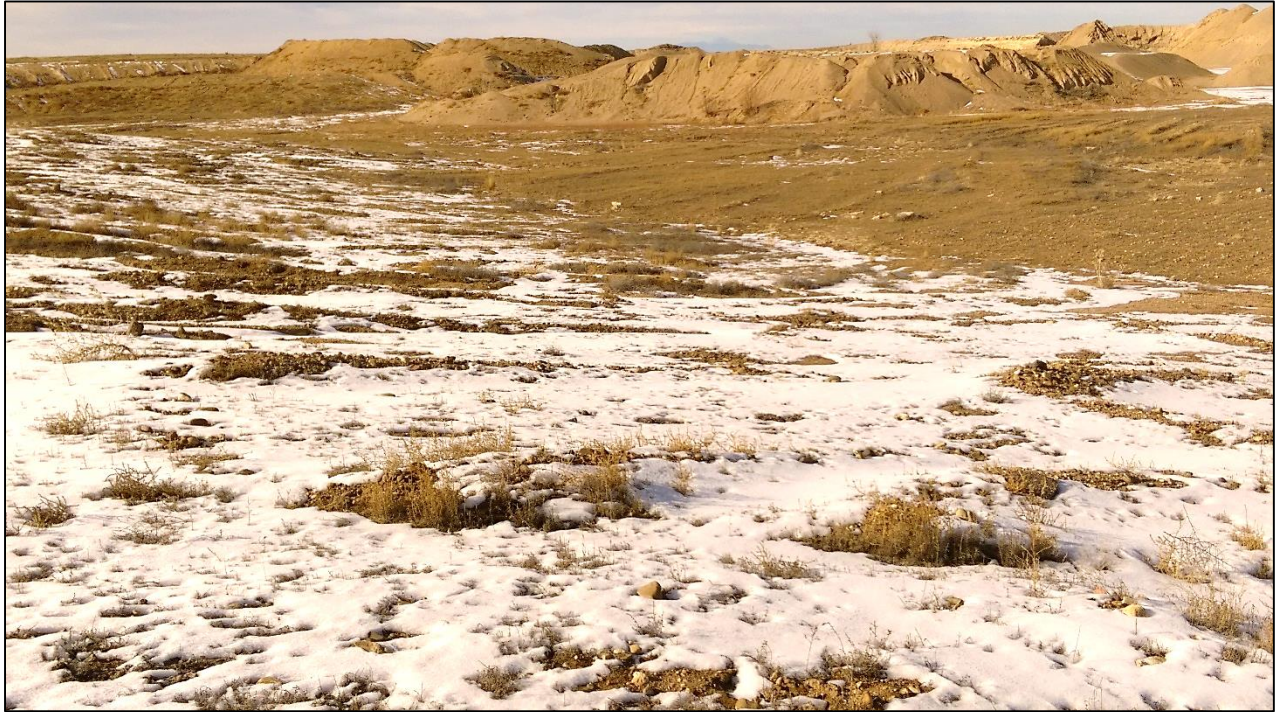
Photo 18. View looking northwest across area in reclamation located in previously mined southern portion of phase 1 mining area. Note area graded to 3H:1V or flatter, backfilled, and retopsoiled, with very sparse vegetation present.

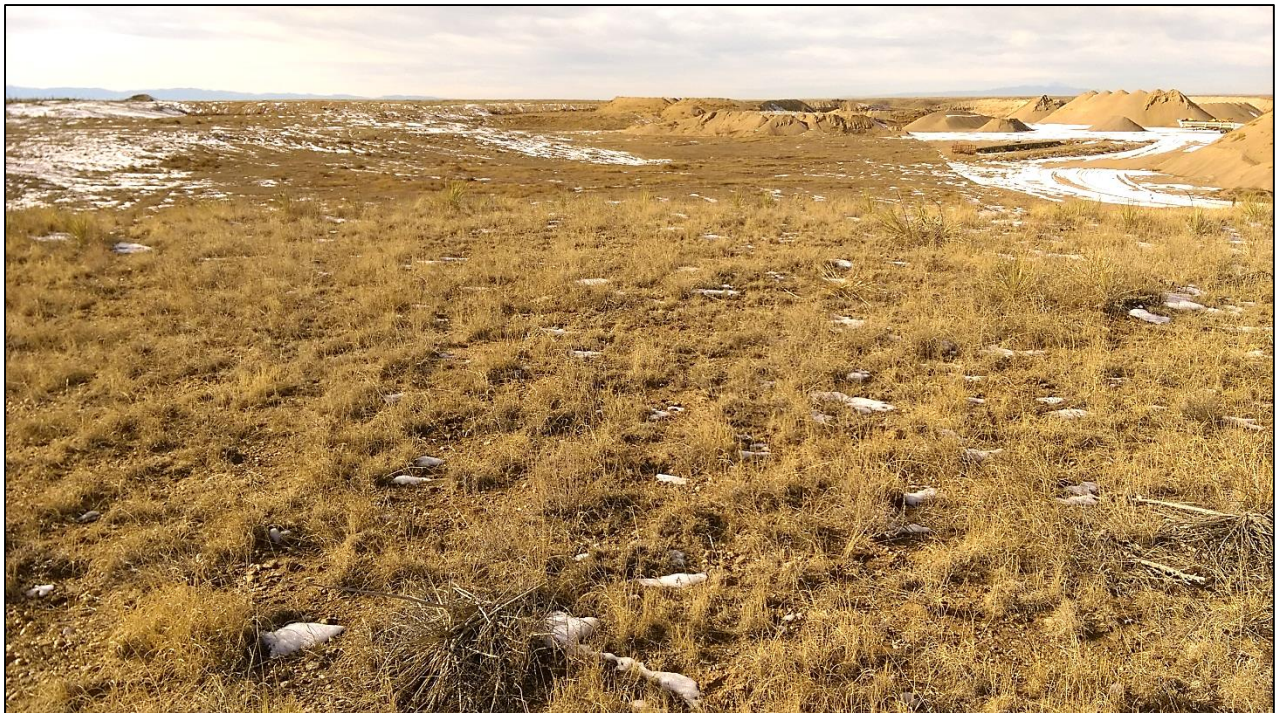
Photo 19. View looking northwest across area in reclamation located in previously mined southern portion of phase 1 mining area. Note area graded to 3H:1V or flatter, backfilled, and retopsoiled, with fairly good establishment of native grasses.

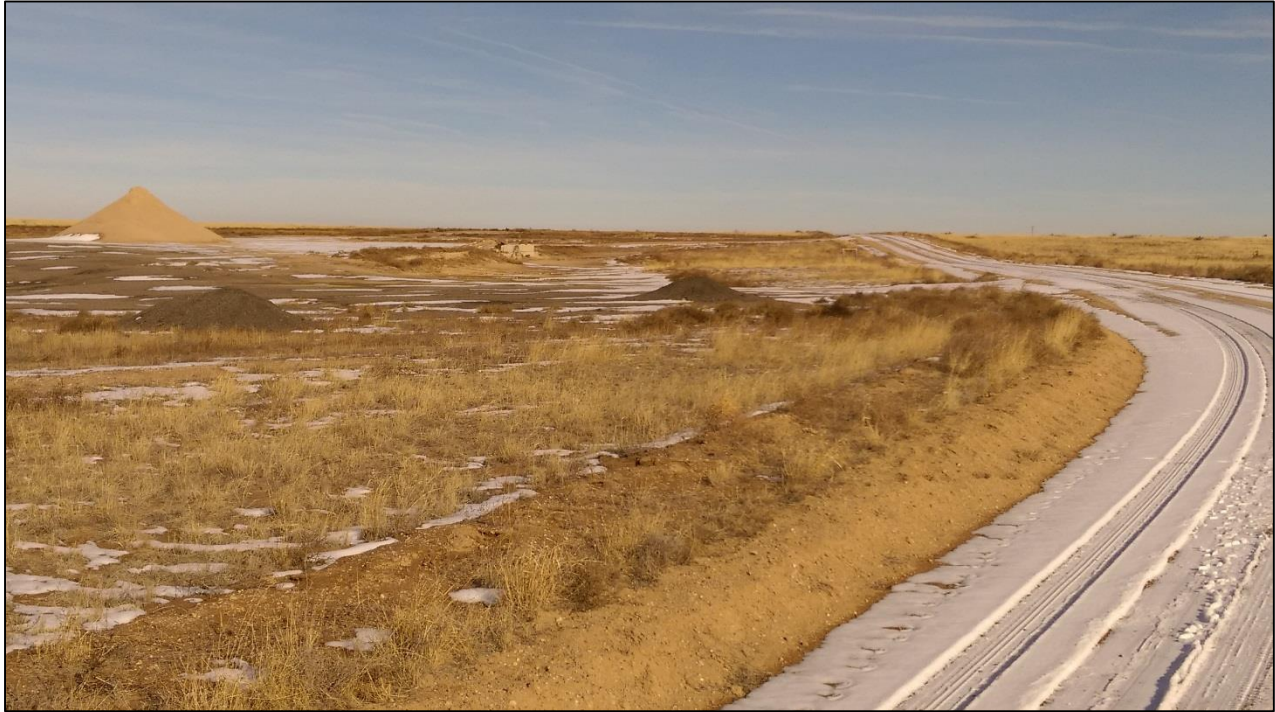
Photo 20. View looking east from main access road, showing southern portion of phase 2 mining area where small batch plant operated in 2012. Note batch plant has been removed from site.

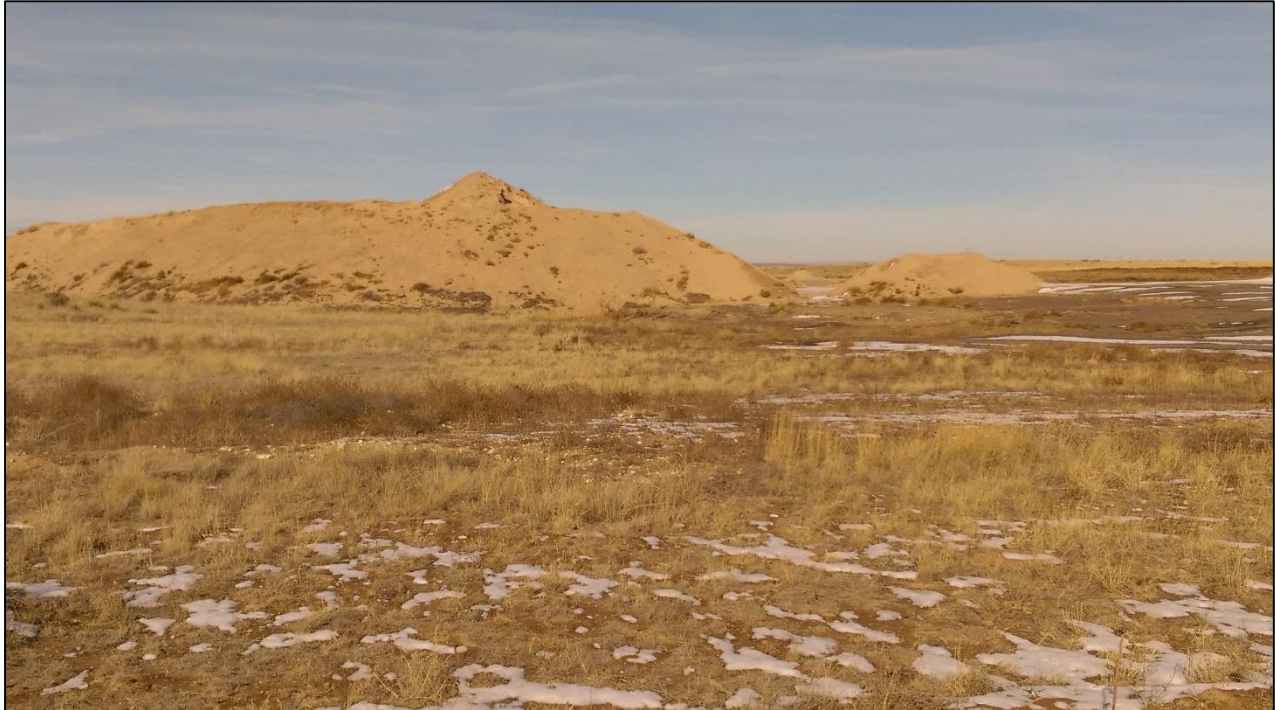
Photo 21. View looking north from main access road, showing material stockpiles stored in southern portion of phase 2 mining area.

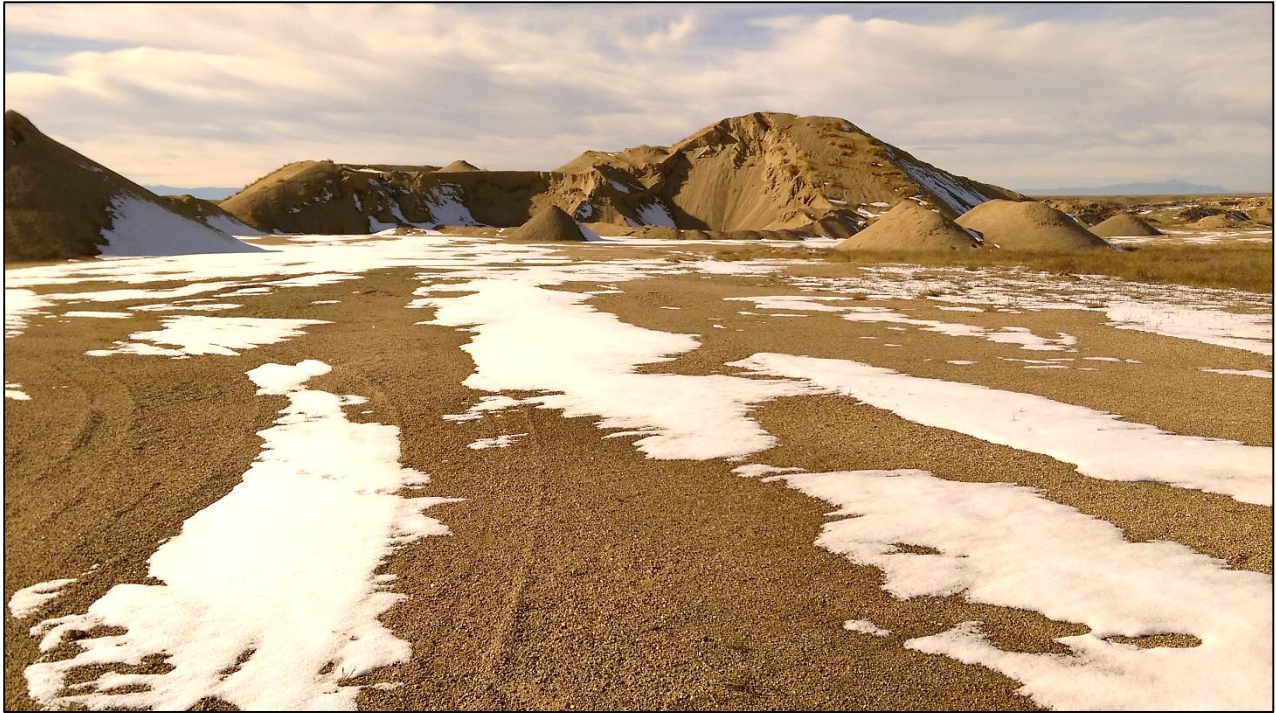
Photo 22. View looking north, showing material stockpiles stored in southern portion of phase 2 mining area.

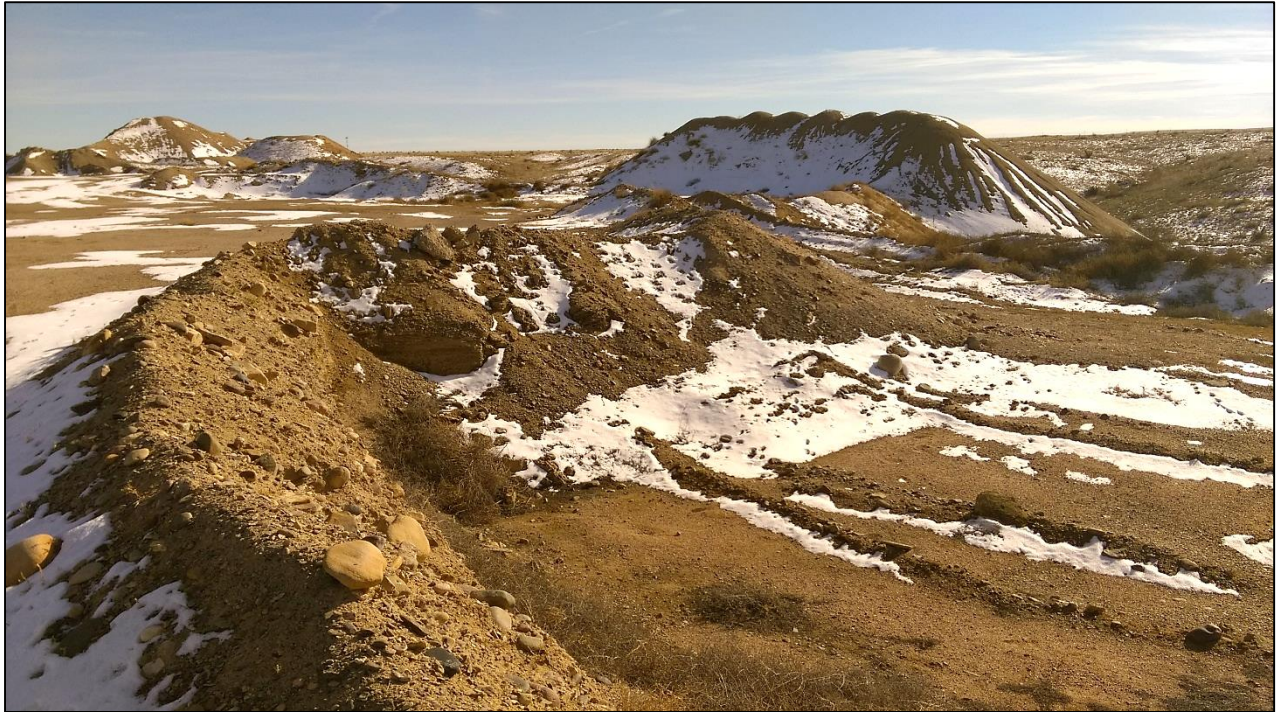
Photo 23. View looking south, showing material stockpiles stored in northwestern portion of phase 2 mining area.

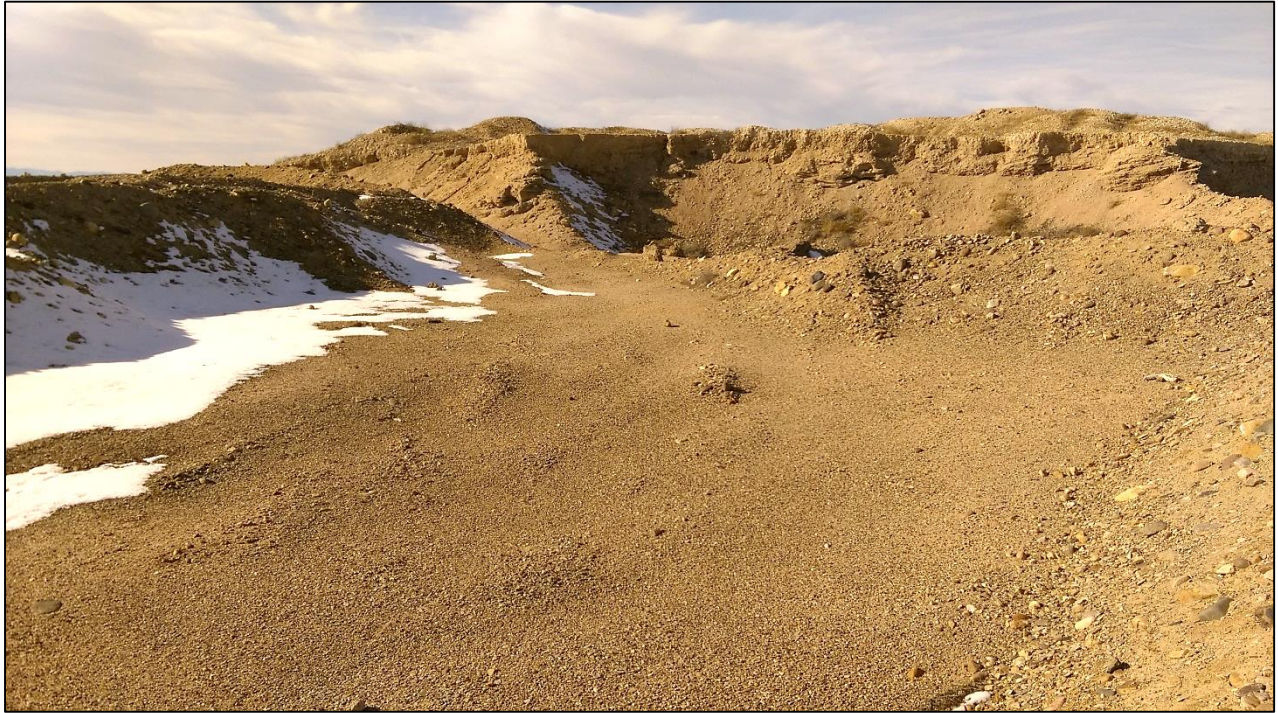
Photo 24. View looking north, showing portion of south-facing mined wall present along northern edge of phase 2 mining area. Note mined wall approximately 10-15 feet in height with near vertical slope gradients.

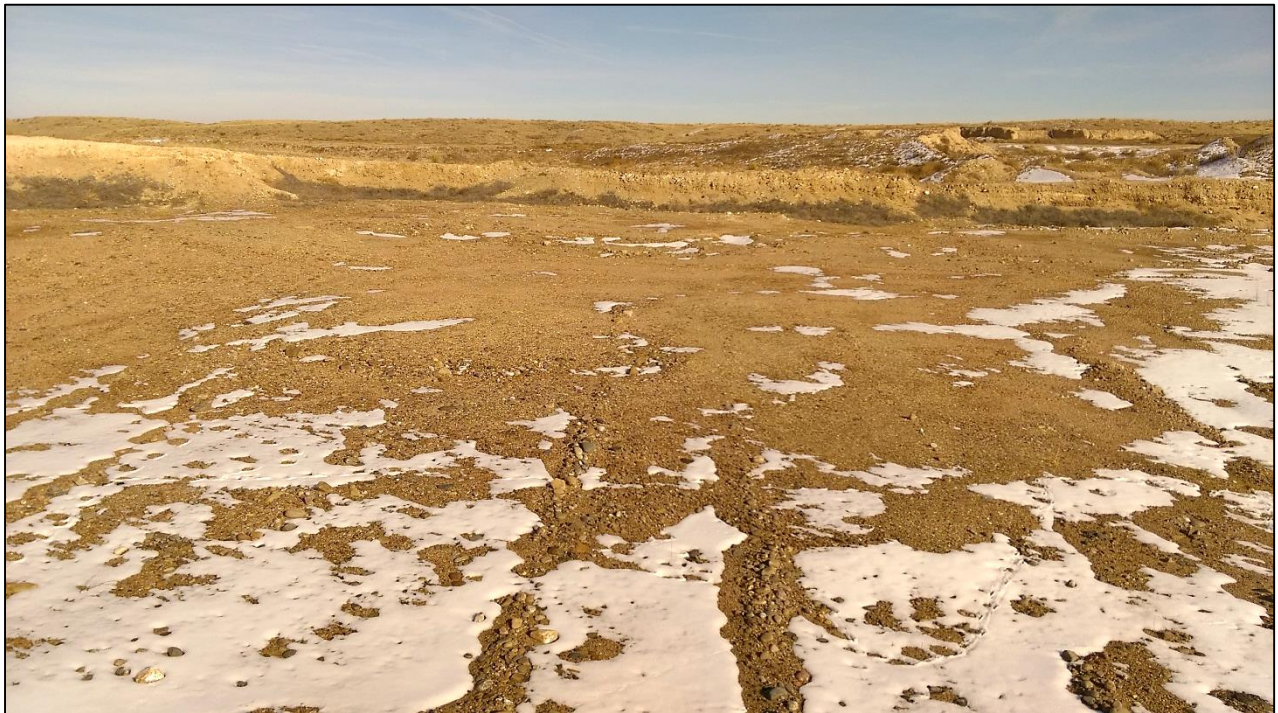
Photo 25. View looking east, showing portion of west-facing mined wall present along northern edge of phase 2 mining area. Note mined wall approximately 5 feet in height with near vertical slope gradients.
