COLORADO DIVISION OF RECLAMATION, MINING AND SAFETY
MINERALS PROGRAM INSPECTION REPORT
PHONE: (303) 866-3567

MINE NAME: Rough Cut Pit	MINE/PROSPECTING ID#: M-2001-033	MINERAL: Sand and gravel	COUNTY: Otero
INSPECTION TYPE: Monitoring	INSPECTOR(S): Amy Eschberger	INSP. DATE: January 13, 2016	INSP. TIME: 13:00
OPERATOR: Rough Cut, L.L.C.	OPERATOR REPRESENTATIVE: Keith Tucker	TYPE OF OPERATION: 112c - Construction Regular Operation

INSPECTION TOPIC: Gen. Compliance With Mine Plan

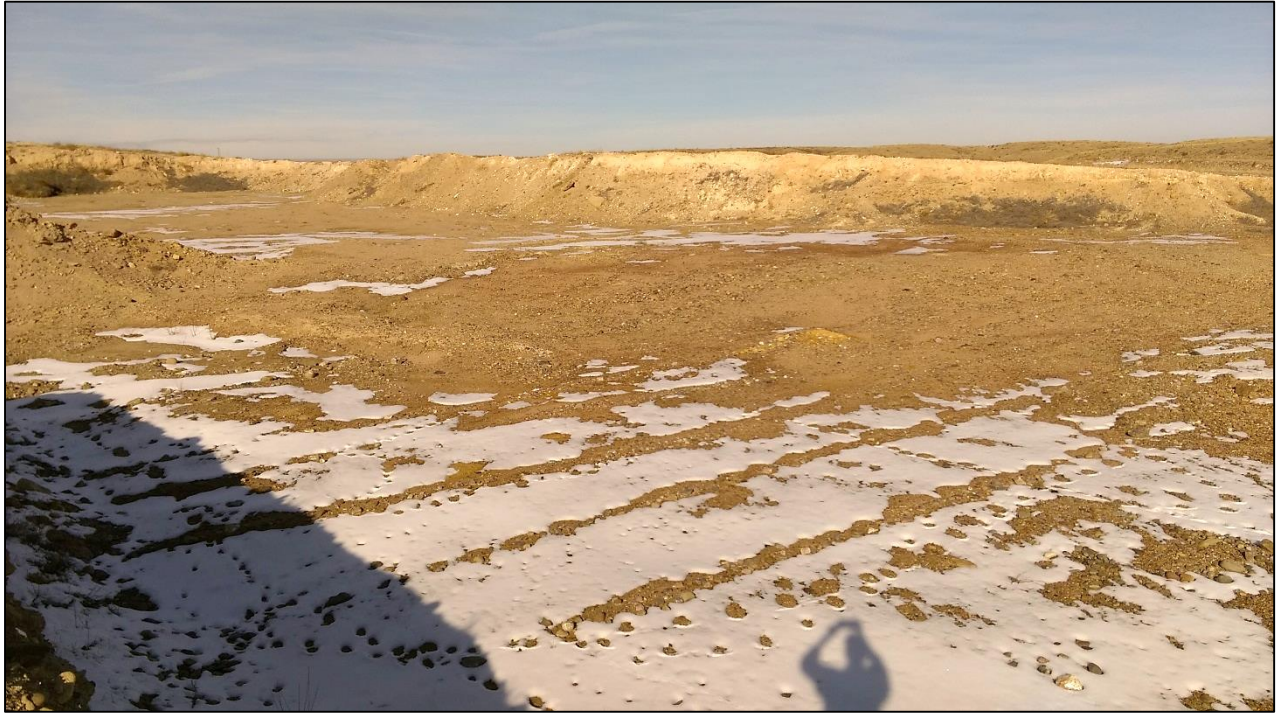
Photo 26. View looking northeast, showing portion of west-facing mined wall present along northern edge of phase 2 mining area. Note mined wall approximately 10 feet in height with near vertical slope gradients.

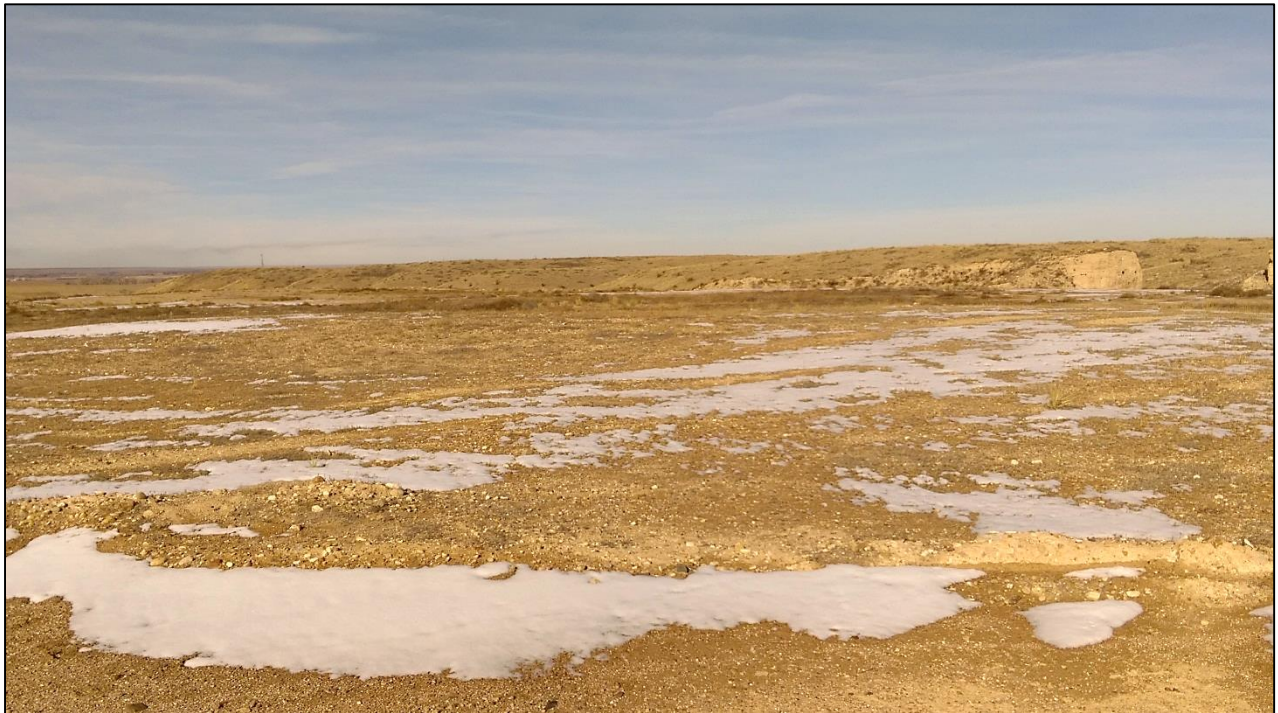
Photo 27. View looking northeast across area in reclamation located in previously mined eastern portion of phase 2 mining area. Note area graded to flatter than 3H:1V and retoppedsoiled, with no vegetation present.

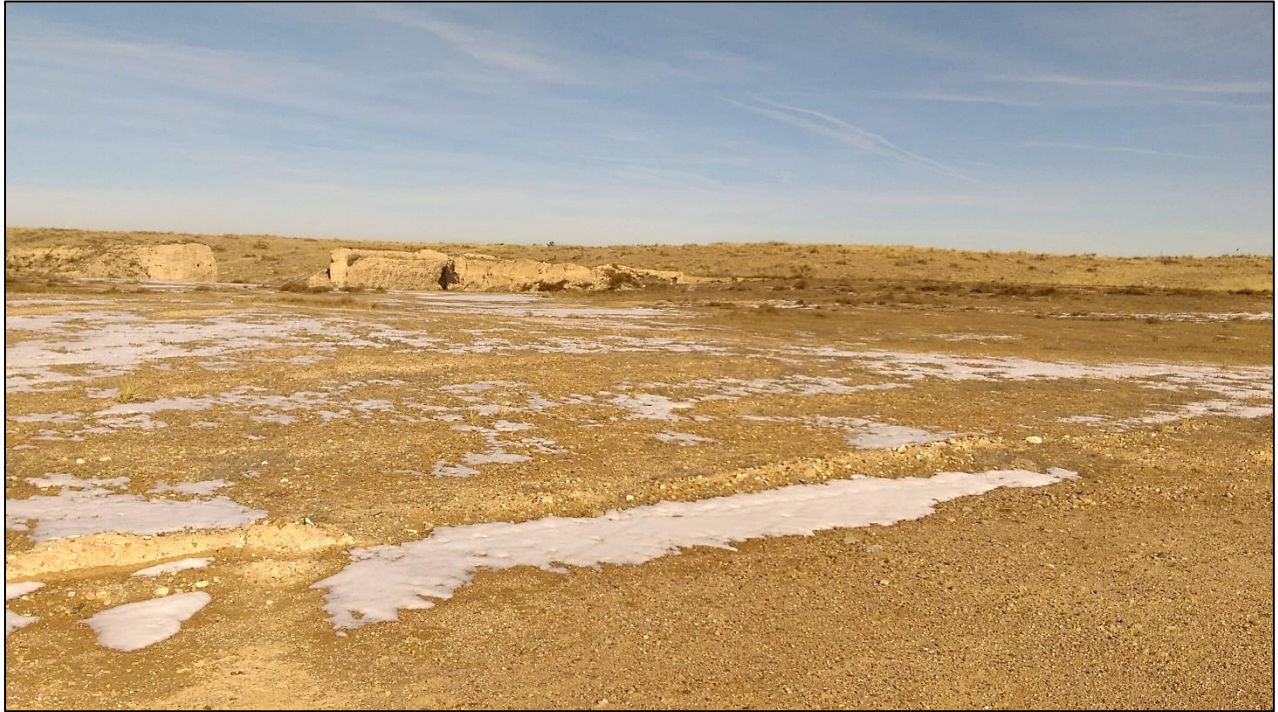
Photo 28. View looking east across area in reclamation located in previously mined eastern portion of phase 2 mining area. Note area graded to flatter than 3H:1V and retopsoiled, with no vegetation present. Portion of overburden stockpile shown in background (at left).

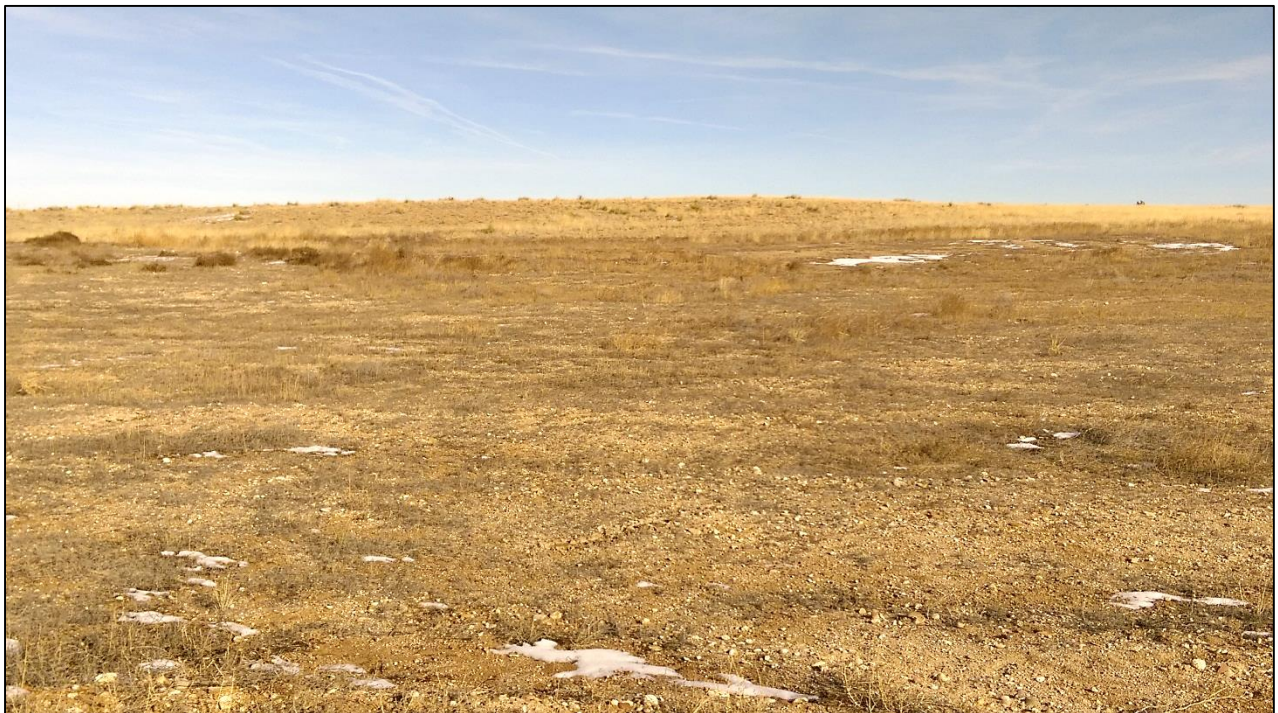
Photo 29. View looking east across area in reclamation located in previously mined eastern portion of phase 2 mining area. Note area graded to flatter than 3H:1V and retopsoiled, with very sparse vegetation present.

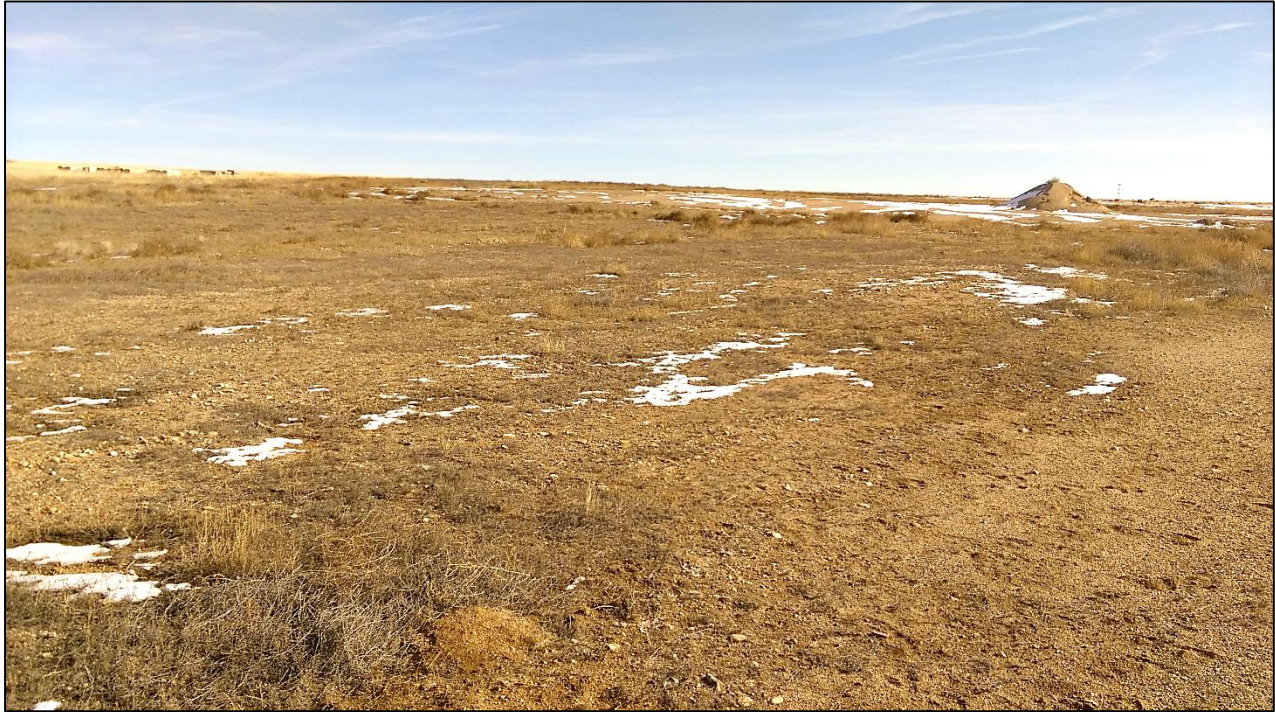
Photo 30. View looking southeast across area in reclamation located in previously mined eastern portion of phase 2 mining area. Note area graded to flatter than 3H:1V and retopsoiled, with very sparse vegetation present.

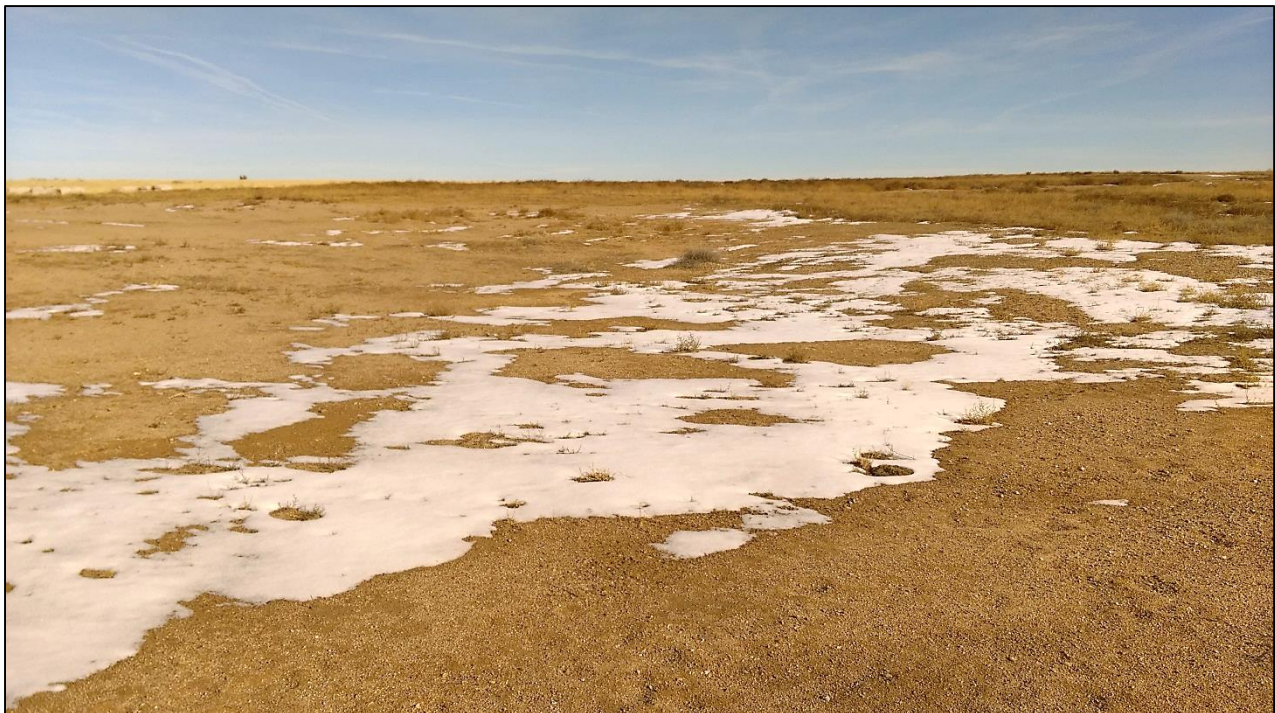
Photo 31. View looking southeast across area in reclamation located in previously mined eastern portion of phase 2 mining area. Note area graded to flatter than 3H:1V and retopsoiled, with very little to no vegetation present.

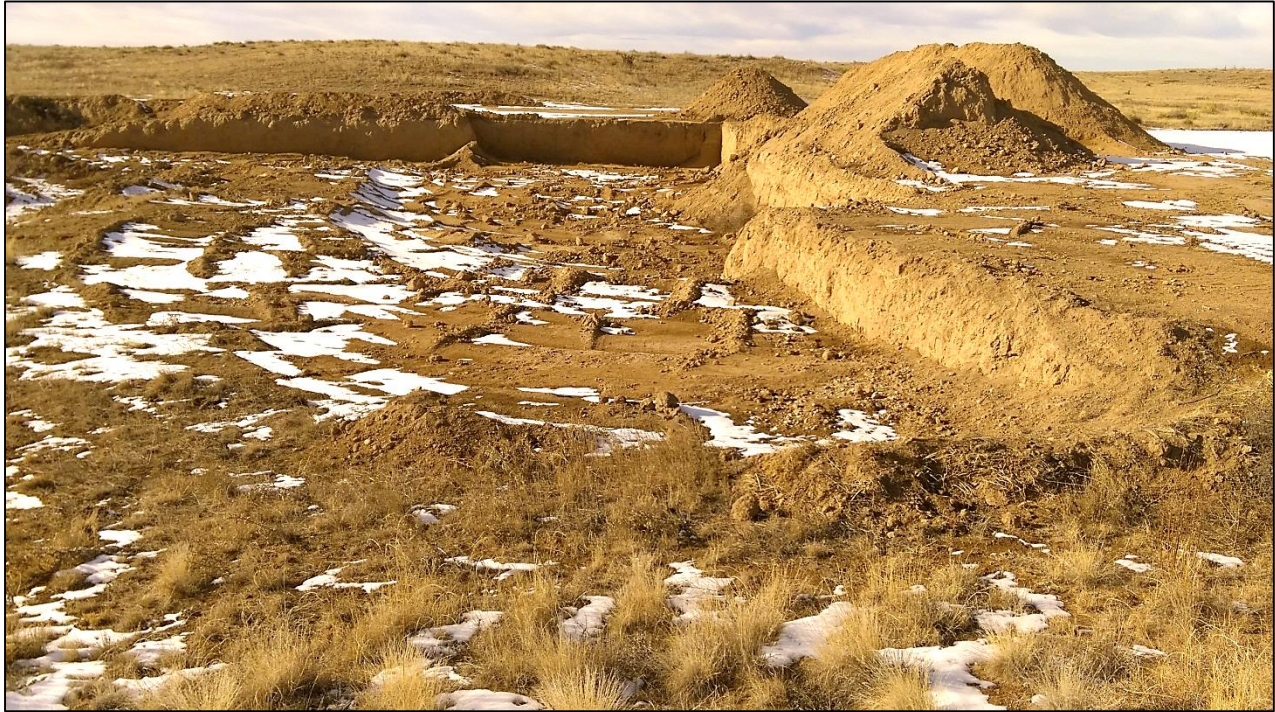
Photo 32. View looking northwest across small pit located in phase 3 mining area. Note mined walls approximately 5 feet or less in height with near vertical slope gradients. Also note small material stockpiles stored along northern edge of pit.

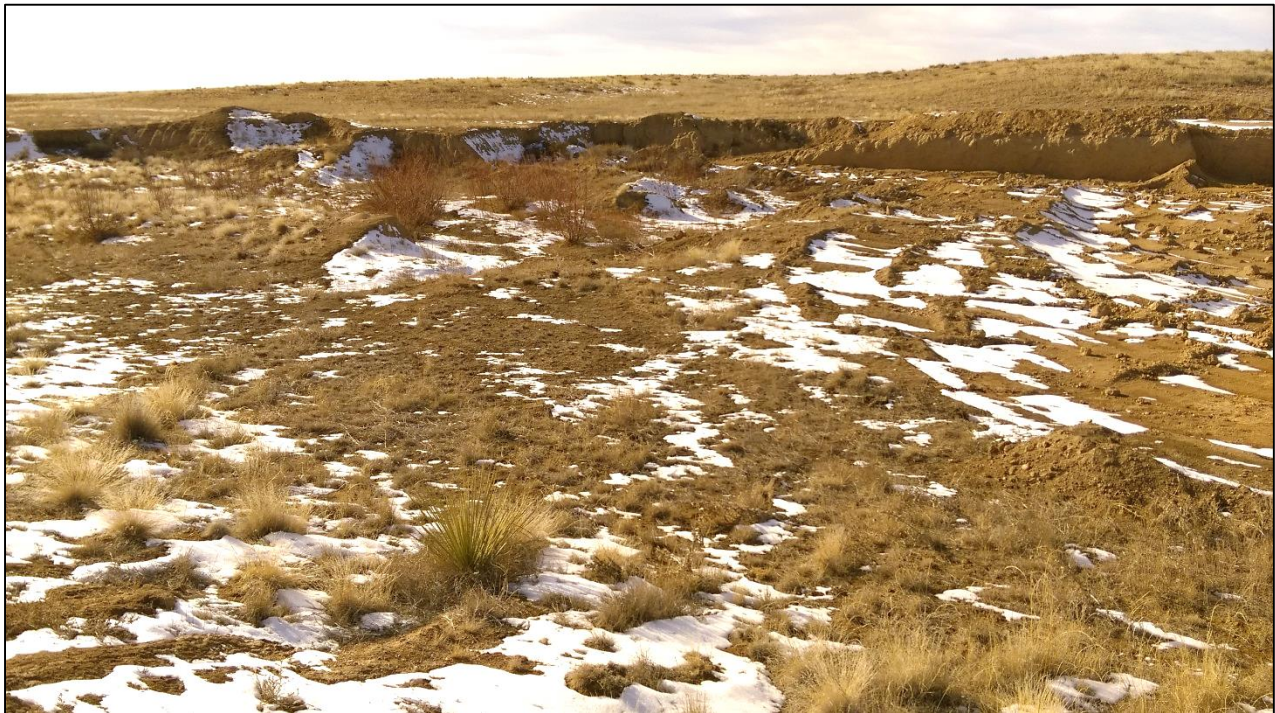
Photo 33. View looking southwest across small pit located in phase 3 mining area. Note mined walls approximately 5 feet or less in height with near vertical slope gradients. Also note native grasses and yucca volunteering into disturbed area.

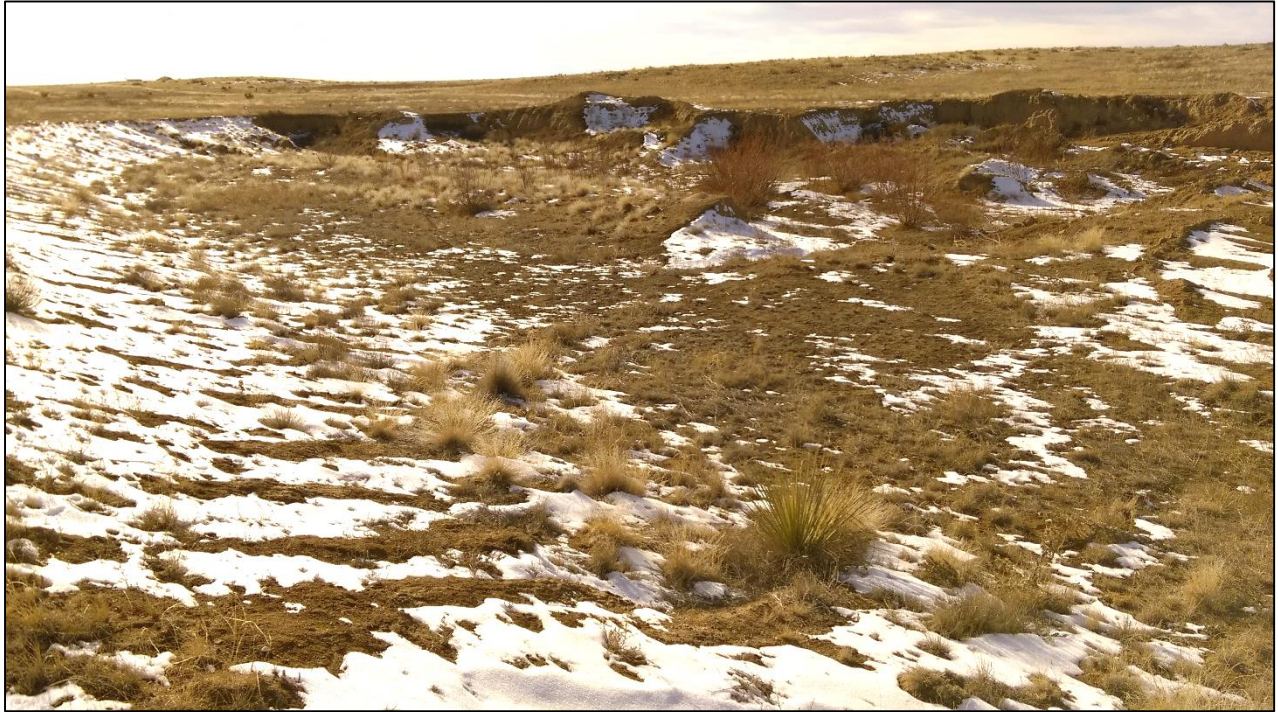
Photo 34. View looking southwest across small pit located in phase 3 mining area. Note mined walls approximately 5 feet or less in height with near vertical slope gradients. Also note native grasses and yucca volunteering into disturbed area.

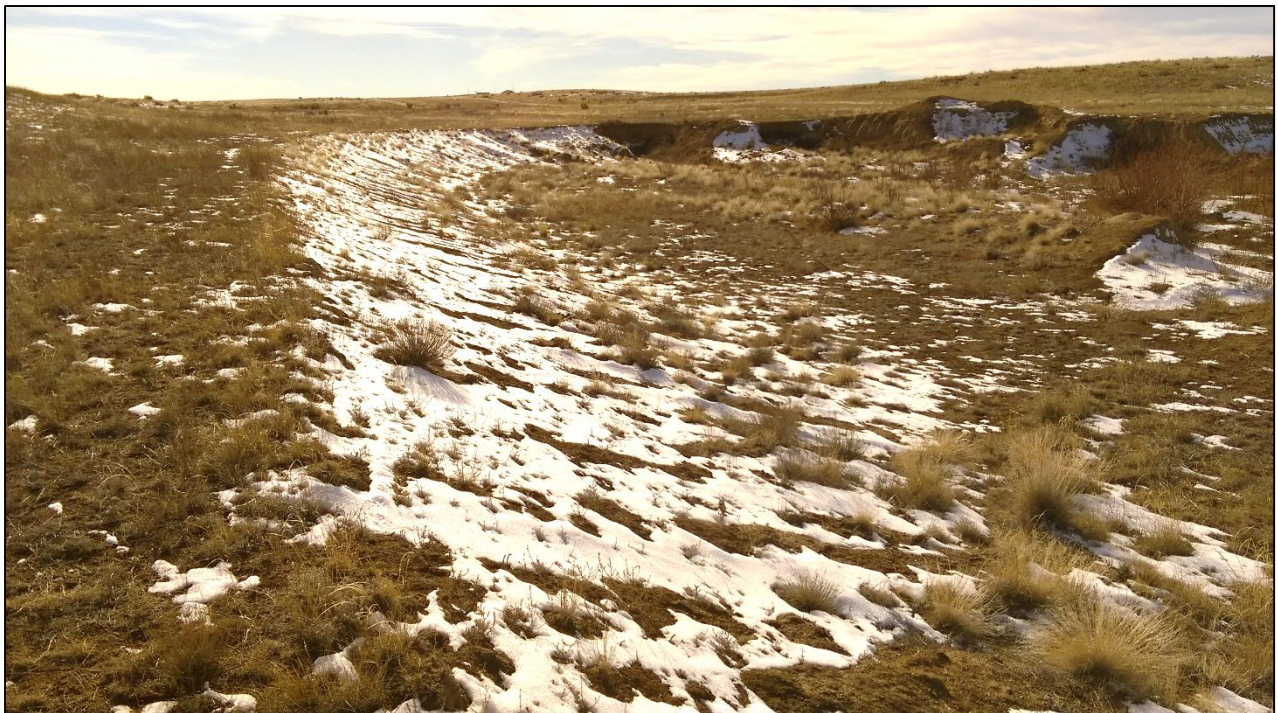
Photo 35. View looking southwest across small pit located in phase 3 mining area, showing south-eastern mined wall graded to 3H:1V. Note native grasses and yucca volunteering into disturbed area.

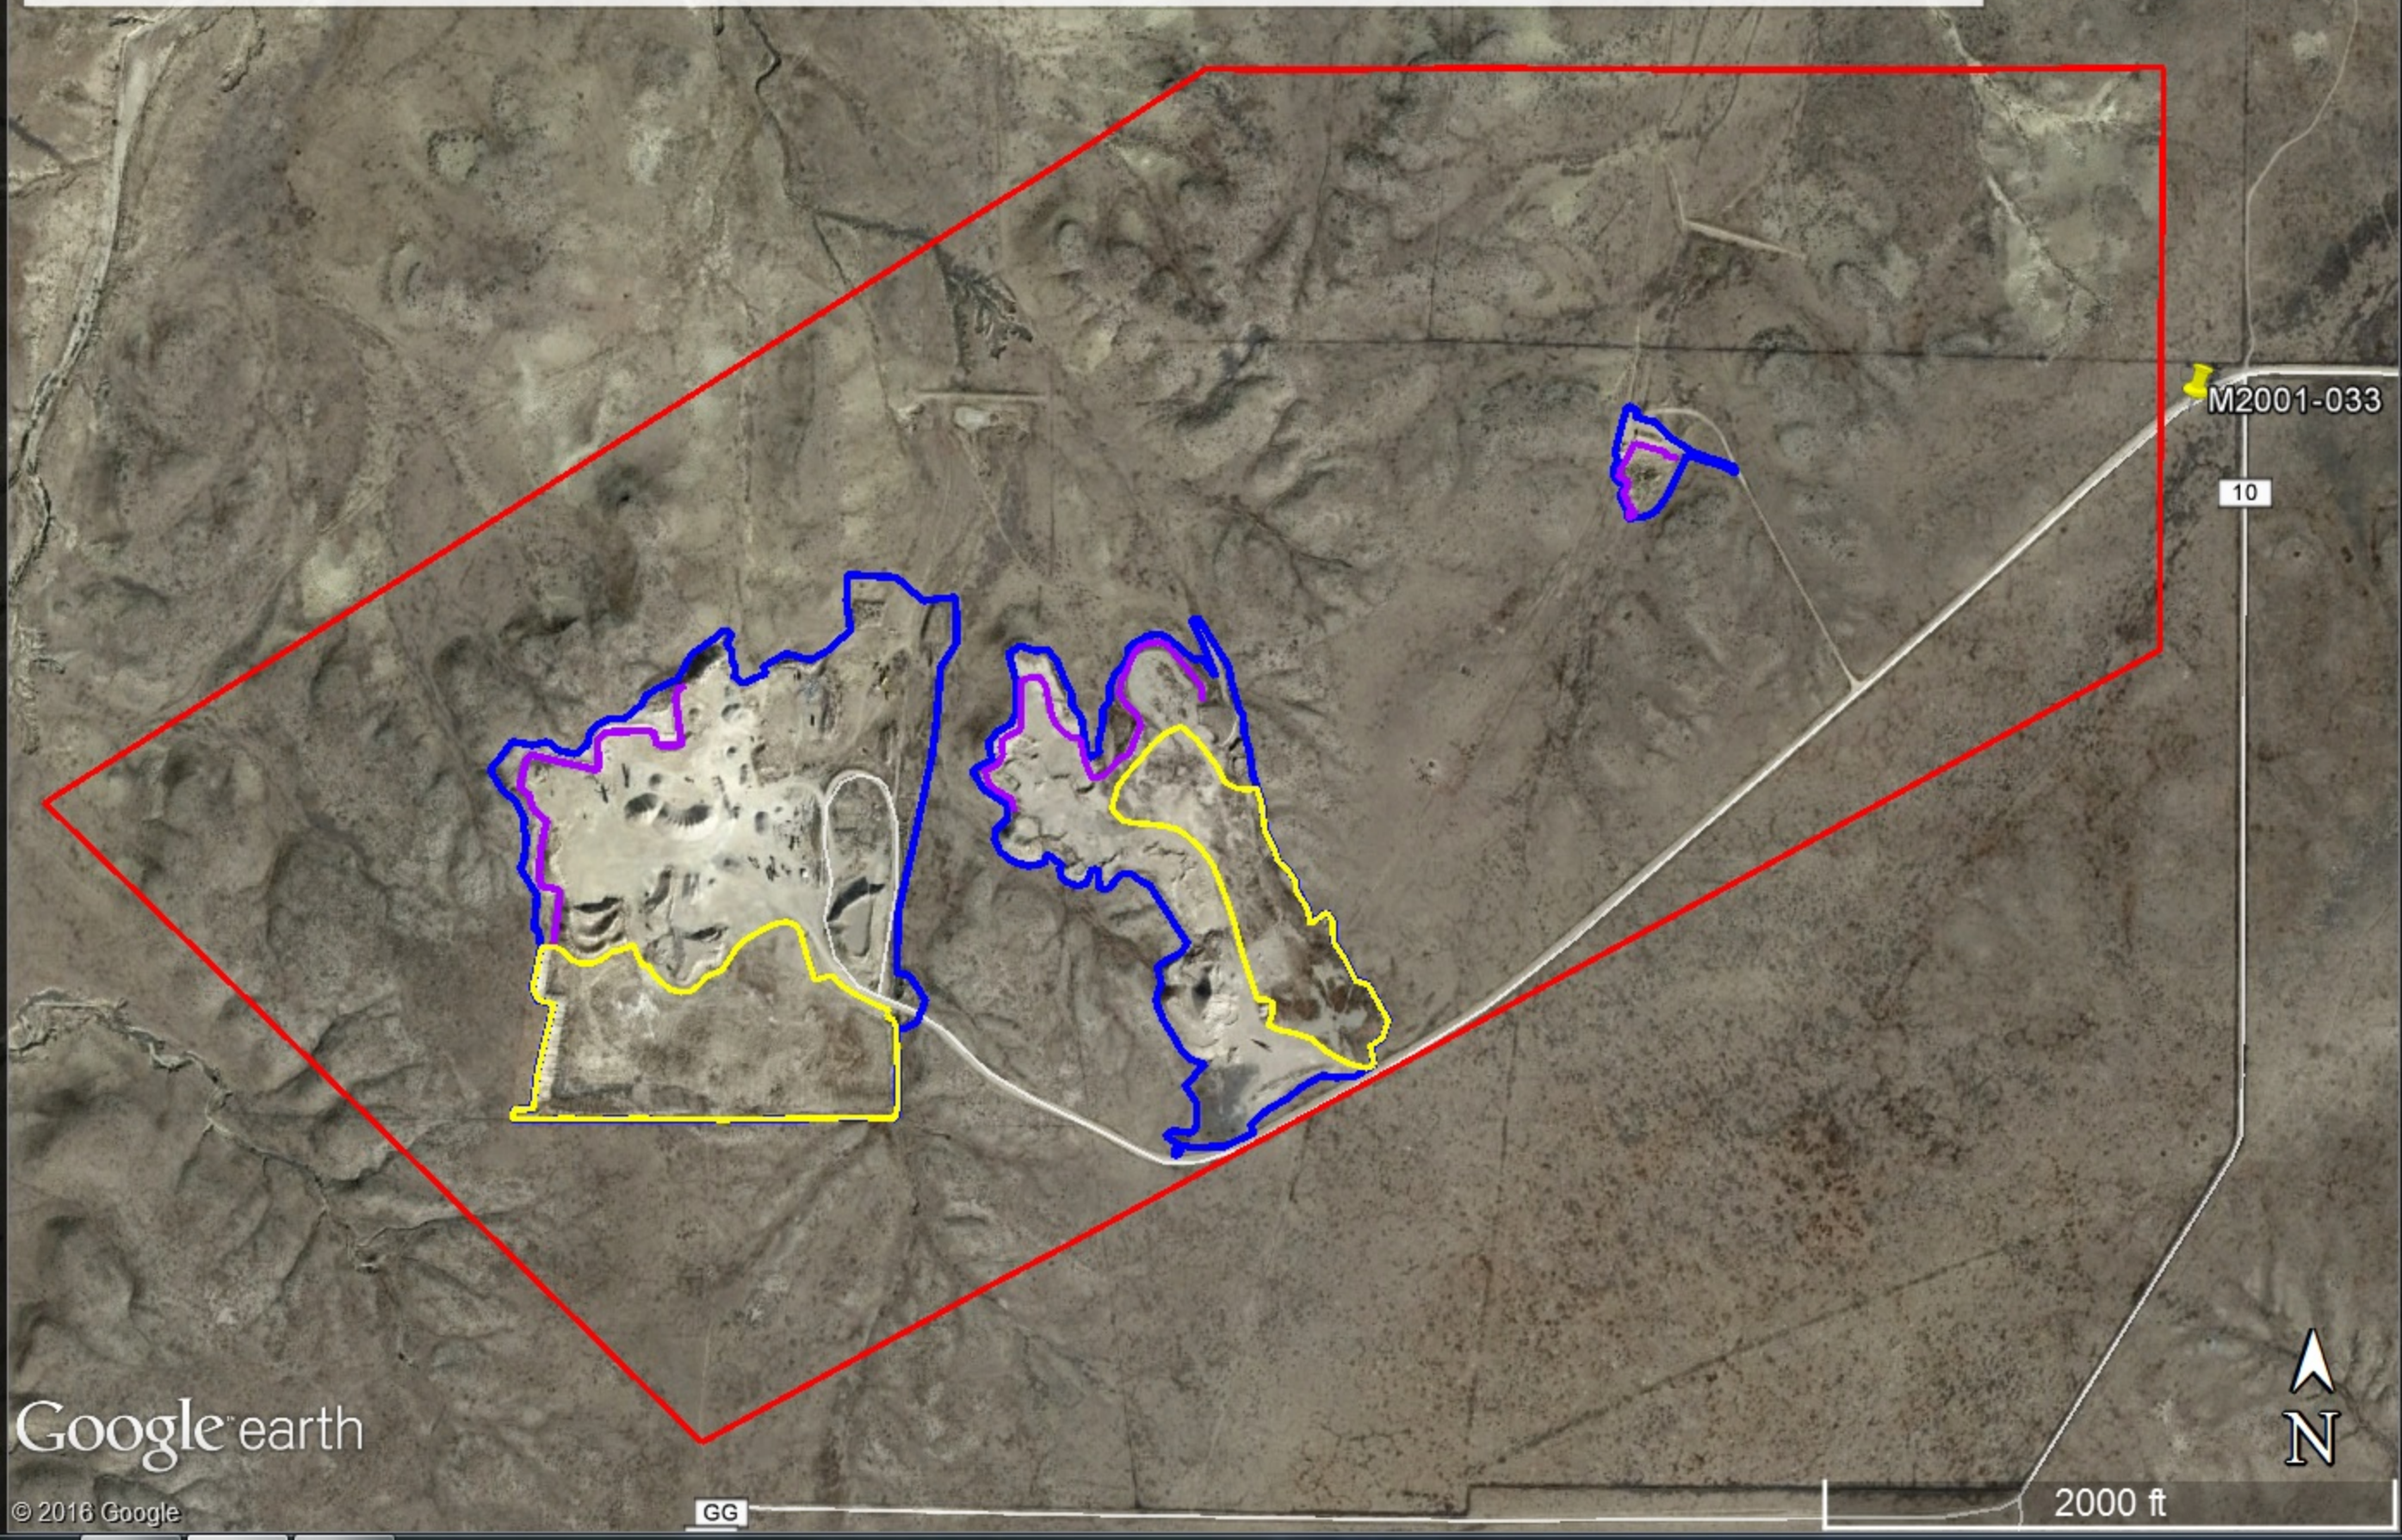
M2001-033 / Rough Cut Pit / Rough Cut L.L.C

Including all three phases mined thus far, the Division estimates that the operation has disturbed a total of approximately 75.7 acres, which is more than the approved maximum allowed disturbance of 45 acres. The Division estimates that a total of 23.25 acres are in reclamation, which would leave 52.45 acres of disturbance that are not in reclamation. The Division understands this is a phased mining operation that wishes to maintain a floating bond. This means that the Division will not include disturbed land that has been graded, retopsoiled and seeded in the maximum allowed disturbed area. However, until the reclaimed areas have a well-established vegetative cover consistent with the approved reclamation plan, the Division must continue to hold a portion of the required bond for revegetating these areas. **A problem is being cited in this report (see page 1) for**

Blue Outline = 75.7 acres = Total Disturbed Area (48.2 acres Phase 1 + 26 acres Phase 2 + 1.5 acres Phase 3)

CORRECTIVE ACTIONS: The operator shall submit a Technical Revision, with the required \$216 revision fee, to update and clarify the current approved mine plan to reflect existing and proposed activities by the corrective action date. Specifically, the operator shall increase the maximum allowed disturbed area to at least 53 acres to account for existing disturbance.
