COLORADO DIVISION OF RECLAMATION, MINING AND SAFETY
MINERALS PROGRAM INSPECTION REPORT
PHONE: (303) 866-3567

MINE NAME: Cresson Project	MINE/PROSPECTING ID#: M-1980-244	MINERAL: Gold	COUNTY: Teller
INSPECTION TYPE: Monitoring	INSPECTOR(S): Elliott R. Russell	INSP. DATE: February 18, 2016	INSP. TIME: 10:00
OPERATOR: Cripple Creek & Victor Gold Mining Company	OPERATOR REPRESENTATIVE: Chris Hanks	TYPE OF OPERATION: 112d-3 - Designated Mining Operation

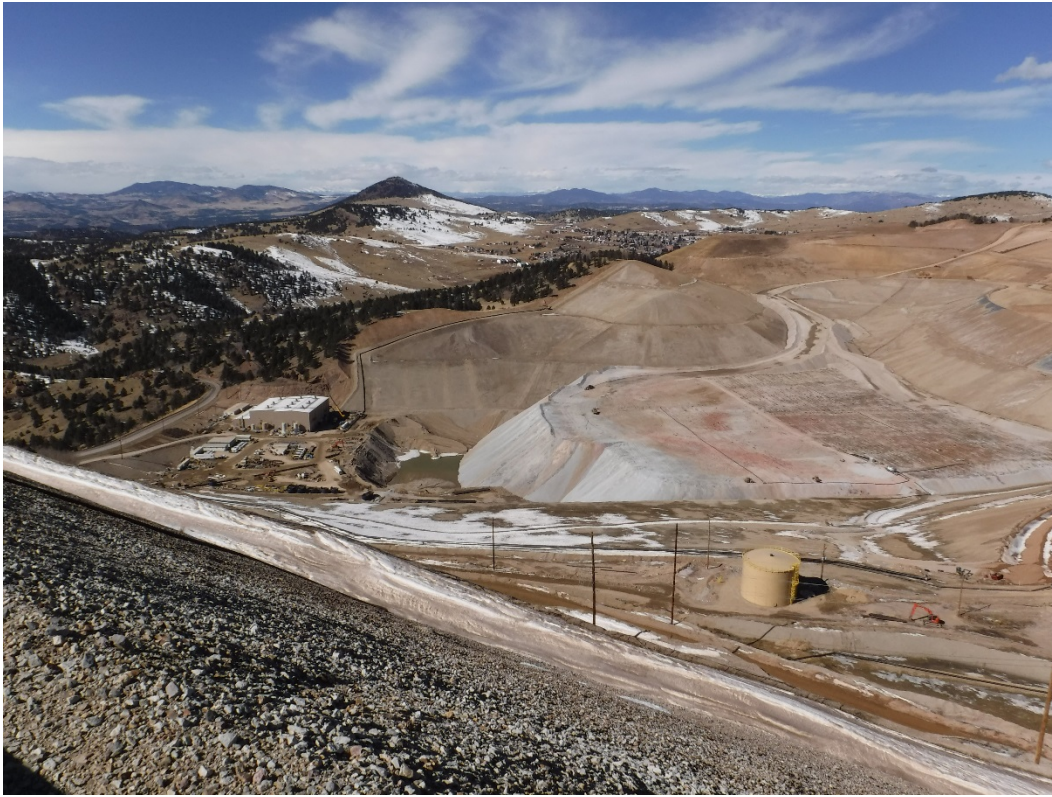
The Division and Mr. Hanks were accompanied by Ron DiDonato into the SGVLF. Ore had been stacked in the majority of the Pregnant Solution Storage Area (PSSA); the pad was being advanced toward the ADR2 and the pad elevation was 9,550' (**Photo 1**). Feeder lines and distribution lines were being installed on the northeast portion of the pad (**Photo 2**). The Division observed standing water/solution, approximately ½ acre in size, in the bottom of the PSSA at the toe of the stacking face (**Photo 3**). The Division met with Jeff Winterton to discuss the start-up of the leaching activities in the SGVLF. Mr. Winterton stated he thought the current exposed pond depth in the PSSA was roughly 10 feet. He was recirculating the solution by pumping from one of the ADR2 riser pipes and planned to pump the pond down beneath the level of the spent ore. Since this water is potentially impacted and greater than 9 sq. ft. as identified in the permit, the Division has cited this as Compliance Problem 1 requiring corrective action which the Operator resolved on March 3, 2016. The Operator emailed photographs showing that the pond had been covered by the advancement of the ore pad and the water was no longer exposed (**Photos 4 & 5**).

Photo 1. Overview of the SGVLF; looking northwest.

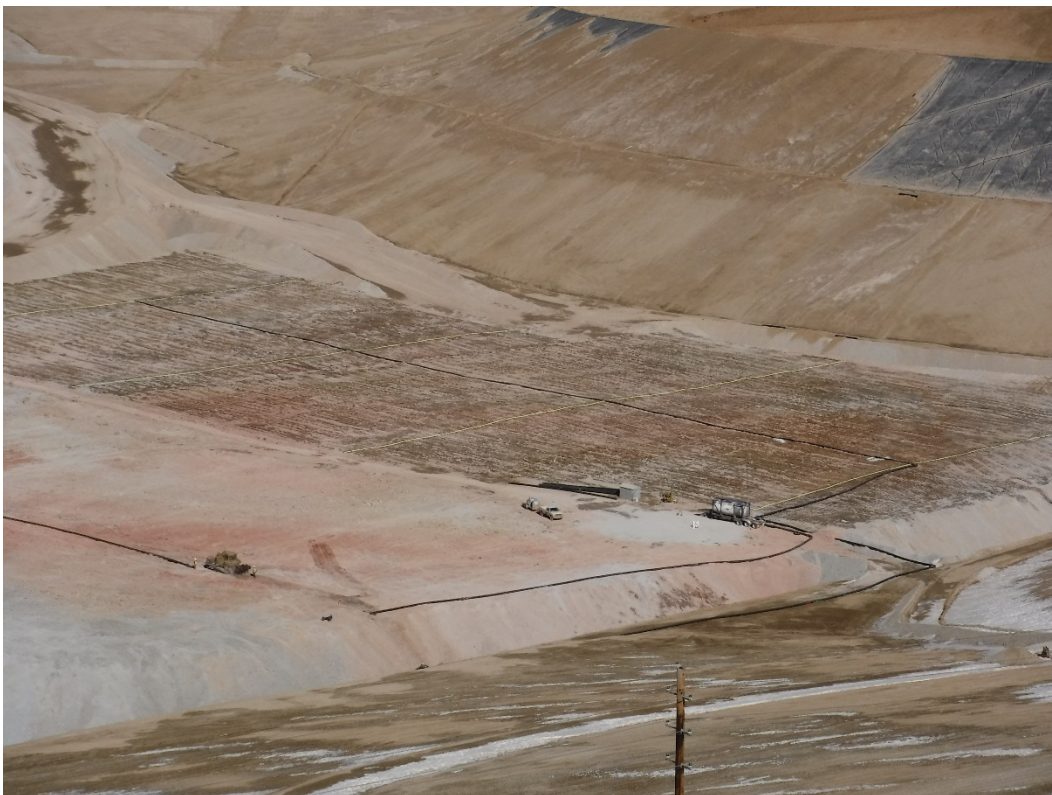
Photo 2. Distribution and feeder lines located on the northeast portion of the SGVLF ore pad; looking northeast.

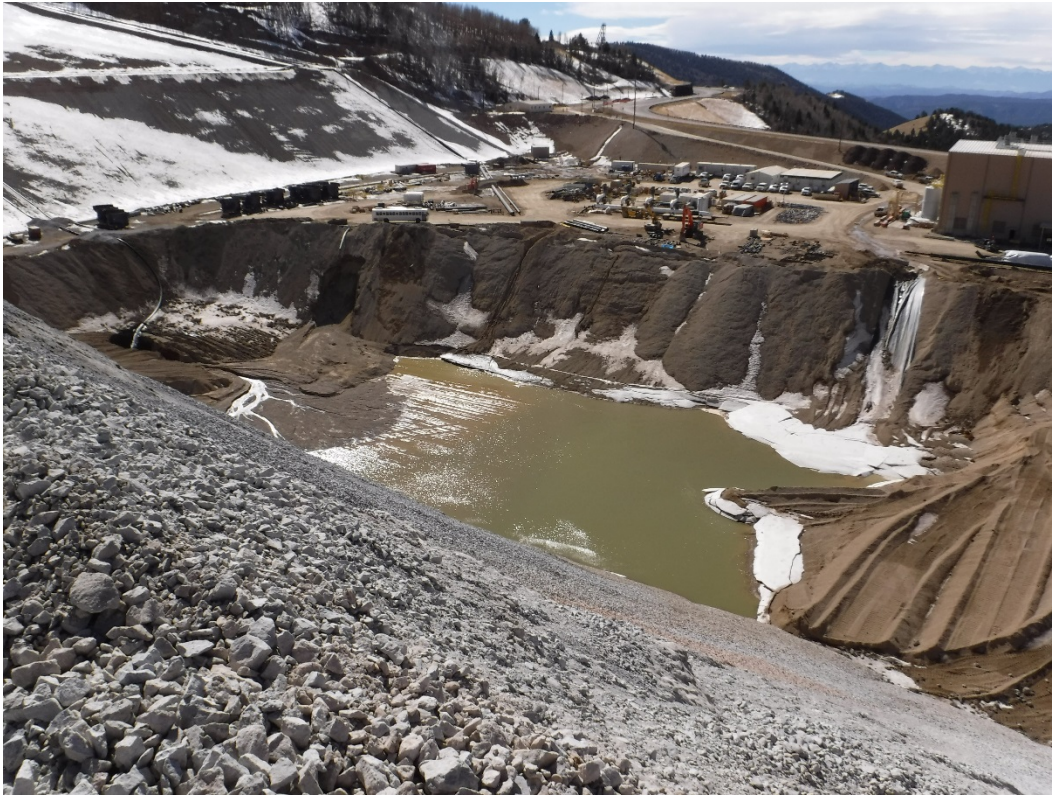
PROBLEM/POSSIBLE VIOLATION: Problem 1: A significant amount of potentially impacted water was observed in the SGVLF PSSA. This is a potential wildlife attractant.

Photo 3. Standing water in the SGVLF PSSA; looking southwest down the active stacking face of the pad.

CORRECTIVE ACTIONS: Provide an estimate as to how long this condition may persist and a proposed means to address/mitigate the problem by the Corrective Action due date.

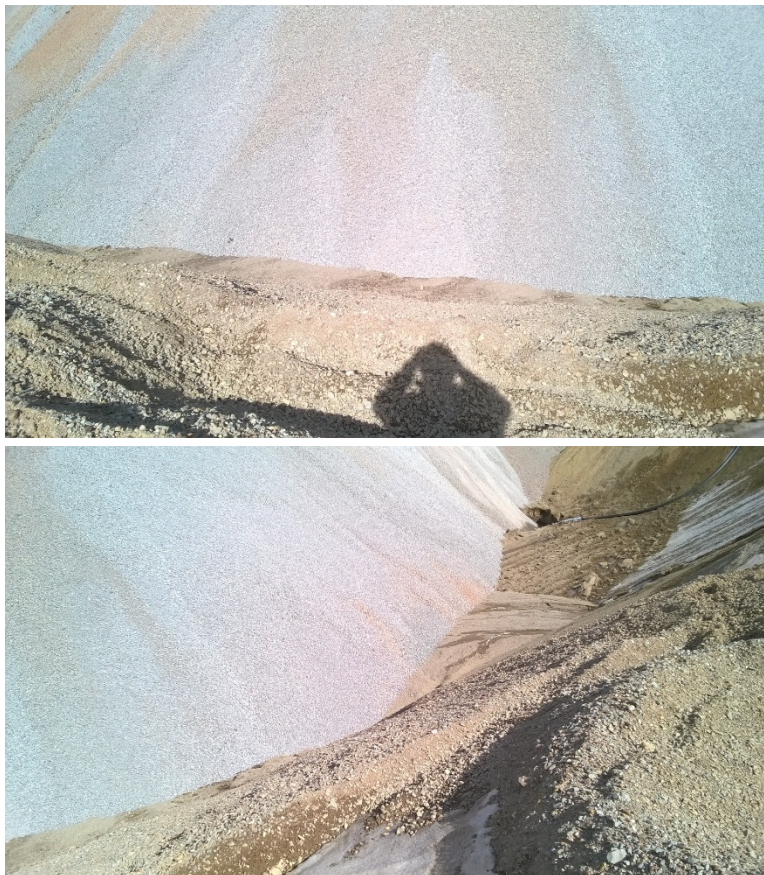
Photos 4 & 5. Photos submitted by the Operator showing ponded solution had been covered by the ore pad.

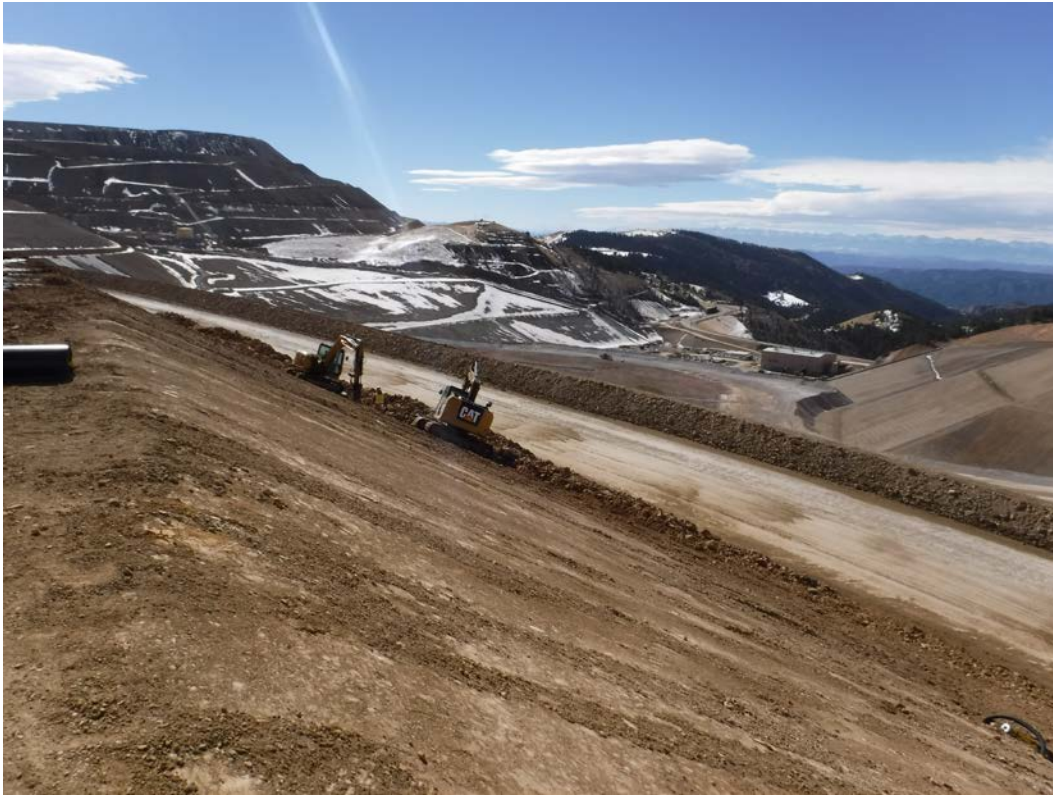
Other SGVLF construction activities occurring at the time of the inspection included a Phase I cut and Phase II fill earthwork project near the entrance of the SGVLF haul road. Mr. DiDonato explained that the Phase II leak detection sump will be constructed slightly different than proposed. The proposed location had the sump being constructed in a portion of a major haul road so they have planned to relocate it to the other side of the haul road's safety berm toward the SGVLF. This modification will remove an area (approximately 2 acres) of the liner as well as a change of the Phase II leak detection trench alignment and length. The Division also observed the construction on the upper reaches of the Phase

Photo 6. Construction of the leak detection trench just above the SGVLF haul road; looking southwest.

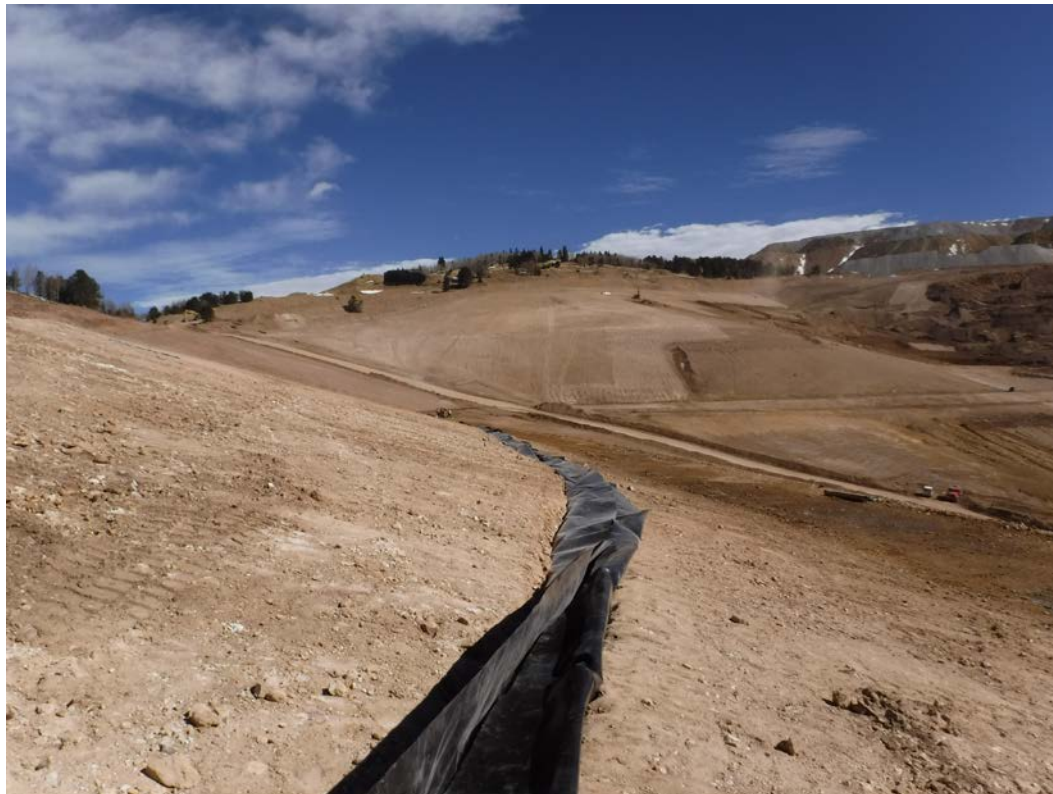
I Leak Detection Trench 1. (**Photos 6 & 7**).

Photo 7. Leak detection trench and membrane completed, awaiting a soil cap; looking northeast.

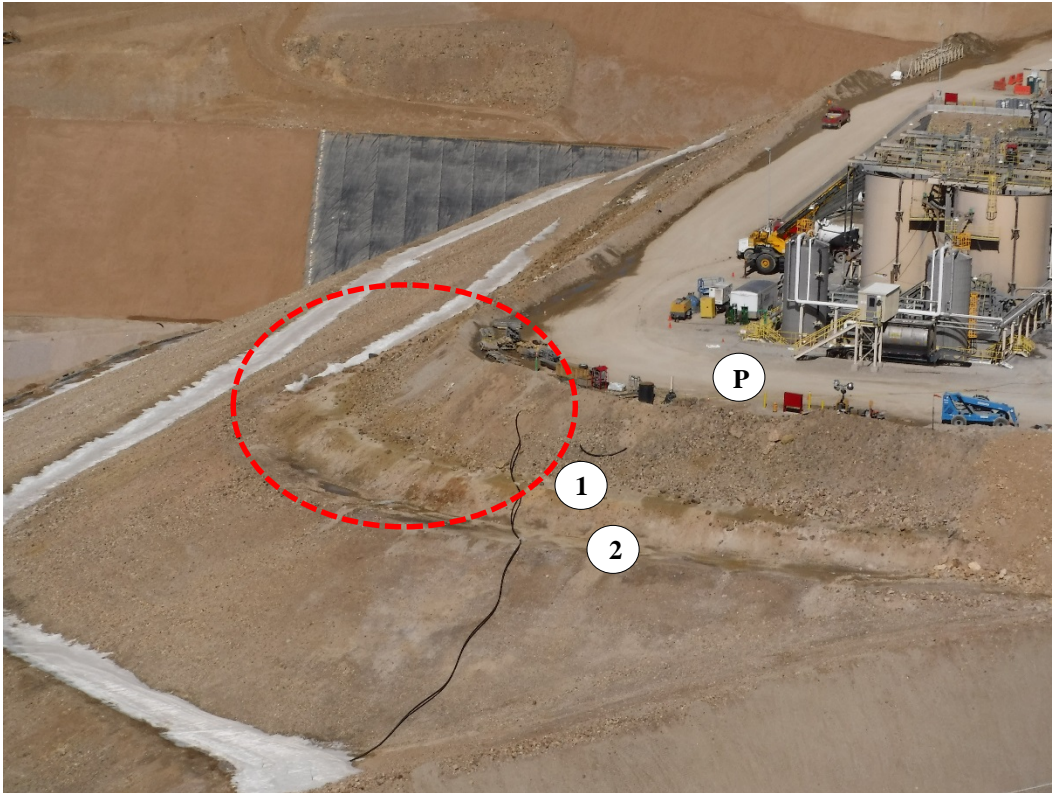
PROBLEM/POSSIBLE VIOLATION: Problem 2: The Division is unable to determine the possible impact with observations made near the southwest corner of the High Grade Mill Pad without definitively knowing where the edge of the mill pad liner is located.

Following up with observations made during the December 28, 2015 Aerial Inspection, the Division inspected the southwest corner of the High Grade Mill Pad (HGM). An aerial photograph showed some stained soils along the outward slope of the HGM. During this site inspection, the Division visited this area and discovered several distinct areas with altered soil colors (**Photos 8-11**). The Division was unable to determine the edge of the HGM pad liner and will need this information to determine significance and possibly the cause of these stained soils. This has been cited as Compliance Problem 2 requiring the Operator to delineate the edge of the mill pad liner before the next site inspection. Division has scheduled a site inspection for March 15, 2016.

Photo 8. Overview of the southwest corner of the High Grade Mill Pad, area of concern circled in red; looking north.
(P=Pad, 1=1st Bench, 2=2nd Bench)

CORRECTIVE ACTIONS: The Operator shall establish temporary markers along the edge of the mill pad liner before the next site inspection.

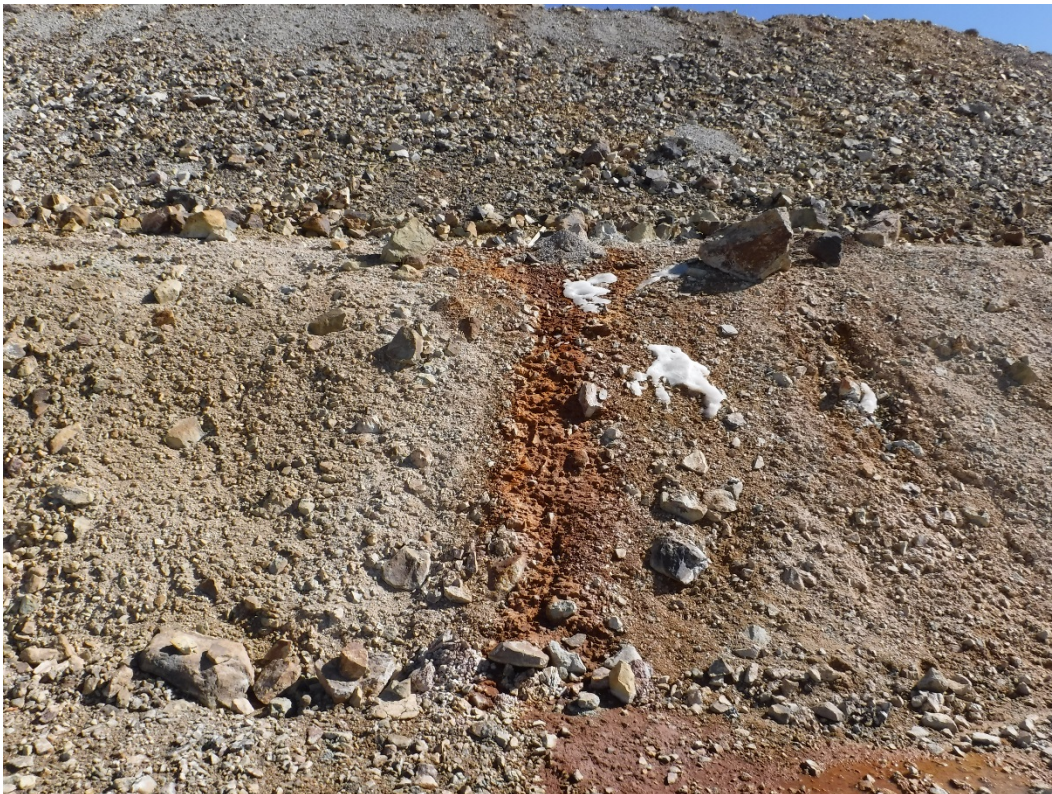
Photo 9. Area of altered soils; looking southeast.

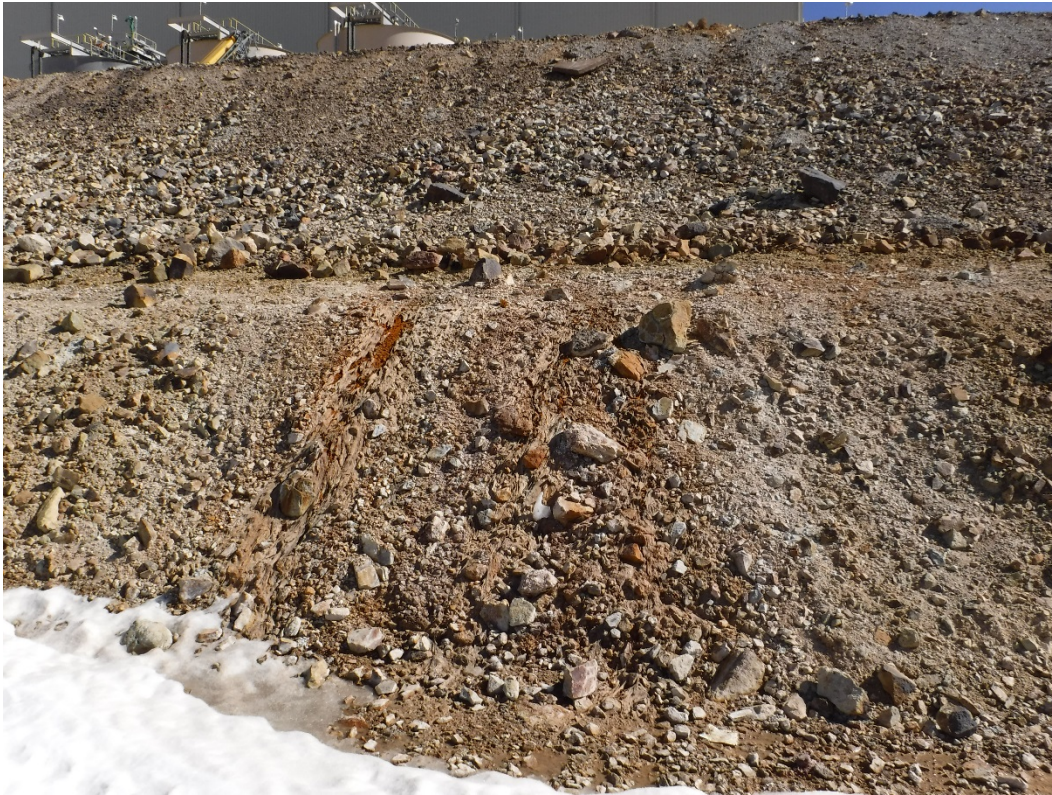
Photo 10. Additional photo of the Area of altered soils; looking southeast.

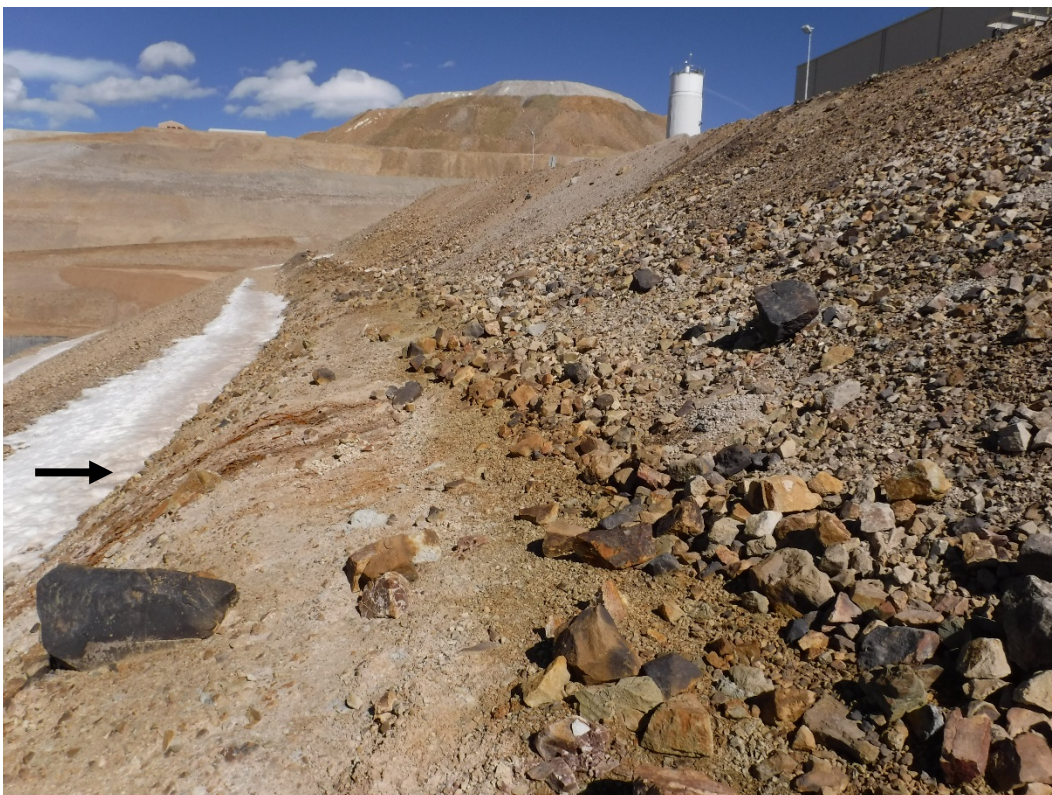
Photo 11. Additional photo of the Area of altered soils; looking northeast from the 1st bench. Black arrow representing direction and approximate location of Photo 10.

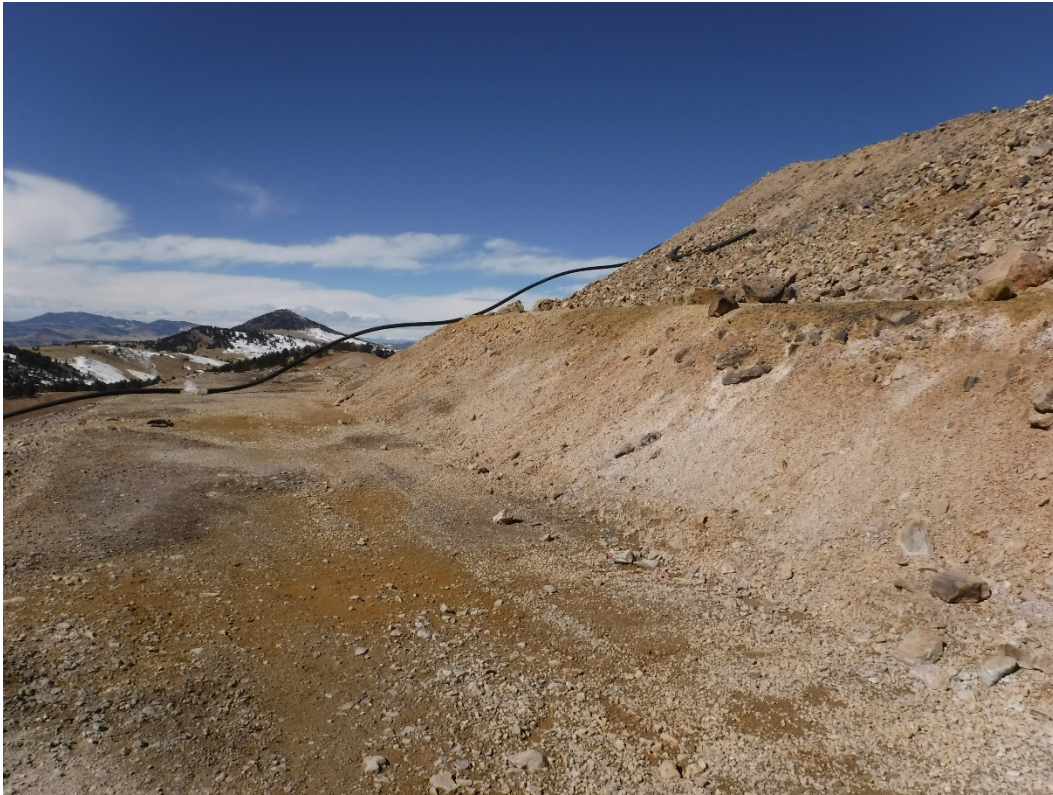
Photo 12. Southern portion of the southwest corner of the High Grade Mill pad, looking northwest.

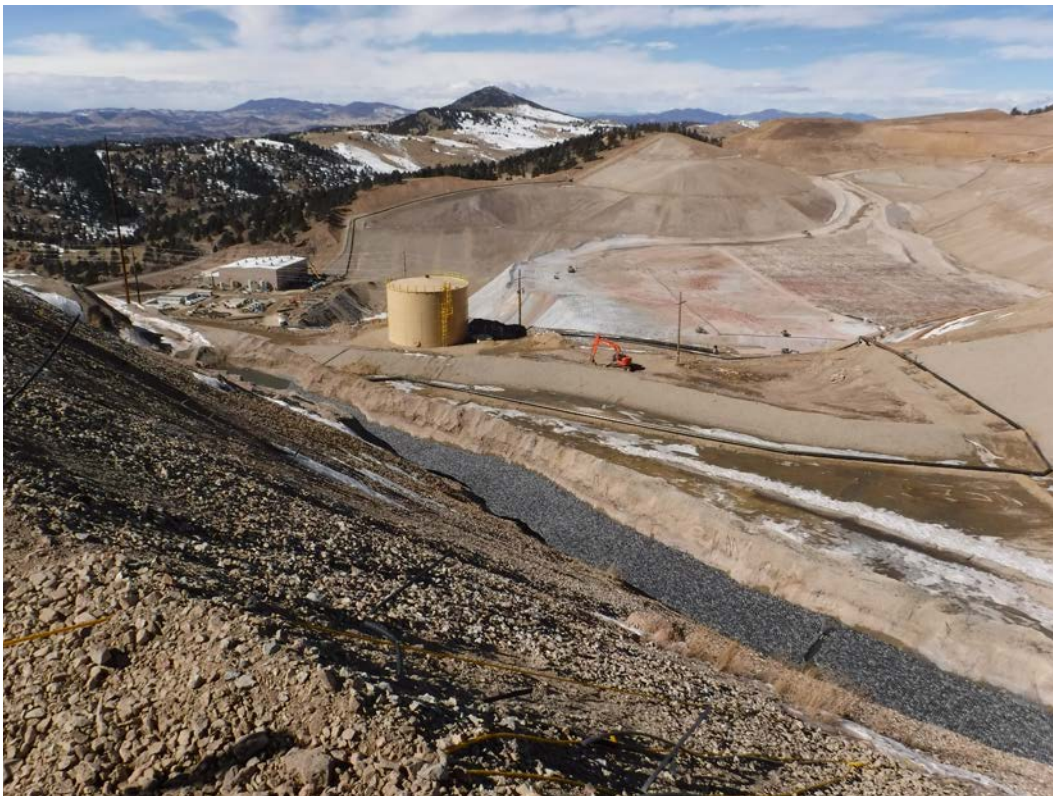
The Division observed “bird balls”, which replaced the temporary netting, in the High Grade Mill solution infiltration trench in the northern portion of the AGVLF pad (**Photo 12**).

Photo 13. High Grade Mill water Infiltration trench on the north side of the AGVLF with "Bird Balls" floating on the surface; looking northwest.

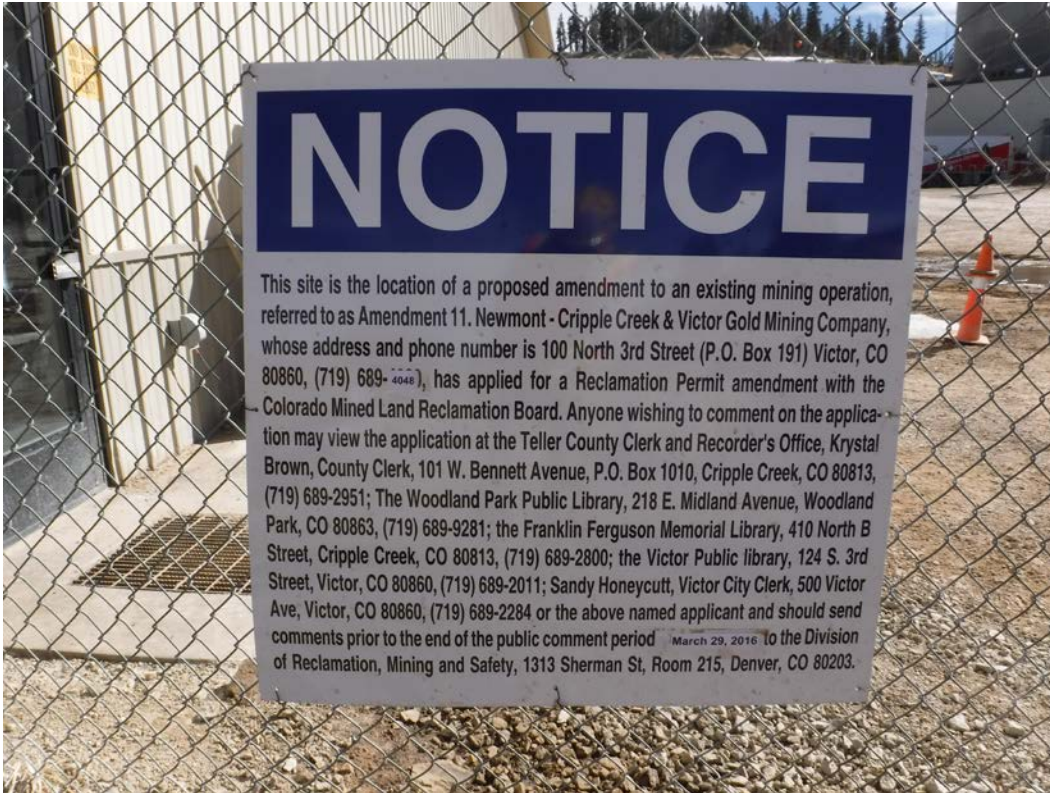
The Division observed the posted Amendment 11 notice at the entrance to the Iron Clad Facilities (**Photo 13**).

Photo 12. Amendment 11 notice at the entrance to the Iron Clad Facilities; looking south.
