**COLORADO DIVISION OF RECLAMATION, MINING AND SAFETY**  
**MINERALS PROGRAM INSPECTION REPORT**  
**PHONE: (303) 866-3567**

<b>MINE NAME:</b> E 8 <sup>th</sup> Street Operation	<b>MINE/PROSPECTING ID#:</b> M-2000-082	<b>MINERAL:</b> Sand and Gravel	<b>COUNTY:</b> Weld
<b>INSPECTION TYPE:</b> Monitoring	<b>INSPECTOR(S):</b> Peter S. Hays	<b>INSP. DATE:</b> March 11, 2016	<b>INSP. TIME:</b> 12:00
<b>OPERATOR:</b> Superior Oilfield Services Co., LTD	<b>OPERATOR REPRESENTATIVE:</b> Jack Miller	<b>TYPE OF OPERATION:</b> 112c - Construction Regular Operation

<b>REASON FOR INSPECTION:</b> Citizen Complaint	<b>BOND CALCULATION TYPE:</b> None	<b>BOND AMOUNT:</b> \$270,000.00
<b>DATE OF COMPLAINT:</b> March 7, 2016	<b>POST INSP. CONTACTS:</b> None	<b>JOINT INSP. AGENCY:</b> None
<b>WEATHER:</b> Clear	<b>INSPECTOR'S SIGNATURE:</b>

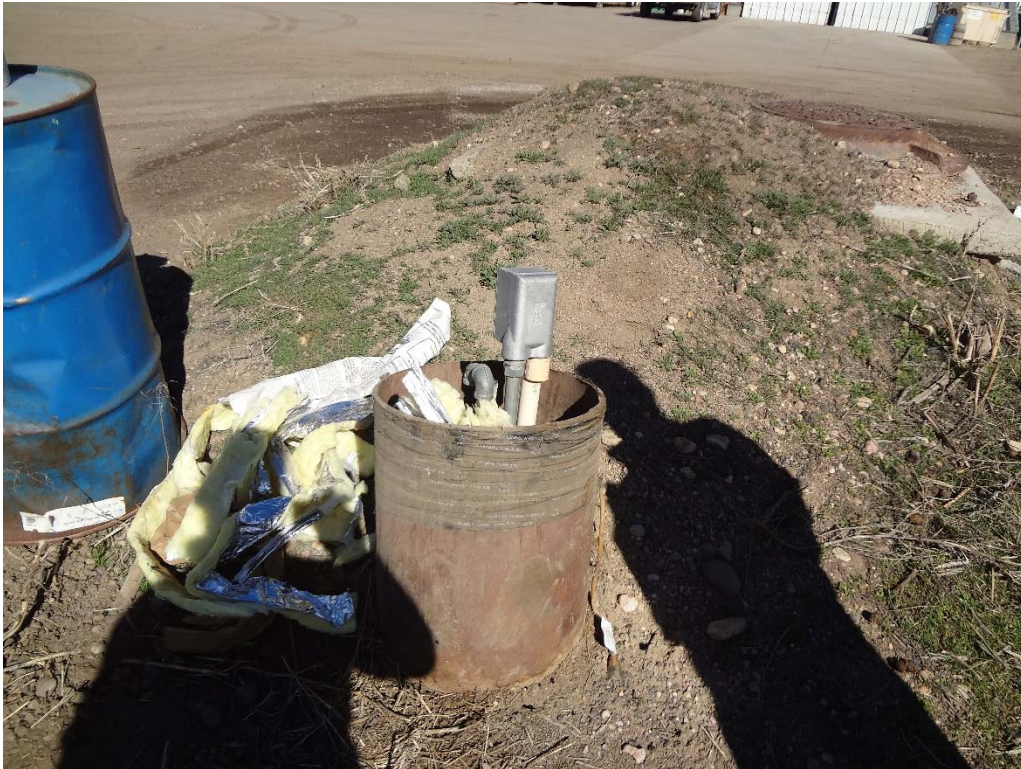
The upper well casing and wellhead were observed during the inspection. The groundwater and pump elevations could not be determined during the inspection, due to the lack of an access port in the well. The well location was GPS surveyed using a Trimble Juno 3B by the Division.

Mr. Tyrrell stated Quality Well and Pump (Quality) inspected the well on February 28, 2016. Mr. Tyrrell stated Quality determined the well pumps were operational and the reason for the lack of water was insufficient groundwater in the well. The Division requested Mr. Tyrrell contact Quality for information on the depth to water, well depth and depth to the pump measured during the Quality inspection, if available. The information has not been received by the Division as of the mailing date of this inspection report. The Tyrrell well pumps to a cistern before water is pumped to the house and shop building. Mr. Tyrrell did not know the capacity of the cistern or if the cistern could be filled with delivered water as a possible short term mitigation measure for the well.

Tyrrell wellhead and casing

As cited as a problem, the Operator must implement the approved groundwater mitigation plan for the site. The Operator must submit a report to the Division within thirty (30) days. The report must include the specific mitigation measures taken by the Operator to alleviate the effect of the dewatering at the E 8th Street Operation on the Tyrrell well.

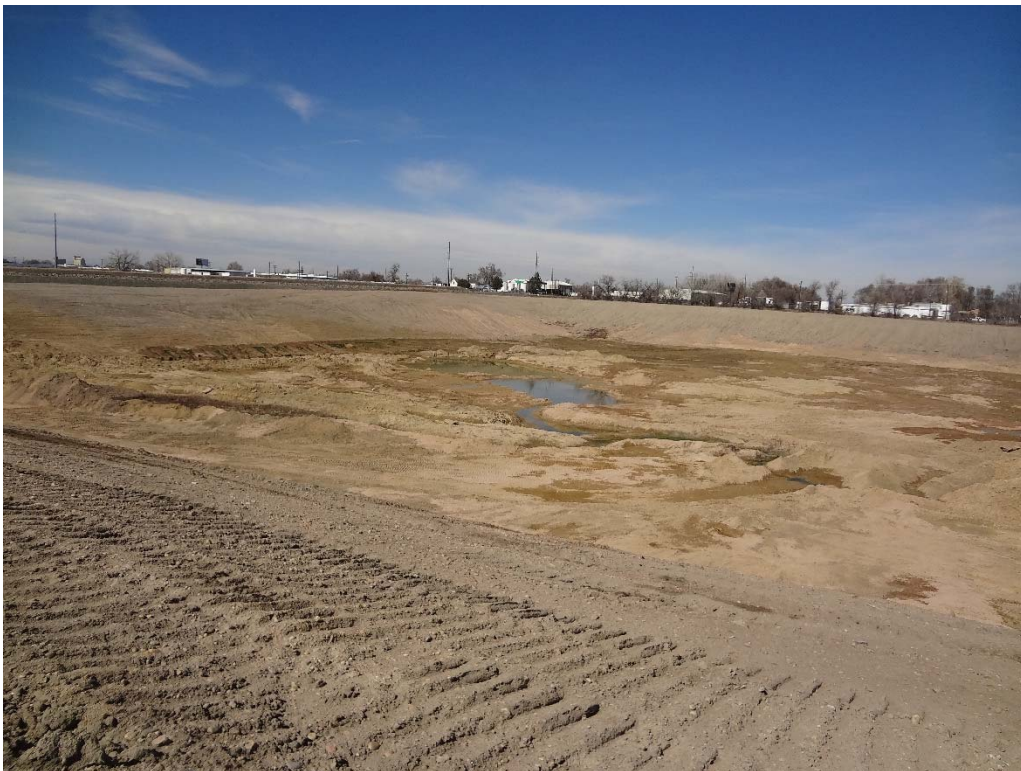
The E 8th Street Operation was active during the inspection. Mining Phase 2 was being dewatered and mined. The Operator stated Phase 2 has been dewatered for 1.5 to 2 years. The Tyrrell well is located approximately 430 feet from Phase 2 of the E 8th Street Operation. The mining phase is dewatered by a dewatering ditch around the perimeter of the excavation and a dewatering pump located in the southwest corner of the phase. The mining phase was estimated by the Division to be seventy (70) percent reclaimed. The north, west and

Looking NW from scale house at Phase 2

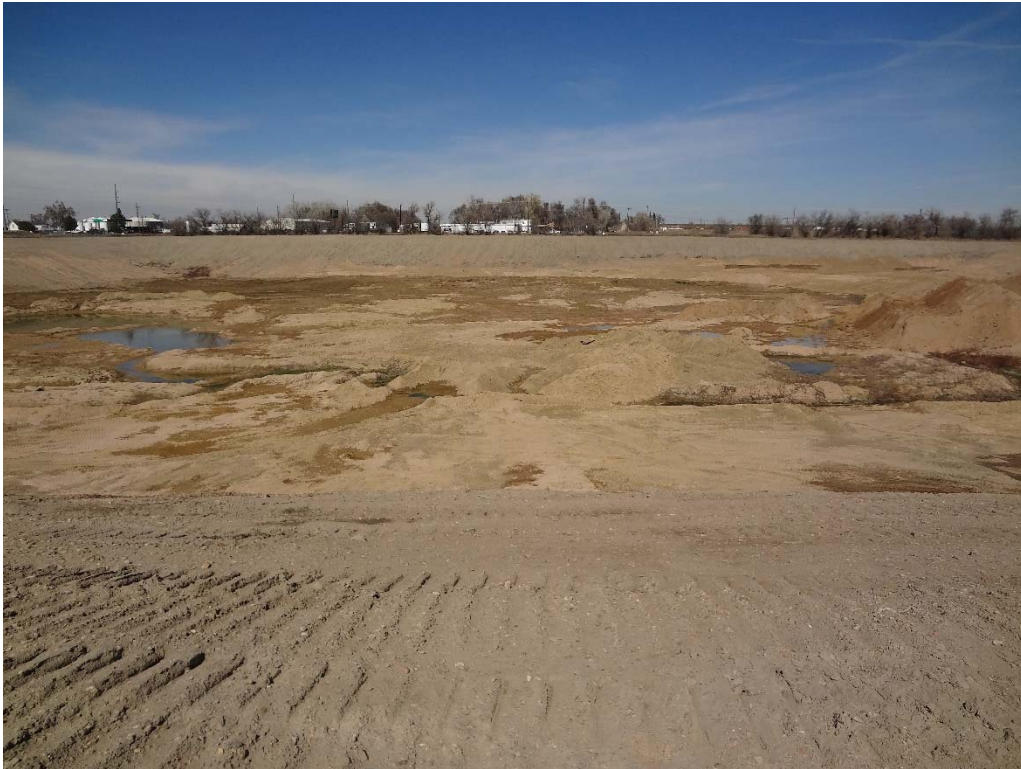
Looking north from scale house at Phase 2

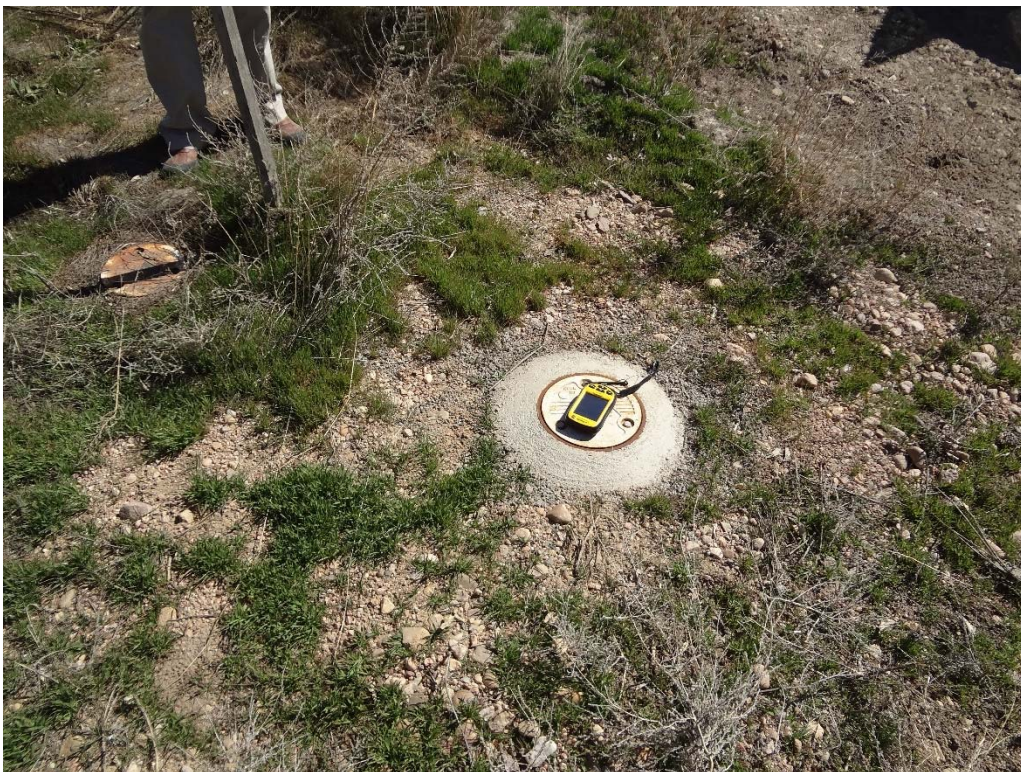
Hill Petroleum installed a replacement monitoring well, Permit # 299316, on the E 8th site on June 19, 2015. The well is located between the Phase 1 monitoring wells, MW-1 and MW-2. The SEO records indicate the well was drilled to thirty (30) feet below grade. Groundwater was not encountered during the well installation. The original Hill monitoring well was observed and measured during the inspection. The well measured eighteen (18) feet below grade and no water was encountered in the well.

Hill Petroleum monitoring wells

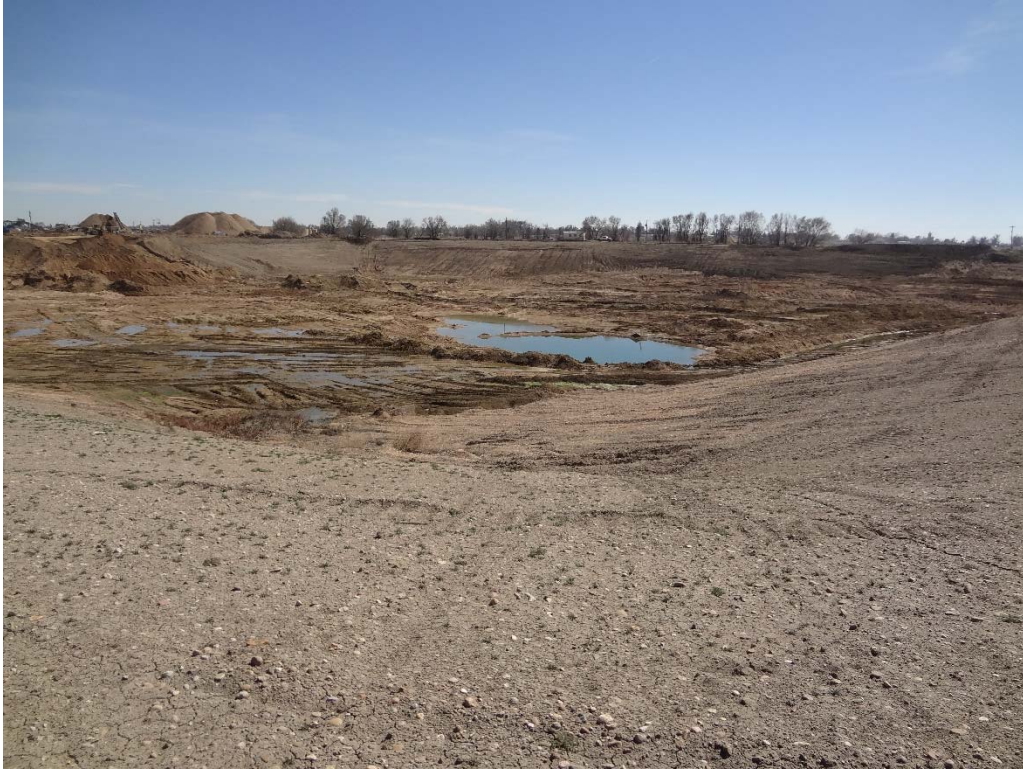
Looking SE from NW corner of Phase 2

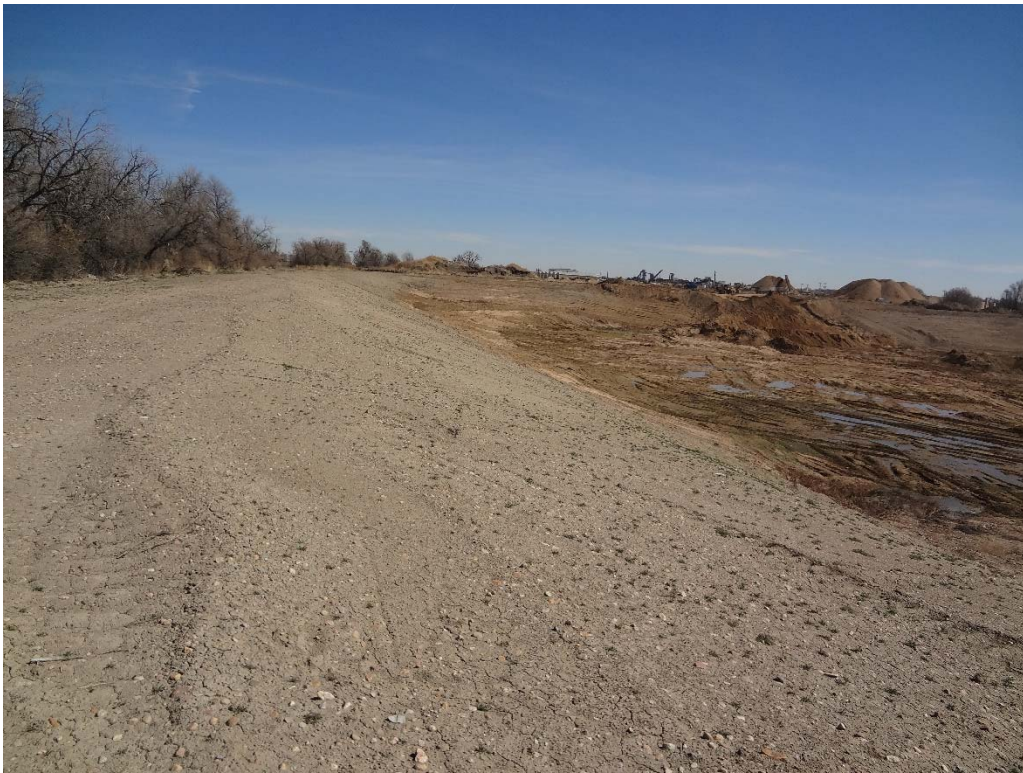
Looking east from NW corner of Phase 2

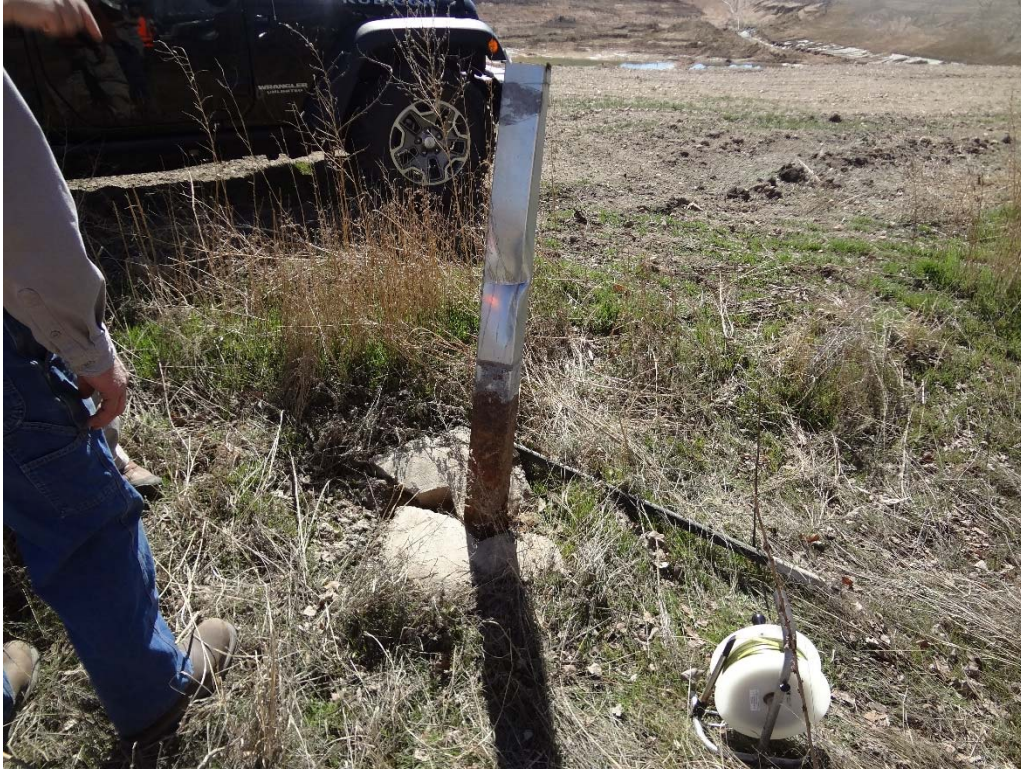
The two approved Phase 1 monitoring wells were searched for during the inspection. Monitoring well No. 1 (MW-1) was located in the northwest corner of the original permit boundary. The western portion of the site was purchased by Leprino Foods Company in 2013. The area was released from the site in 2013, under AR-01. The Leprino Foods Company, constructed a lined pond in the northwest corner of the original permit boundary (Phase 4). It appears MW-1 was destroyed during the construction of the pond. Monitoring well No. 2 (MW-2) was located during the inspection. The upper well casing was damaged, causing the PVC pipe to pinch closed at ground level. A groundwater elevation could not be determined during the inspection. The well appeared to be repairable, if the upper well casing is excavated and a new riser pipe and protective well casing were installed.

Superior MW-2

As cited as a problem, the Operator must reinitiate the approved groundwater monitoring plan, provide groundwater measurements for all current wells and install a replacement monitoring well for the damaged MW-1 well and repair MW-2 well by the corrective action date.

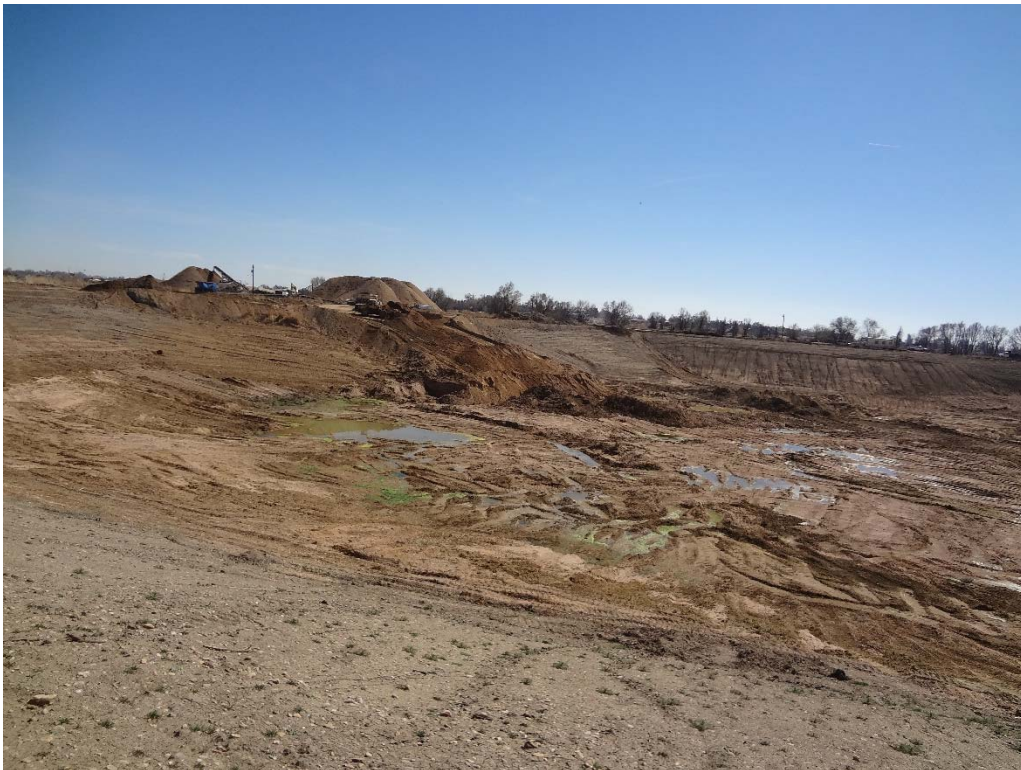
south slopes have been graded and the upper banks of the future lake have been topsoiled above the anticipated water elevation. The access ramp on the east slope of the Phase was being removed by mining excavation. The Operator estimated the ramp will be removed in the next 2 months and reclamation will be complete in the Phase by the end of June 2016. The depth of the pit was surveyed according to the Operator. The pit floor is fifty (50) below the top of slope. The Operator stated the water seep elevation in the pit slopes is approximately forty five (45) feet below the top of slope. The phase will be allowed to fill with groundwater following completion of reclamation. The groundwater infiltration should restore the drawdown effects on the Tyrrell well.

Looking south from MW-2 at ramp excavation
