COLORADO DIVISION OF RECLAMATION, MINING AND SAFETY
MINERALS PROGRAM INSPECTION REPORT
PHONE: (303) 866-3567

MINE NAME: Loloff Mine	MINE/PROSPECTING ID#: M-1985-112	MINERAL: Sand and gravel	COUNTY: Weld
INSPECTION TYPE: Monitoring	INSPECTOR(S): Peter S. Hays	INSP. DATE: March 11, 2016	INSP. TIME: 11:15
OPERATOR: Loloff Construction, Inc.	OPERATOR REPRESENTATIVE: Kelly Hodge	TYPE OF OPERATION: 112c - Construction Regular Operation	
REASON FOR INSPECTION: Citizen Complaint	BOND CALCULATION TYPE: None	BOND AMOUNT: \$689,552.00	
DATE OF COMPLAINT: NA	POST INSP. CONTACTS: None	JOINT INSP. AGENCY: None	
WEATHER: Clear	INSPECTOR'S SIGNATURE:

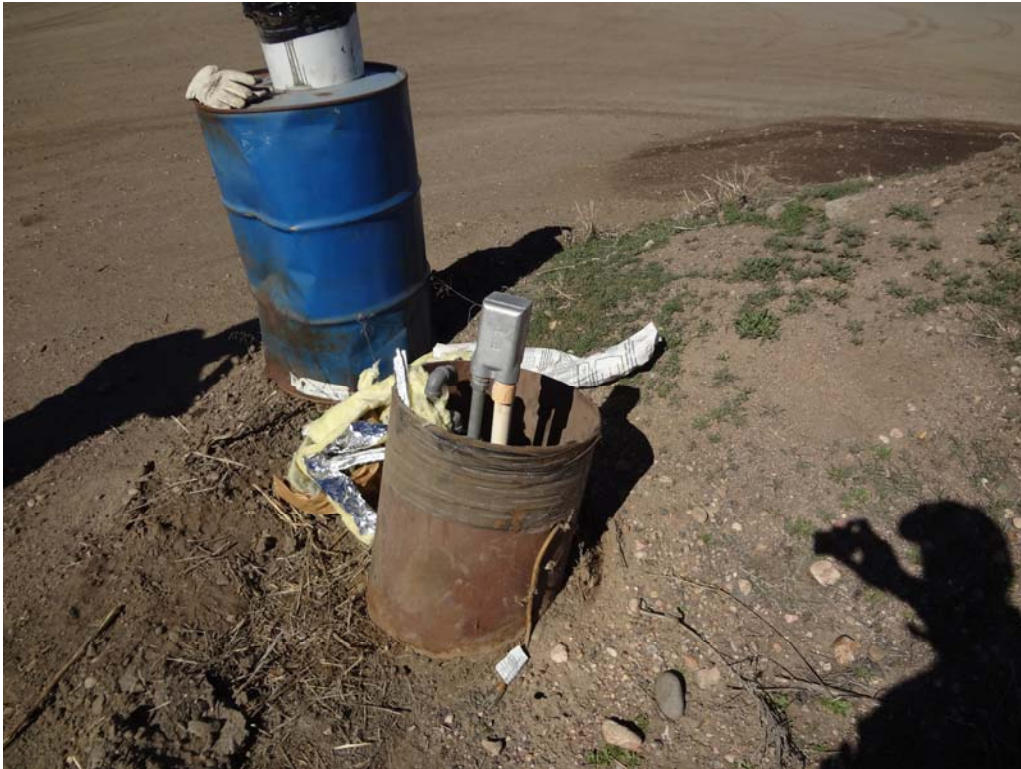
The upper well casing and wellhead were observed during the inspection. The groundwater and pump elevations could not be determined during the inspection, due to the lack of an access port in the well. The well location was GPS surveyed using a Trimble Juno 3B by the Division.

Mr. Tyrrell stated Quality Well and Pump (Quality) inspected the well on February 28, 2016. Mr. Tyrrell stated Quality determined the well pumps were operational and the reason for the lack of water was insufficient groundwater in the well. The Division requested Mr. Tyrrell contact Quality for information on the depth to water, well depth and depth to the pump measured during the Quality inspection, if available. The information has not been received by the Division as of the mailing date of this inspection report. The Tyrrell well pumps to a cistern before water is pumped to the house and shop building. Mr. Tyrrell did not know the capacity of the cistern or if the cistern could be filled with delivered water as a possible short term mitigation measure for the well.

Based on the GPS data and calculations from Google Earth Pro, the Division estimates the Tyrrell well is located 900 feet (275 meters) south of the southern Loloff Mine boundary. The pit radius of Loloff Mine was estimated at 270 feet (82 meters). Using the USGS Analytical and Numerical Simulation of Steady-State Hydrologic Effects of Mining Aggregate in Hypothetical Sand-and-Gravel and Fractured Crystalline-Rock Aquifers, Report 02-4267, the Division calculated a drawdown of 7.5 feet (2.3 meters) for the Tyrrell well due to the dewatering of the Loloff Mine.

The Division believes sufficient evidence exists to support the Tyrrell complaint that the current dewatering activity at the Loloff Mine is affecting the groundwater well located at 417 East 8th Street, Greeley, CO 80631. This is a problem related to Rule 3.1.6 of the Mineral Rules and Regulations of the Colorado Mined Land Reclamation Board for the Extraction of Construction Materials and CRS 34-32.5-116(4)(h) of the Colorado Land Reclamation Act for the Extraction of Construction Materials.

Tyrrell wellhead and casing

As cited as a problem, Loloff Construction, Inc. must implement the approved mitigation plan for the site and work with Mr. Tyrrell to investigate and rehabilitate the well on this property within 30 days of the mailing date of this inspection report. Failure to comply with the corrective action may result in the problem escalating to possible violation and an enforcement hearing being scheduled in front of the Mined Land Reclamation Board.
