**COLORADO DIVISION OF RECLAMATION, MINING AND SAFETY**  
**MINERALS PROGRAM INSPECTION REPORT**  
**PHONE: (303) 866-3567**

<b>MINE NAME:</b> Loloff Mine	<b>MINE/PROSPECTING ID#:</b> M-1985-112	<b>MINERAL:</b> Sand and gravel	<b>COUNTY:</b> Weld
<b>INSPECTION TYPE:</b> Monitoring	<b>INSPECTOR(S):</b> Peter S. Hays	<b>INSP. DATE:</b> March 11, 2016	<b>INSP. TIME:</b> 11:00
<b>OPERATOR:</b> Loloff Construction, Inc.	<b>OPERATOR REPRESENTATIVE:</b> Kelly Hodge	<b>TYPE OF OPERATION:</b> 112c - Construction Regular Operation

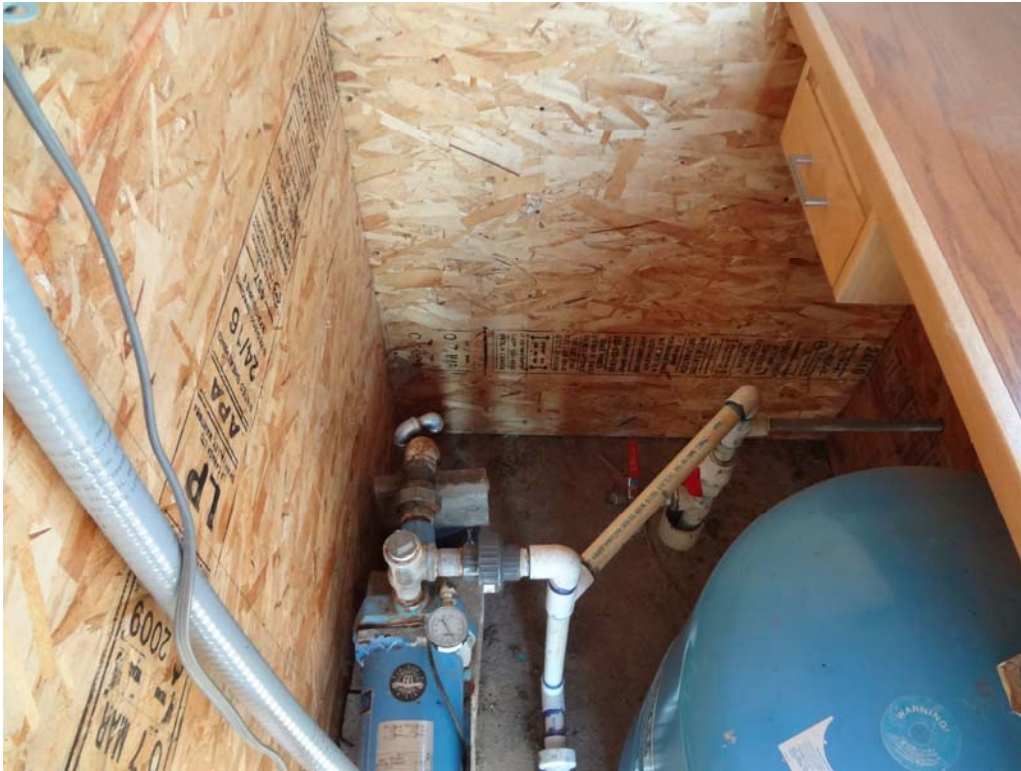
The Division met with Mrs. Taylor following the inspection of the Loloff Mine. The well and pump house were observed and GPS surveyed by the Division. The Office of the State Engineer (SOE) records indicate a replacement well was drilled at the Taylor property in 2008, Permit # 223885-A. The well was drilled to a total depth of forty-four (44) feet with a static water level of fifteen (15) feet below grade. Mrs. Taylor confirmed during the meeting, the water bill had been paid by Loloff Construction and her water service had not been shut off.

Taylor well

The Division considers the complaint (CT-06) resolved by the payment of Mrs. Taylor's water bill by Loloff Construction. The Operator will be required to continue to pay the water bill until the Taylor well is capable of producing water at the same quantity and quality as historic use.

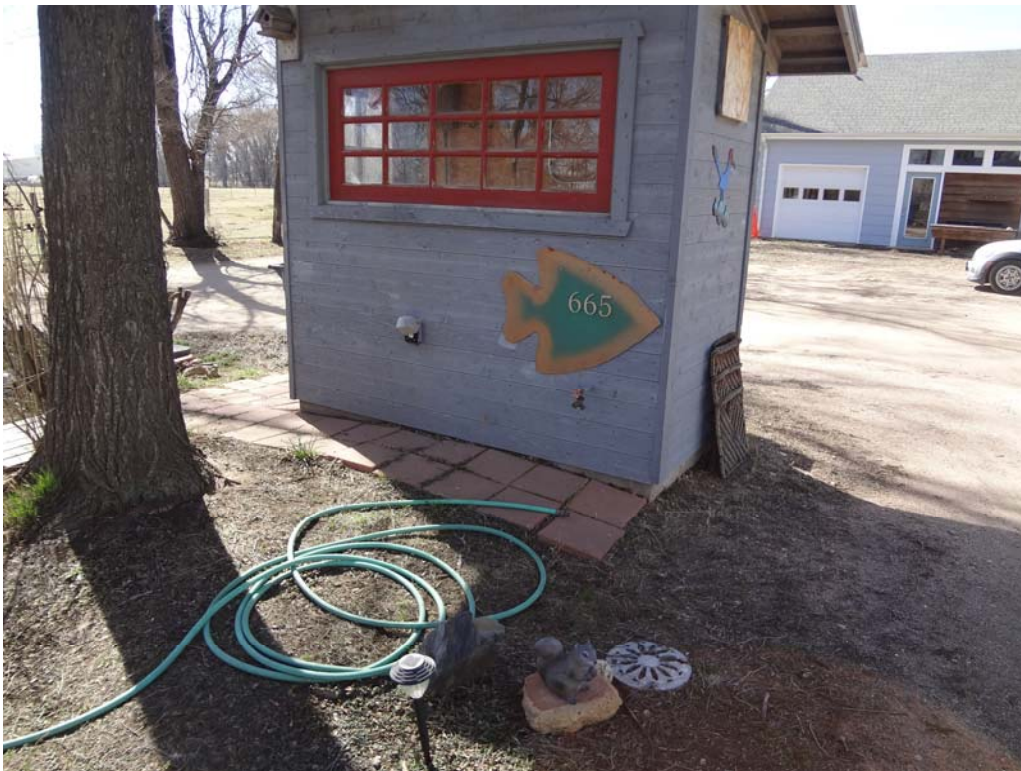
Taylor well pump house

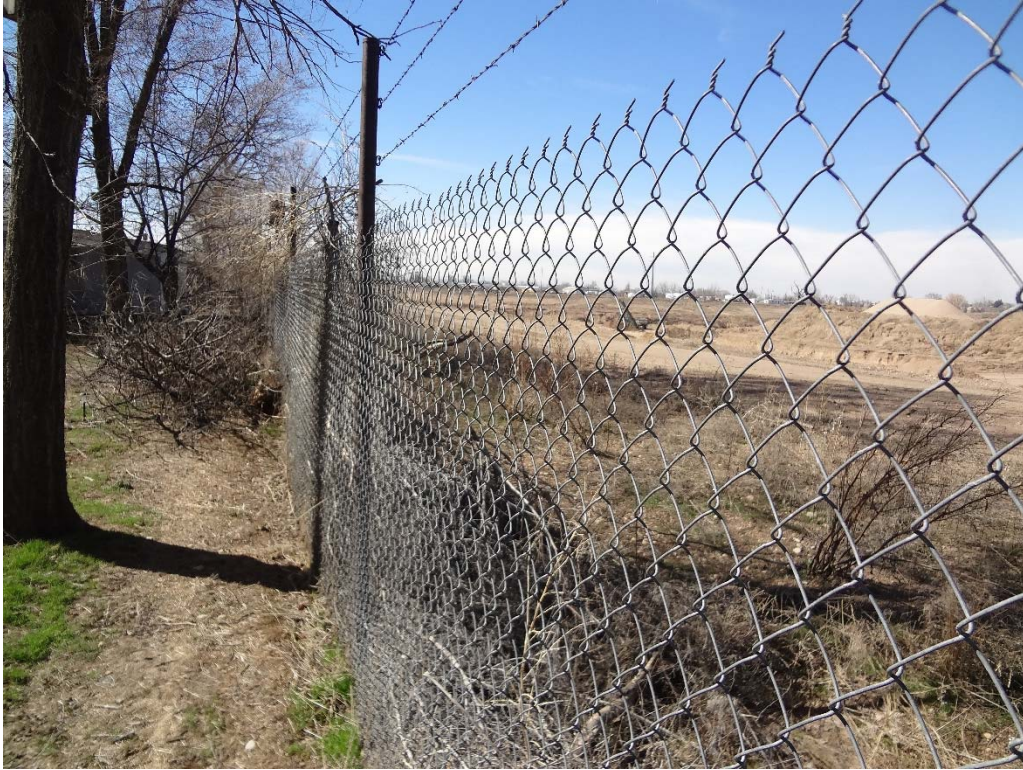
Looking NW from Taylor yard at Loloff Mine

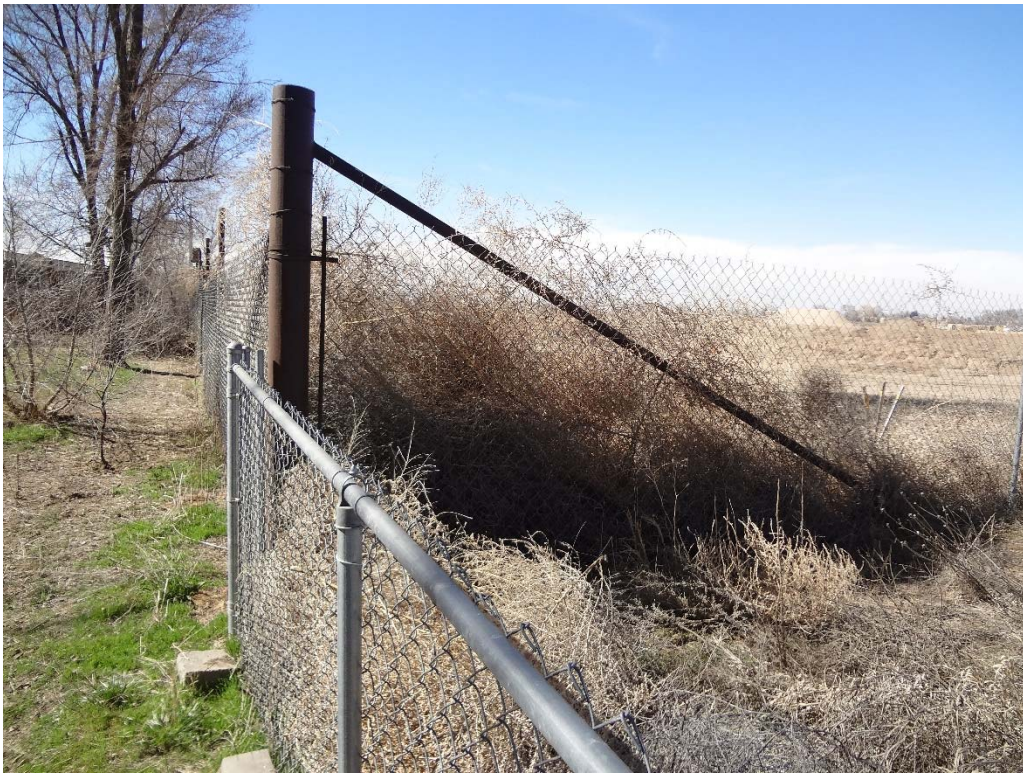
Looking west at fence between Taylor property and Loloff Mine
