COLORADO DIVISION OF RECLAMATION, MINING AND SAFETY
MINERALS PROGRAM INSPECTION REPORT
PHONE: (303) 866-3567

MINE NAME: Peters Pit	MINE/PROSPECTING ID#: M-1991-078	MINERAL: Gravel	COUNTY: Crowley
INSPECTION TYPE: Monitoring	INSPECTOR(S): Amy Eschberger	INSP. DATE: January 14, 2016	INSP. TIME: 10:45
OPERATOR: Kiowa County	OPERATOR REPRESENTATIVE: Rick Spady	TYPE OF OPERATION: 112c - Construction Regular Operation

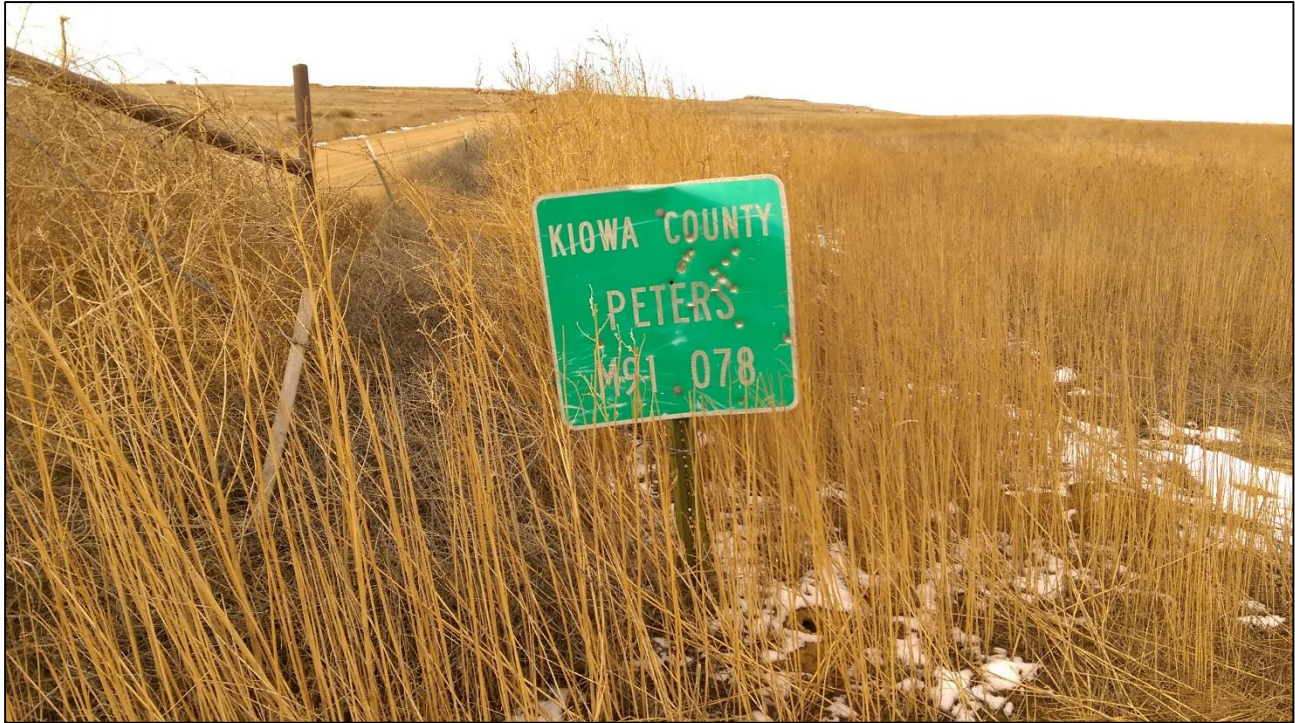
At the time of the inspection, the weather was clear, sunny and cool. No standing water was observed on site. A permit sign was posted at the main site entrance off of County Lane 31 (**Photo 1**). The corners of the permit boundary were marked by metal posts (**Photos 2 and 3**) and rock/dirt piles. The site was not active during the inspection, and no equipment was stored on site. However, Mr. Spady indicated that the site is active (e.g., extracting, processing and/or hauling off material) every year, which is in compliance with its intermittent status. The active pit is located in the northwestern portion of the permit area (**Photos 4 and 5**), and appeared to be expanding southward. The active pit is approximately 15-20 feet in depth. The mined walls have slope gradients ranging from approximately 1H:1V to 3H:1V. The pit appeared to be stable with no erosion problems observed. A few material stockpiles were scattered around the pit area (**Photo 6**).

Photo 1. View of permit sign posted at main site entrance off of County Lane 31.

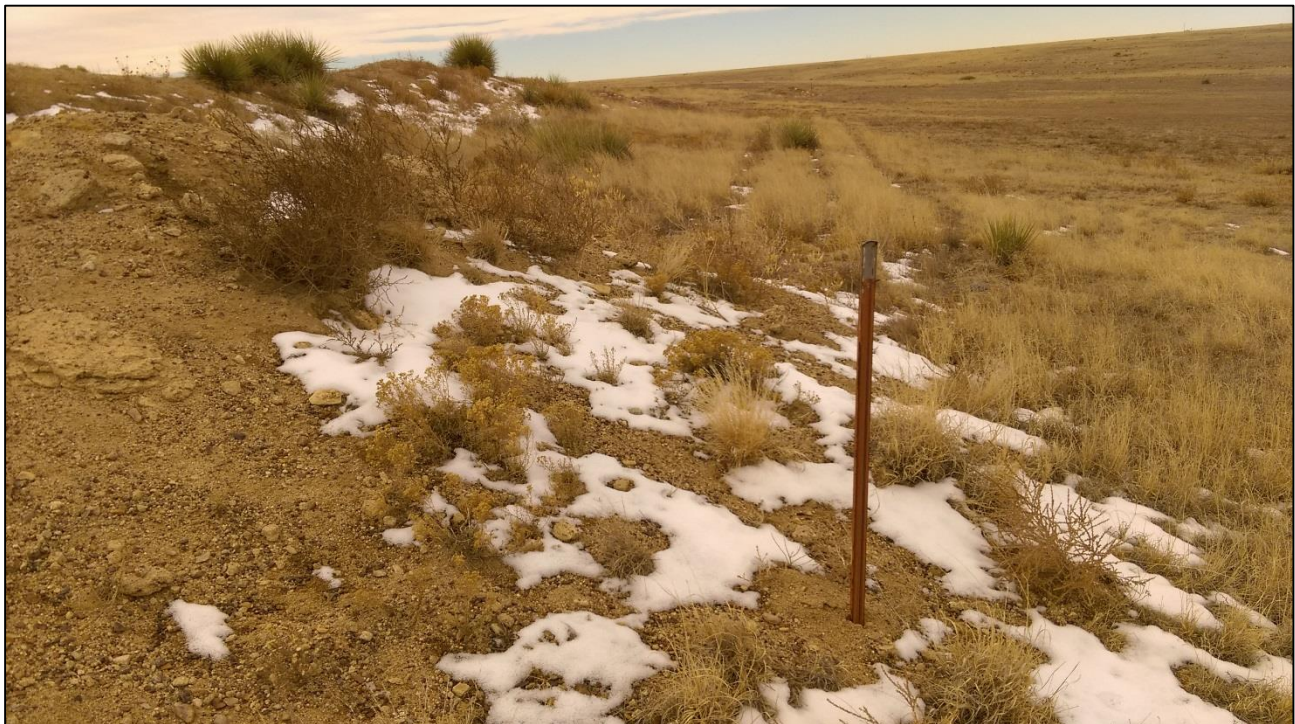
Photo 2. View looking west, showing metal post marking northeastern corner of permit boundary.

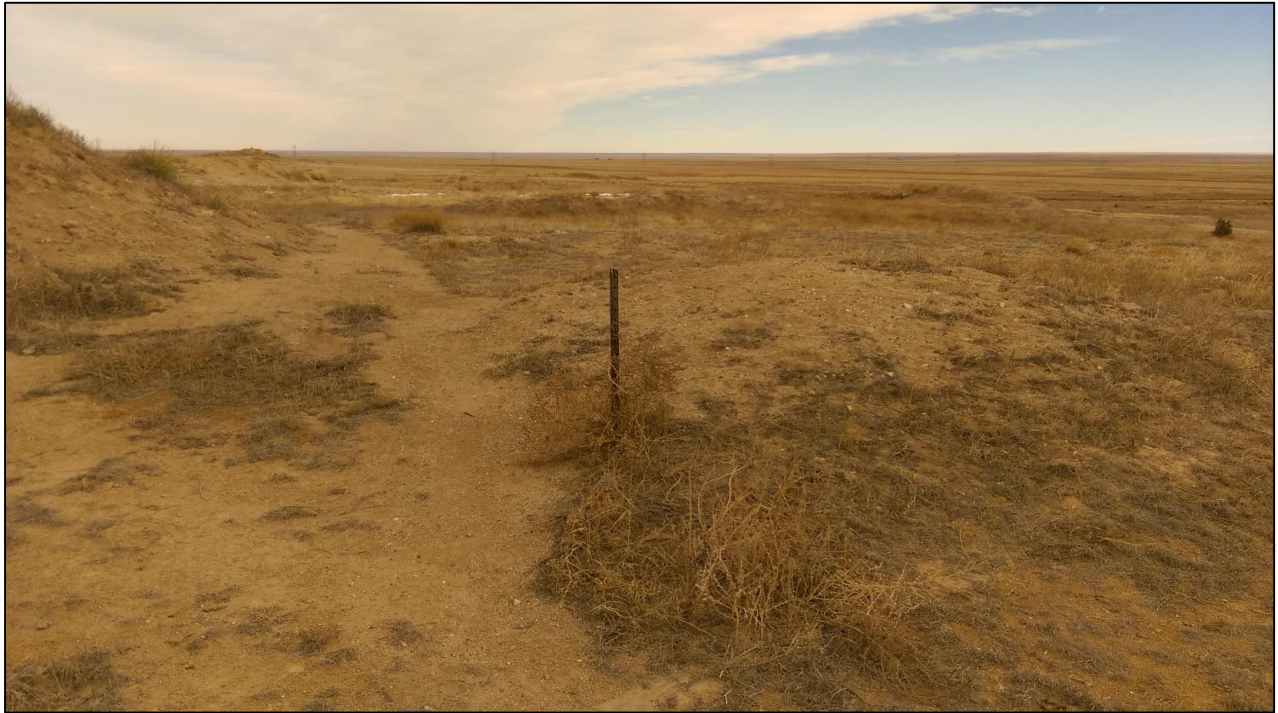
Photo 3. View looking north, showing metal post marking eastern corner of permit boundary.

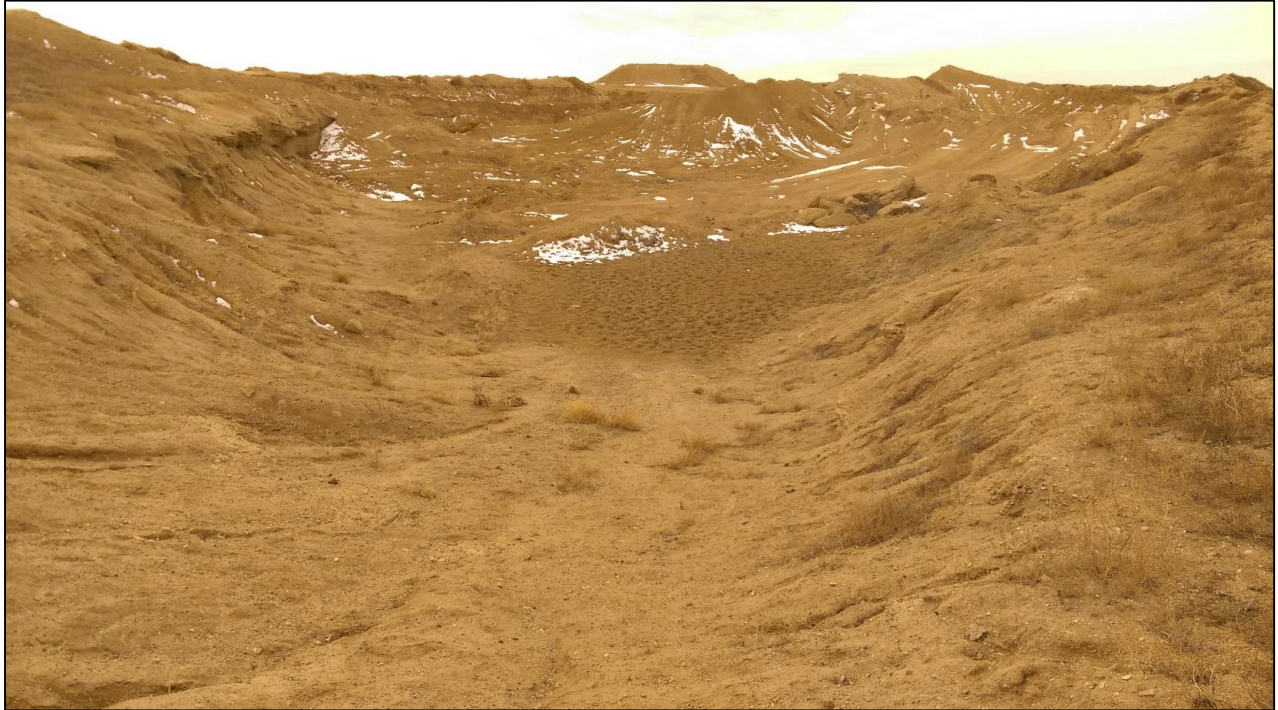
Photo 4. View looking south across active pit located in northwestern portion of permit area. Note mined walls have slope gradients ranging from 1H:1V to 3H:1V, and appear to be stable.

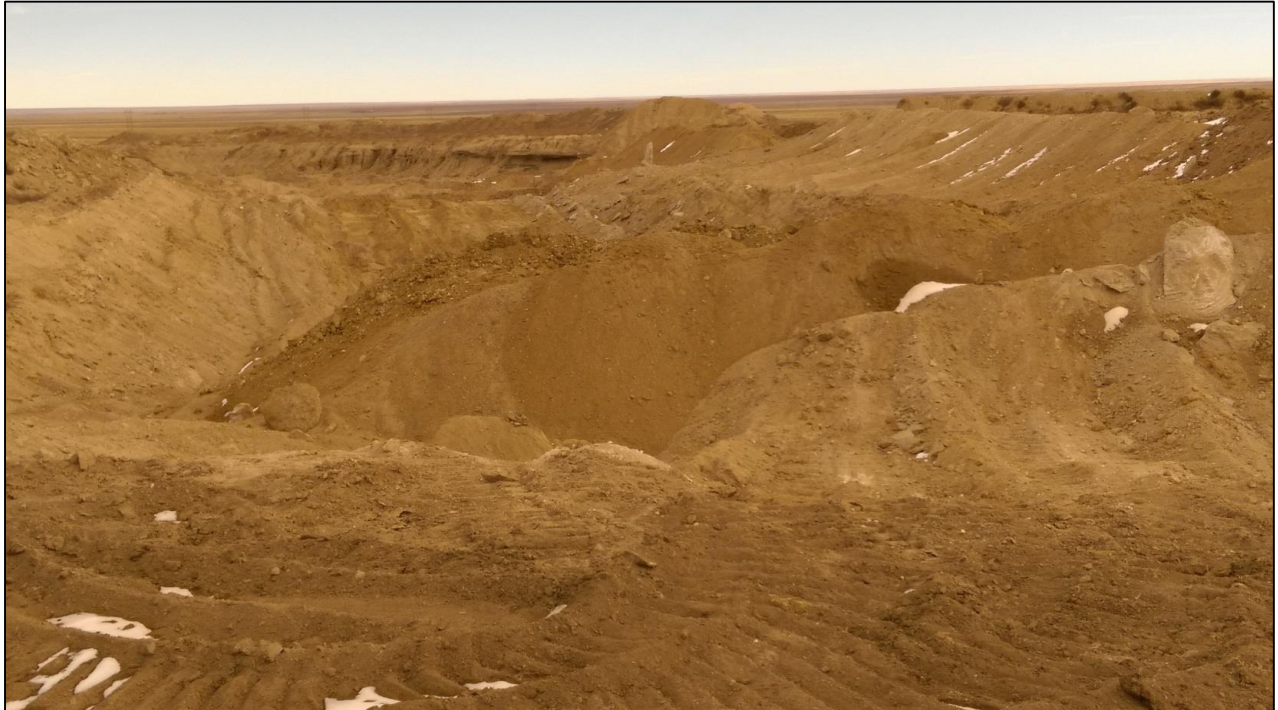
Photo 5. View looking north across active pit located in northwestern portion of permit area. Note mined walls have slope gradients ranging from 1H:1V to 3H:1V, and appear to be stable.

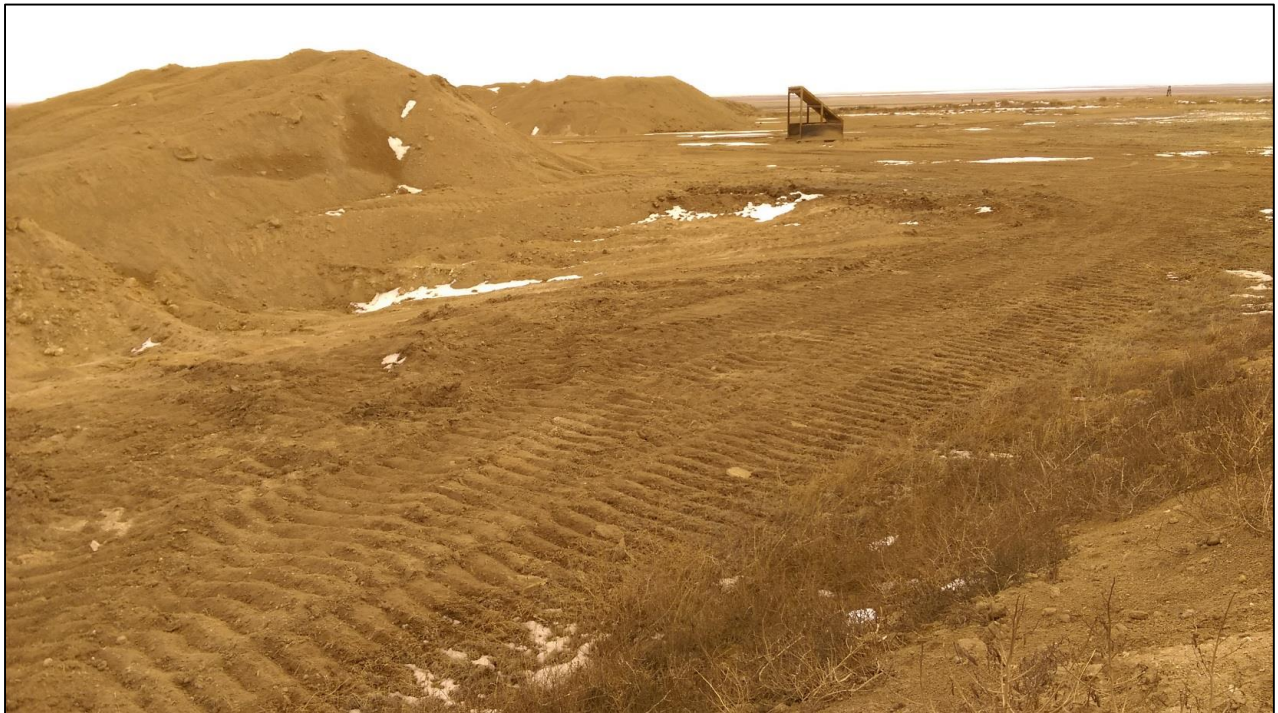
Photo 6. View looking southeast, showing a few material stockpiles stored south and southeast of the pit (at left).

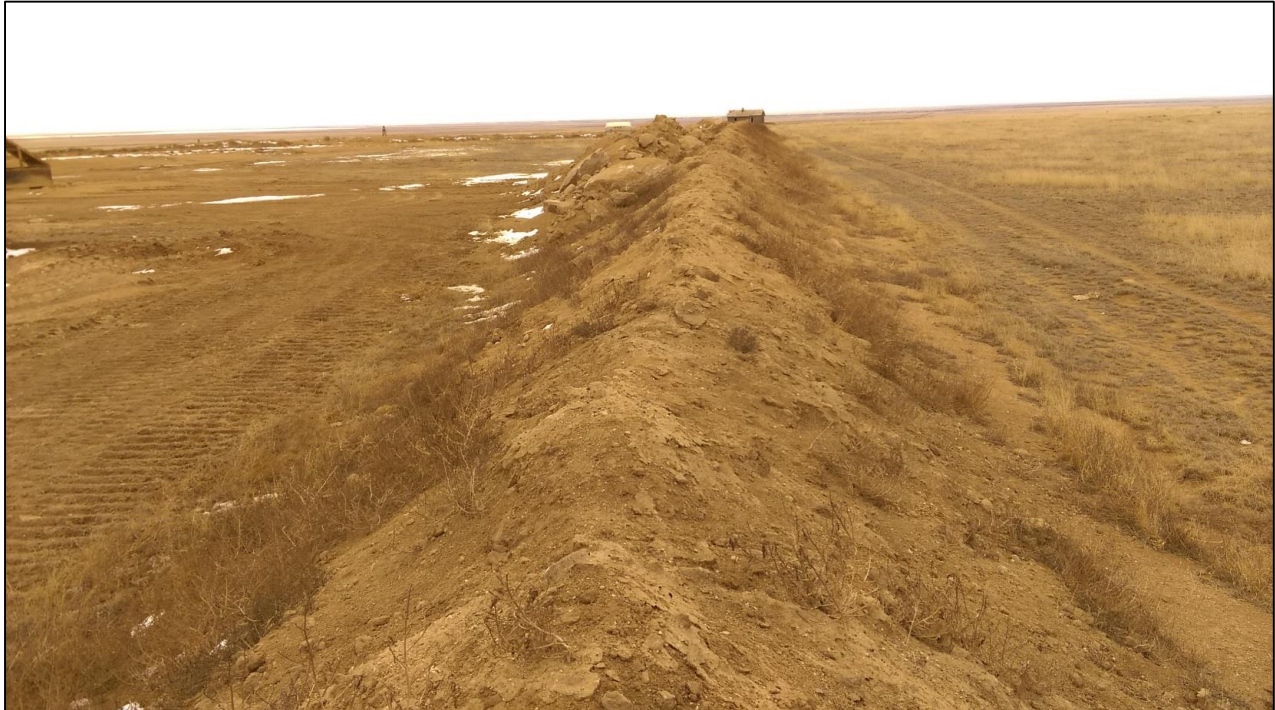
Topsoil has been stripped from the western portion of land that was added in the conversion, and is stored in berms along the perimeter of this area (**Photo 7**). The topsoil stockpiles appeared to be stable with some vegetative cover. Additional topsoil and overburden is stored in the eastern portion of the permit area which was mined first and has been partially reclaimed. According to Mr. Spady, the operation was unable to mine deeper than 10 feet or so before reaching the underlying sandstone layer in the eastern portion of the permit area. However, the operation is able to mine deeper in the western portion of the permit area. A new excavation, approximately 8-10 feet deep, has been started at the southern edge of the permit area (**Photo 8**).

Photo 7. View looking south, showing topsoil berm stored along western edge of permit area. Note berm appears to be stable.

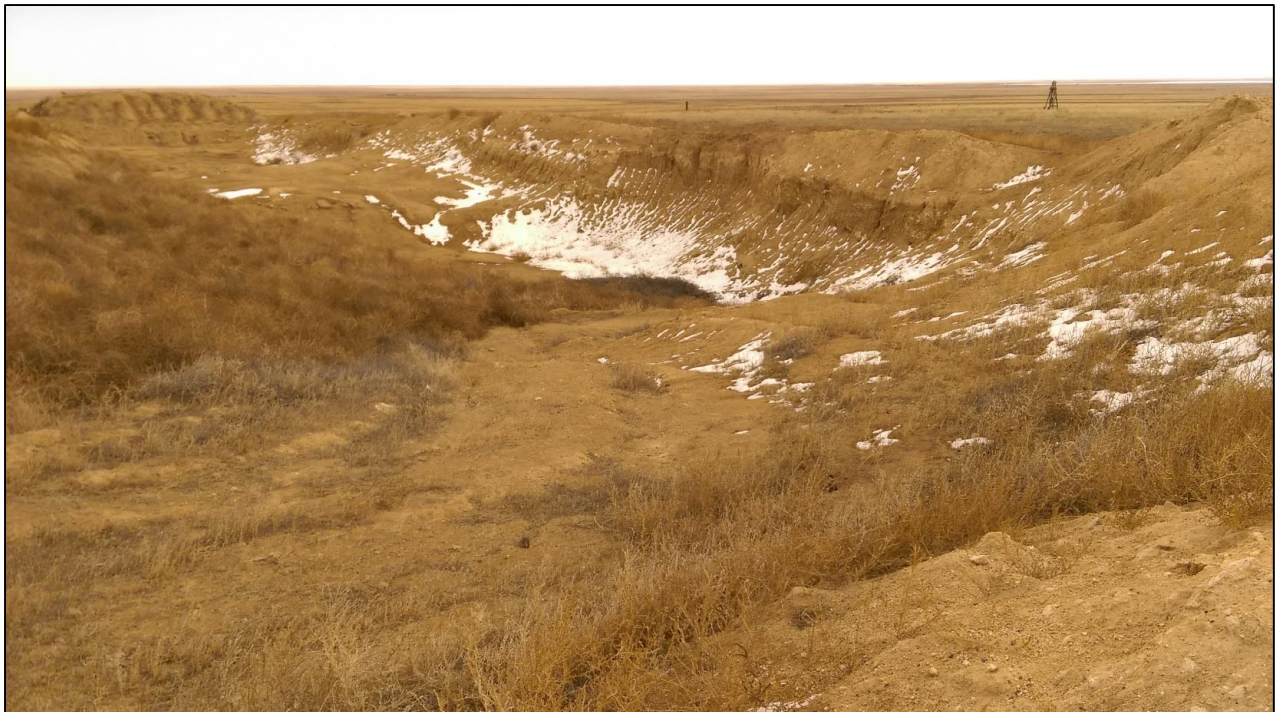
Photo 8. View looking southeast across small excavation, approximately 8-10 feet deep, located at southern edge of permit area.

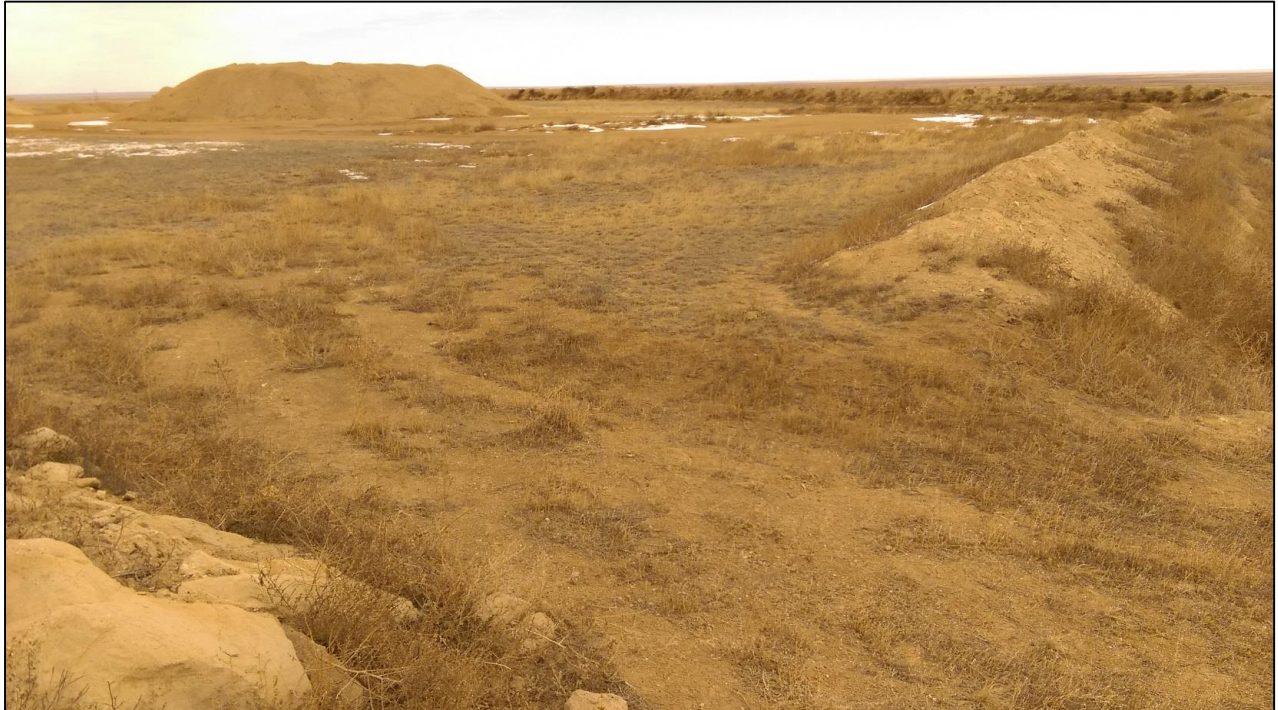
Native grasses, broom snakeweed, and yucca are volunteering across the disturbed land (**Photos 9 and 10**). Some Russian thistle (tumbleweed) was also present on site, as is common throughout the region. No state-listed noxious weed species were observed on site. All disturbance appeared to be kept within the approved permit boundary. The operation appears to be following the approved mining plan.

Photo 9. View looking northeast across southwestern portion of permit area, showing some native grasses and Russian thistle volunteering across disturbed area.

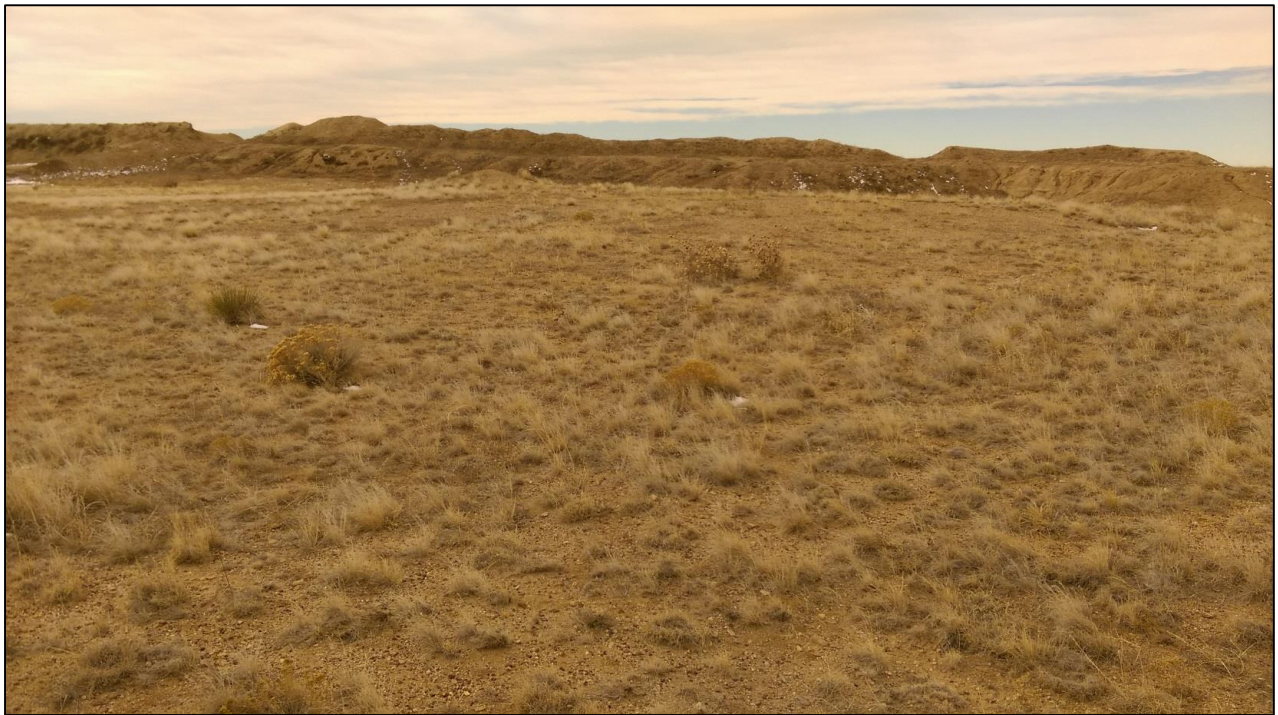
Photo 10. View looking west across northeastern portion of permit area, showing some native grasses, broom snakeweed, and yucca volunteering across disturbed area.
