COLORADO DIVISION OF RECLAMATION, MINING AND SAFETY
MINERALS PROGRAM INSPECTION REPORT
PHONE: (303) 866-3567

| MINE NAME: Cresson Project | MINE/PROSPECTING ID#: M-1980-244 | MINERAL: Gold | COUNTY: Teller |
| INSPECTION TYPE: Monitoring | INSPECTOR(S): Timothy A. Cazier | INSP. DATE: January 20, 2016 | INSP. TIME: 10:00 |

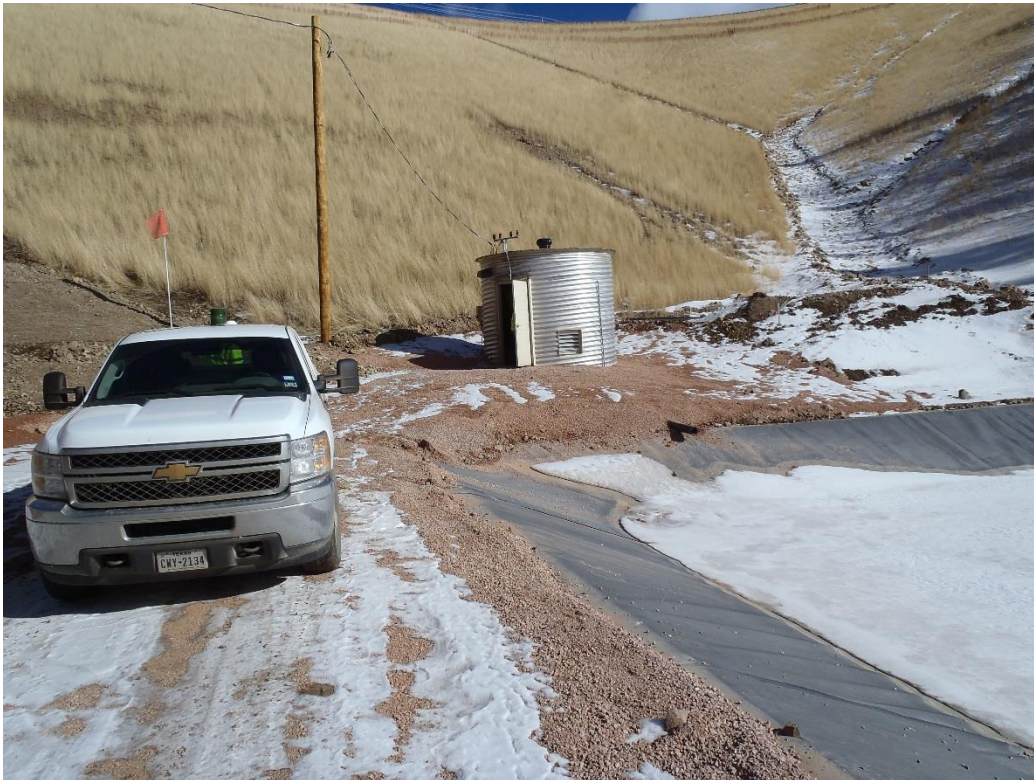
The Squaw Gulch Pumpback System surface enclosure (see **Photo 1**) was recently completed and the pumps were installed (see **Photo 2**). Mine personnel indicated water level depth in the sumps still needed to be calibrated.

Photo 1. Recently installed Squaw Gulch Pumpback System surface enclosure.

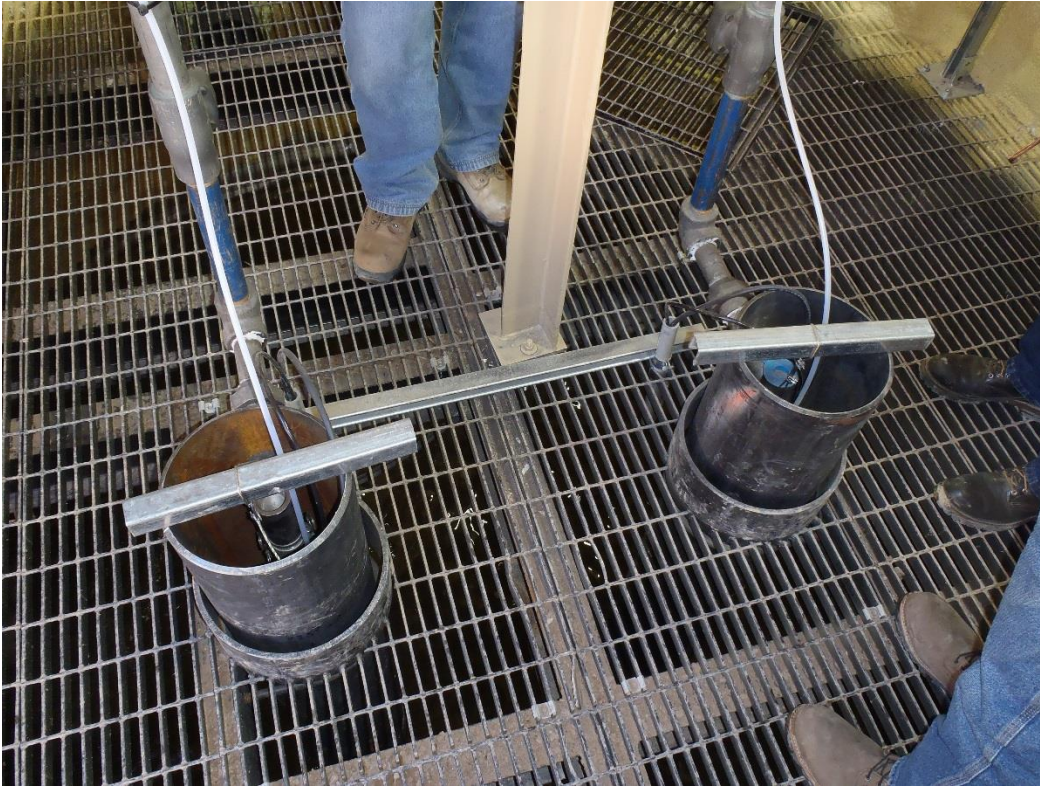
Photo 2. Final installation of underdrain sump pumps at the toe of the SGVLF toe berm.

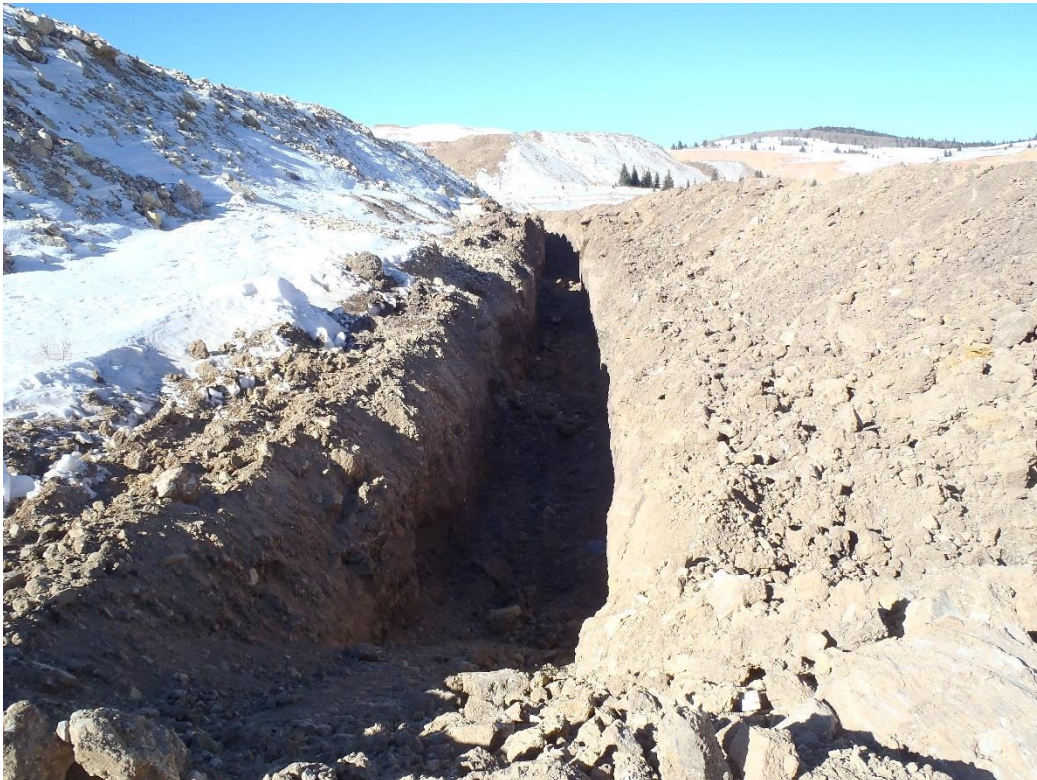
Portions of the northern end of the ECOSA are outside the diatreme. The Division approved the design proposed in Amendment 10 to construct seepage mitigation trenches under the ECOSA to convey potential infiltrated meteoric water from within the ECOSA footprint to where it can be captured by the diatreme. The Division approved the trench (see **Photo 3**).

Photo 3. Third and final ECOSA seepage mitigation trench (looking NW).

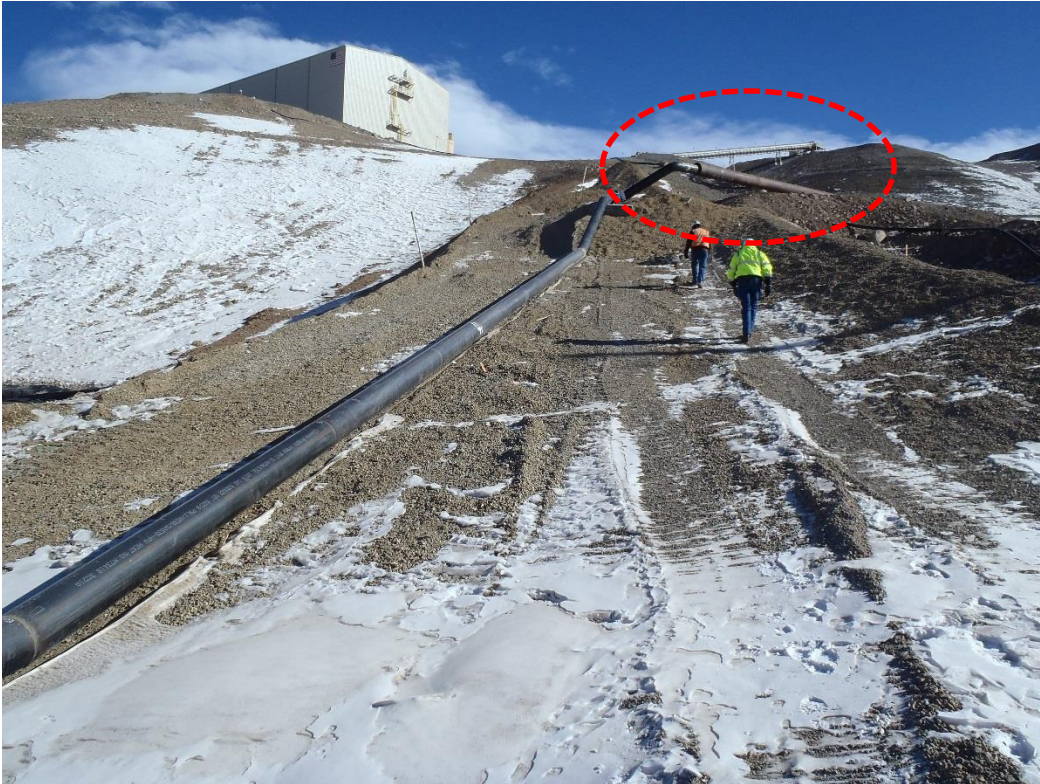
Mr. Ron DiDonato (CC&V) provided an overview in the field of the dual containment of the 14-inch barren solution pipeline (see **Photo 4**) where it traverses an approximately 15-foot segment off liner. The Division approved the dual containment in TR-76. CC&V agreed to provide and CQA certification for the barren solution pipeline stamped by a professional engineer. Subsequent to this inspection, the Division received the requested certification report on 2/1/2016.

Photo 4. Dual containment of the 14-inch barren solution pipeline (looking SE).

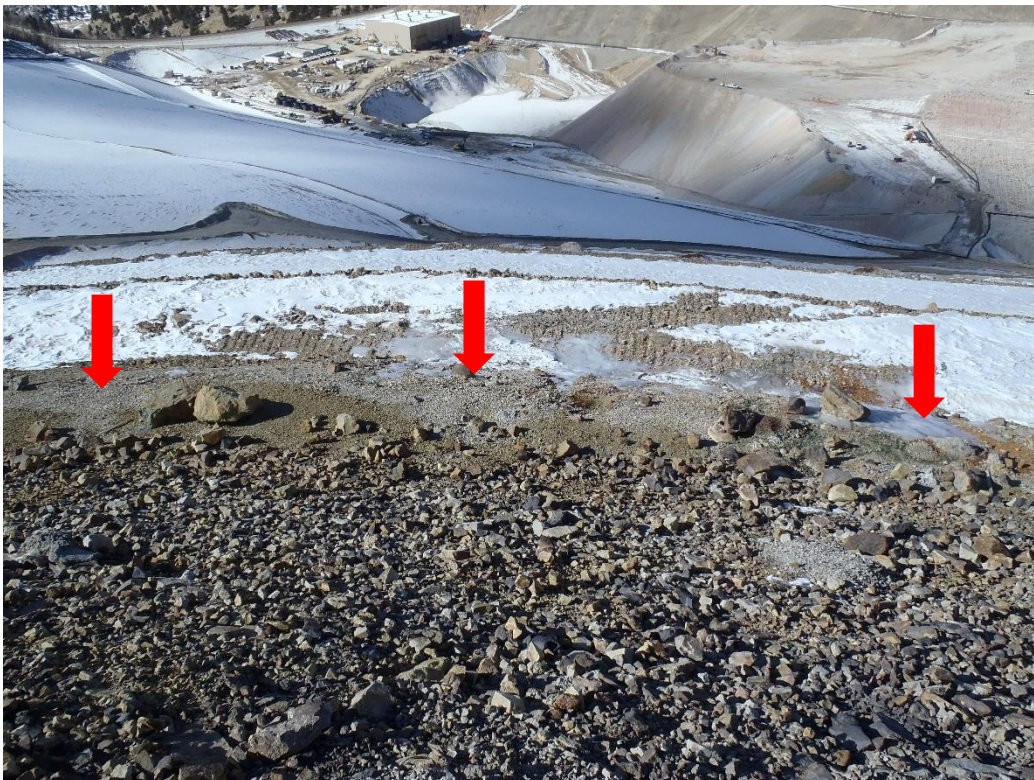
The Division followed up on the apparent seeps observed from photos taken during the December 28, 2015 aerial inspection. The seep areas were frozen at the time of the inspection (see **Photo 5**), therefore difficult to determine if the seeps were active. The Division and CC&V agreed to continue to monitor and assess the seep areas.

Photo 5. Frozen mill seep areas from mill platform safety berm (looking NW).

1. The Division plans to continue observing the mill seep areas.
2. The Division received and approved the requested barren solution CQA certification report.
3. CC&V completed construction of the third and final seepage mitigation trench.
