COLORADO DIVISION OF RECLAMATION, MINING AND SAFETY
MINERALS PROGRAM INSPECTION REPORT
PHONE: (303) 866-3567

MINE NAME: Kit Carson County	MINE/PROSPECTING ID#: M-1982-094	MINERAL: Sand and gravel	COUNTY: Kit Carson
INSPECTION TYPE: Monitoring	INSPECTOR(S): Elliott R. Russell	INSP. DATE: August 6, 2015	INSP. TIME: 08:45
OPERATOR: Kit Carson County	OPERATOR REPRESENTATIVE: Dave Hornung	TYPE OF OPERATION: 110c - Construction Limited Impact

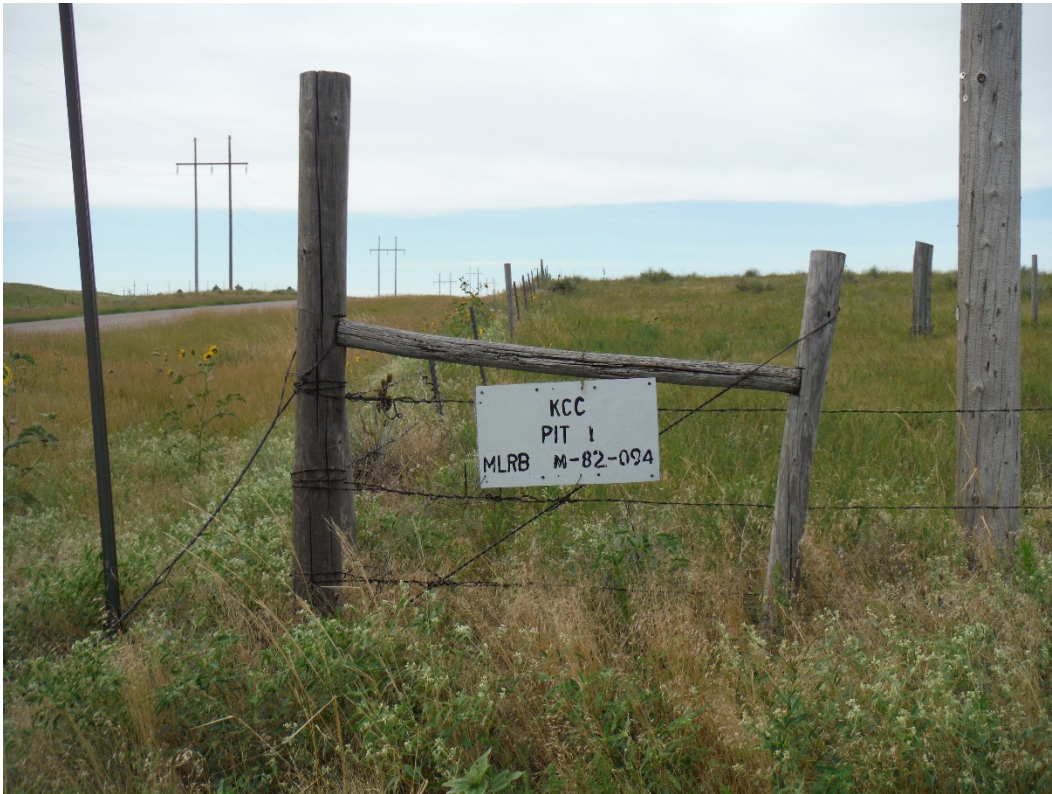
Mine identification sign posted at the site entrance; looking south.

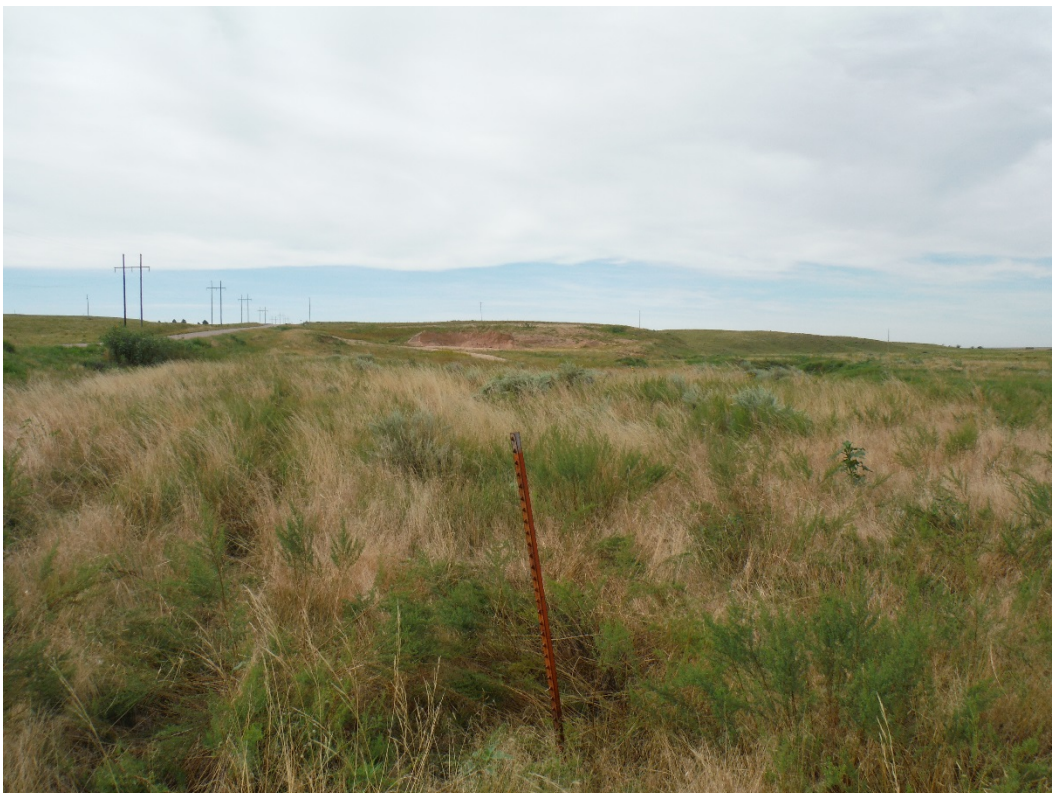
Northern boundary corner; looking south.

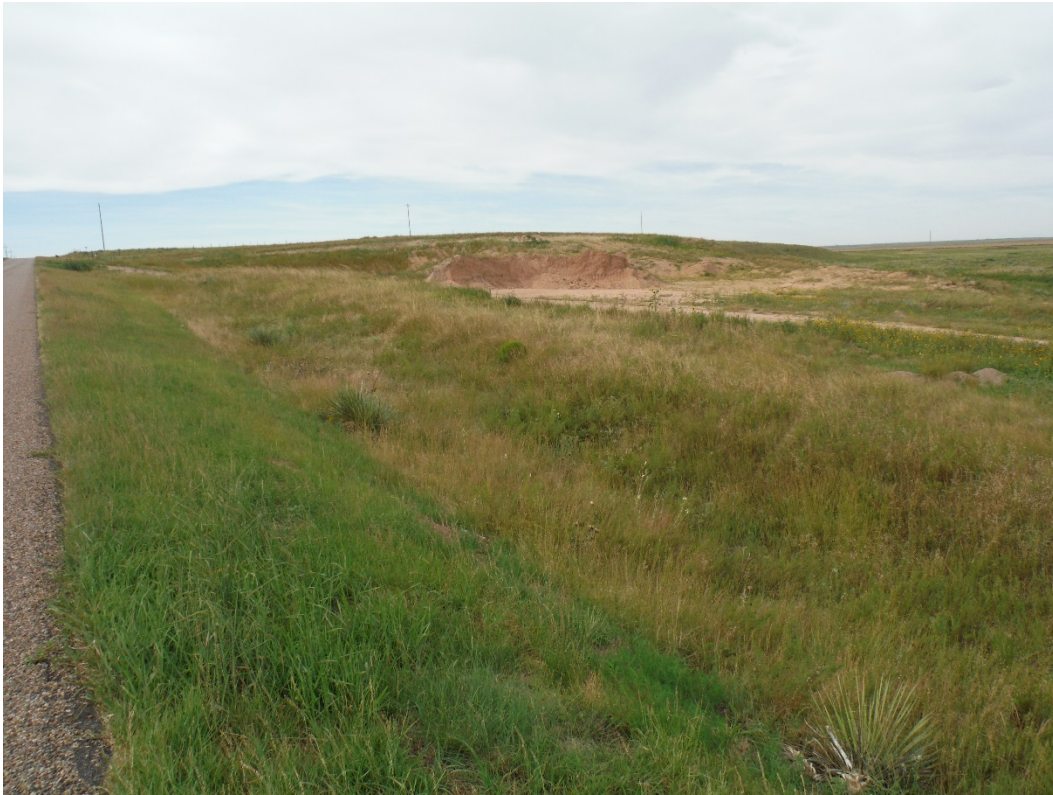
Site overview; looking southwest.

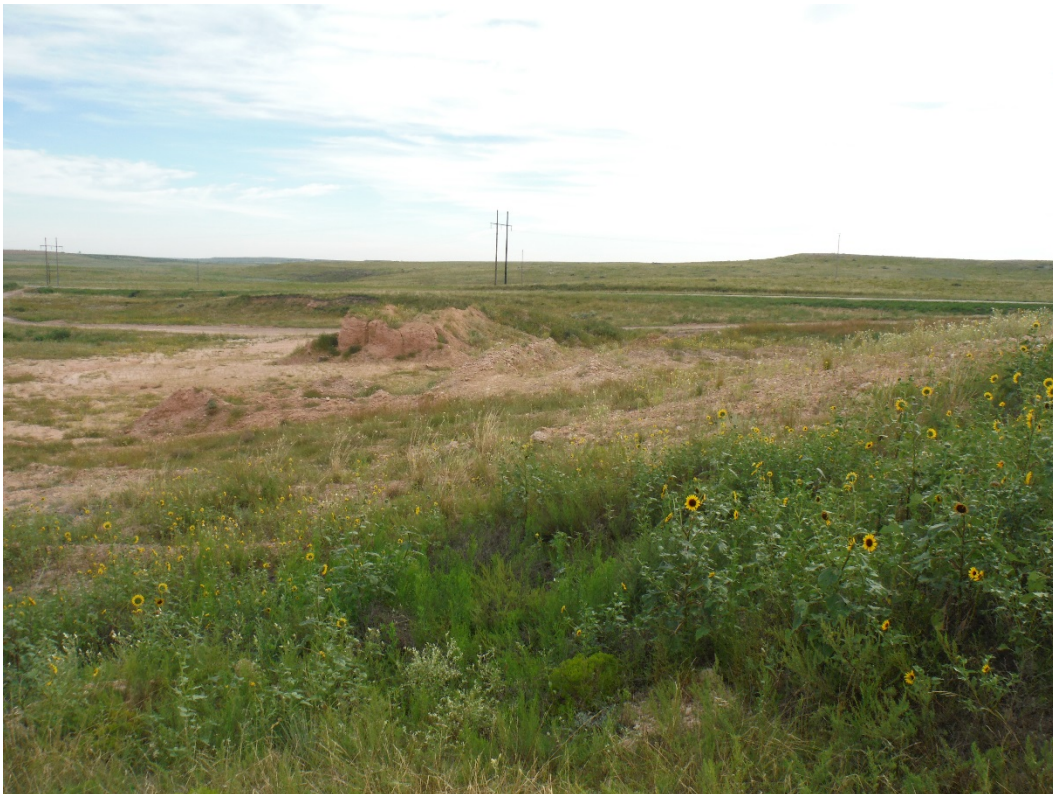
The site consists of an excavated bluff facing north with approximately 4.5 acres of disturbance. Topsoil has been stockpiled along the eastern boundary, adjacent to County Road 30. Mined material had been stockpiled on the pit floor and the Division observed evidence that the stockpile had hauled from recently. It appears that there is still material on the south side of the site that could be mined. The site is approved to have a maximum slope of 3H:1V. The Division recommend establishing the final slope and stockpiling material to ensure that the mining-face doesn't come too close to the southern boundary; if the mining face advances much further, the County will need to backfill the slope or expand the permit to acquire enough material to cut/fill the slope.

Southern mine face and stockpile material; looking northeast.
