COLORADO DIVISION OF RECLAMATION, MINING AND SAFETY
MINERALS PROGRAM INSPECTION REPORT
PHONE: (303) 866-3567

MINE NAME: Weimer No. 2	MINE/PROSPECTING ID#: M-1996-031	MINERAL: Gravel	COUNTY: Montrose
INSPECTION TYPE: Monitoring	INSPECTOR(S): Dustin Czaplá	INSP. DATE: March 16, 2016	INSP. TIME: 11:30
OPERATOR: Sutherland Brothers, Inc.	OPERATOR REPRESENTATIVE: None	TYPE OF OPERATION: 110c - Construction Limited Impact

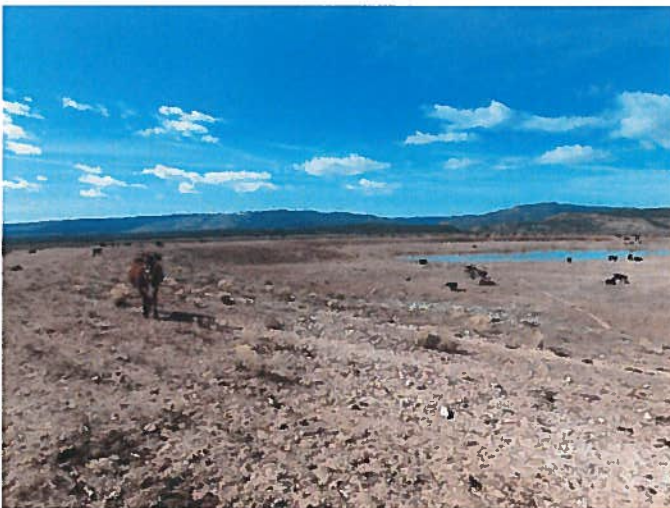
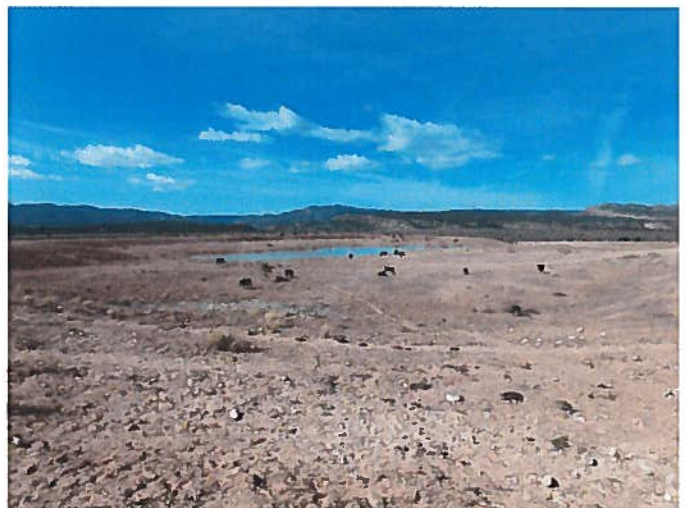
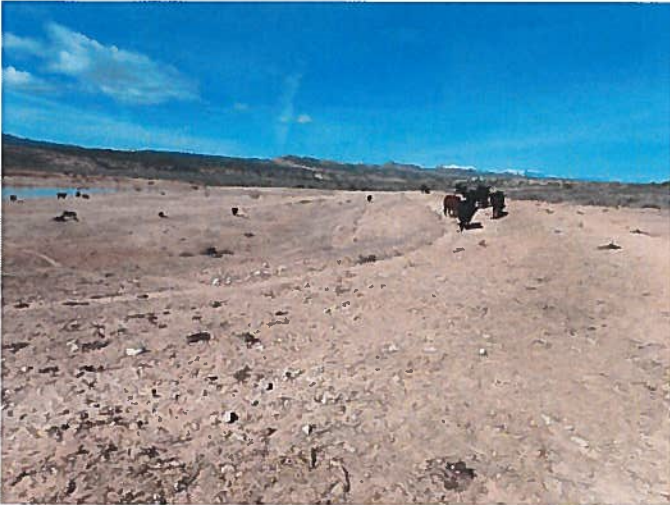
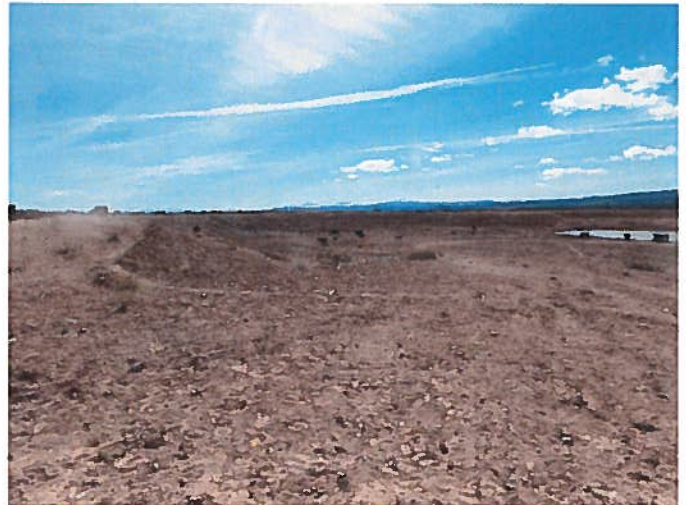
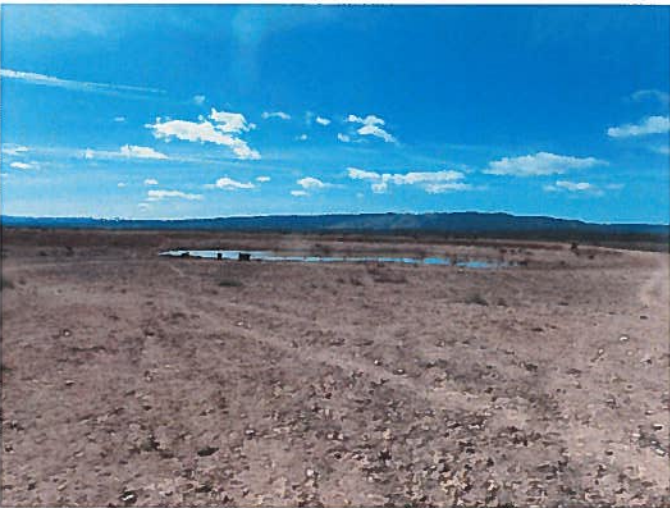
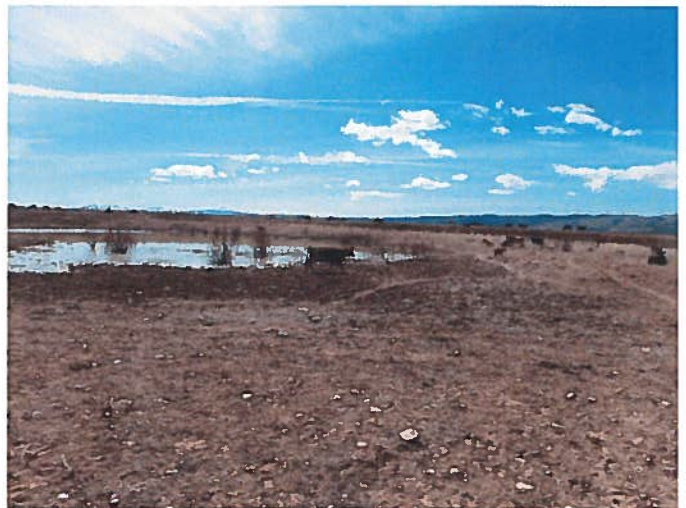
PHOTOGRAPHS

The site is in final reclamation. All grading has been completed. All slopes appeared stable with no erosional concerns noted. Vegetation, mostly volunteer species such as rabbit brush and sage, is becoming established over the reclaimed slopes. The site is currently used for cattle. Based on the conditions observed during this inspection the site could be considered eligible for release from further reclamation responsibility. The operator should contact the Division upon receiving this report.
