COLORADO DIVISION OF RECLAMATION, MINING AND SAFETY
MINERALS PROGRAM INSPECTION REPORT
PHONE: (303) 866-3567

MINE NAME: Uncompahgre Pit	MINE/PROSPECTING ID#: M-2013-007	MINERAL: Gravel and sand	COUNTY: Montrose
INSPECTION TYPE: Monitoring	INSPECTOR(S): Dustin Czaplá	INSP. DATE: March 24, 2016	INSP. TIME: 11:30
OPERATOR: Lazy K-Bar Land & Cattle Company, LLLP	OPERATOR REPRESENTATIVE: Zane Luttrell	TYPE OF OPERATION: 112c - Construction Regular Operation

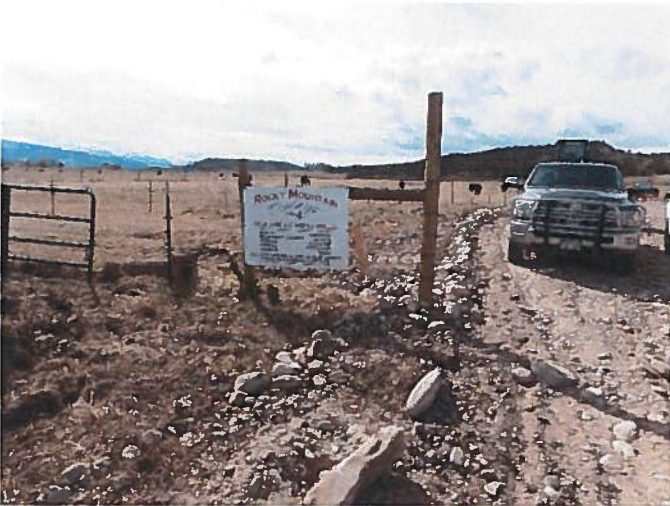
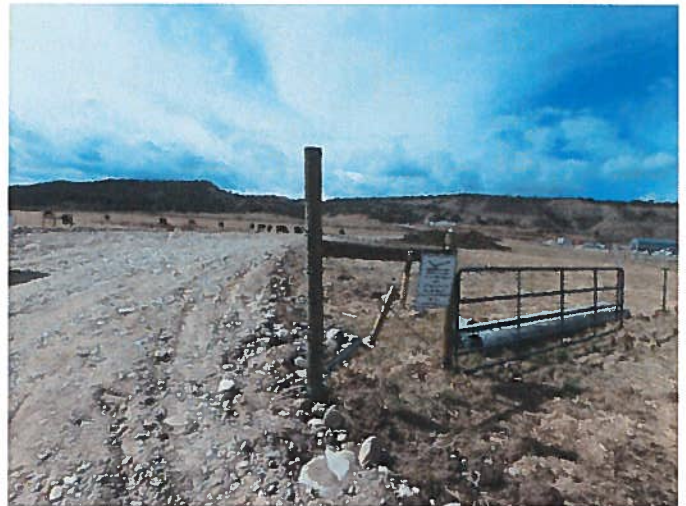
Adequate mine identification signage was noted at the entrance to the site.

Figure 1: Site entrance

Figure 2: Site entrance

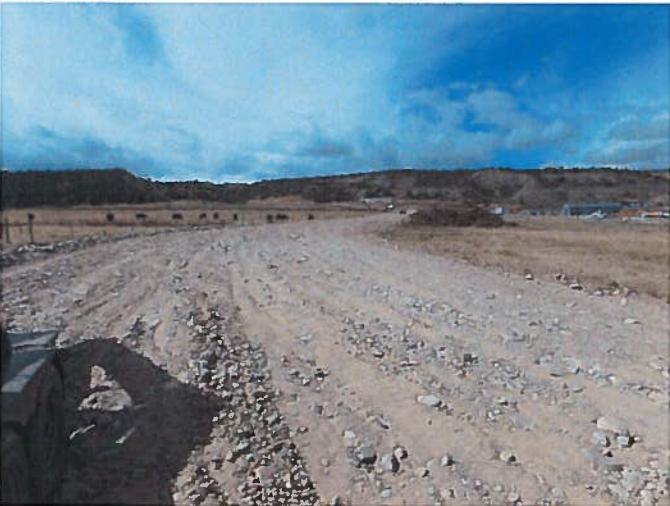
This inspection verified that the access road is being constructed in the correct location, as approved through TR-2. The road was nearly complete at the time of this inspection. Cut slopes along the roadway appeared stable. Topsoil to be applied to the slopes was stockpiled along the side of the road in several locations. The topsoil is being allowed to dry some before it is placed on the slopes. Stormwater ditches and culverts are being constructed along the road in accordance with the approved design. No problems were noted regarding the road construction.

Figure 3: Access road

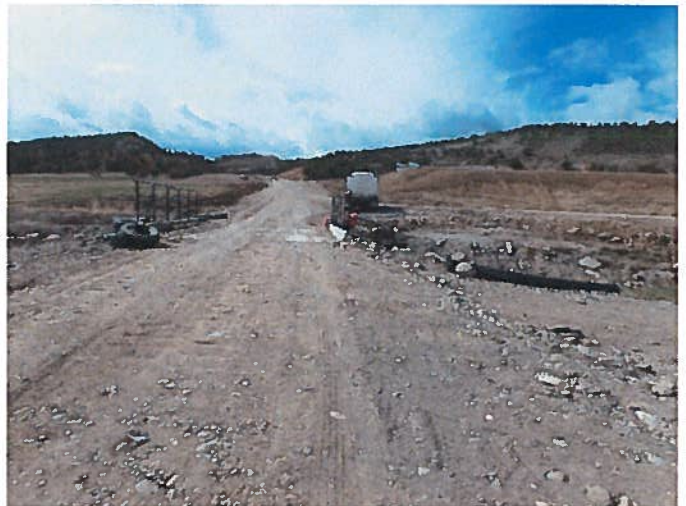
Figure 4: Access road canal crossing

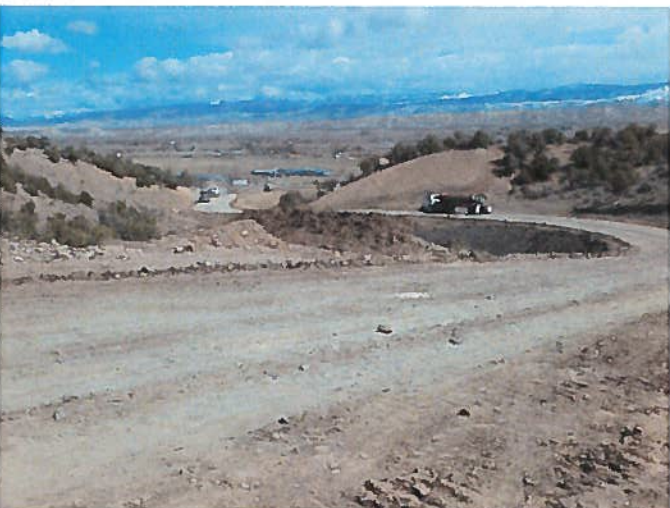
Figure 5: Looking down the access road

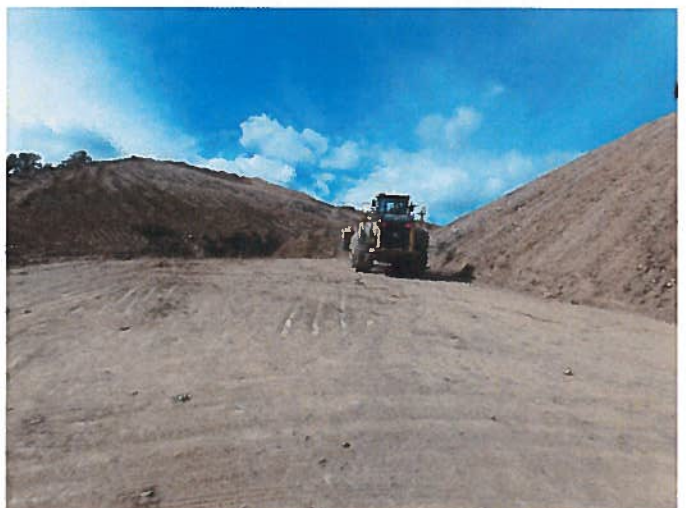
Figure 6: Upper extent of the access road construction

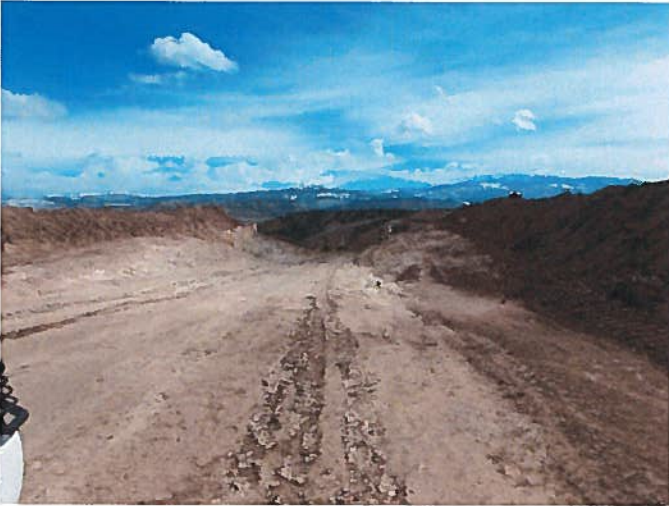
Figure 7: Upper end of the access road where it enters the Phase 3 area

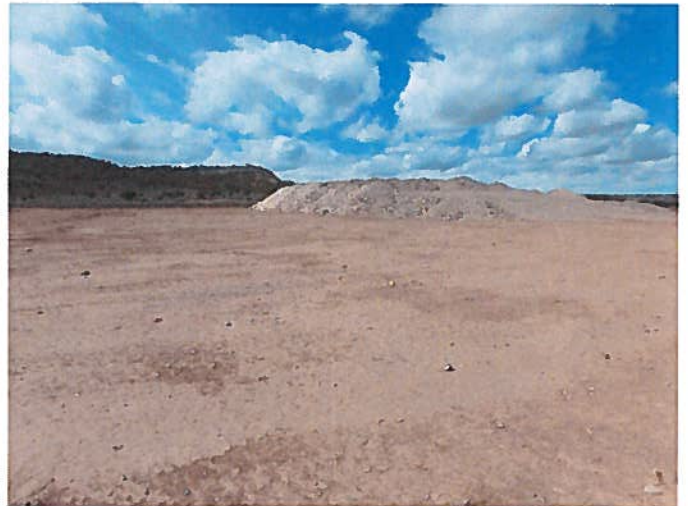
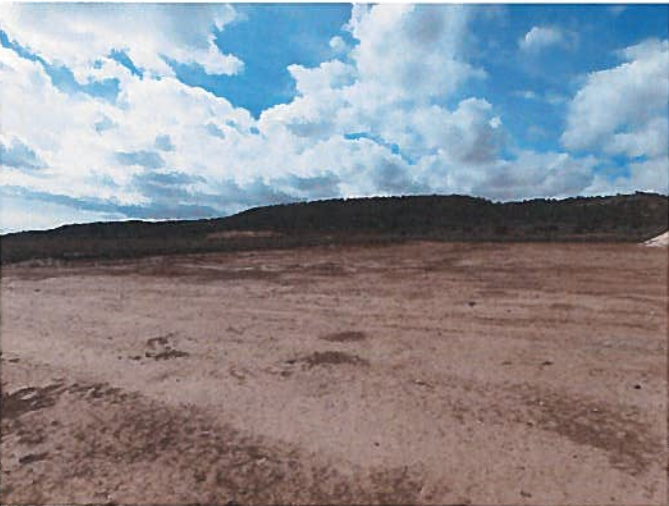
Topsoil has been stripped from the plant area and stockpiled on the west side of the Phase 1 area. The plant area has been graded flat. A stockpile of pit run is located on the east side of the plant area.

Figure 8: Plant area

Figure 9: Plant area

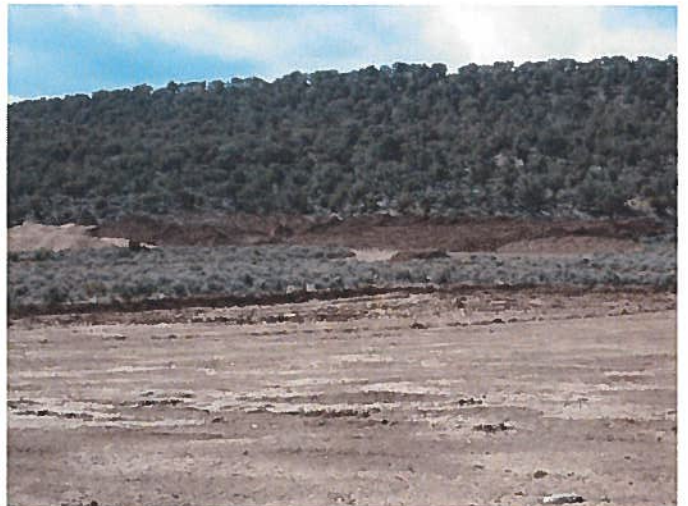
Figure 10: Topsoil stockpiled on west side of Phase 1 area

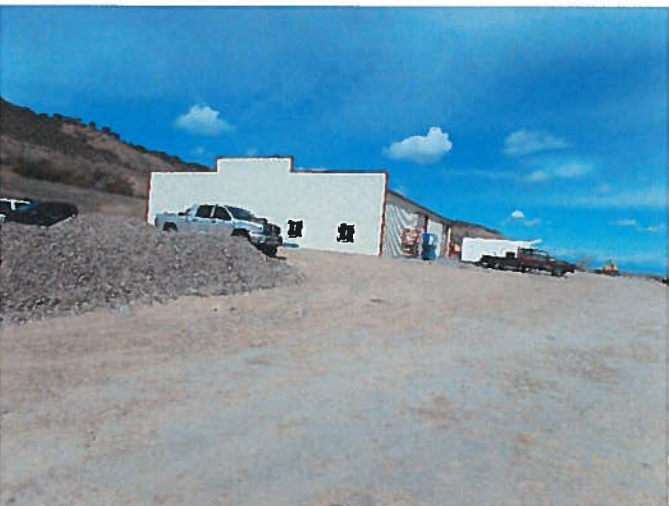
The shop and office area are under construction as well. The bench area has been built up and the shop building has been constructed. The slopes around the bench perimeter appeared stable. No problems were noted.

Figure 11: Shop/office area
