COLORADO DIVISION OF RECLAMATION, MINING AND SAFETY
MINERALS PROGRAM INSPECTION REPORT
PHONE: (303) 866-3567

MINE NAME: Mamm Creek Sand & Gravel	MINE/PROSPECTING ID#: M-2000-113	MINERAL: Sand and gravel	COUNTY: Garfield
INSPECTION TYPE: Monitoring	INSPECTOR(S): Amy C. Yeldell	INSP. DATE: March 15, 2016	INSP. TIME: 13:00
OPERATOR: Oldcastle SW Group, Inc. dba United Compai County	OPERATOR REPRESENTATIVE: Jason Burkey	TYPE OF OPERATION: 112c - Construction Regular Operation

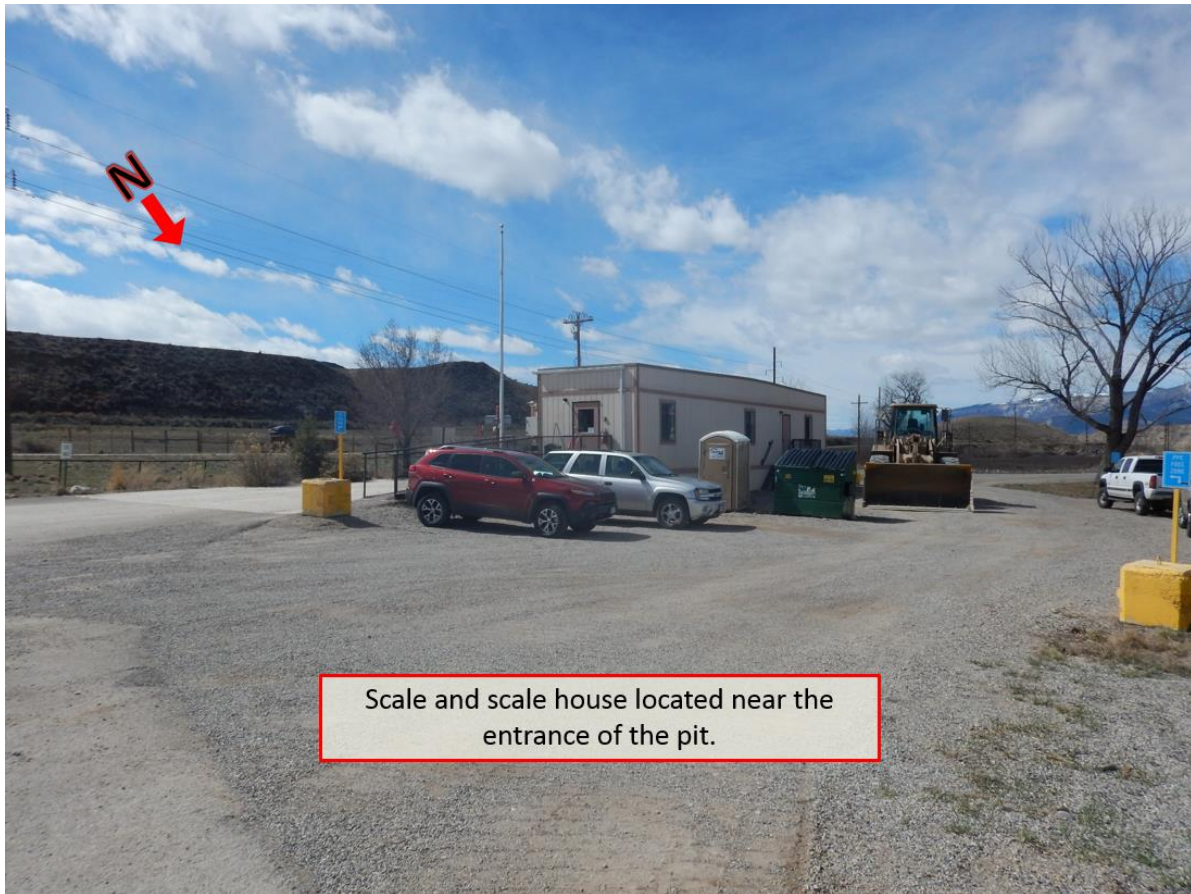
Scale and scale house located near the entrance of the pit.

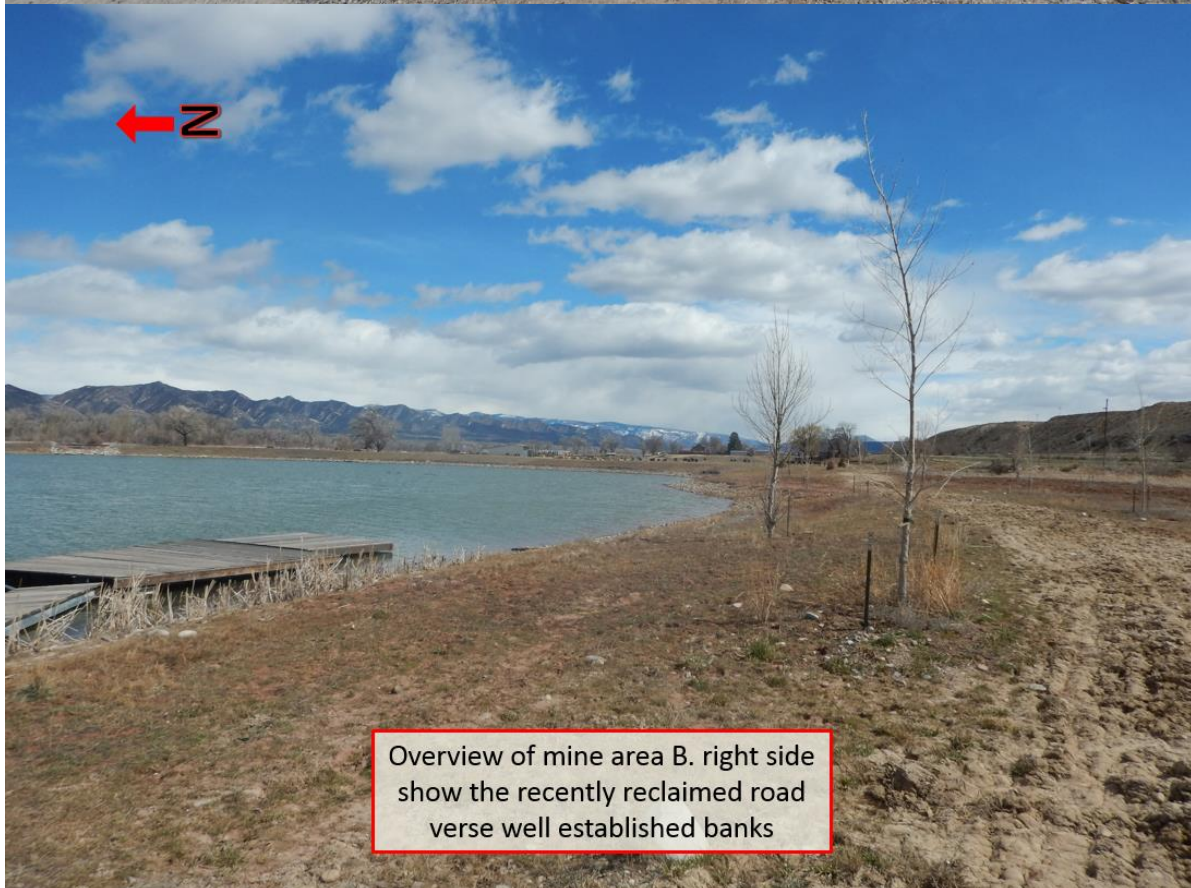
At the request of the landowner Mr. Snyder, Oldcastle would like to pursue a partial release of mining area B. The majority of the area surrounding the lake appears to have well established grasses and trees that look to be healthy. In areas with adequate vegetation slopes were graded properly to 3:1 or less. Mr. Burkey indicated that since the last inspection all of the identified dead trees have been replaced. Last fall work was done to the Army Corp of Engineers (ACOE) permitted spill structure. This resulted in a small road being disturbed which has since been reclaimed. The spill structure appears to be stable and functioning properly. Typically the Division would like to see at least two growing seasons before inspecting areas for release. This helps the Division ensure that reclamation is successful and sustainable rather than the result of one good year. The Division observed a sprinkler system which will likely speed up revegetation success. However grazing of cattle is likely placing undue stress on young plants. Being that this inspection was conducted in March, a large majority of the vegetation is still dormant. Come spring when plants germinate it will help indicate what vegetation was established and was hearty enough to survive the winter and ultimately be considered sustainable. It is noted that the south and west banks of mining area B lake are adjacent to the scale and processing area. Additionally there is a gas pad in the southwest portion. These areas will require additional grading and seeding come final reclamation if responsibility is not assumed by the gas company.

Regarding a partial release of successfully reclaimed acreage or undisturbed lands. If requested at this time the Division cannot with confidence approve land in mine area B since the road was reclaimed recently. Depending on reclamation success come this fall the Division may consider a request for the north east portions at that time. Regarding the lake portion of mining area E, the Division feels this area does meet the requirements of the reclamation plan. Similarly Mine area D is undisturbed and also meet those requirements. Bases on this inspection it is determined that the Operator has successfully complied with the requirements, and that a portion of the site is ready to be released from any further reclamation responsibility. If the operator submits an acreage release request within 60 days, this inspection will count as the acreage release inspection. In your request please include a detailed map depicting the specific areas you wish to release. Upon approval a technical revision (TR) will be required to update all maps.

Overview of mine area B. right side show the recently reclaimed road verse well established banks

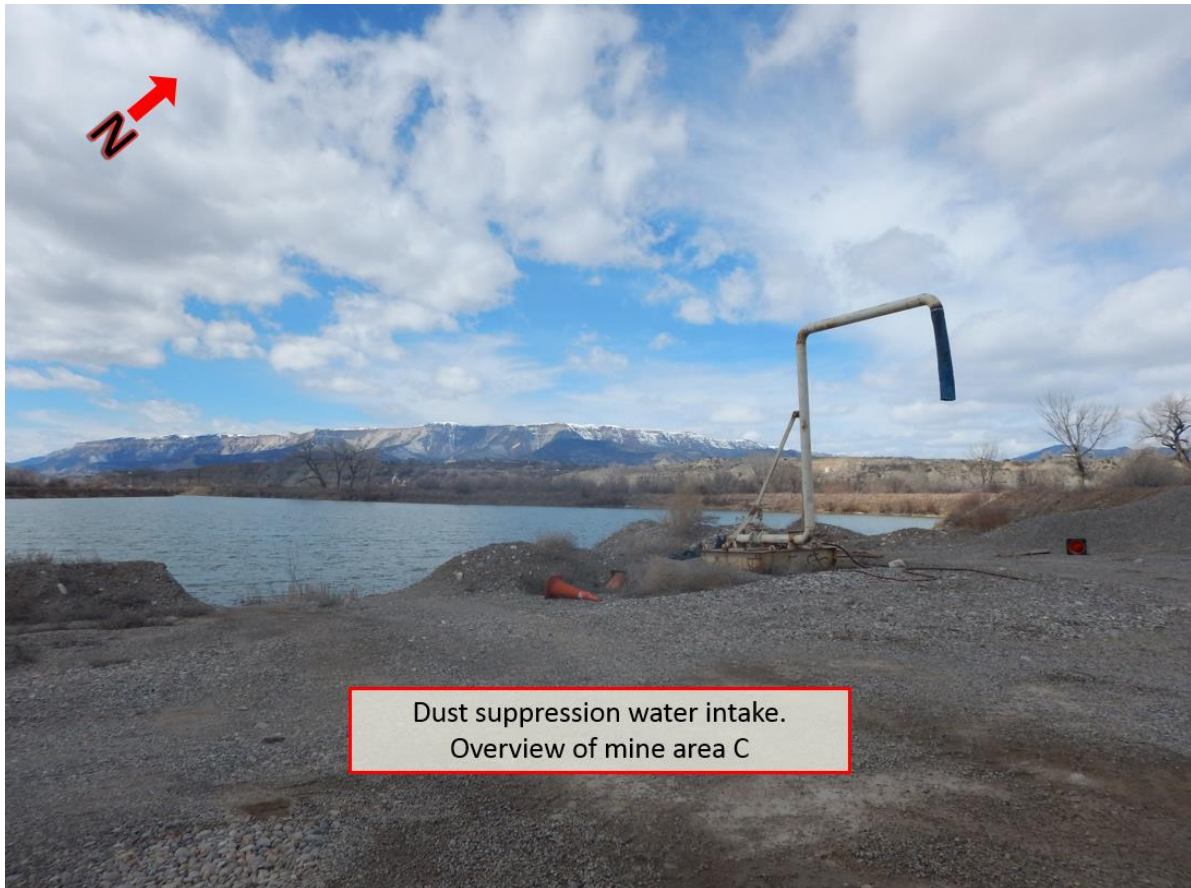
In the processing area a portable conveyor belt is used to extend the fixed conveyor belt that spans the Colorado River. From there material is moved via dozer and stacked in its respective pile. All piles are neatly organized according to size and appear to be stable. Electrical utility boxes are protected by jersey barriers. There is a double walled diesel tank on site. Mr. Burkey indicated this will likely be removed since only one piece of equipment is being used in this area. Other miscellaneous hydrocarbon materials and smaller jugs are stored in a secondary containment or the storage locker. Excess construction materials and debris are neatly stacked near the storage locker. There is also a fresh water load out area for dust suppression drawing water from the lake in mine area C.

Dust suppression water intake.
Overview of mine area C

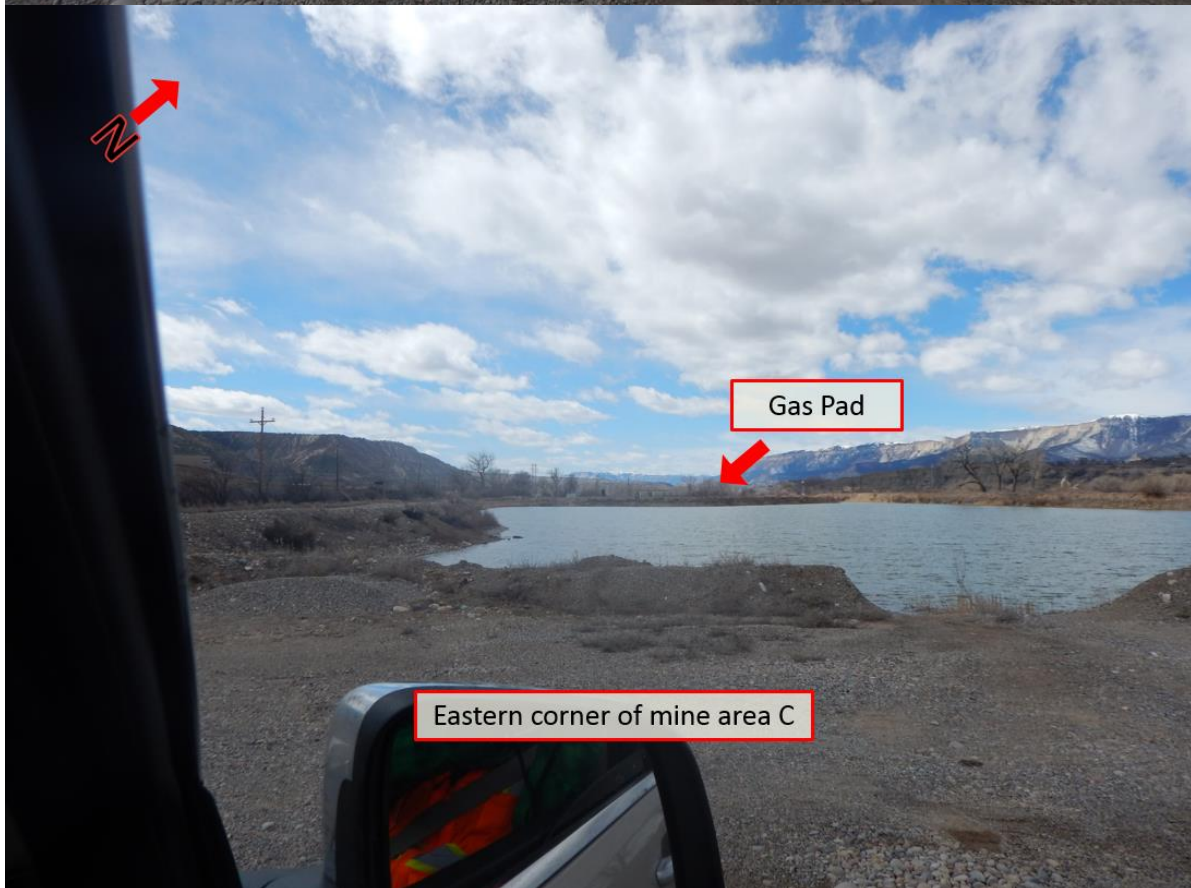
Mine area C as indicated by Mr. Burkey has also been mined out. There is a drill pad in the middle of the south west portion of the lake. This mining area is partially reclaimed. Most of the slopes are approximately 2:1. For final reclamation slopes are required to be graded to 3:1 or less. Additionally some of the banks appear to be in excess of 15 feet above existing grade on either side. These banks where otherwise not required for flood protection should blend naturally into the surrounding topography. Reclamation maps should distinguish areas with steep grade or berms that will remain for flood protection. Additional top soiling and seeding of the graded portions will be required. Currently vegetation is adequate and the ground is stable with no visible evidence of erosion.

Gas Pad

Eastern corner of mine area C
