COLORADO DIVISION OF RECLAMATION, MINING AND SAFETY
MINERALS PROGRAM INSPECTION REPORT
PHONE: (303) 866-3567

MINE NAME: Prather Pit	MINE/PROSPECTING ID#: M-1977-136	MINERAL: Sand and gravel	COUNTY: Rio Blanco
INSPECTION TYPE: Monitoring	INSPECTOR(S): Travis H. Marshall	INSP. DATE: March 16, 2016	INSP. TIME: 09:00
OPERATOR: Rio Blanco County	OPERATOR REPRESENTATIVE: Clint Chapel	TYPE OF OPERATION: 112c - Construction Regular Operation

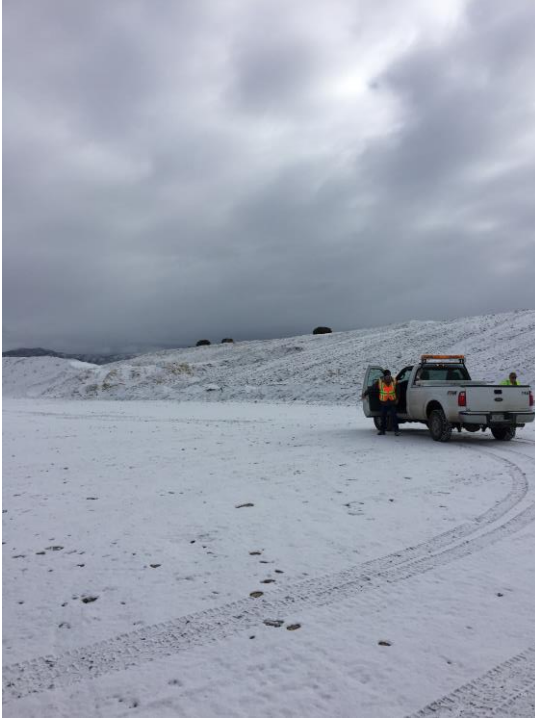
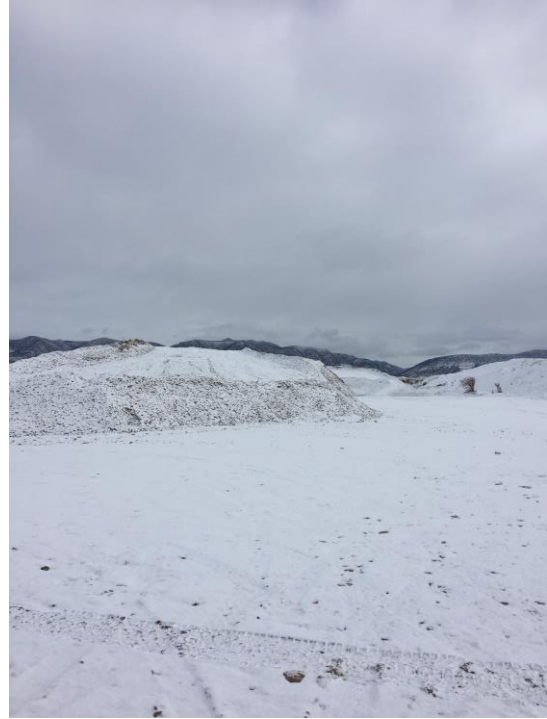
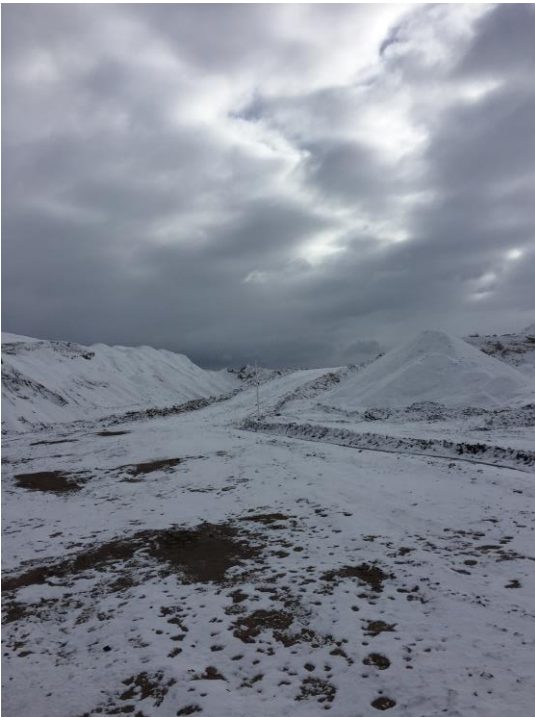
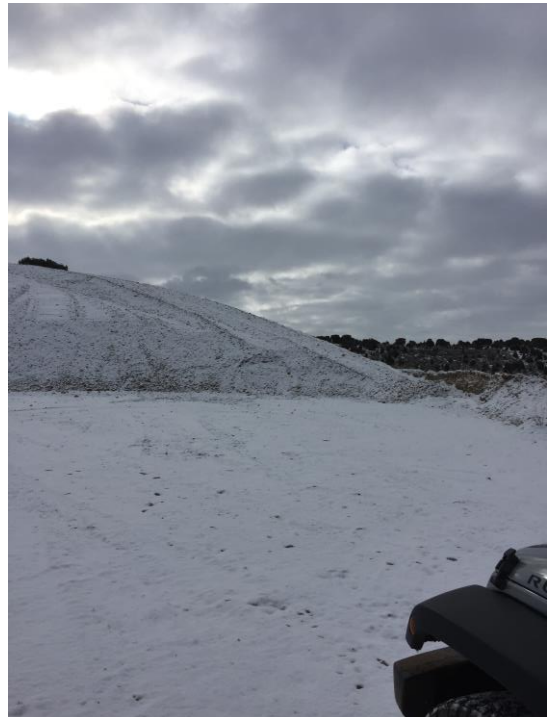
The mine identification sign and the affected area boundary markers are in place and in compliance with rule 3.1.12. The sign is located on a post at the main entrance of the gravel mine. The permit boundaries are comprised of fence posts that are easily identifiable around the entire perimeter of the mine.

The mine is active, however, due to the snow cover that existed no mining activities were observed during the inspection. Various stockpiles of material were observed on the pit floor. The majority of the permit area appeared to be disturbed.

The site was covered with approximately 1-2 inches of snow during the inspection therefore evaluation of revegetative success was not possible during the inspection. Topsoil stock piles were observed at the top and adjacent to the east slope of the permit area.

No evidence of erosion or off site damage was observed during the inspection.
