COLORADO DIVISION OF RECLAMATION, MINING AND SAFETY
MINERALS PROGRAM INSPECTION REPORT
PHONE: (303) 866-3567

MINE NAME: Piceance Pit	MINE/PROSPECTING ID#: M-2001-077	MINERAL: Sand and gravel	COUNTY: Rio Blanco
INSPECTION TYPE: Monitoring	INSPECTOR(S): Travis H. Marshall	INSP. DATE: March 16, 2016	INSP. TIME: 10:00
OPERATOR: Rio Blanco County	OPERATOR REPRESENTATIVE: Clint Chappell	TYPE OF OPERATION: 112c - Construction Regular Operation

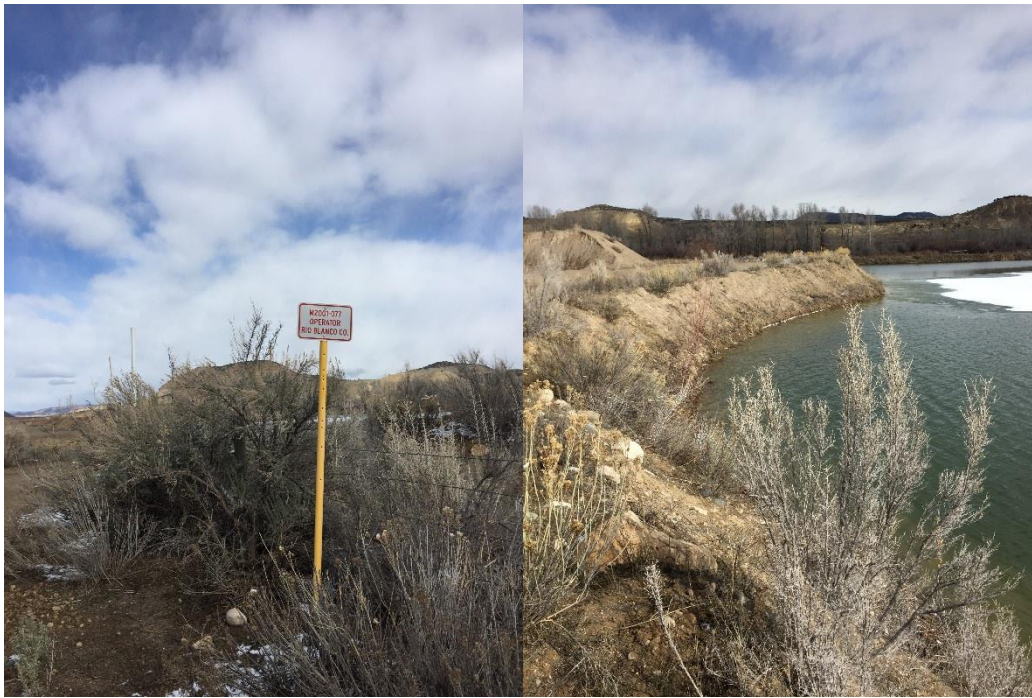
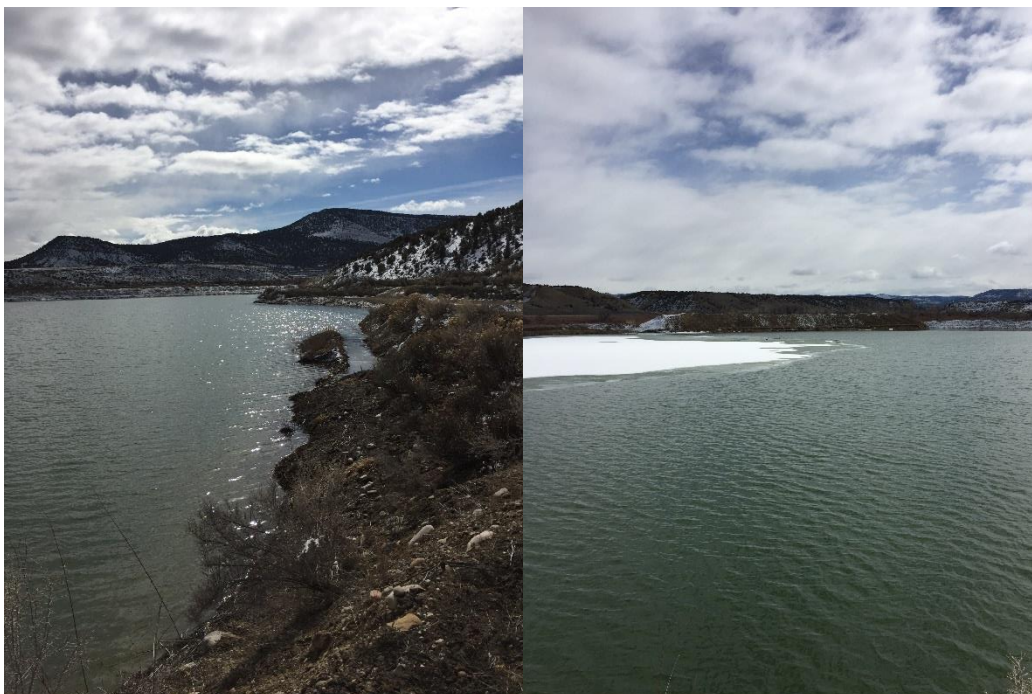
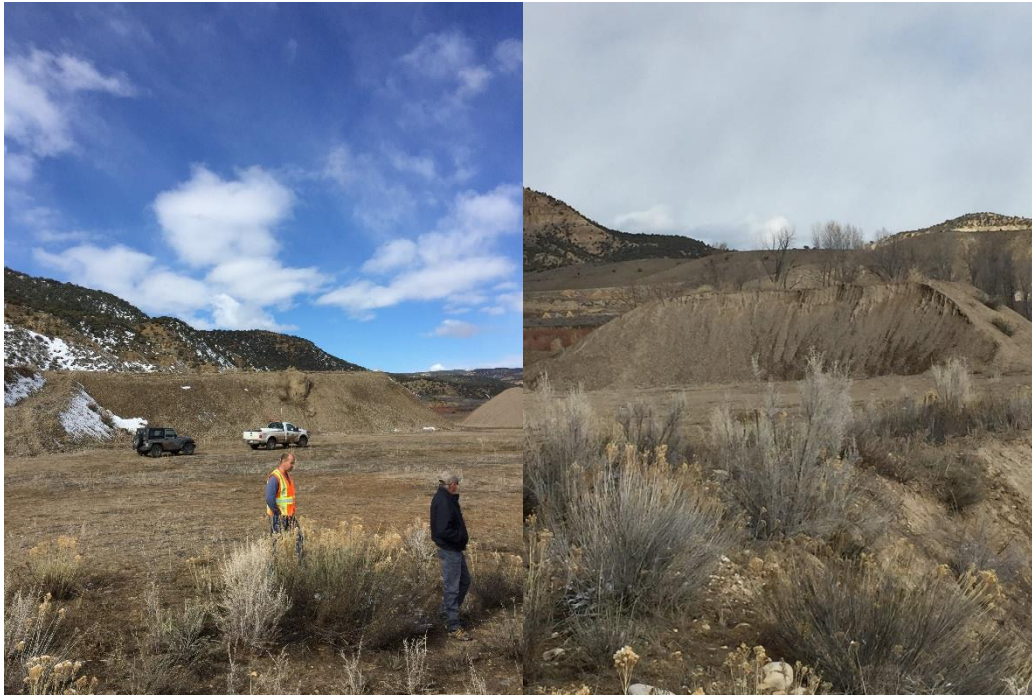
The pit is currently active but no equipment was observed working in the permit area. Various stockpiles of construction materials were observed at various location of the process area. The area that has been excavated was full of water during the inspection. It did not appear that the pit slopes had been regrade to the final configuration which requires slopes to be no steeper than 3H:1V.
