COLORADO DIVISION OF RECLAMATION, MINING AND SAFETY
MINERALS PROGRAM INSPECTION REPORT
PHONE: (303) 866-3567

| MINE NAME: Quinn Draw Gravel Pit | MINE/PROSPECTING ID#: M-2002-049 | MINERAL: Gravel | COUNTY: Rio Blanco |
| INSPECTION TYPE: Monitoring | INSPECTOR(S): Travis H. Marshall | INSP. DATE: March 16, 2016 | INSP. TIME: 10:45 |

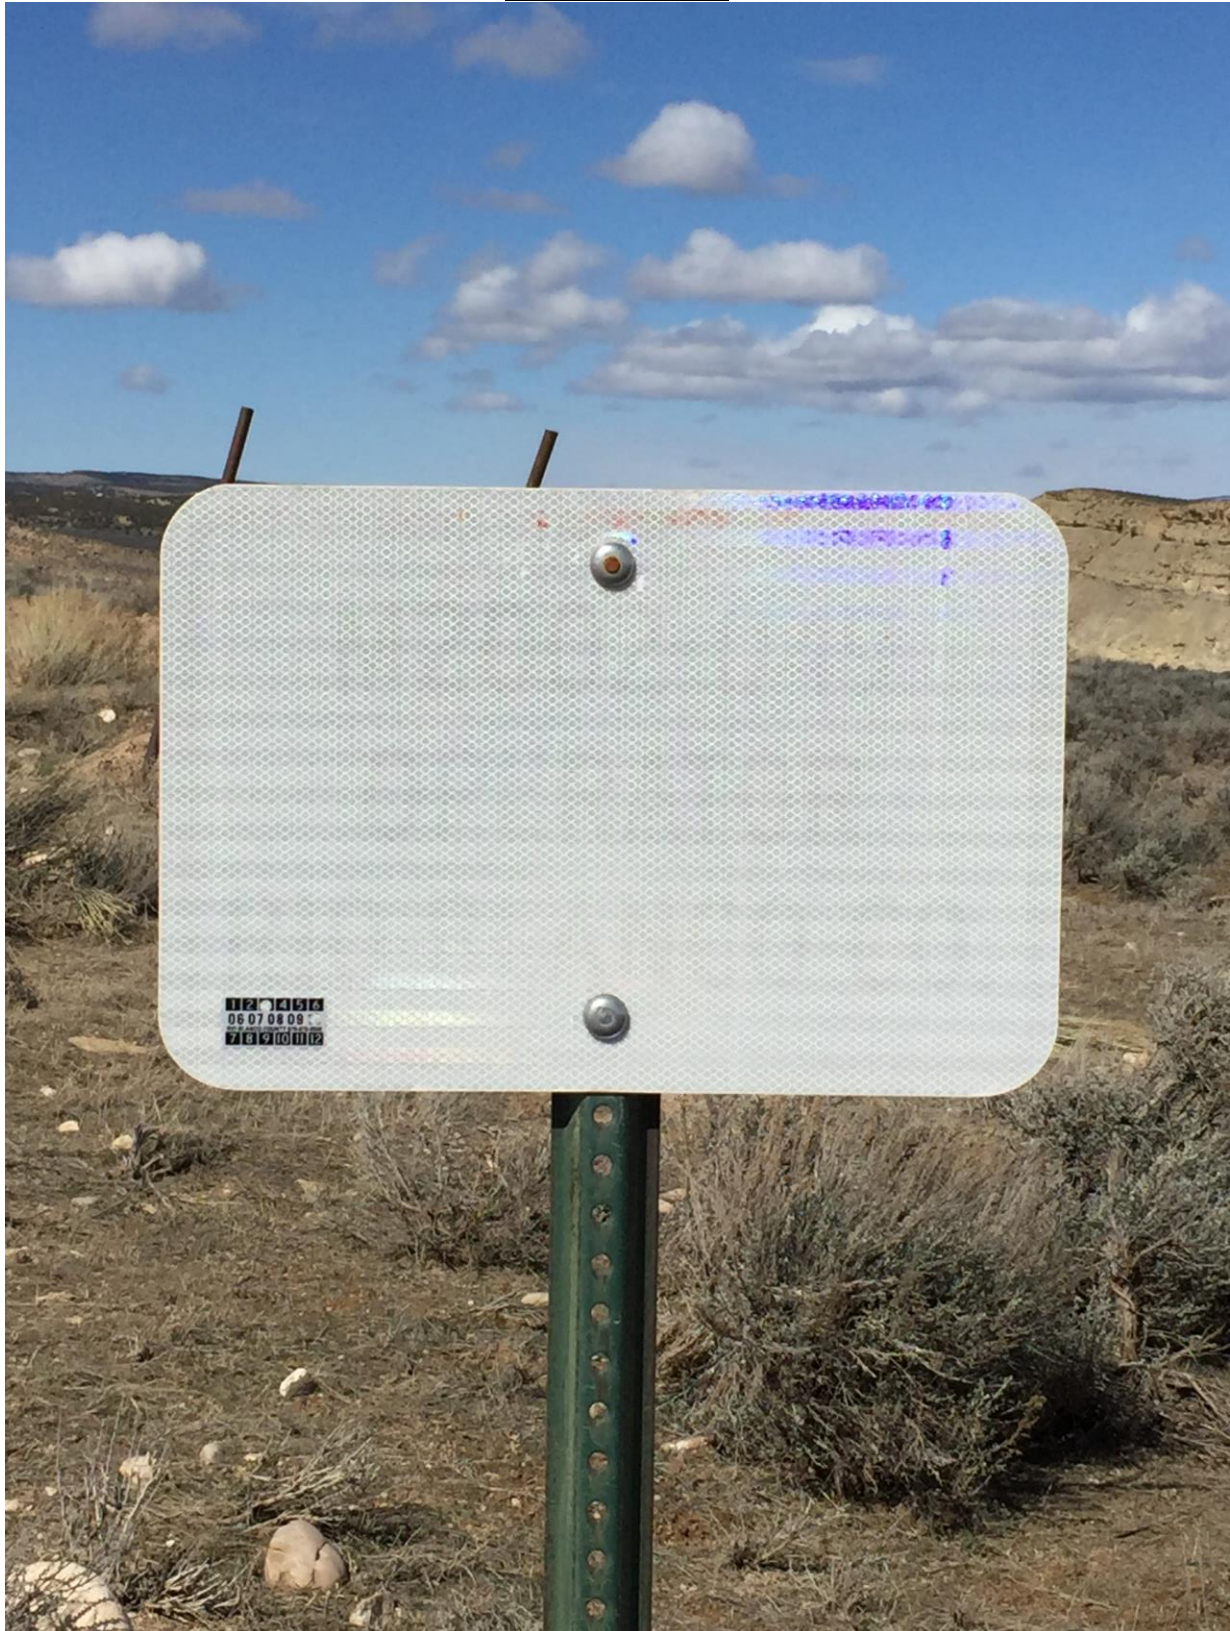
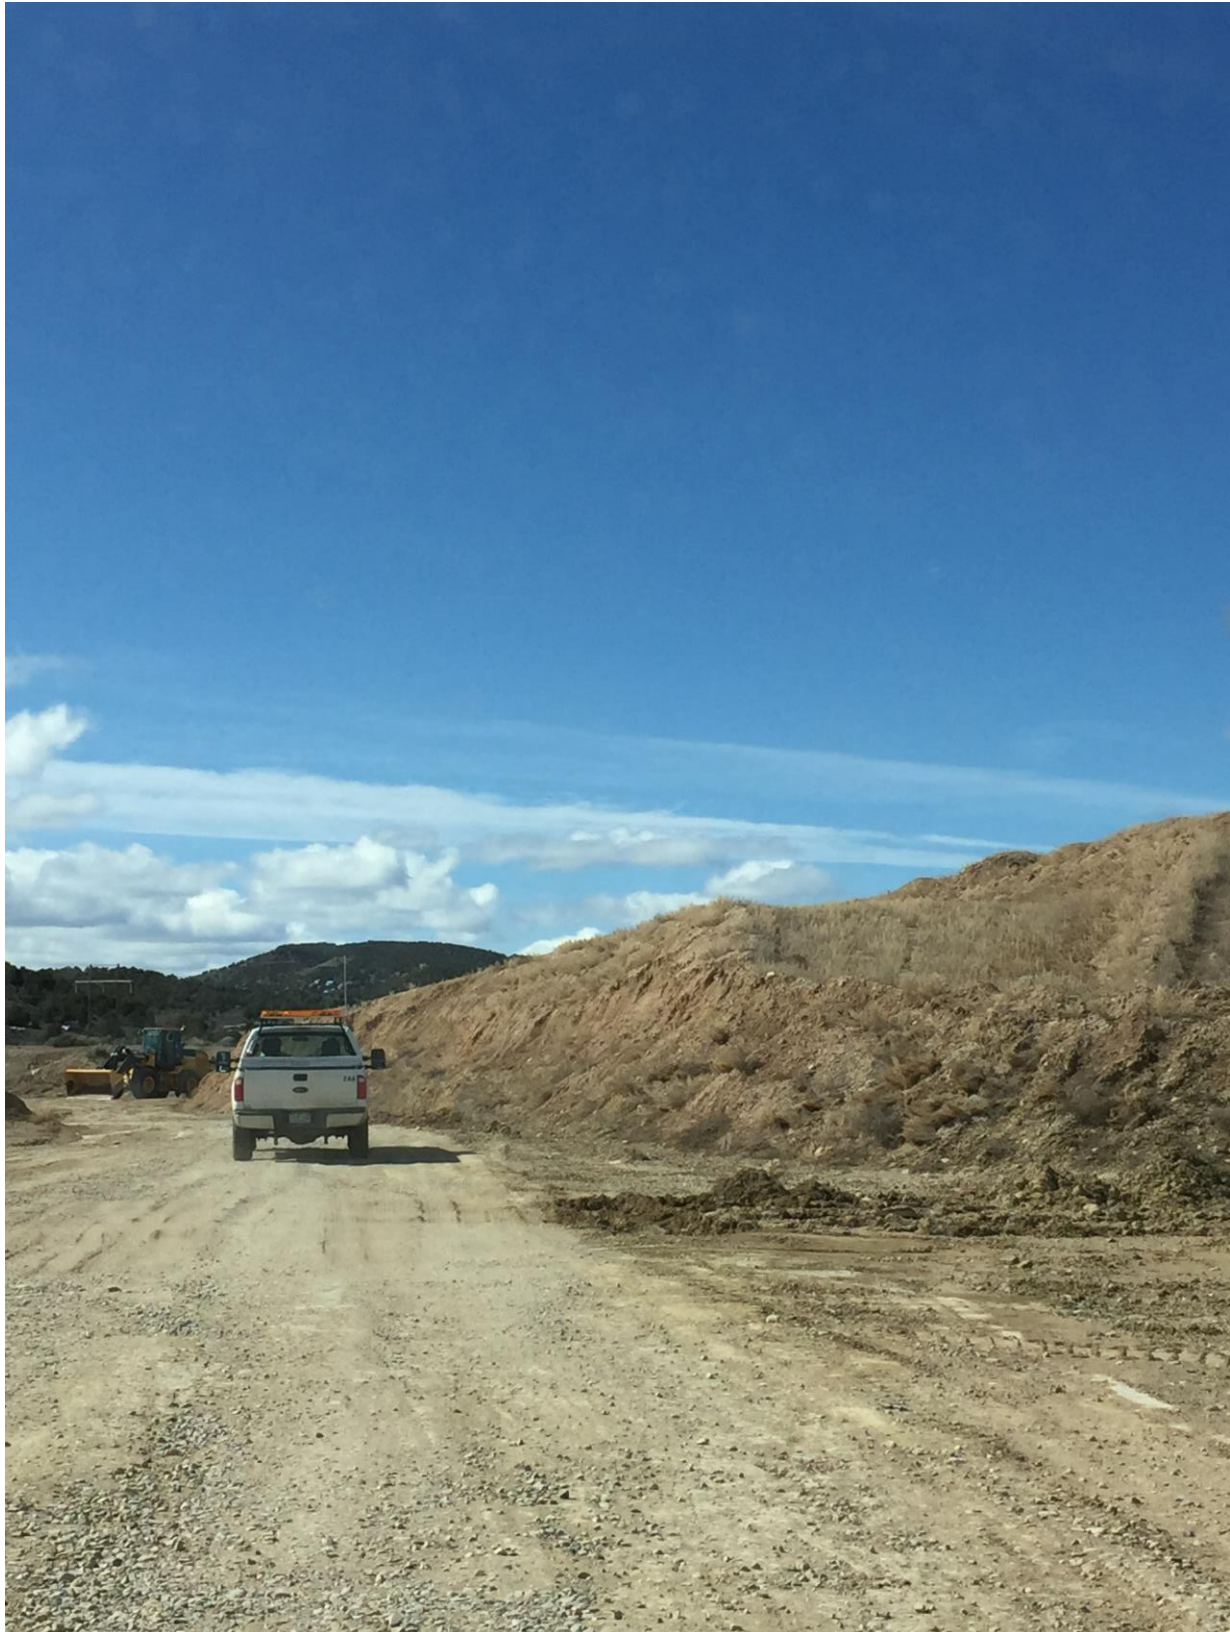
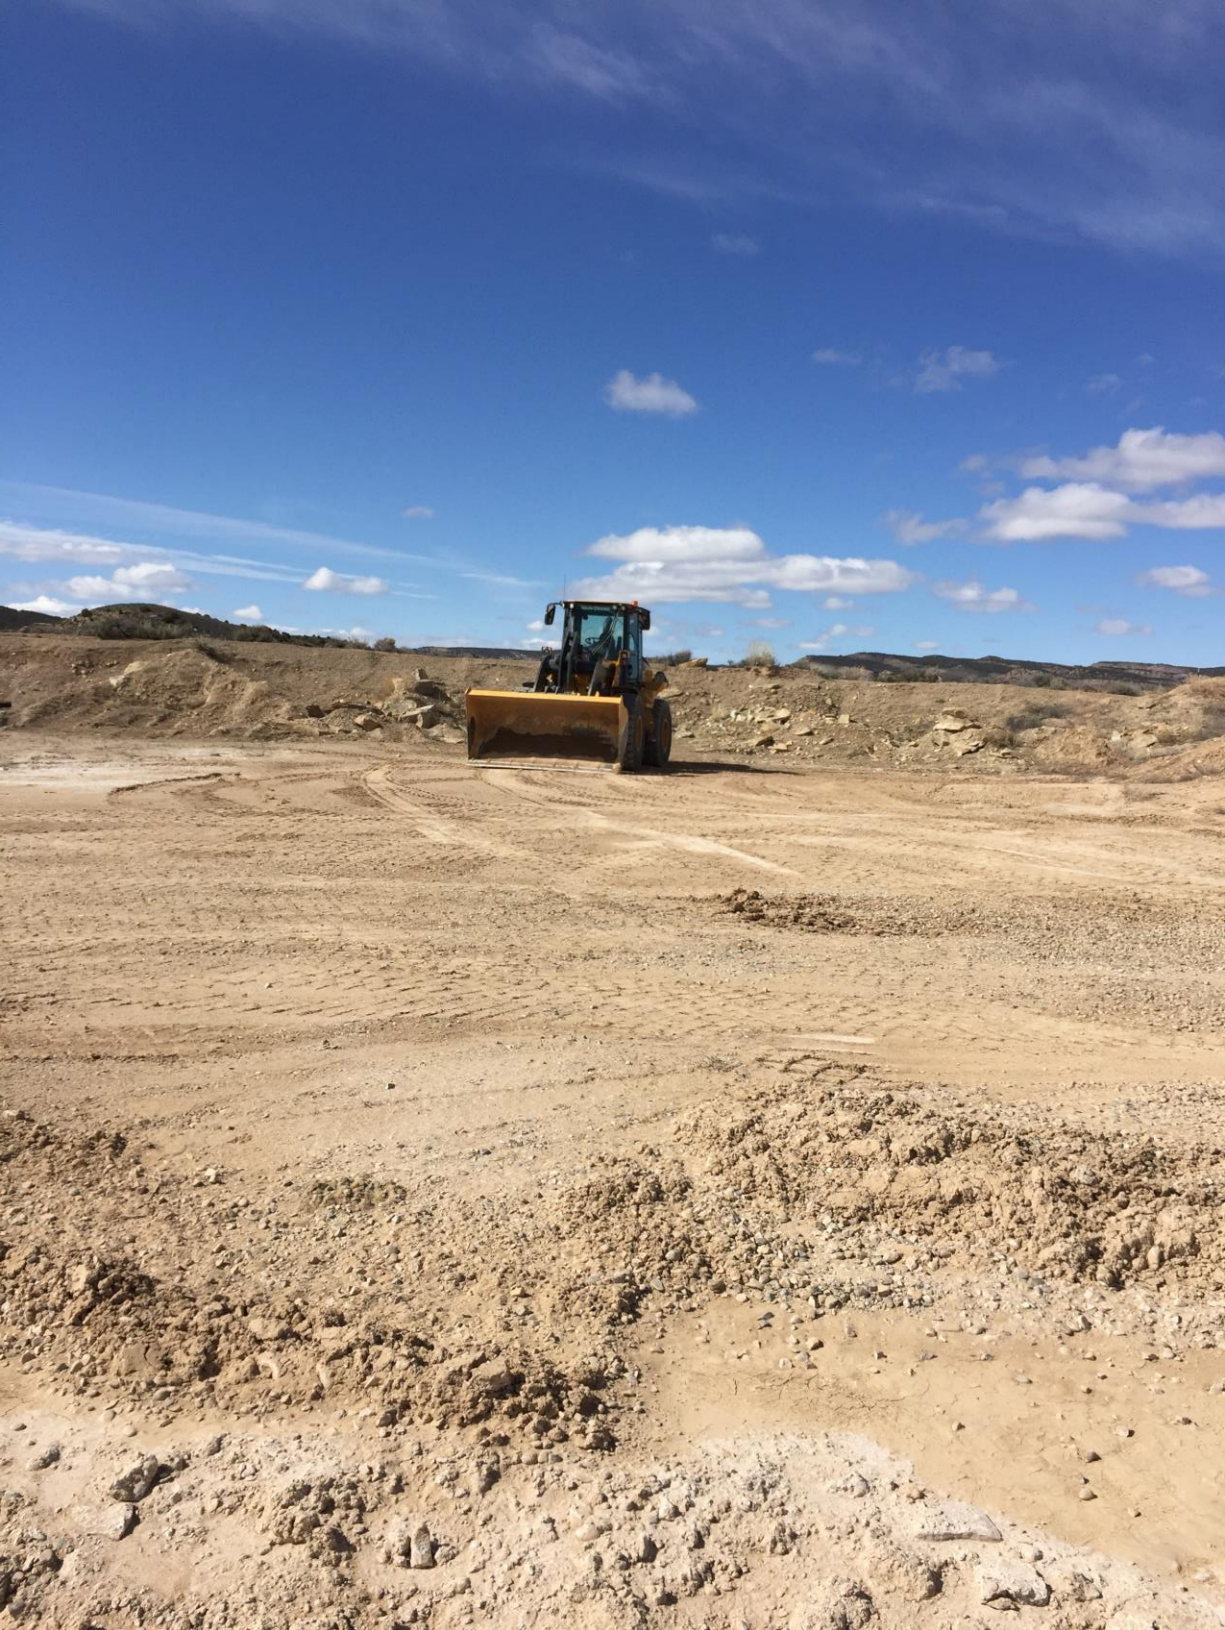
A sign was observed at the entrance of the mine site but it is not compliant with Rule 3.1.12(1). According to Rule 3.1.12(1) the following must be visible on the sign: The name of the operator; a statement that a reclamation permit for the operation has been issued by the Colorado Mined Land Reclamation Board; and the permit number. Please post a sign at the site that meets the criteria of Rule 3.1.12 and provide photo-documentation of its placement to this office no later than the date indicated on the last page of this report. The permit boundaries are comprised of fence posts that are easily identifiable around the entire perimeter of the mine.

The mine is active but no mining activities were observed during the inspection. Various stockpiles of material were observed on the pit floor. The majority of the permit area appeared to be disturbed.

Topsoil stock piles were observed adjacent to the east slope of the permit area. The site appears to be mined out and no current mine face or high wall was observed during the inspection. The operator stated that the site would likely be reclaimed in the near future.

No evidence of erosion or off site damage was observed during the inspection.

CORRECTIVE ACTIONS: The operator shall, at the entrance of the mine site, post a sign which shall be clearly visible from the access road with the following: the name of the operator, a statement that a reclamation permit for the operation has been issued by the Colorado Mined Land Reclamation Board; and the permit number. The operator shall submit photo documentation that a proper sign has been posted by the corrective action date.
