**COLORADO DIVISION OF RECLAMATION, MINING AND SAFETY**  
**MINERALS PROGRAM INSPECTION REPORT**  
**PHONE: (303) 866-3567**

<b>MINE NAME:</b> Arkins Park Quarries	<b>MINE/PROSPECTING ID#:</b> M-1985-212	<b>MINERAL:</b> Sandstone	<b>COUNTY:</b> Larimer
<b>INSPECTION TYPE:</b> Monitoring	<b>INSPECTOR(S):</b> Michael A. Cunningham	<b>INSP. DATE:</b> December 10, 2015	<b>INSP. TIME:</b> 09:00
<b>OPERATOR:</b> ARKINS PARK STONE CORPORATION	<b>OPERATOR REPRESENTATIVE:</b> Chantea Honer	<b>TYPE OF OPERATION:</b> 112c - Construction Regular Operation

# Arkins Park Quarries

M-1985-212

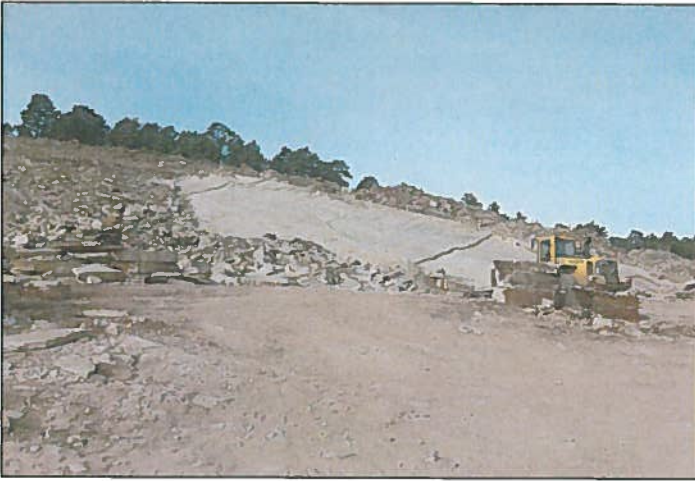
1. South quarry area.

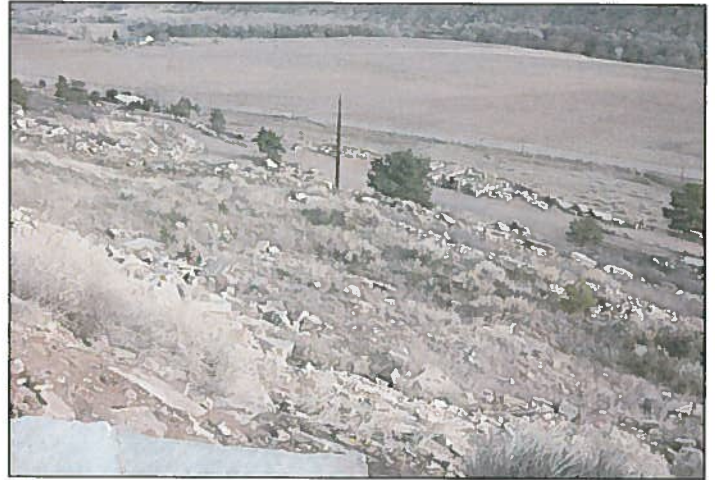
2. Product storage area, east side of permit area.

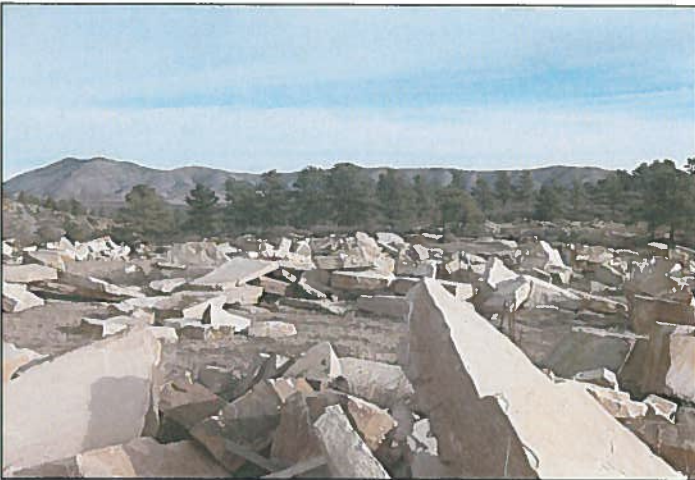
3. Product storage area, west side of permit area.

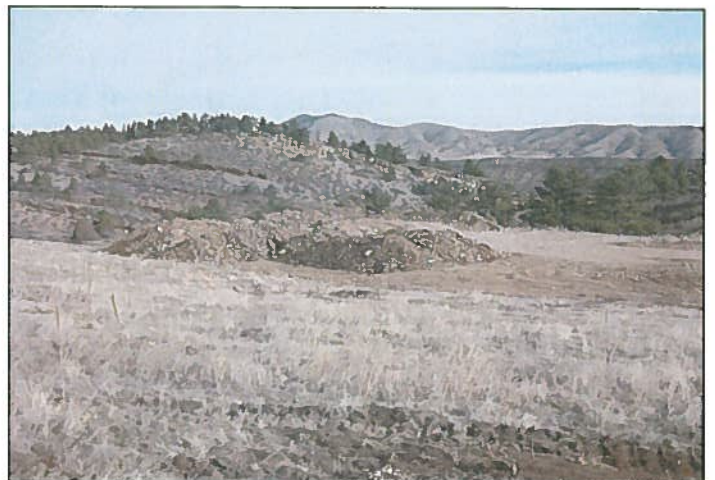
**PROBLEM/POSSIBLE VIOLATION:** Problem: The current mine plan needs to be updated and clarified pursuant to C.R.S. 34-32.5-112 (1)(c)(VI). The operator must provide sufficient information to describe or identify how the operator intends to conduct the operation.

The Reclamation Plan specifies that all available topsoil and sandstone fines will be salvaged and stockpiled for use during reclamation. The Division observed a topsoil stockpile in the Meadow area, north of the product storage area. However, in the active quarry areas the topsoil is mixed with overburden and is placed around the perimeter of the individual quarry areas. The Reclamation Plan does not specify where topsoil will be stockpiled, how the stockpiles will be stabilized, how the topsoil will be segregated from the sandstone overburden or the total depth of topsoil to be replaced. **The lack of detail in the Reclamation Plan regarding the salvaging and stockpiling of topsoil has been cited as a problem and will require corrective action. Please see the first page of this report for additional information.**

4. Topsoil/overburden stockpile.

**CORRECTIVE ACTIONS:** The operator shall submit a Technical Revision, with the required \$216 revision fee, to update and clarify the current approved mine plan to reflect existing and proposed activities by the corrective action date. The Technical Revision shall specify where topsoil will be stockpiled, how the stockpiles will be stabilized, how the topsoil will be segregated from the sandstone overburden and the total depth of topsoil to be replaced.

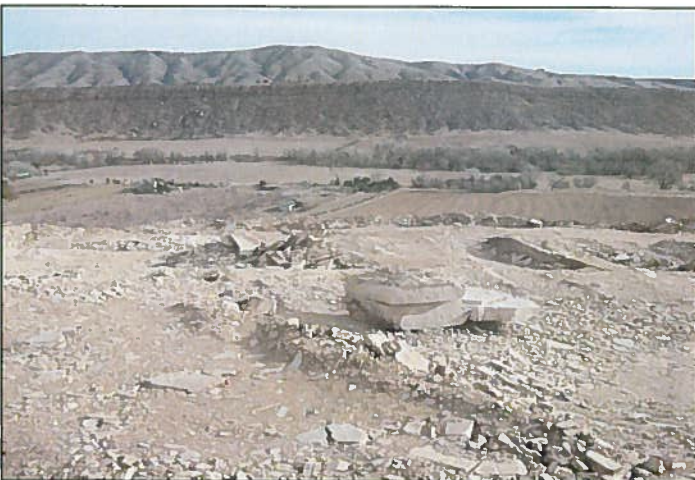
5. North quarry area.

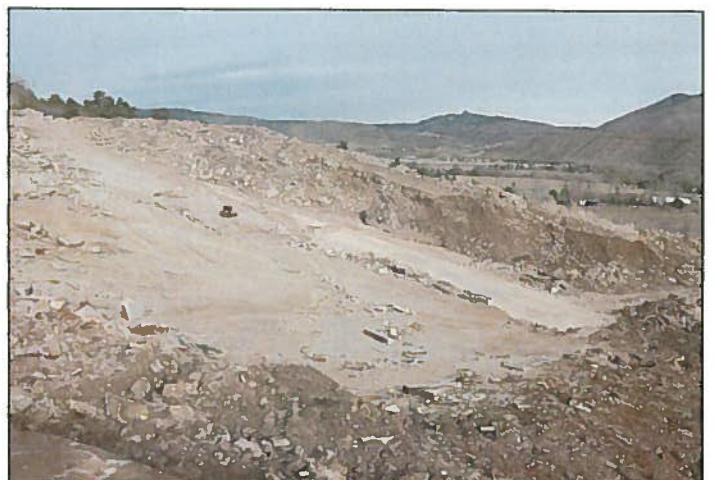
6. North quarry area.

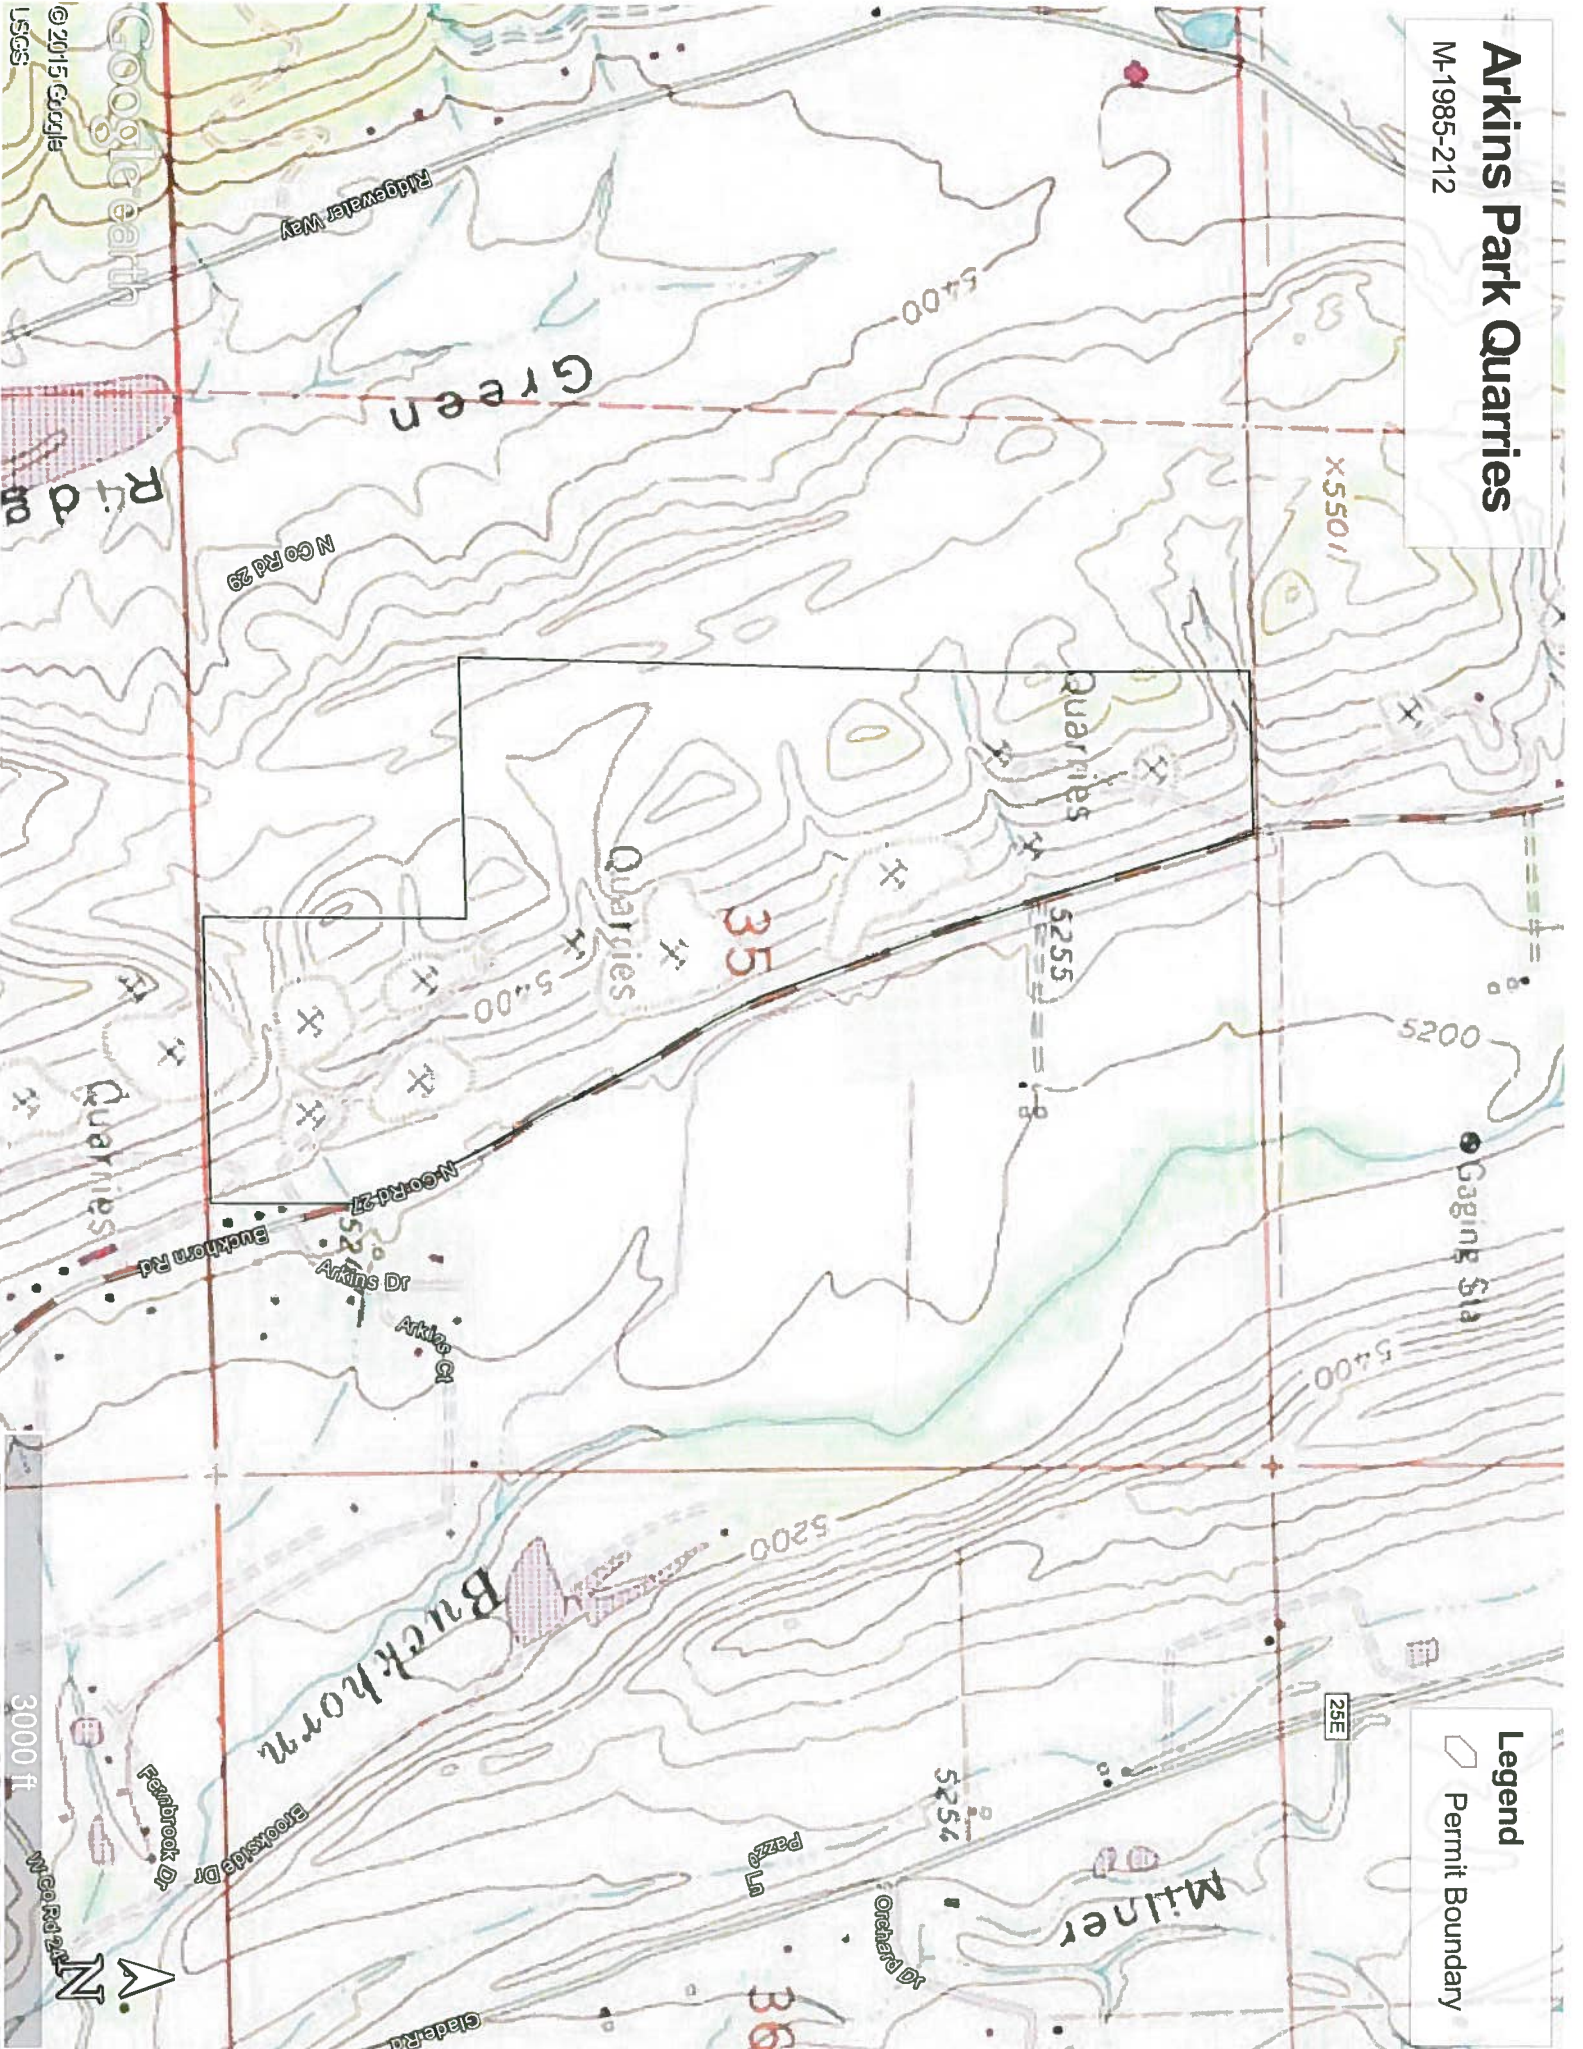
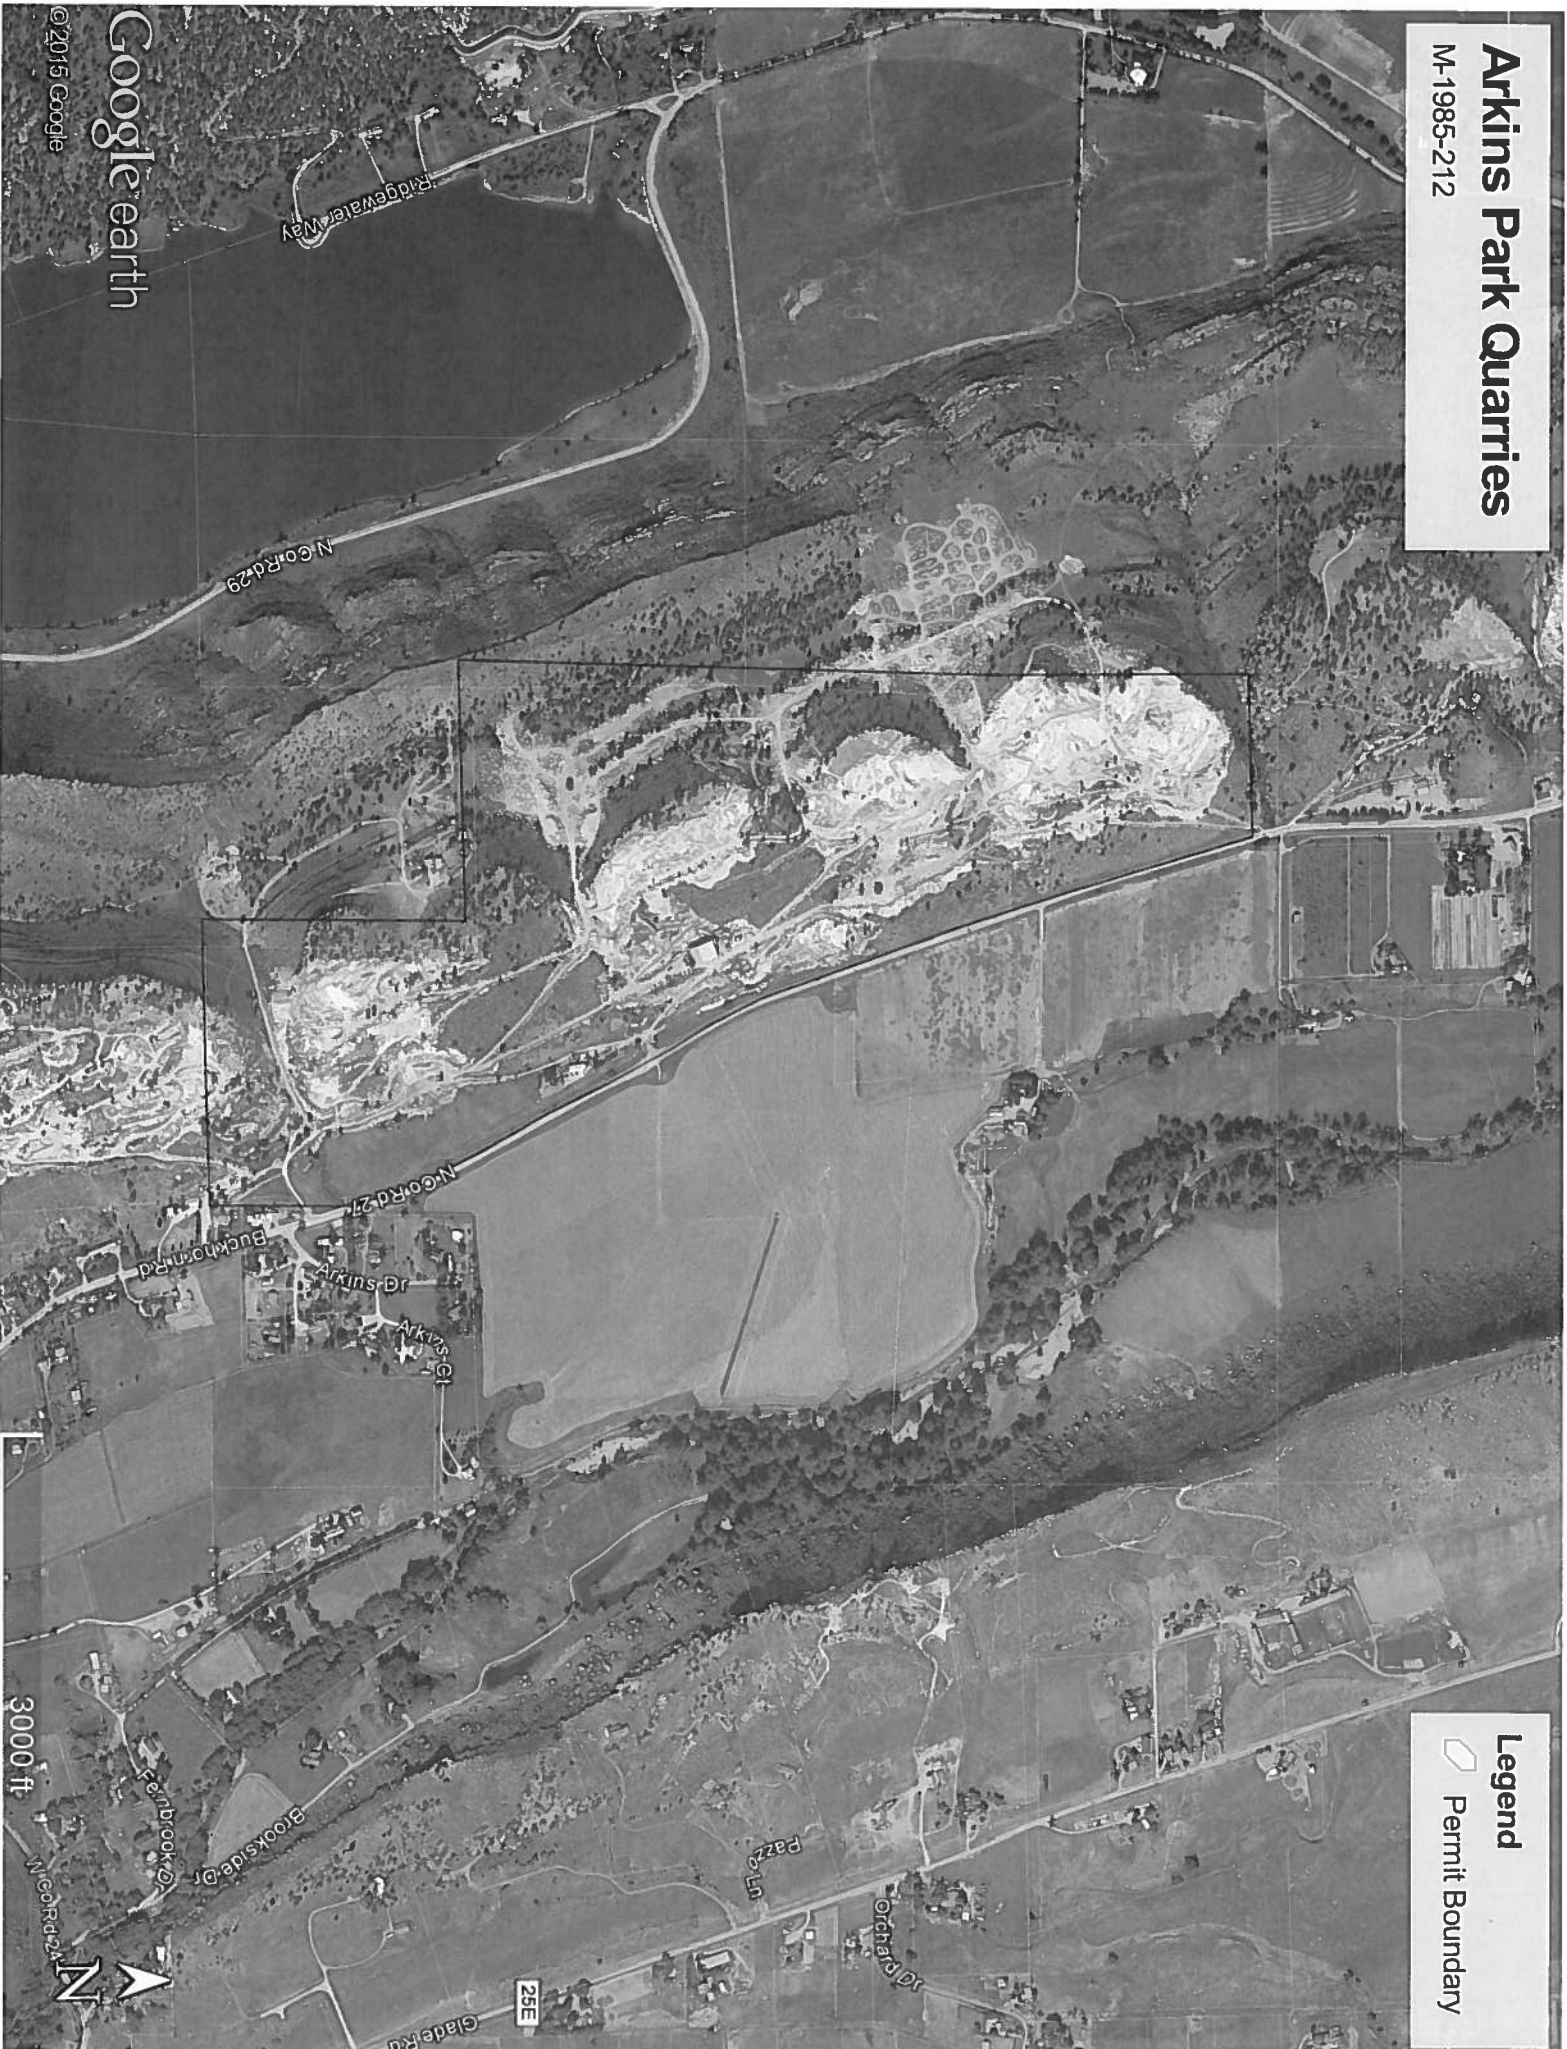
**PROBLEM/POSSIBLE VIOLATION:** Problem: The Division has reason to believe, based on a review of Mining Plan Maps and aerial photographs, that the Operator may have affected land outside of the permit boundary. This is a problem pursuant to C.R.S. 34-32.5-116(4)(i) for failure to protect areas outside of the affected land from slides or damage occurring during the mining operation and reclamation.

Following the inspection, the Division utilized Google Earth Pro to overlay the permit boundary onto an aerial photograph of the Arkins Park Quarry. The aerial photograph was taken on June 19, 2014 and is considered to be representative of current site conditions. The permit boundary was recreated by referencing Exhibit C - Mining Plan Map which was submitted under Conversion No. 2 (approved August 28, 1986) as well as Exhibit C - Mining Plan Map submitted under Amendment No. 2 (approved April 21, 1994). The approved Mining Plan Maps depict the permit boundary on a USGS 7.5 minute topographic map. Utilizing historical topographic maps in Google Earth Pro, the Division was able to draw the permit boundary using the contour lines as reference points. Upon review of the completed maps, the Division believes a portion of the western permit boundary is incorrectly delineated in the field. As a result, the Division has reason to believe that approximately 16.3 acres of land have been affected outside of the approved permit boundary. Failure to protect areas outside of the affected land may result in a possible violation. However, the Division will afford the Operator an opportunity to demonstrate that the currently delineated permit boundary accurately encompasses the 177 acre permit area.

The Division has included the two maps created in Google Earth Pro, one depicting the permit boundary over an aerial photograph of the site and the other depicting the permit boundary over a topographic map. In addition, copies of the above referenced Mining Plan Maps have been enclosed with this report. **This matter has been cited as a problem and will require corrective action by the Operator. Please see the first page of this report for additional information.**

**CORRECTIVE ACTIONS:** The Operator shall conduct a professional survey of the permit boundary, as it is currently delineated, and shall provide the Division with a map depicting the surveyed permit boundary on or before the corrective action date.
