COLORADO DIVISION OF RECLAMATION, MINING AND SAFETY
MINERALS PROGRAM INSPECTION REPORT
PHONE: (303) 866-3567

MINE NAME: West Johnson Draw	MINE/PROSPECTING ID#: M-2004-038	MINERAL: Gravel	COUNTY: Rio Blanco
INSPECTION TYPE: Monitoring	INSPECTOR(S): Travis H. Marshall	INSP. DATE: March 16, 2016	INSP. TIME: 13:00
OPERATOR: Rio Blanco County	OPERATOR REPRESENTATIVE: Clint Chappell	TYPE OF OPERATION: 112c - Construction Regular Operation

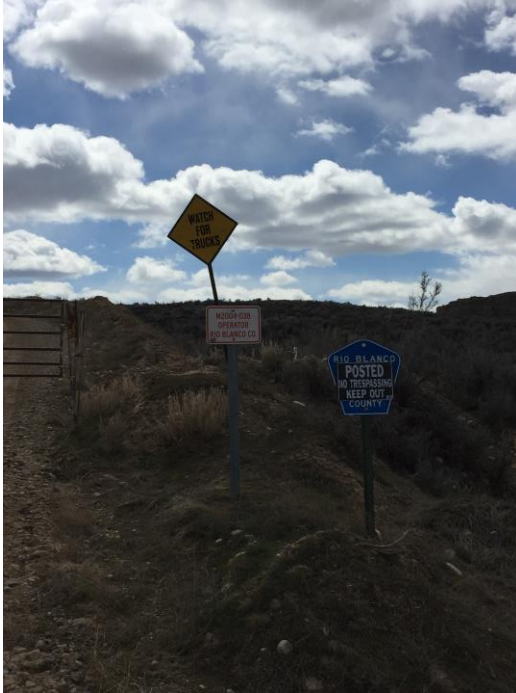
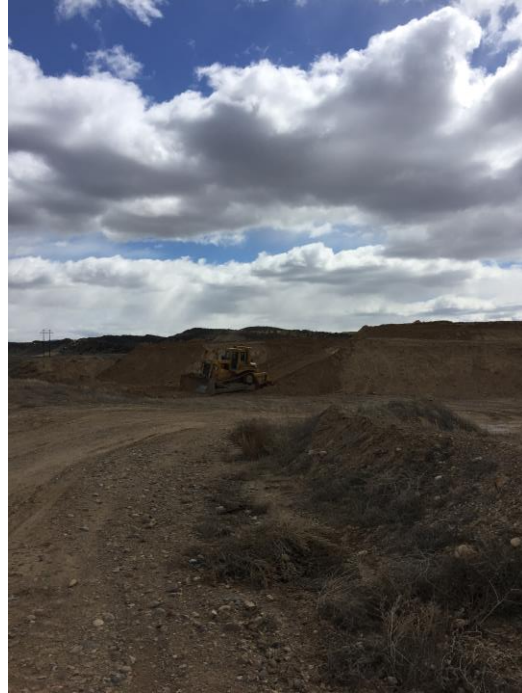
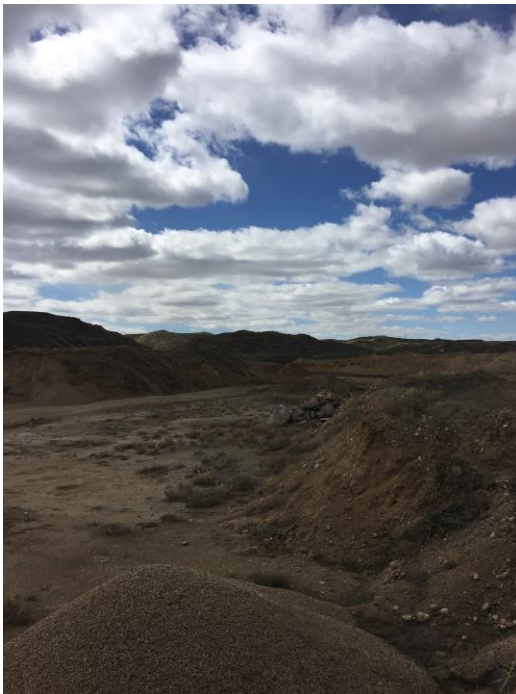
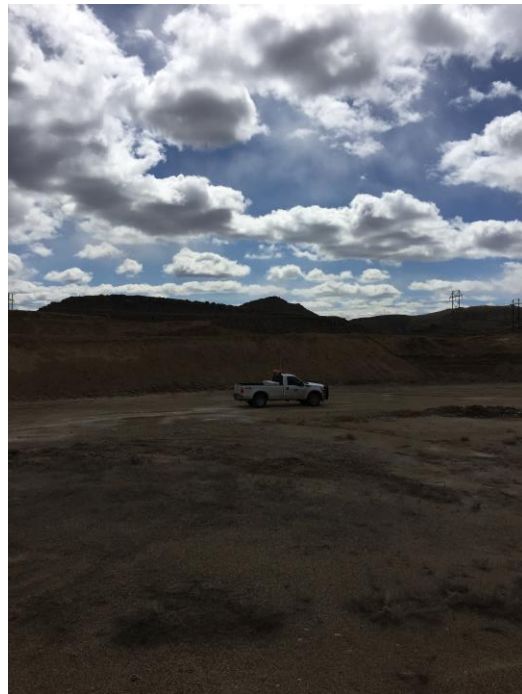
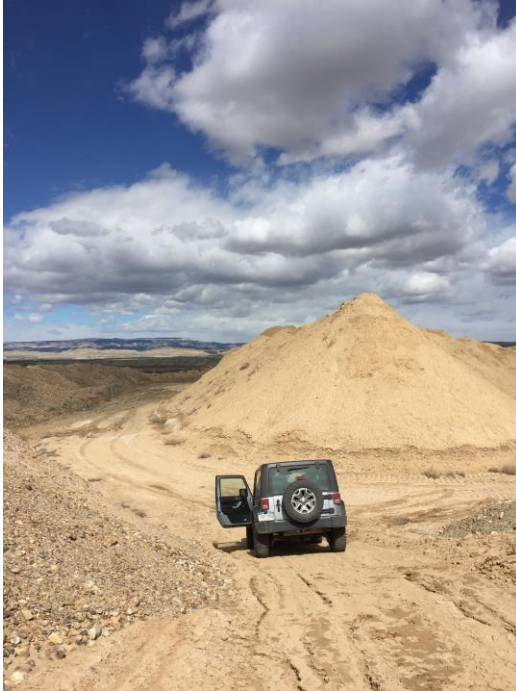
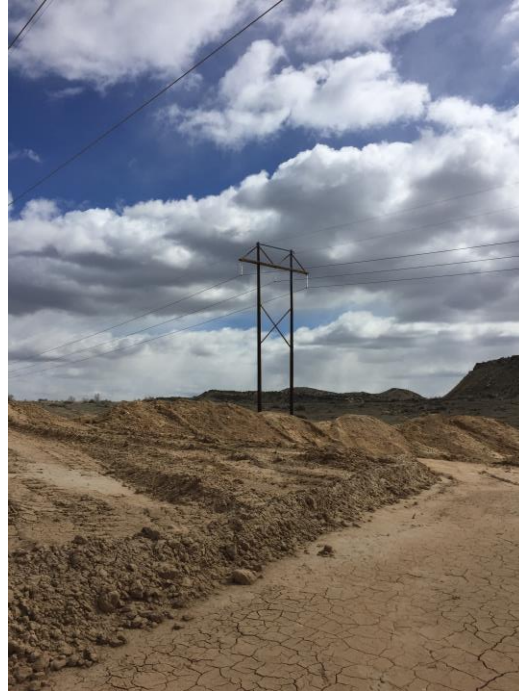
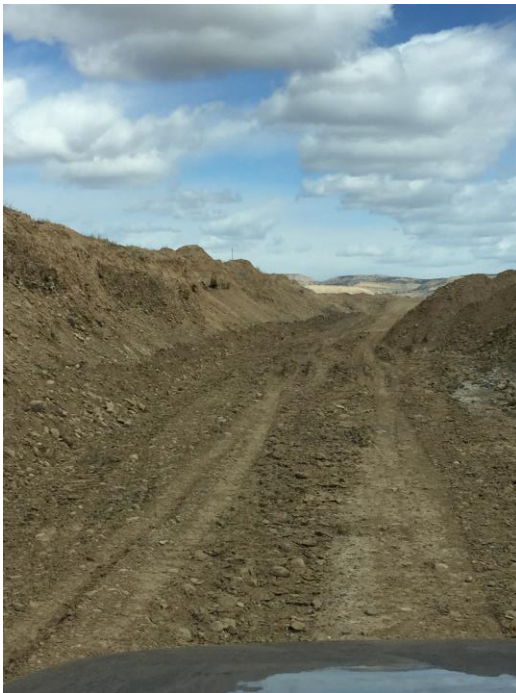
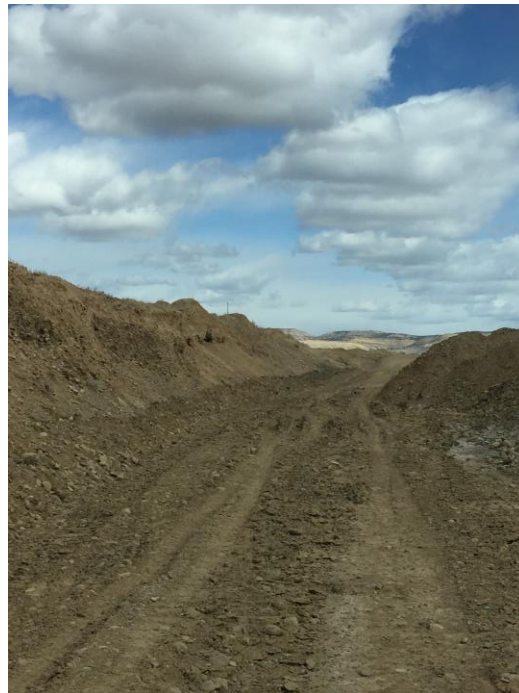
The mine is active and evidence of recent excavation was observed at the mine site. The site appears to have an extensive amount of overburden material stockpiled at various locations within the permit area. Various stockpiles of construction materials were observed within the permit area. The majority of new excavation was observed in the western portion of the permit area.

No evidence of erosion or off site damage was observed during the inspection.
