COLORADO DIVISION OF RECLAMATION, MINING AND SAFETY
MINERALS PROGRAM INSPECTION REPORT
PHONE: (303) 866-3567

MINE NAME: Red Wash Gravel Pit	MINE/PROSPECTING ID#: M-1999-040	MINERAL: Gravel	COUNTY: Rio Blanco
INSPECTION TYPE: Monitoring	INSPECTOR(S): Travis H. Marshall	INSP. DATE: March 16, 2016	INSP. TIME: 15:00
OPERATOR: Rio Blanco County	OPERATOR REPRESENTATIVE: Clint Chappell	TYPE OF OPERATION: 110c - Construction Limited Impact

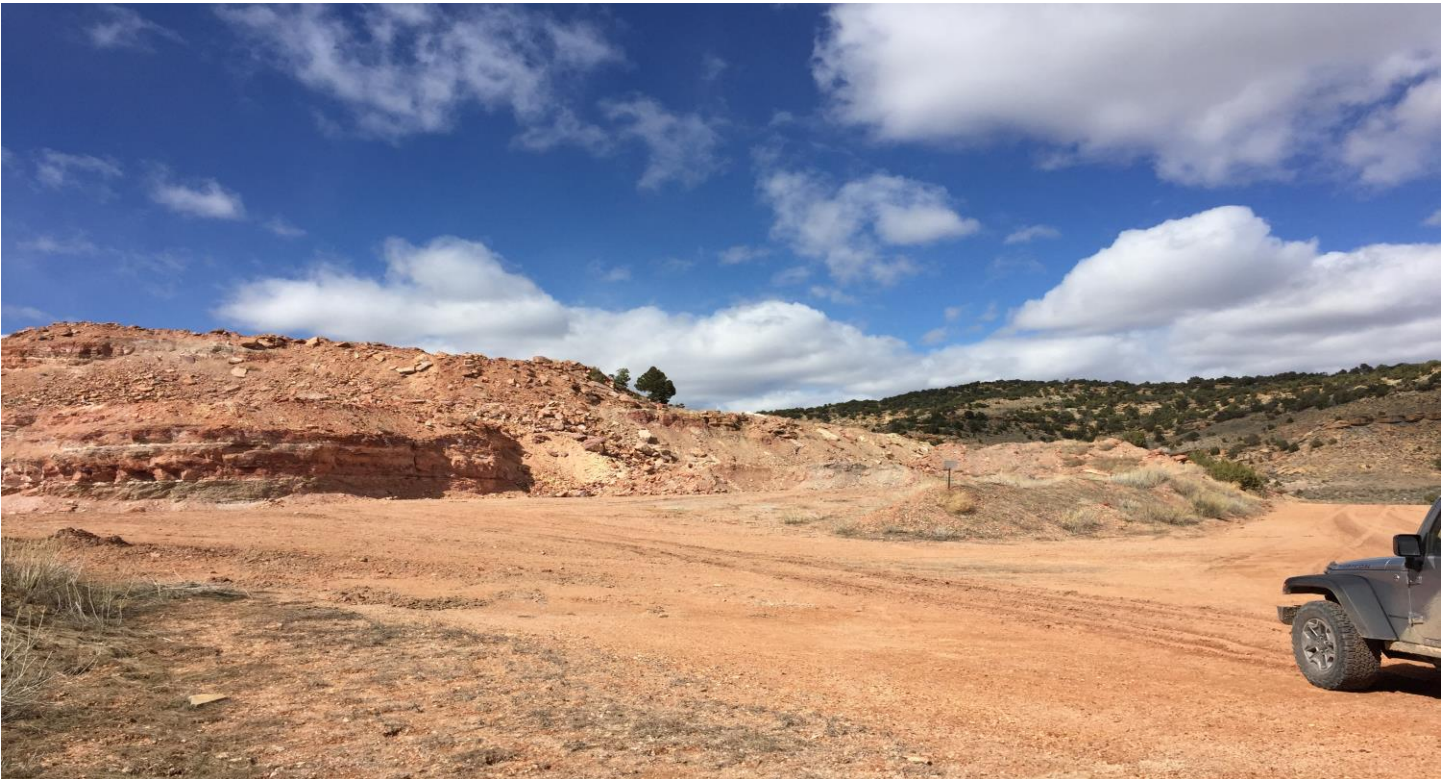
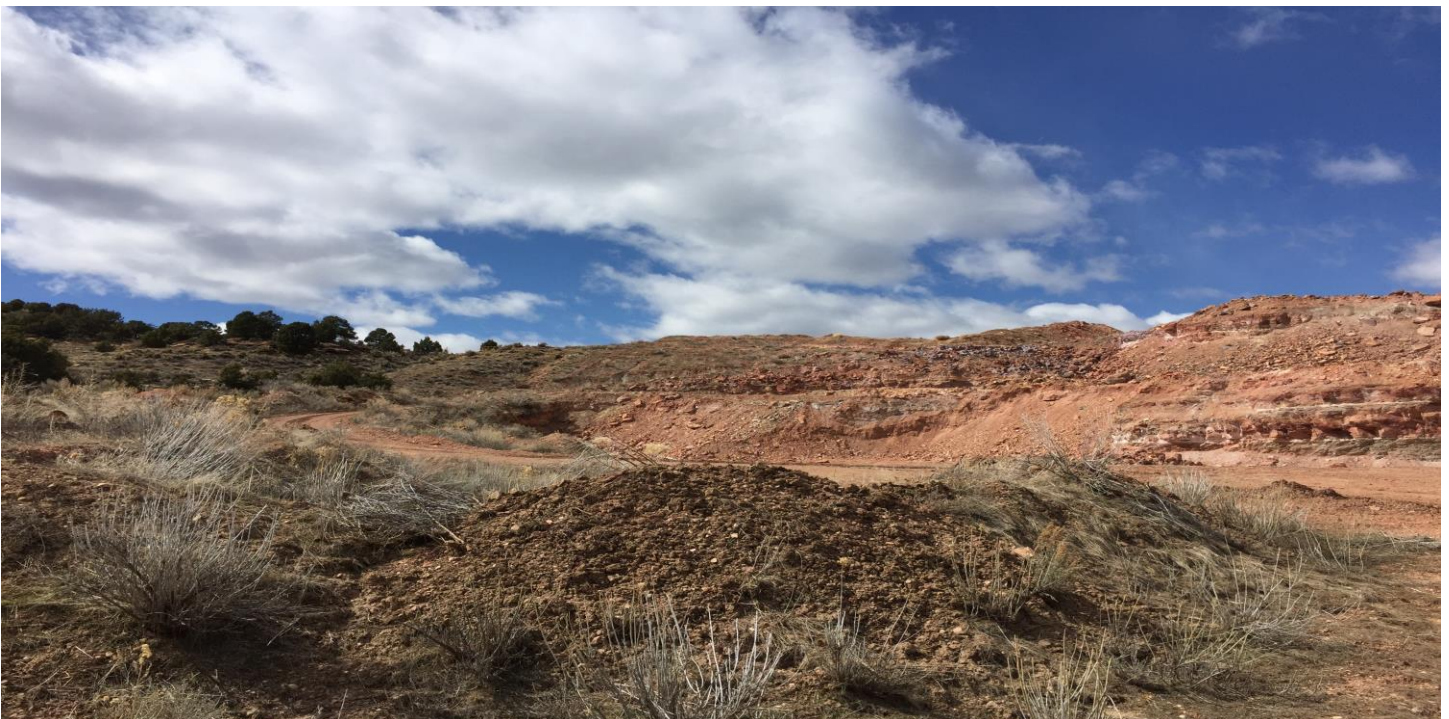
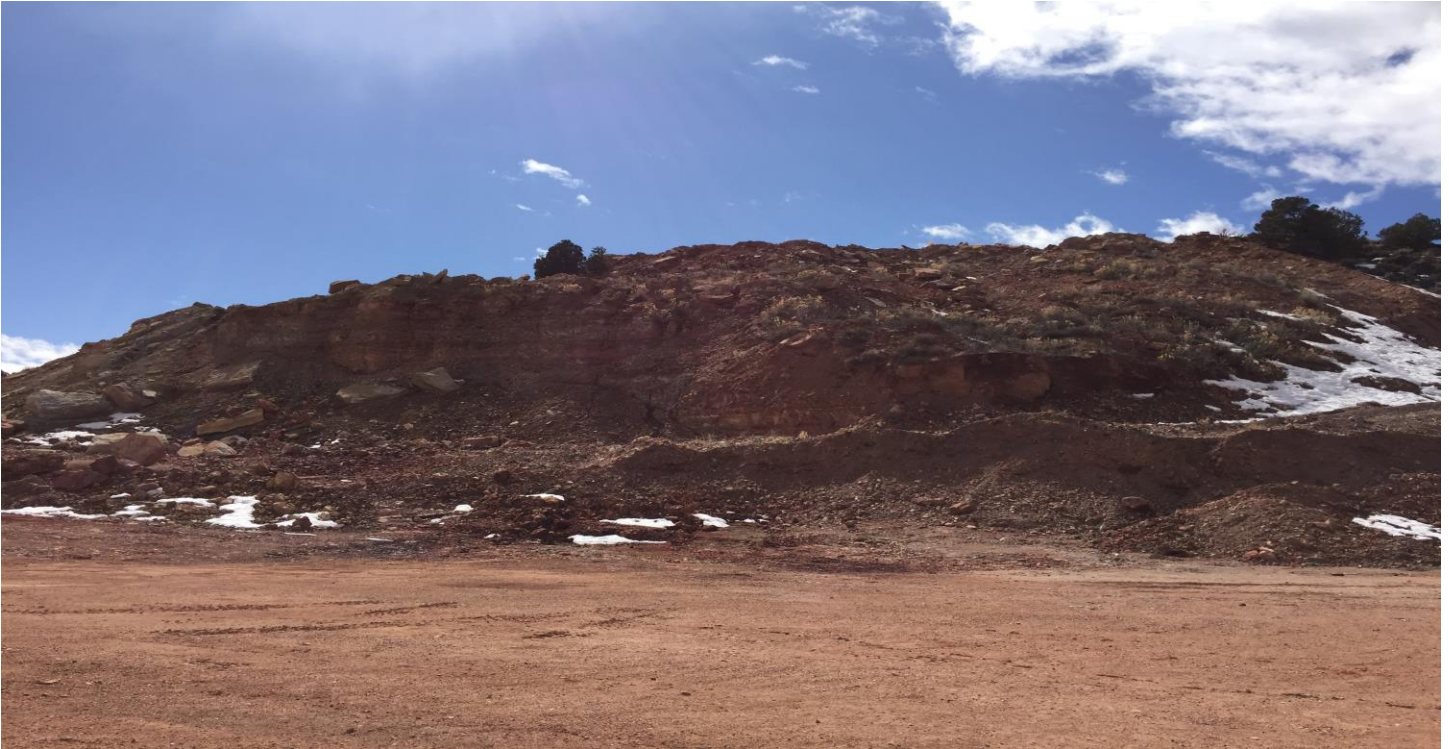
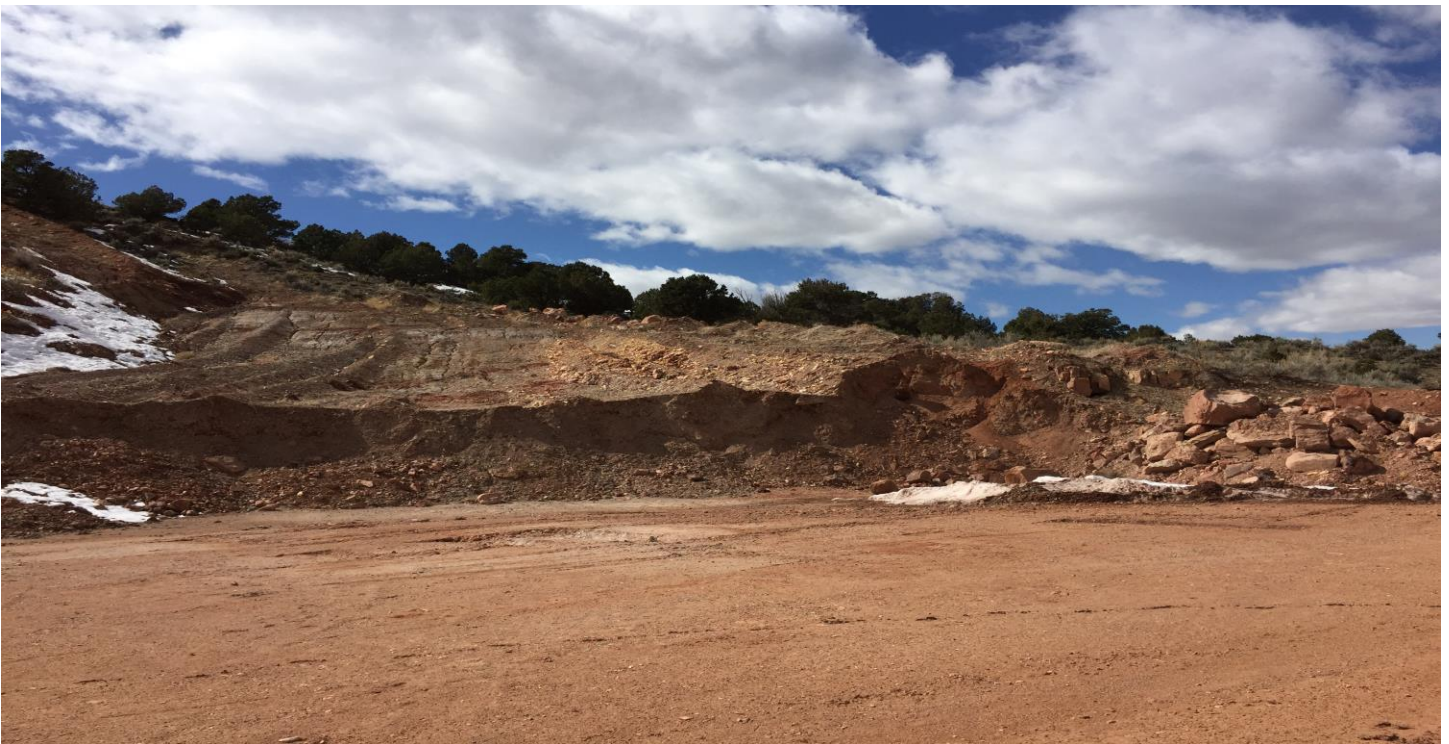
PHOTOGRAPHS

The mine is active and evidence of recent excavation was observed at the mine site. Various stockpiles of construction materials were observed within the permit area. It appeared that some of the final grade was being established along the southern permit boundary. It also appeared that the mine was close to being mined out.

No evidence of erosion or off site damage was observed during the inspection.
