**COLORADO DIVISION OF RECLAMATION, MINING AND SAFETY**  
**MINERALS PROGRAM INSPECTION REPORT**  
**PHONE: (303) 866-3567**

<b>MINE NAME:</b> Baxter Pass Gravel Pit	<b>MINE/PROSPECTING ID#:</b> M-2000-037	<b>MINERAL:</b> Gravel	<b>COUNTY:</b> Rio Blanco
<b>INSPECTION TYPE:</b> Monitoring	<b>INSPECTOR(S):</b> Travis H. Marshall	<b>INSP. DATE:</b> March 16, 2016	<b>INSP. TIME:</b> 15:00
<b>OPERATOR:</b> Rio Blanco County	<b>OPERATOR REPRESENTATIVE:</b> Clint Chappell	<b>TYPE OF OPERATION:</b> 110c - Construction Limited Impact

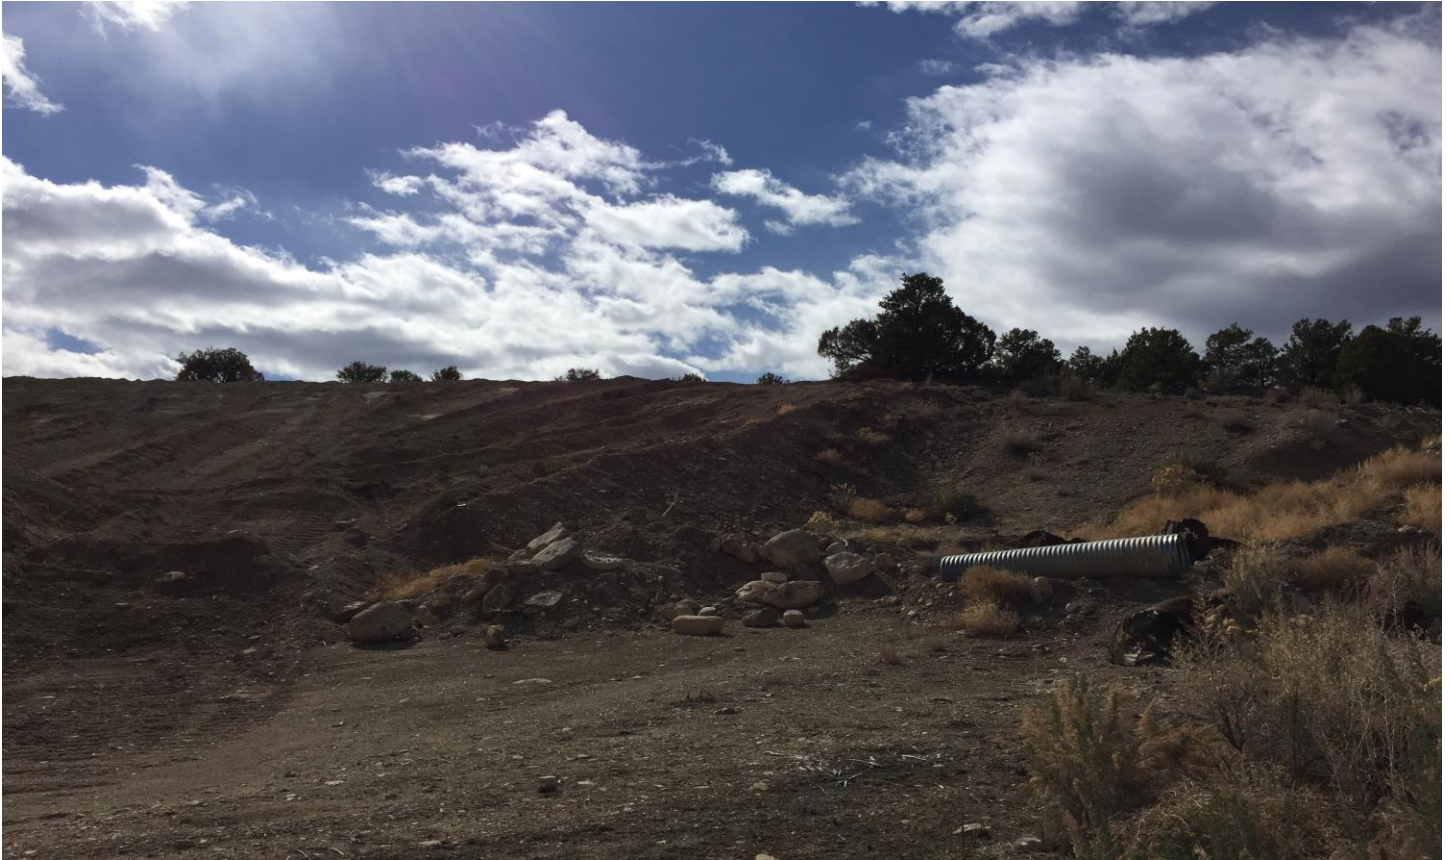
The mine is active and evidence of recent excavation was observed at the mine site. Various stockpiles of construction materials were observed within the permit area. It appeared that some of the final grade was being established along the southern permit boundary. It also appeared that the mine was close to being mined out.
