**COLORADO DIVISION OF RECLAMATION, MINING AND SAFETY**  
**MINERALS PROGRAM INSPECTION REPORT**  
**PHONE: (303) 866-3567**

<b>MINE NAME:</b> Cresson Project	<b>MINE/PROSPECTING ID#:</b> M-1980-244	<b>MINERAL:</b> Gold	<b>COUNTY:</b> Teller
<b>INSPECTION TYPE:</b> Aerial Inspection	<b>INSPECTOR(S):</b> Timothy A. Cazier	<b>INSP. DATE:</b> March 24, 2016	<b>INSP. TIME:</b> 11:40
<b>OPERATOR:</b> Cripple Creek & Victor Gold Mining Compar	<b>OPERATOR REPRESENTATIVE:</b> None	<b>TYPE OF OPERATION:</b> 112d-3 - Designated Mining Operation

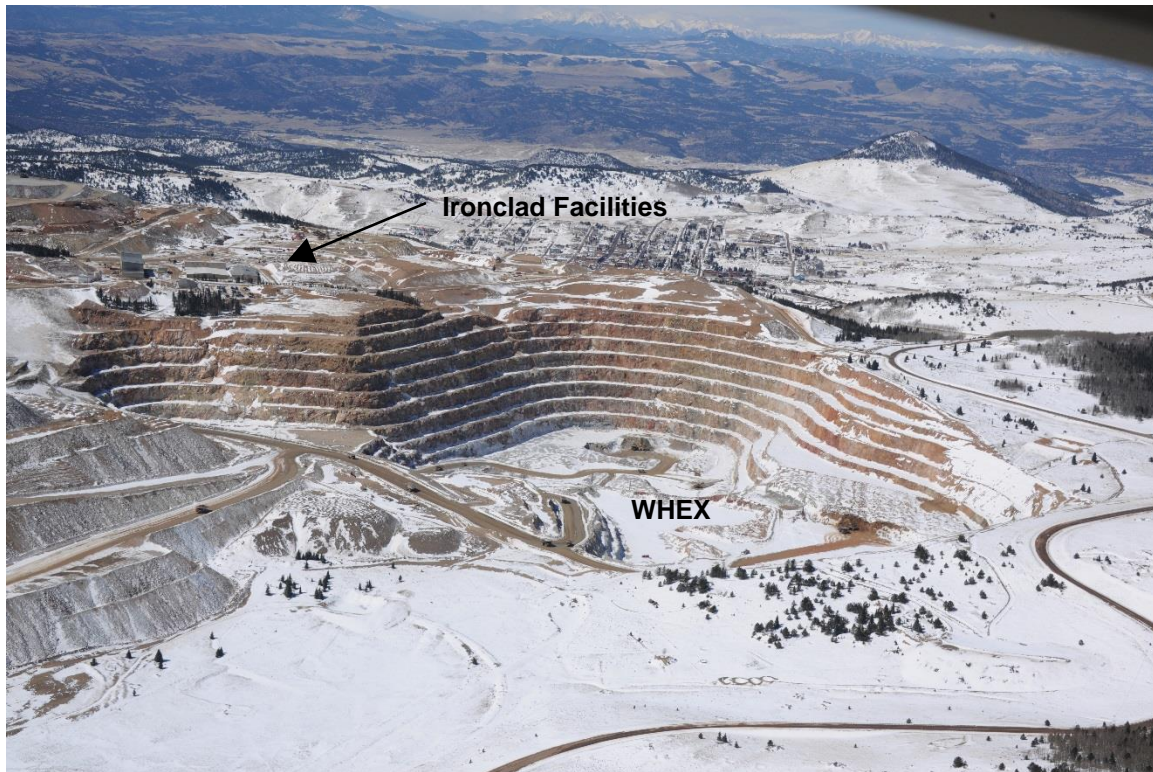
Photo 1. Wildhorse Extension Pit (Looking west).

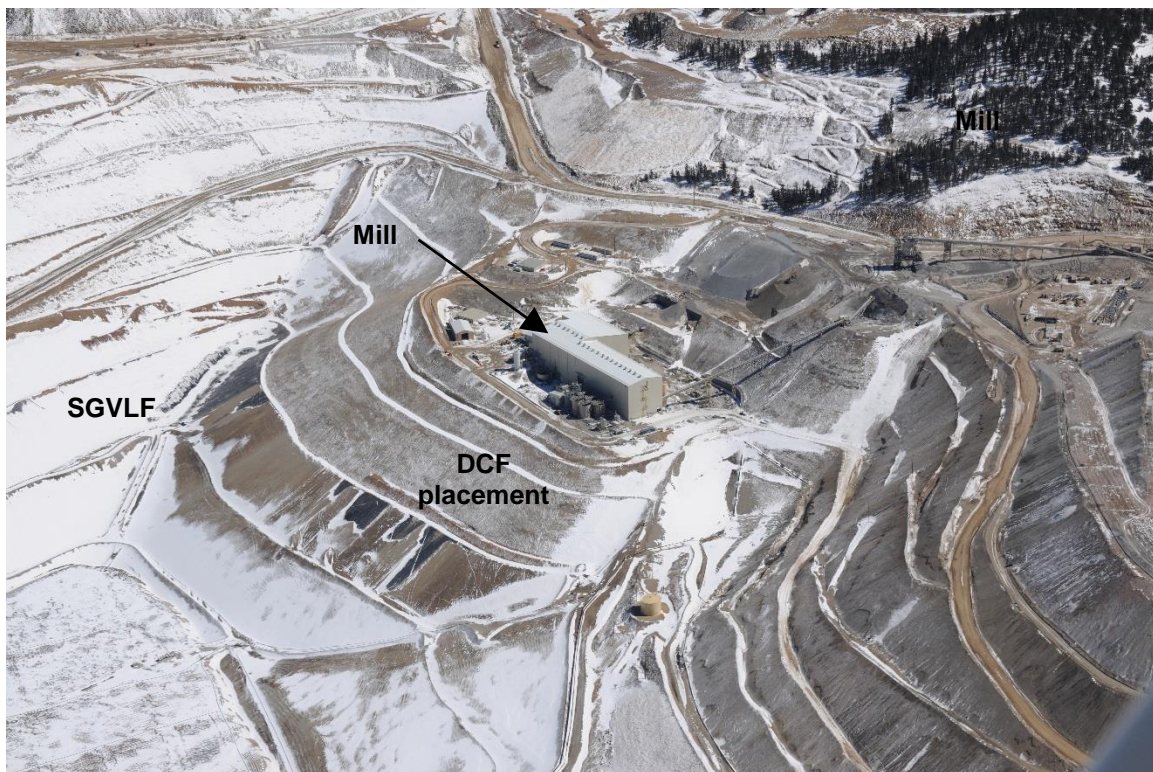
Photo 2. High Grade Mill (Looking NE).

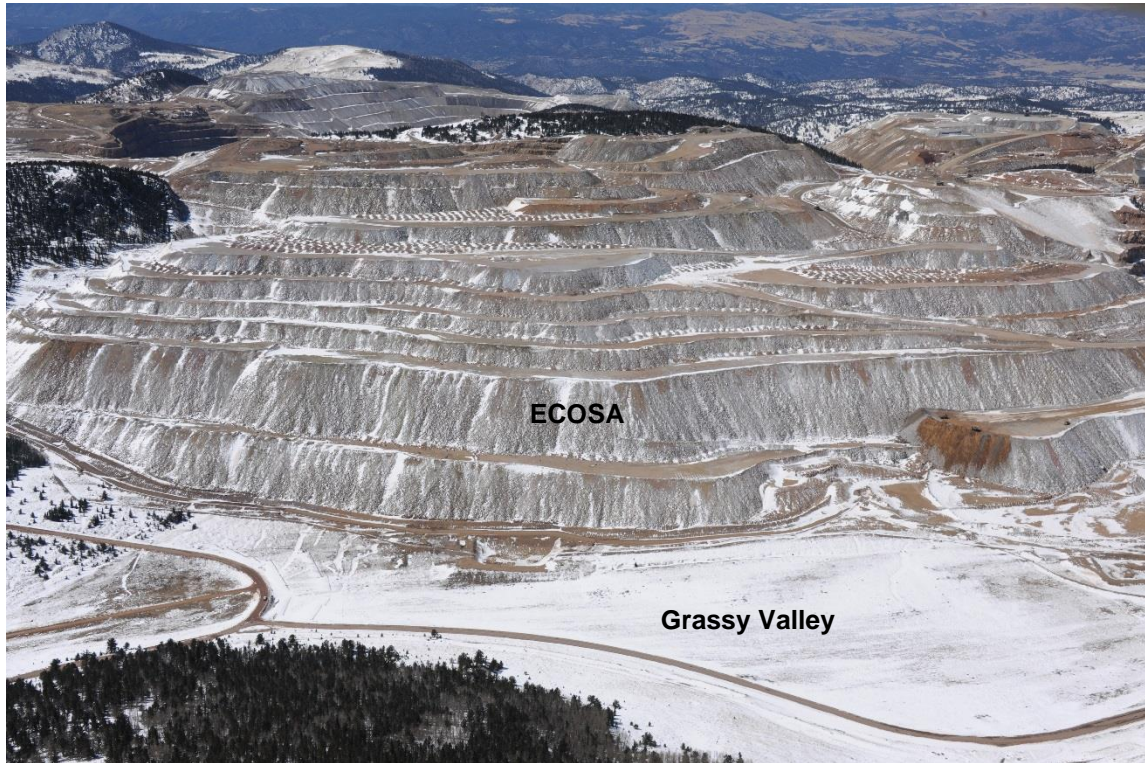
Photo 3. East Cresson OSA (looking SW).

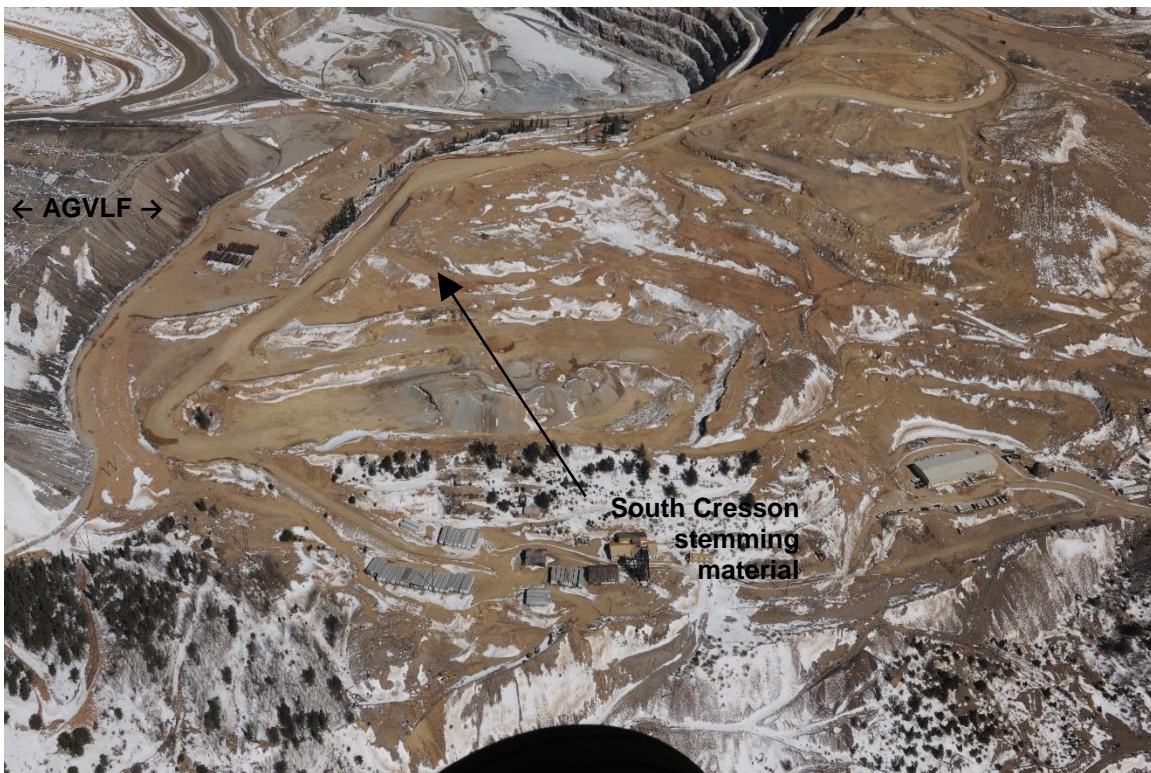
Photo 4. South Cresson (looking north).

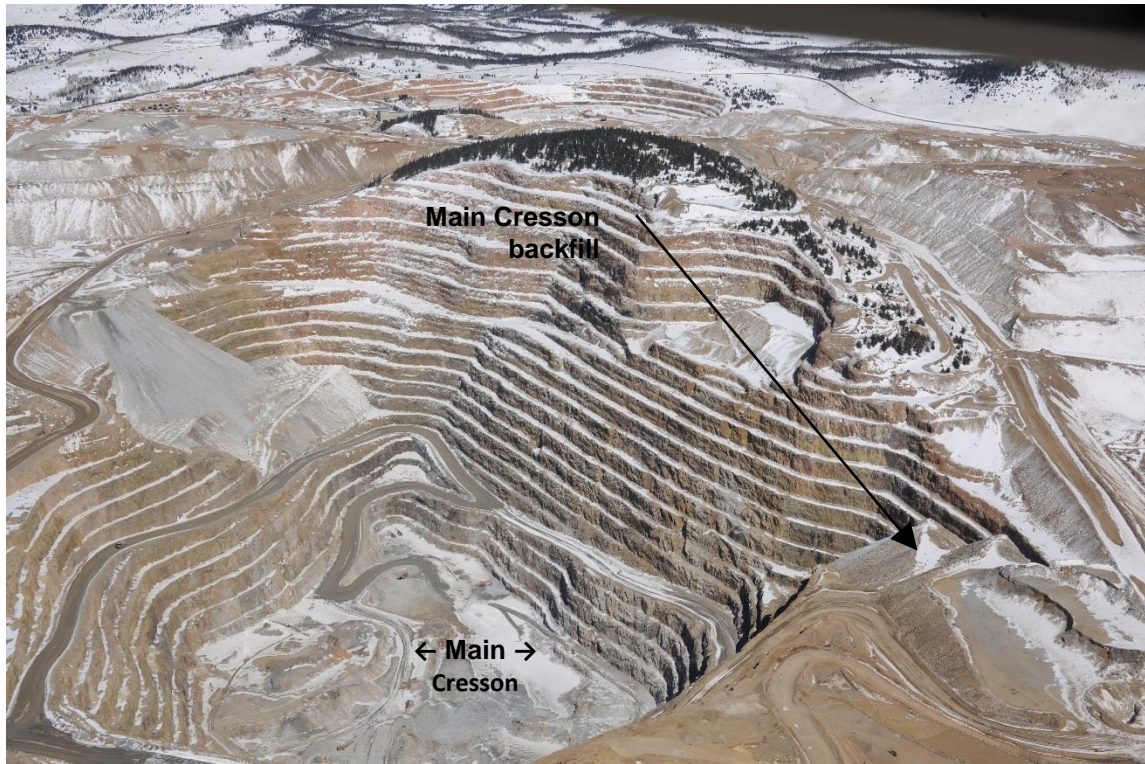
Photo 5. Main Cresson Pit (looking north).

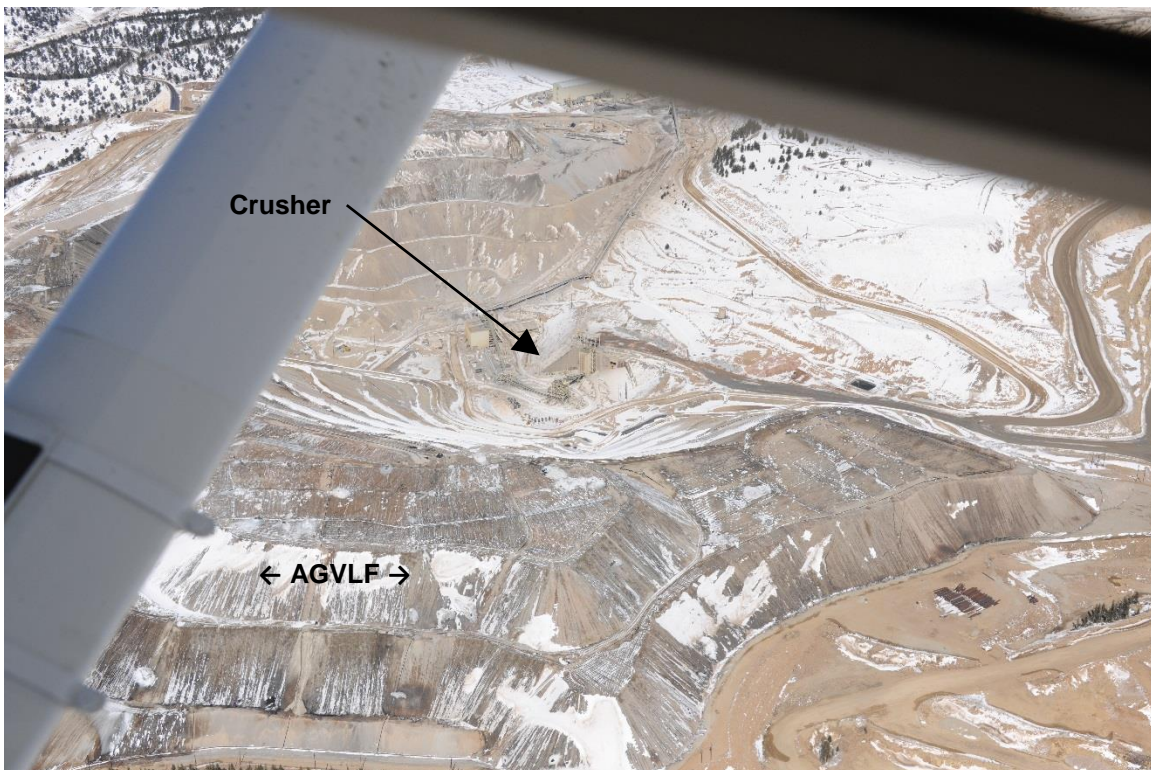
Photo 6. Arequa Gulch VLF (looking NW).

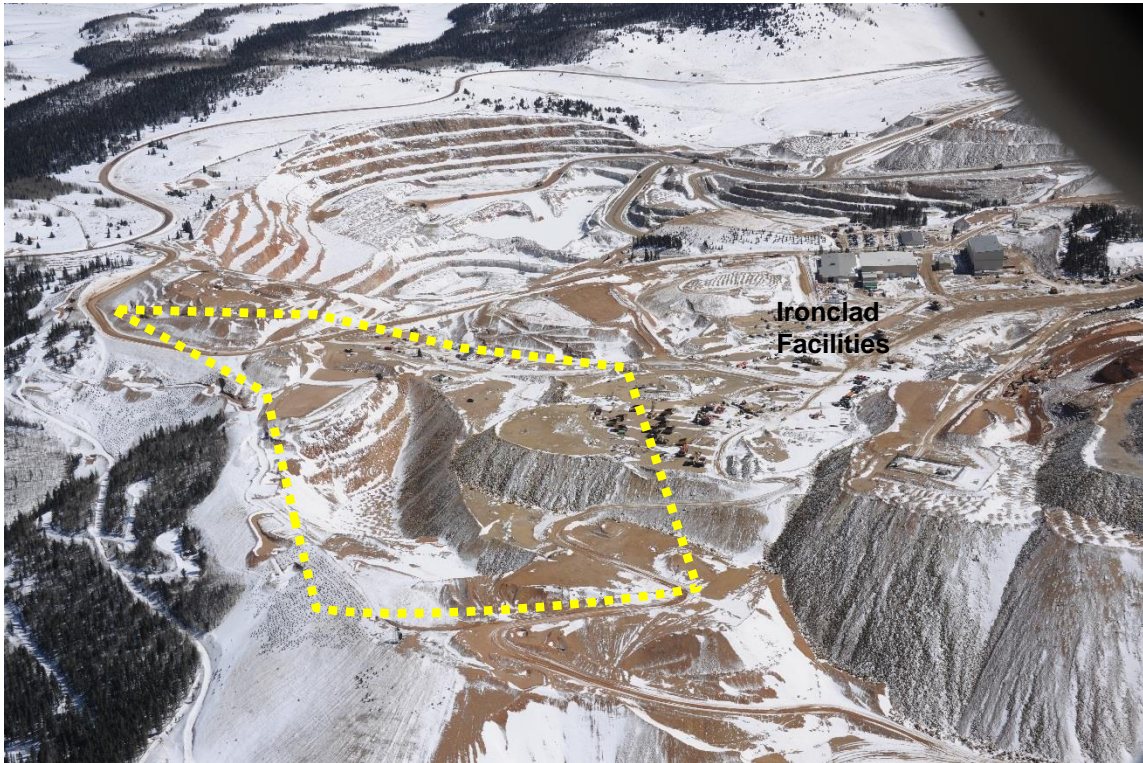
Photo 7. North Cresson (future pit area – looking NE).

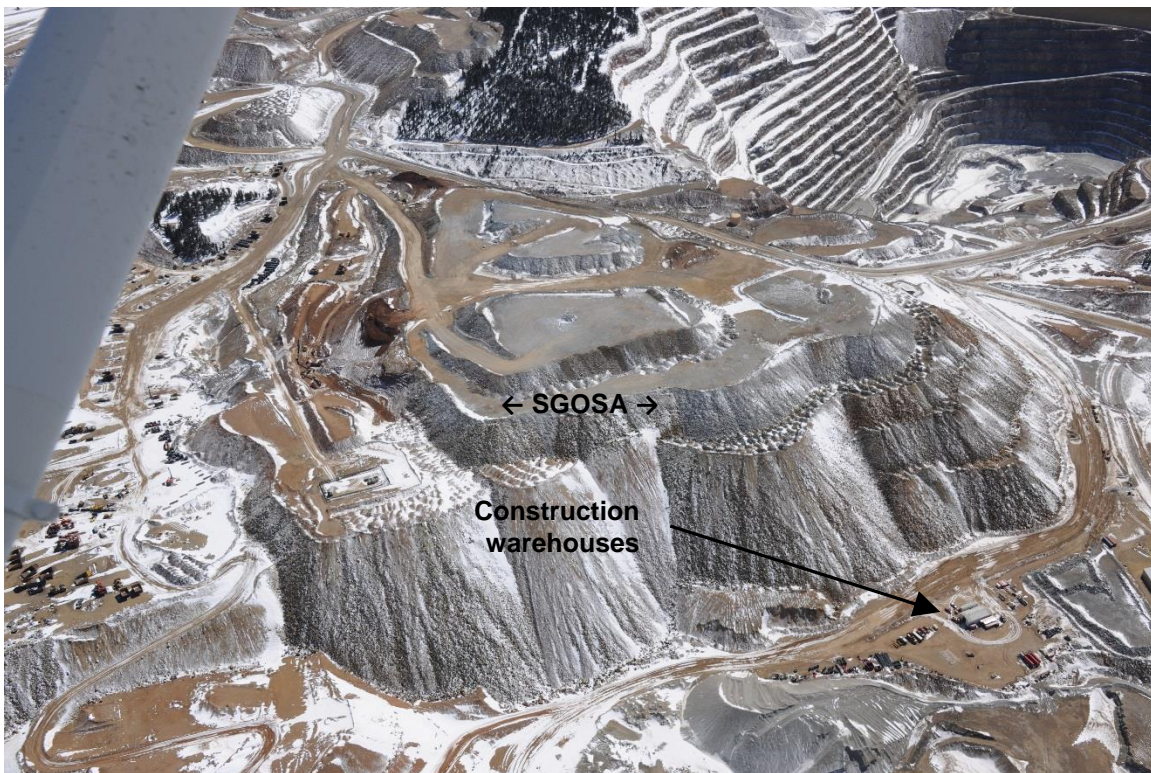
Photo 8. Squaw Gulch OSA (Looking SE).

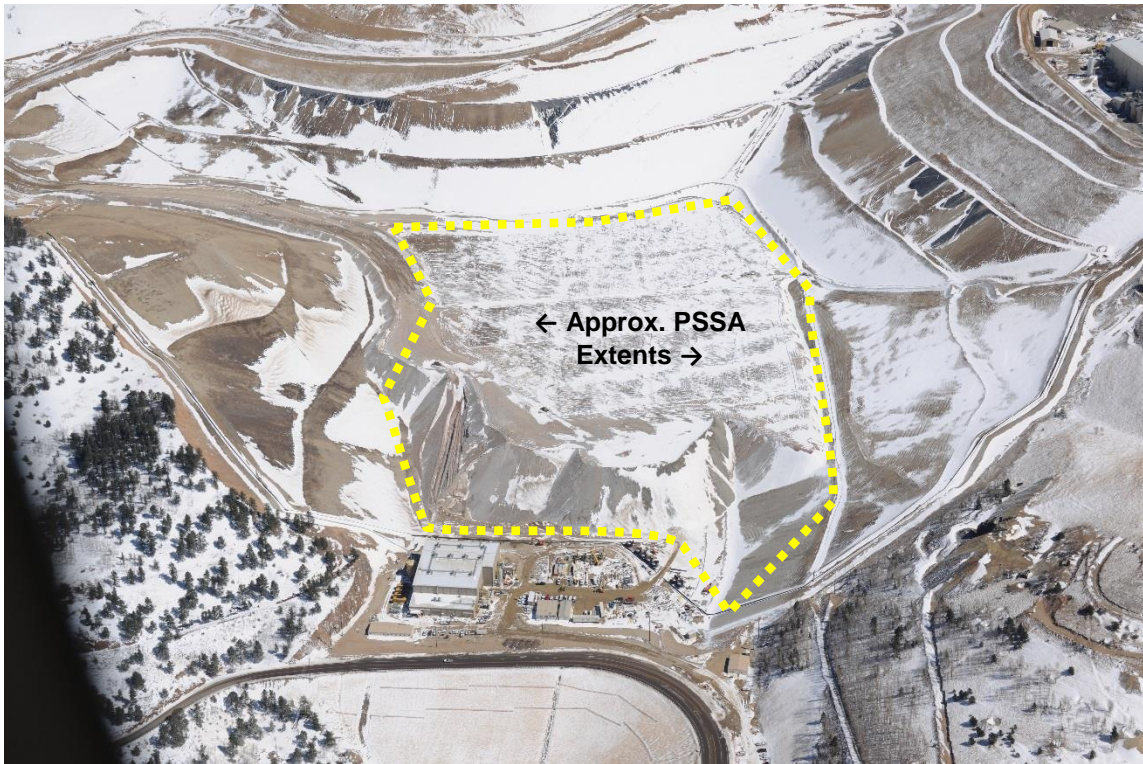
Photo 9. Squaw Gulch VLF – no exposed water in PSSA (Looking NE).

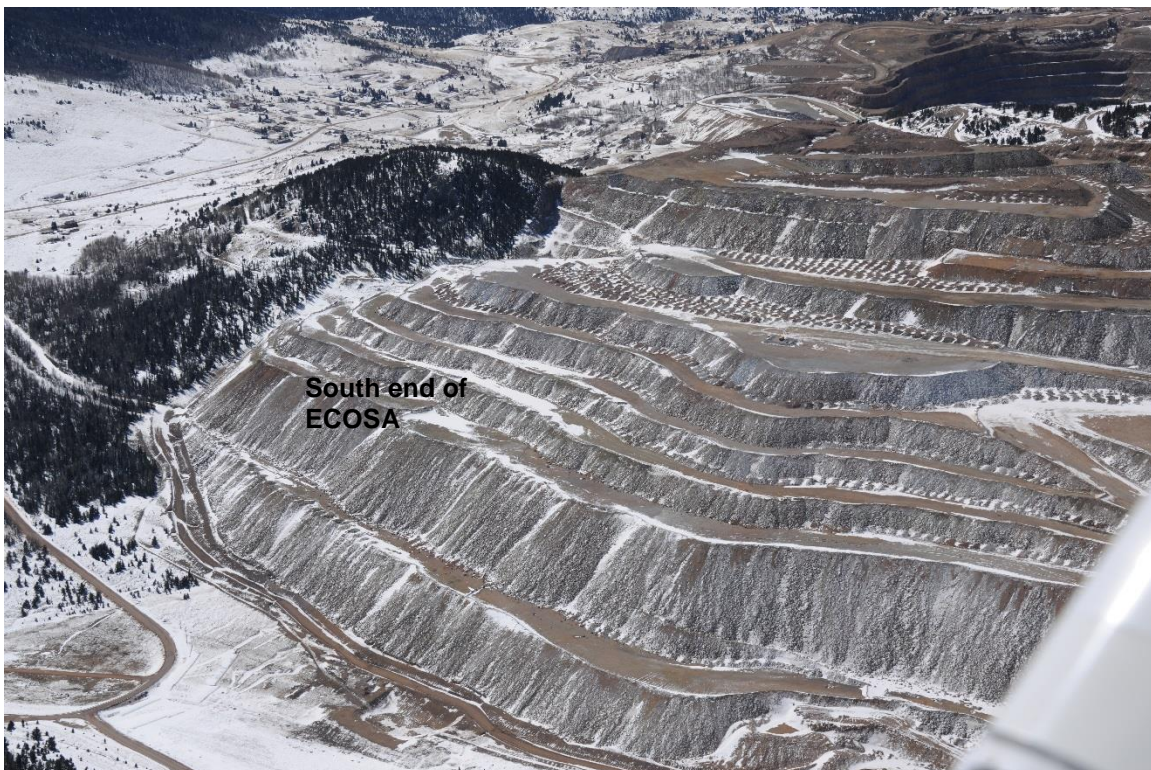
Photo 10. ECOSA – southern extents (looking south).
