COLORADO DIVISION OF RECLAMATION, MINING AND SAFETY
MINERALS PROGRAM INSPECTION REPORT
PHONE: (303) 866-3567

MINE NAME: Grand River Park Project	MINE/PROSPECTING ID#: M-2006-046	MINERAL: Sand and gravel	COUNTY: Garfield
INSPECTION TYPE: Monitoring	INSPECTOR(S): Amy C. Yeldell	INSP. DATE: March 23, 2016	INSP. TIME: 08:00
OPERATOR: Silt Sand & Gravel, LLC	OPERATOR REPRESENTATIVE: Sean Mello	TYPE OF OPERATION: 112c - Construction Regular Operation

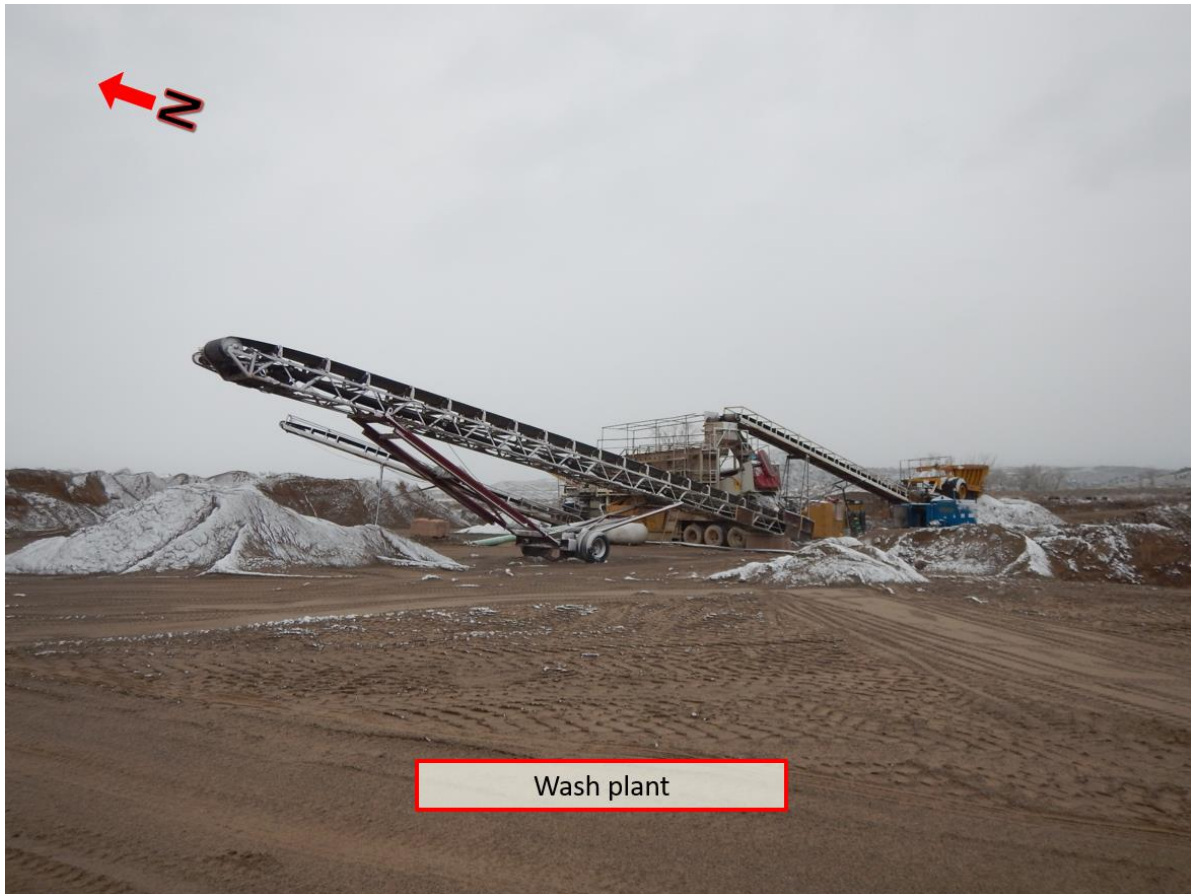
Wash plant

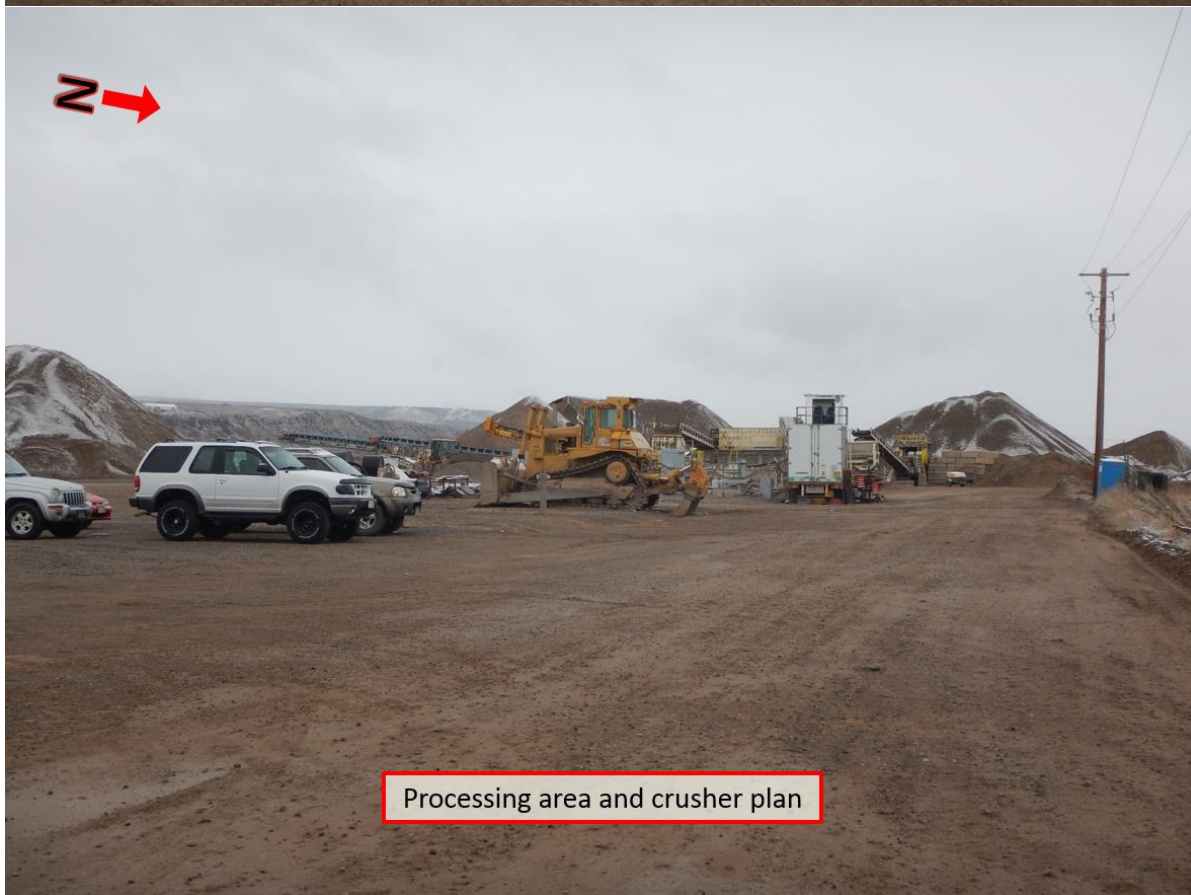
Processing area and crusher plant
